1 RADSTOCK COTTAGE, READING

PART NORTH WEST ELEVATION  
TIMBER FRAME REPAIRS AND  
WORK SEQUENCE

| REV | Drawn | Chkd | Appd | date | description |
|---|---|---|---|---|---|
| DRAWING NUMBER: | | | | | 23093-SFK-RAD-XX-DR-S-0101 |

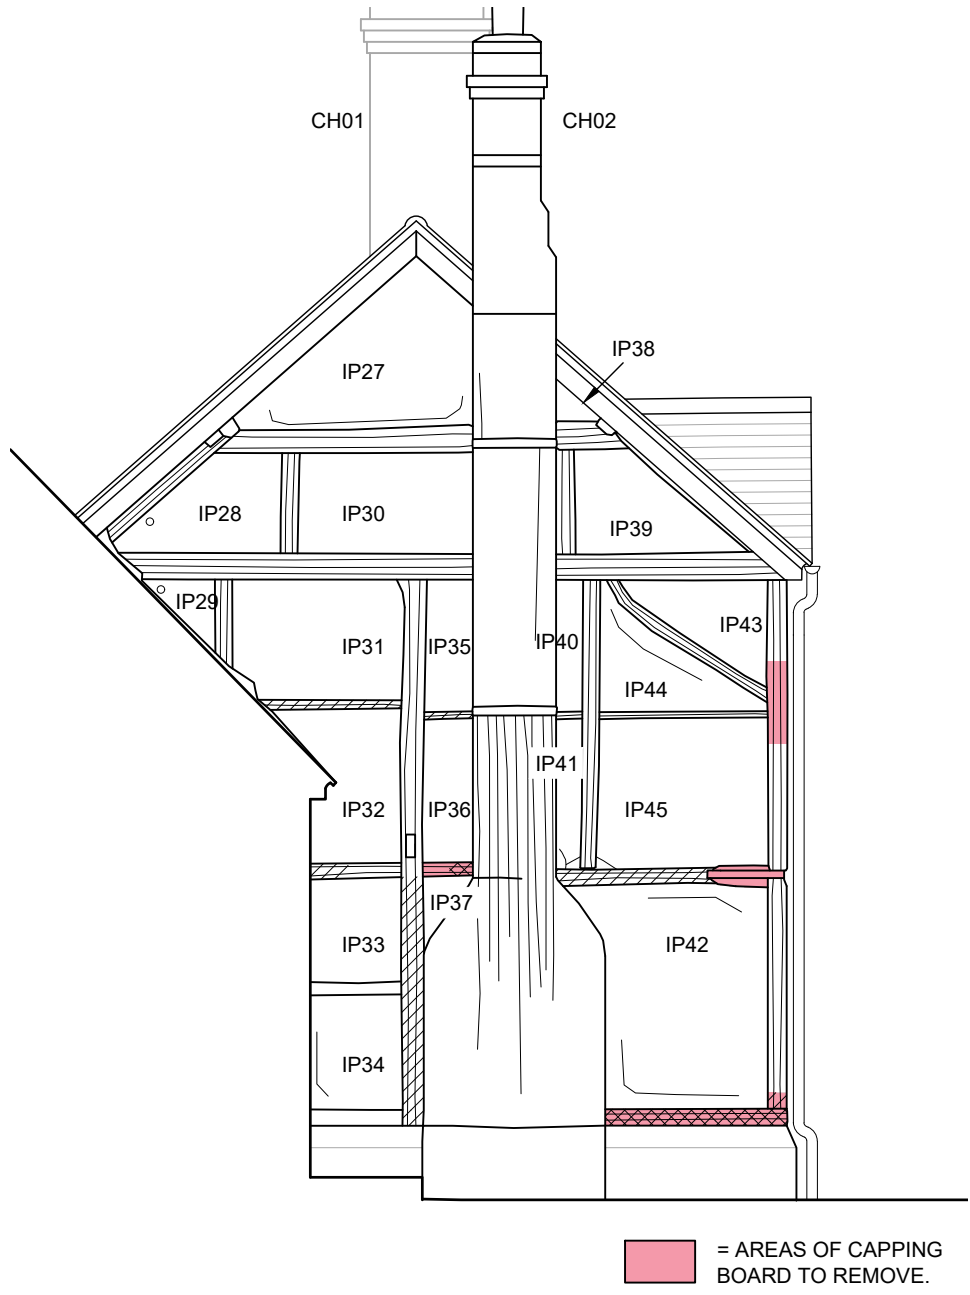
STEP 1

- CAREFULLY REMOVE EXISTING TIMBER CAPPING BOARDS. THESE ARE CURRENTLY NAILED ON.

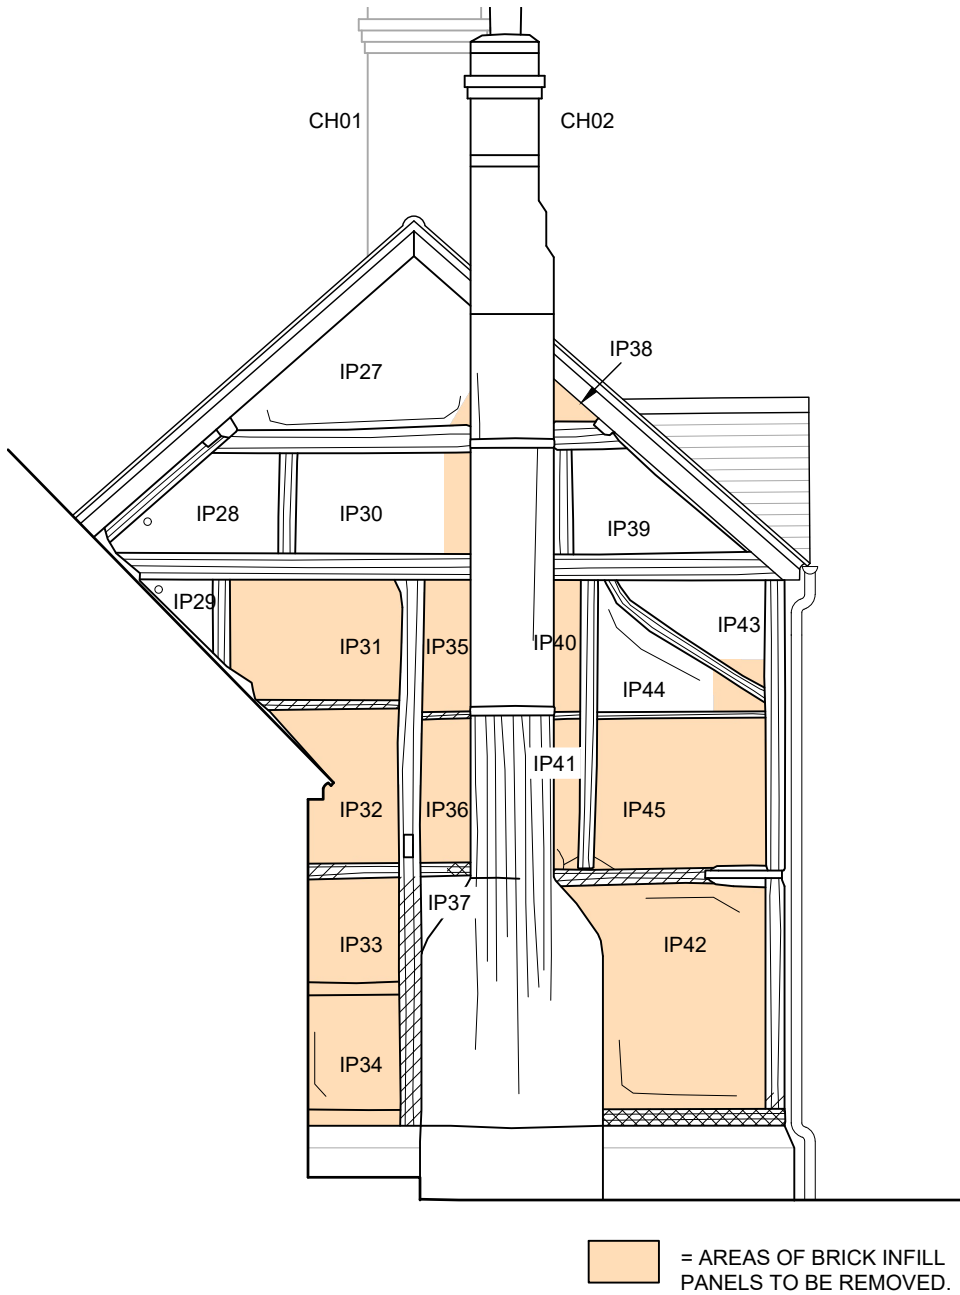
STEP 2

- CAREFULLY REMOVE BRICK INFILL PANELS TO ENABLE THE TIMBERS TO BE ACCESSED AND REPAIRED.
- ALLOW FOR TEMPORARY PROPPING TO PANELS ABOVE THOSE REMOVED.

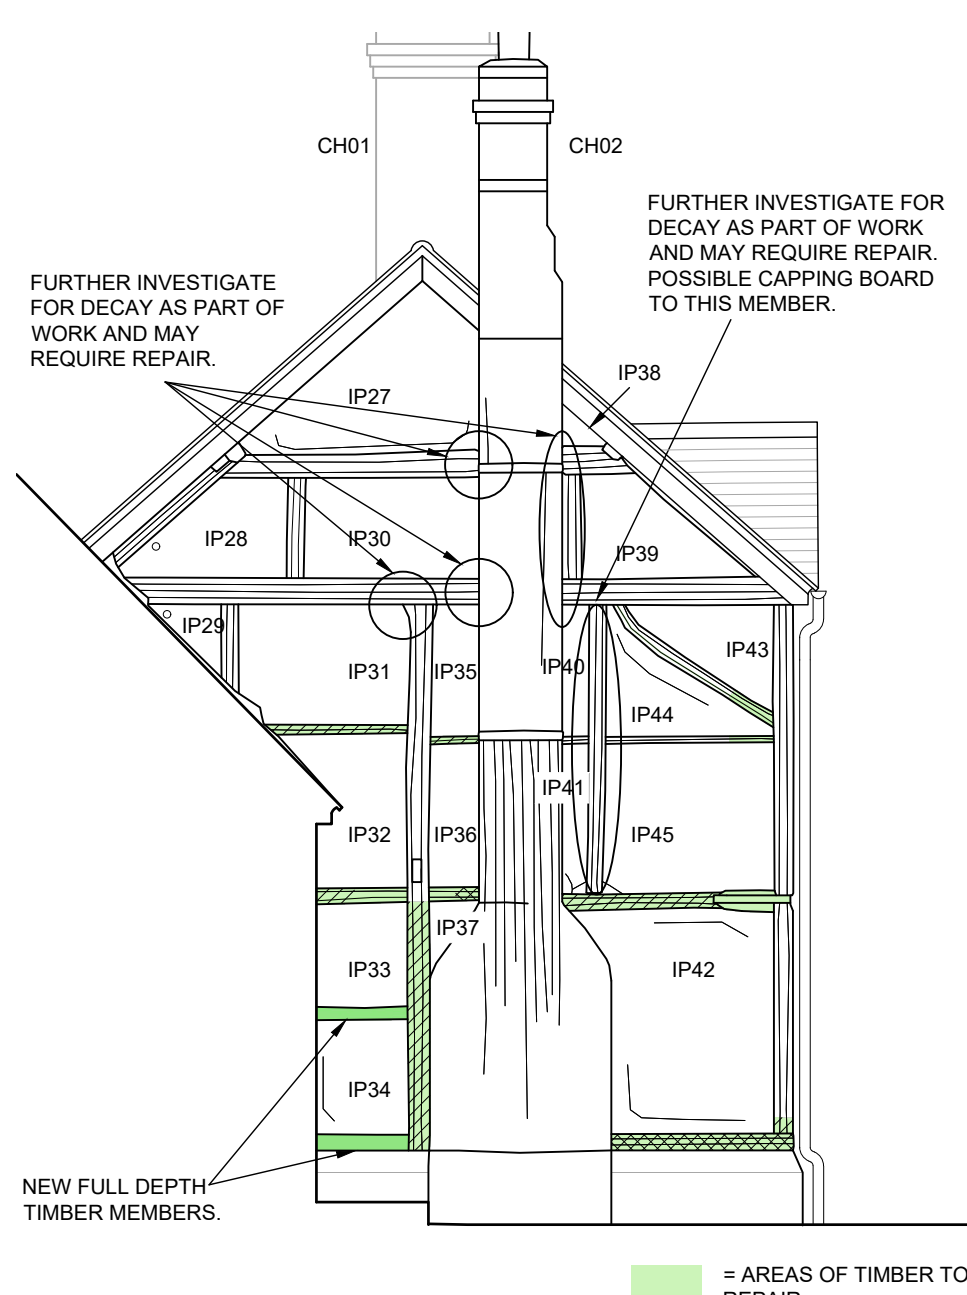
STEP 3

- CARRY OUT TIMBER REPAIRS.
- REFER TO SFK DRAWING 23093-0102 FOR REPAIR DETAILS.

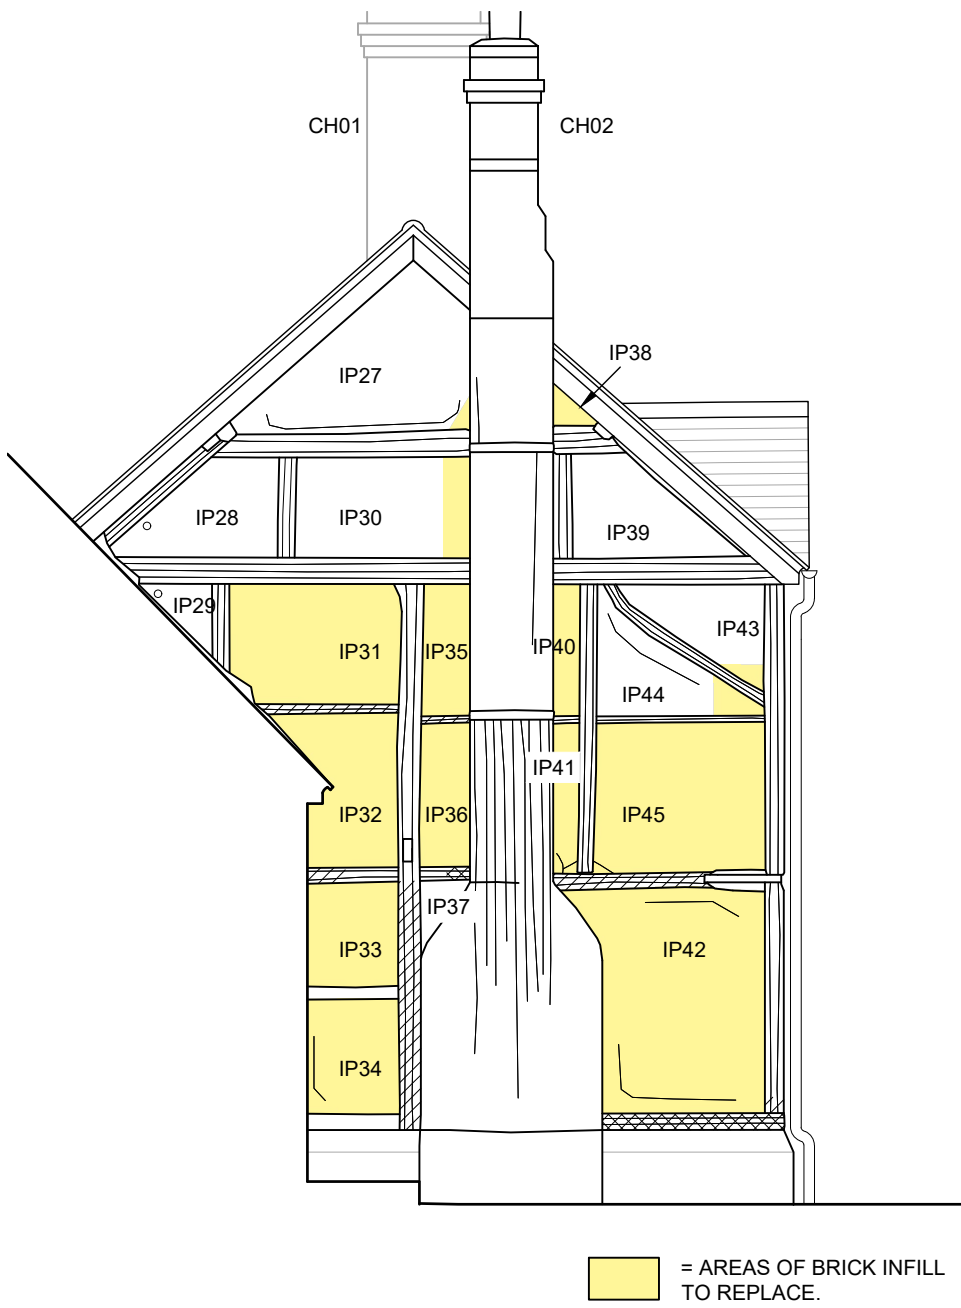
STEP 4

- REPLACE BRICK INFILL PANELS AND RENDER TO ARCHITECT'S RECOMMENDATIONS.

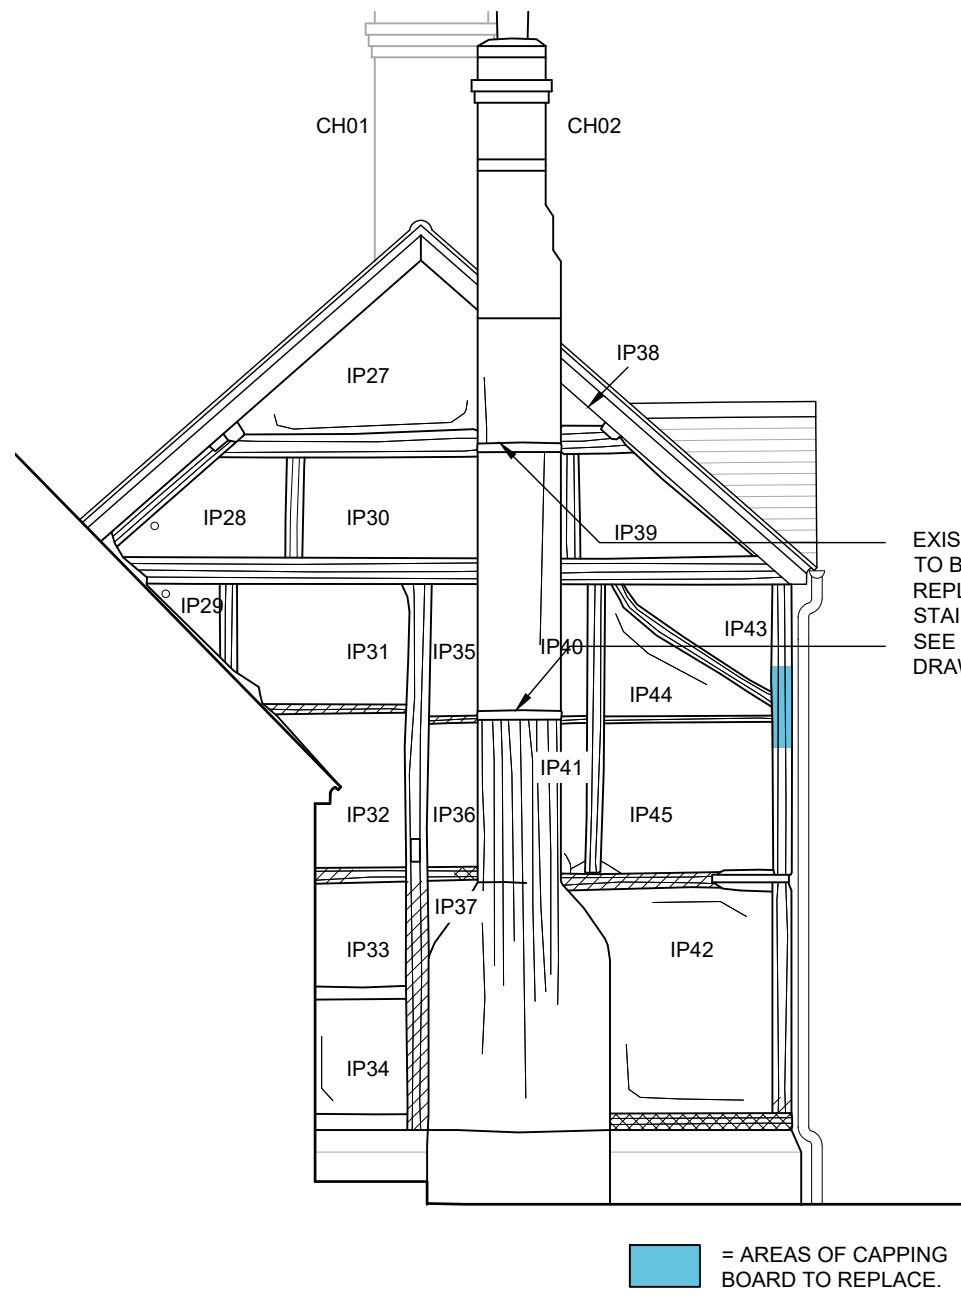
STEP 5

- REPLACE CAPPING BOARDS. REFER TO DETAILS ON SFK DRAWING 23093-0102.
