# BRE365 SOAKAGE TESTING AT GROVELANDS ROAD, READING, BERKSHIRE, RG7 1DP.

H2Ogeo Reference: 20260513P2

Date: 5 June 2026

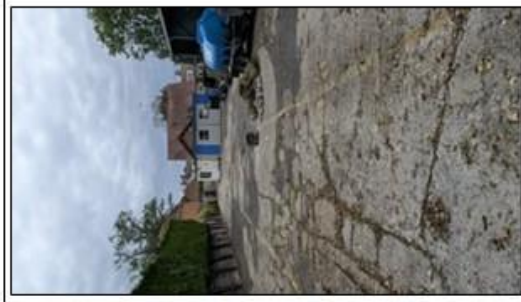
Figure 2 - Site Photos

| | Looking East | | SA1 Test Pit | | Excavated Clay material | | Surface water drainage features | | Anticipated conveyance |

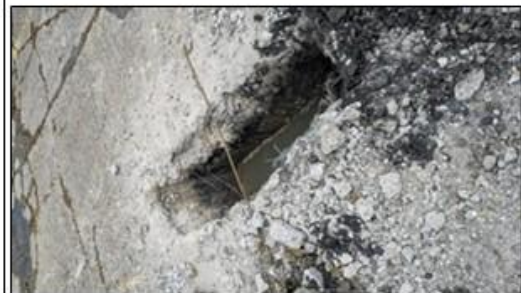
Following excavation, TP1 was filled to 0.5 metres below ground level (mbgl) with clean water then levels recorded at defined time intervals to capture the rate of infiltration through the soils.

Only one test took place that was abandoned following 4 hours of testing with a fall of only 0.03m during the testing duration. On completion the pit was backfilled.

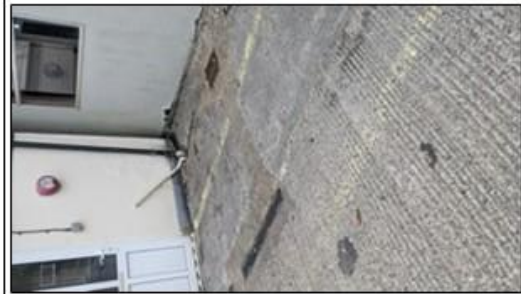
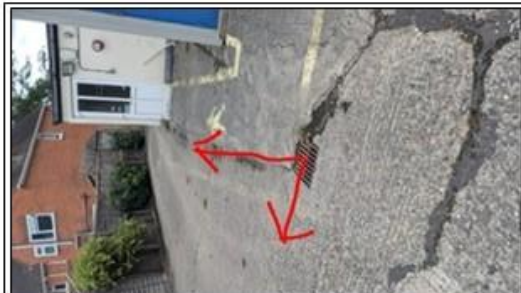
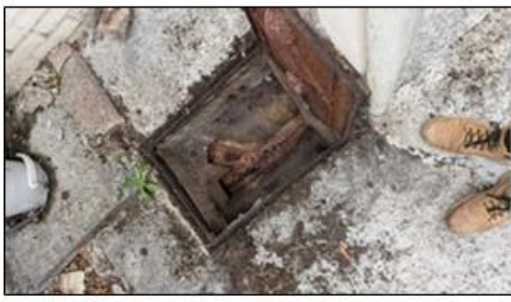
Surface water drainage features were noted on site and these are presented in the photo log with anticipated flow directions towards the front access and egress.

| | | | | | Surface water drainage feature | | | | |

Subsequent drainage assessments should evaluate the feasibility of discharge to nearby watercourses or other suitable receiving systems, incorporating appropriate attenuation and flow control measures to ensure that post-development runoff rates do not increase flood risk either on-site or elsewhere within the catchment.

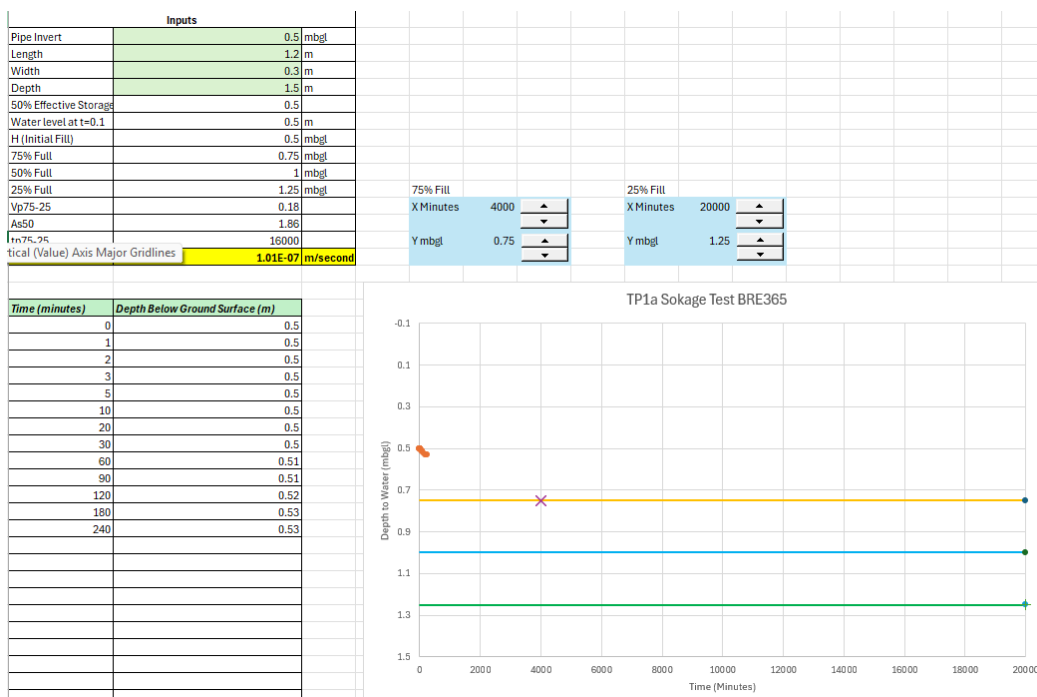
### SA1 - Calculations

The single test did not reach completion (25 to 75% effective storage) over a 4-hour period and therefore the 25 and 75% empty period has been projected.

The single test carried out on the 5 June 2026 failed BRE365. The test did not reach the 25% and 75% drain down thresholds and therefore the values have been projected graphically and the resultant infiltration value is  $1.01 \times 10^{-07} \text{m/sec}$  or  $3.63 \times 10^{-04} \text{m/day}$ .
