**Ref: Property demolition and construction of new dwelling at 43 Old Bath Road, Sonning.**

The Ecology Co-op undertook a bat scoping assessment at 43 Old Bath Road on the 3<sup>rd</sup> of January 2024 at the request of Arif Mohammed. This assessment was undertaken further to a proposal to demolish the current property including the detached garage, and construct a new dwelling. The survey was undertaken in accordance with best practice guidance produced by the Bat Conservation Trust<sup>1</sup>.

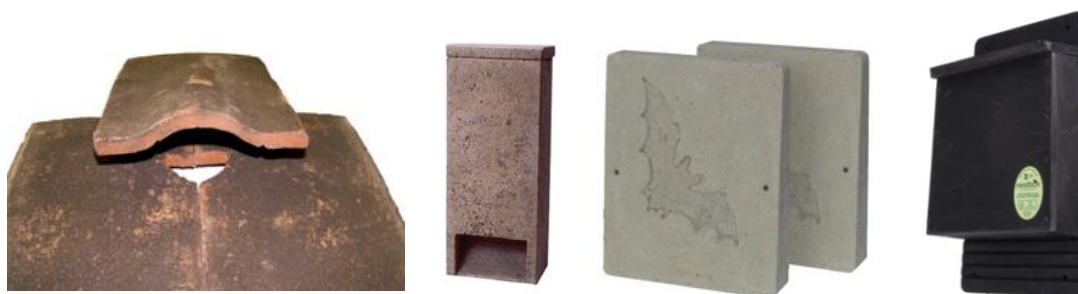
**Bat Access Tile Set, 2FR Schwegler Bat Tube, 2FE Schwegler Wall-Mounted bat shelters and Improved Crevice Bat Box.**

Additionally, the site can be enhanced for bats by incorporating the features below into the fabric of the buildings. Where bat access tiles are used, only a Type 1F bitumen lining must be used instead of modern breathable membranes such as Tyvec, which over time fray and entangle bats. The bat boxes and features should be installed under the instruction of a suitably licensed ecologist to ensure that the positioning is optimal, but generally locations above 3.5m in the most southeasterly facing aspect of the building would be best.

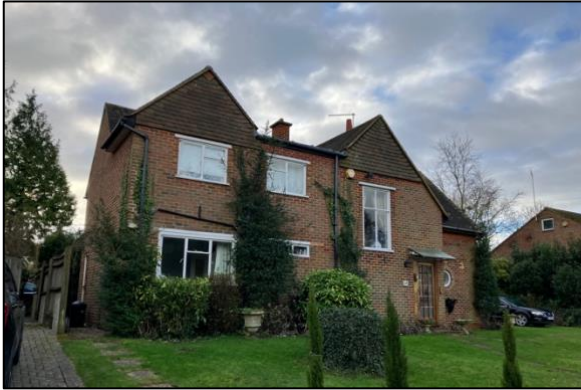
| Building section | Description of features | Assessment of suitability (Collins 2016) |
|---|---|---|
| Main house – exterior | <p>The house is a brick-built detached property, approximately 70 years old, with an intersecting pitched roof (Photograph 1). The northern and southern aspects are clad in clay hanging tiles, and an orangery-style ground-floor extension on the western aspect. The windows and doorframes are uPVC.</p> <p>On the front (northern) aspect all hanging and roof tiles are well appointed and in place (Photograph 2). All lead flashing is in place, and all brickwork is in good condition. On the western aspect, there is some lifted lead flashing on the roof of the orangery (Photograph 3). On the</p> | Low bat roost suitability |

**Photograph 1.** The front elevation of the property.

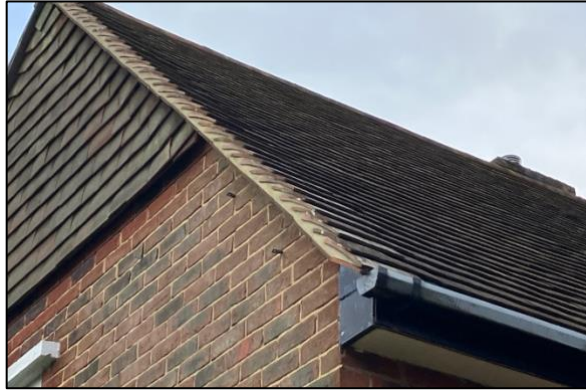
**Photograph 2.** Flush roof and hanging tiles on the front aspect.

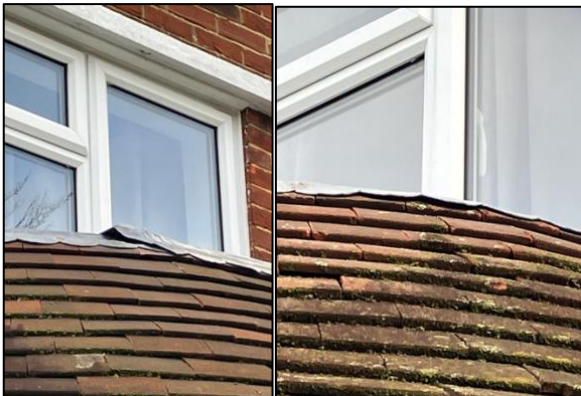
**Photograph 3.** Raised lead flashing on the roof of the orangery.

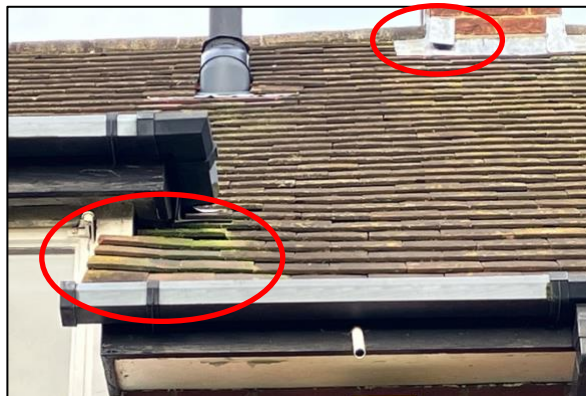
| Building section | Description of features | Assessment of suitability (Collins 2016) |
|---|---|---|
| | rear (southern) aspect all brickwork and soffits are in good condition. There is some raised lead flashing and the roof tiles have slipped in some places creating potential roosting features for use by bats (Photograph 4). On the eastern aspect all brickwork and soffits are in good condition. | |

**Photograph 4.** Raised lead flashing around the chimney and slipped roof tile on the rear aspect.

The identification of a bat roost would mean that careful timing of the development may be required in order to avoid impacts on bats, a precautionary 'soft strip' of tiles supervised by a licensed and suitably qualified bat ecologist and provision of permanent bat roosting features into the development may also be required, the nature of which will be dependent on the outcome of the one survey.

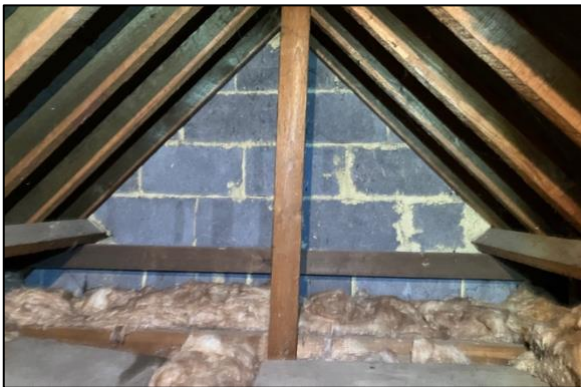
| Building section | Description of features | Assessment of suitability (Collins 2016) |
|---|---|---|
| Main house – interior | The house contains a loft void that is accessed through two hatches. The timber frame is protected with roofing felt, all in good condition with no nicks or tears (Photograph 5). All timber is also in excellent condition. The ceiling joists are covered with fibreglass insulation. The water heater for the property is present, maintaining the temperature of the void. Mice droppings and old wasps' nests are present in the void (Photograph 6), but no signs of bats were found. The presence of mice droppings indicates there is access to the void that has potential to be used by bats. | Low bat roost suitability |

**Photograph 5.** Loft void showing fibreglass insulation.

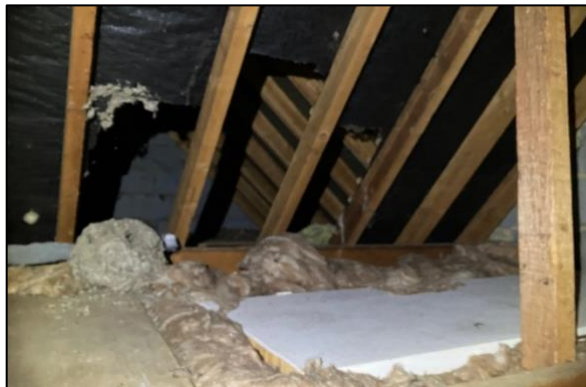
**Photograph 6.** Old wasps' nest and connectivity throughout the loft void.

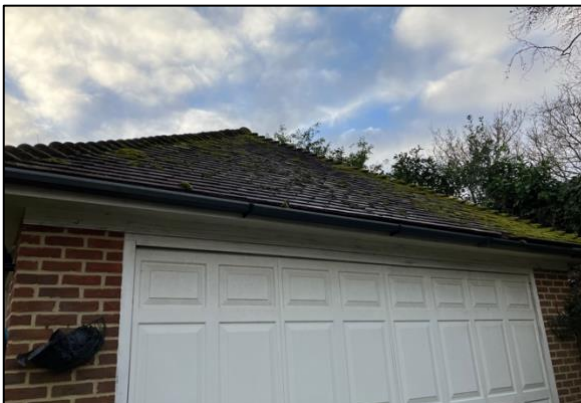
| Building section | Description of features | Assessment of suitability (Collins 2016) |
|---|---|---|
| Garage – exterior | The detached garage is brick-built with a pyramid hipped roof (Photograph 7). The roof field and hip tiles are all well-appointed with no gaps. The brickwork is in excellent condition. | Negligible bat roost suitability |

**Photograph 7.** Detached garage with flush roof tiles.

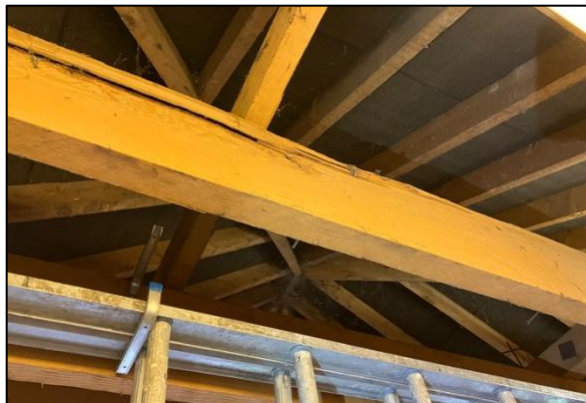
| Building section | Description of features | Assessment of suitability (Collins 2016) |
|---|---|---|
| Garage – interior | The interior of the garage does not contain a ceiling, so the rafters and roof lining are visible from the ground, and these are all in excellent condition with no cracks or tears (Photograph 8). The regular use of the garage by the homeowner greatly reduces the potential for bats to be roosting in here. The only visible access to the void is through the mechanical garage door. | Negligible bat roost suitability |

**Photograph 8.** Internal roof pitch of the garage.
