## Bat Emergence and Re-Entry Surveys (BERS)

155 Barkham Road, Wokingham, Berkshire, RG41 2RS

“The construction of a two storey roof extension including the removal of the dormer windows and the demolition of the existing garage”

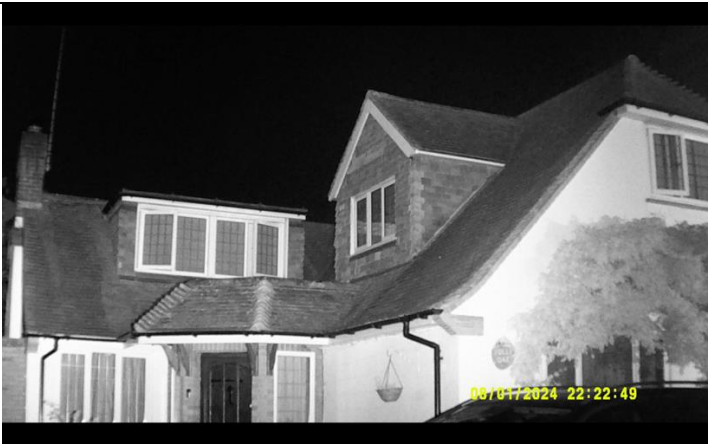
| <i>IR position 1</i> | The footage reflected the view of surveyor 1. No bat emergence or additional bat activity was recorded | |

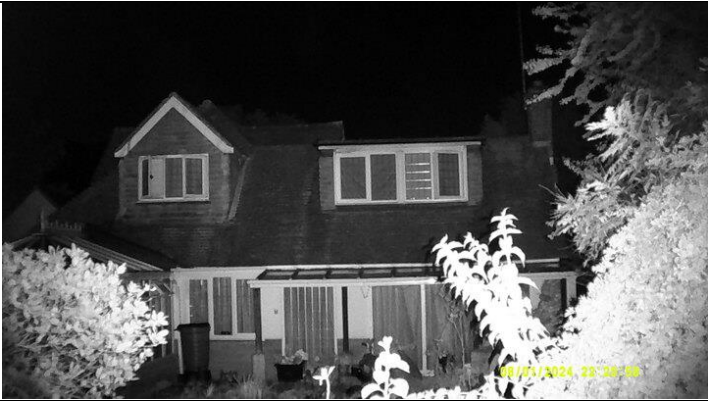
| <i>IR position 2</i> | The footage reflected the view of surveyor 2. No bat emergence or additional bat activity was recorded | |

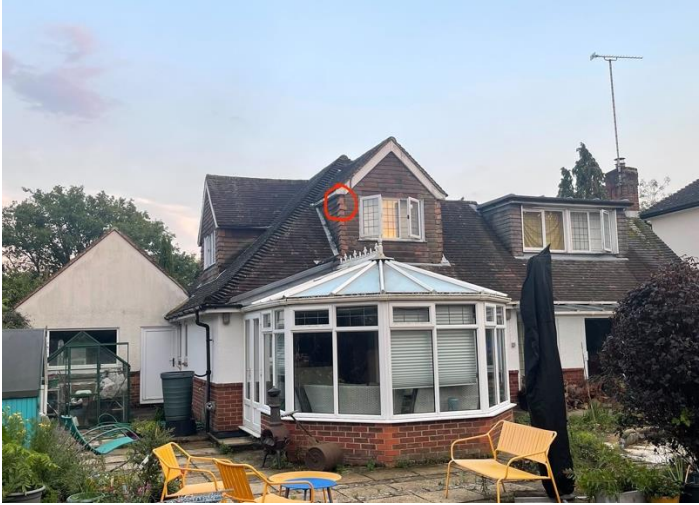
| <i>Surveyor 3</i> | <p>The first bat detected was a common pipistrelle heard not seen (quite faint) at 21:08. At 21:12 there was an emergence by a common pipistrelle from the edge hanging tile of the dormer window above the conservatory heading south-east to north-west. At the time 21:17 a common pipistrelle was also heard not seen. However, for more than 30 minutes (from the time 21:19-22:03) there was constant foraging activity in the rear garden recorded by possibly 2 common pipistrelles, this activity was constant with many sightings. Between this time (at 21:25) one common pipistrelle was recorded flying south-east to north-west along the south-western elevation of B1. Also, at the time 21:34 a Noctule was heard not seen. The last bat recorded was a common pipistrelle heard not seen at 22:16.</p> | |

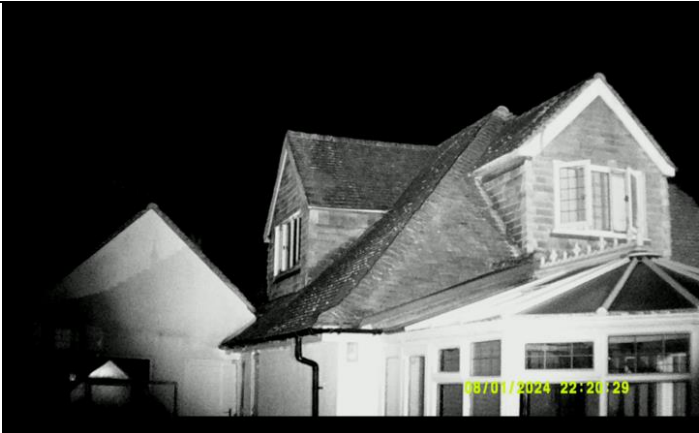
| <i>IR position 3</i> | <p>The footage reflected the view of surveyor 3. No bat emergence or additional bat activity was recorded</p> | |

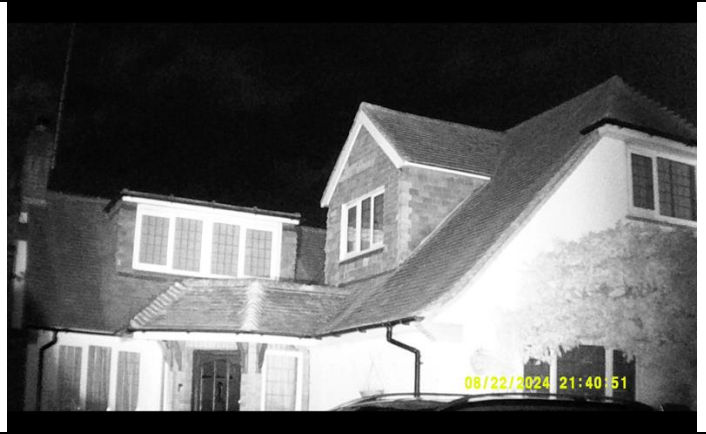
| <i>IR position 1</i> | The footage reflected the view of surveyor 1. No bat emergence or additional bat activity was recorded. | |

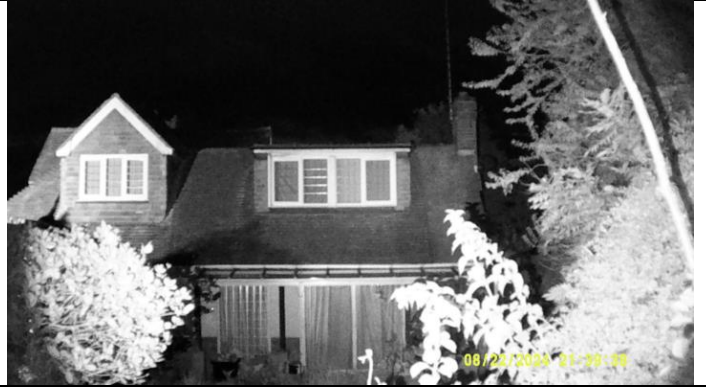
| <i>IR position 2</i> | The footage reflected the view of surveyor 2. No bat emergence or additional bat activity was recorded. | |

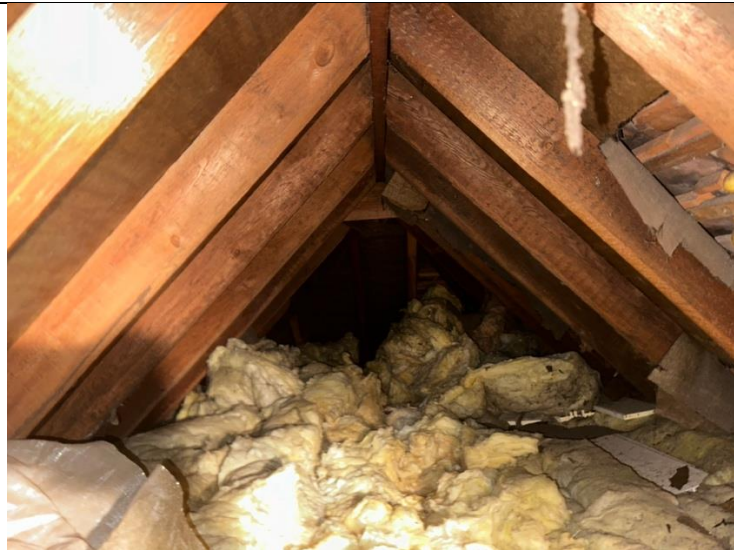
| Field Survey | |
|---|---|
| Building inspection<br>prior to survey | <u>Summary</u> <ul style="list-style-type: none"><li>- One bat dropping found inside roof space at the north-east hip of the roof void behind a fold of the insulation, in the same place as described from the PEA/PRA. This dropping was crushed to tell if it was a bat dropping or a mouse dropping and was likely pipistrelle as described in the PEA/PRA.</li><li>- Ripped roof lining present along much of the loft space exposing bare tiles.</li><li>- Cobwebs present along the ridge beams suggest a lack of void dwelling species activity.</li><li>- The loft space was small so the far ends could not be accessed directly to look for droppings.</li></ul> |
| | <p>Photo 1. Looking south at the southern section of the loft space. Ripped roof lining can be seen on the right of the picture and at the end of loft on the right, as described in the PRA.</p> A photograph showing the interior of a roof void. Wooden rafters are visible, forming a triangular structure. Below the rafters, there is a layer of yellow insulation. On the right side, there is a hole in the roof lining, revealing a dark space above. The lighting is warm, likely from a flashlight. |

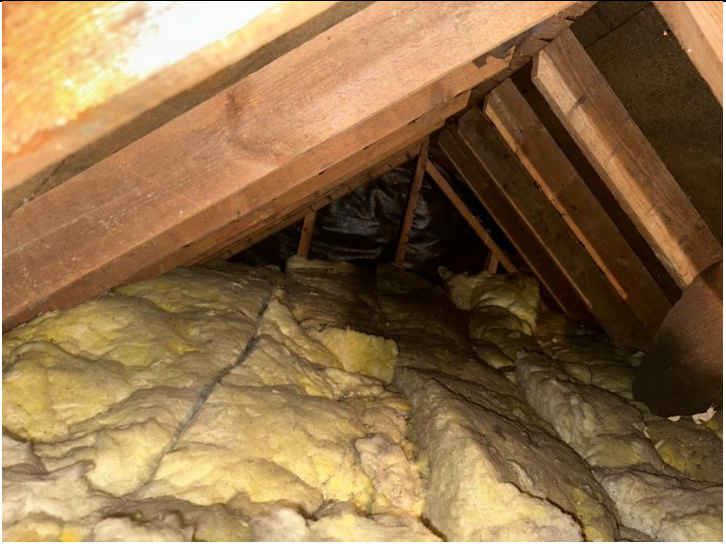
| | <p>Photo 2. Looking west down the western section of the loft space</p> | | |

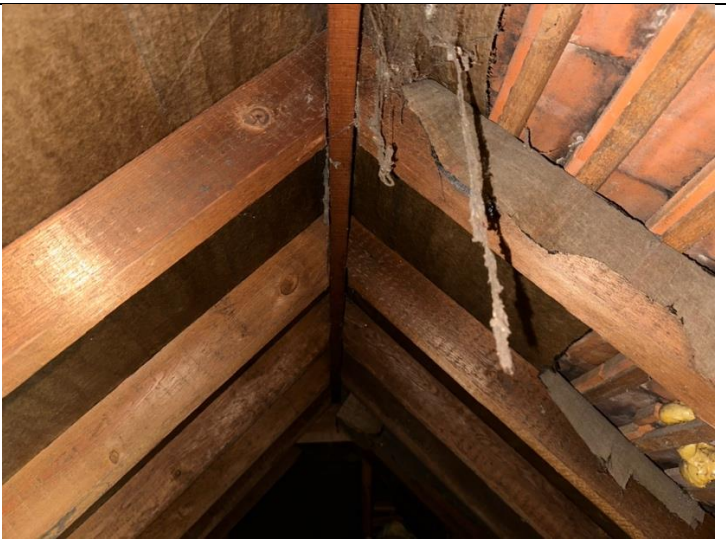
| | <p>Photo 3. The ridge beam present on the southern end of the loft space, showing cobwebs and ripped roof lining with exposed tiles</p> | | |

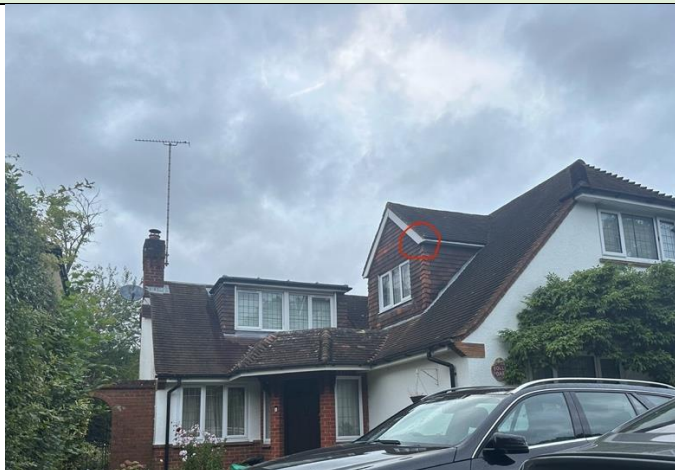
| Surveyor 1 | <b>One re-entry seen.</b> The first bat activity was a common pipistrelle that was heard not seen at 19:40. At 20:06 a soprano pipistrelle was seen foraging around the south-western dormer then seen re-entering at the bottom right corner of the bargeboards on the dormer window. At 20:14 a brown long-eared bat was seen passing west to south along the western elevation. The final bat activity was a soprano pipistrelle that was heard not seen at 20:18 | | | | | | |

| <i>Recommendations</i> | <p>An EPSL application to Natural England will be required to legally permit the proposed works. Due to the number of roosts and species present, the site is eligible for a Bat Mitigation Class Licence (BMCL). The BMCL application requires that surveys have been undertaken within the most recent active bat season (optimal May to August, suboptimal September). Planning permission must have been granted and all relevant wildlife-related conditions have been discharged prior to submission, where possible to do so.</p> <p>A Material Changes Check will be required within three months of the BMCL submission, if no survey work has been undertaken within that period.</p> <p>The BMCL will include the following measures:</p> <ul style="list-style-type: none"><li>• The installation of two bat boxes at the site (one bat box per species) prior to works commencing to form a receptor site for any bats found during the works. These boxes may be installed on buildings or trees but must be in an undisturbed location and will need to be maintained in this location post-development. Bat boxes should be positioned 3-5m above ground level facing in a south or south-westerly direction with a clear flight path to and from the entrance, away from artificial light.</li><li>• The provision of a toolbox talk to contractors, by the Registered Consultant or an Accredited Agent, to inform them of the presence of bat roosts.</li><li>• A pre-commencement inspection of any roost features by the Registered Consultant or an Accredited Agent using a torch and an endoscope (this may be via ladders, scaffolding or a mobile elevated platform).</li></ul> |

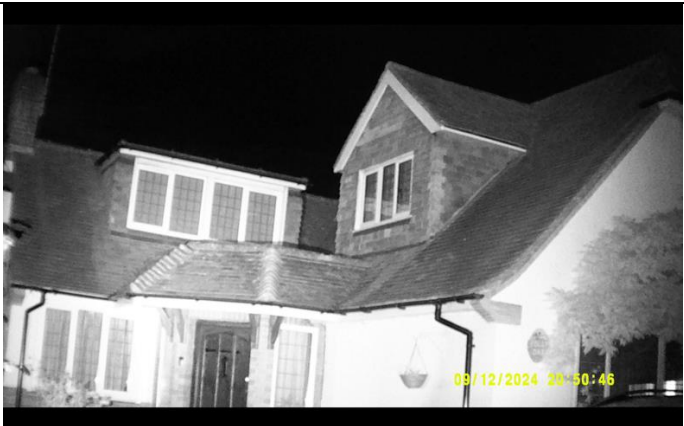
| <i>IR position 1</i> | The footage reflected the view of surveyor 1. No bat emergence or additional bat activity was recorded. | |

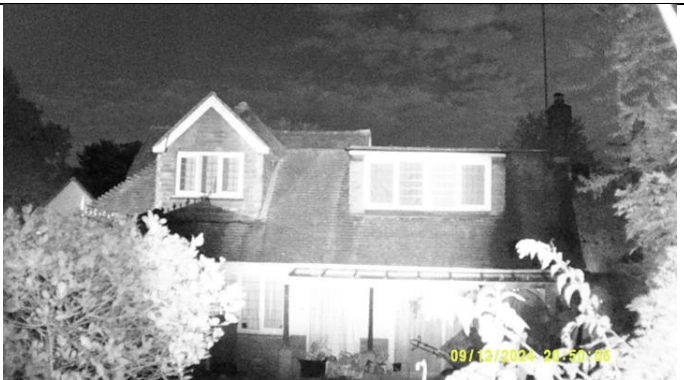
| <i>IR position 2</i> | The footage reflected the view of surveyor 2. No bat emergence or additional bat activity was recorded. | |

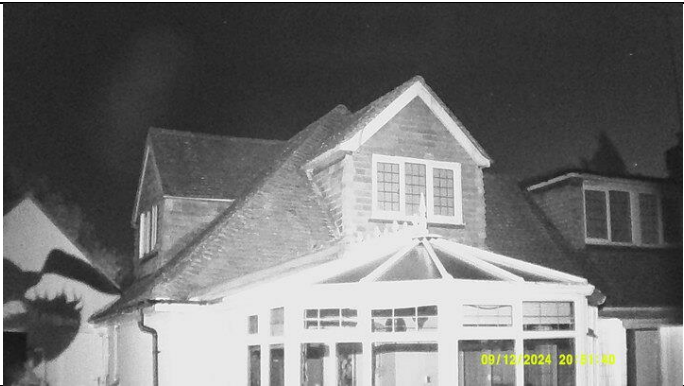
| <i>IR position 3</i> | The footage reflected the view of surveyor 3. No bat emergence or additional bat activity was recorded. | A nighttime infrared (IR) photograph of a two-story house with a prominent conservatory. The conservatory has a gabled roof and multiple windows. A timestamp in the bottom right corner reads "09/12/2024 20:18:00". |

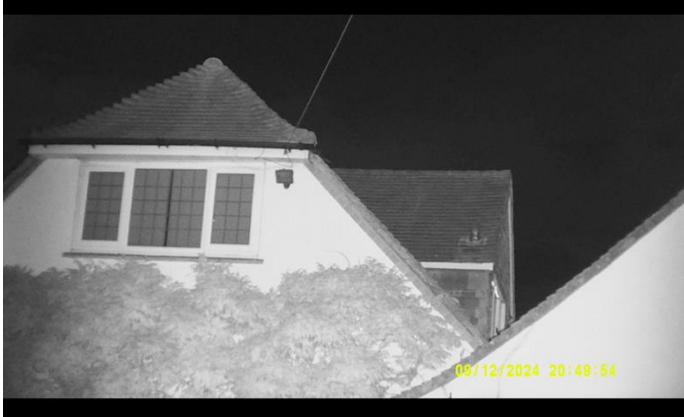
| <i>Unmanned Camera</i> | <b>No emergences seen.</b> No bat activity seen. | A nighttime infrared (IR) photograph of a house, showing a dormer window with multiple panes. The house is partially obscured by foliage in the foreground. A timestamp in the bottom right corner reads "09/12/2024 20:49:54". |
