# SHINFIELD PARK

## Historic Building Recording

Prepared by Stantec  
December 2025

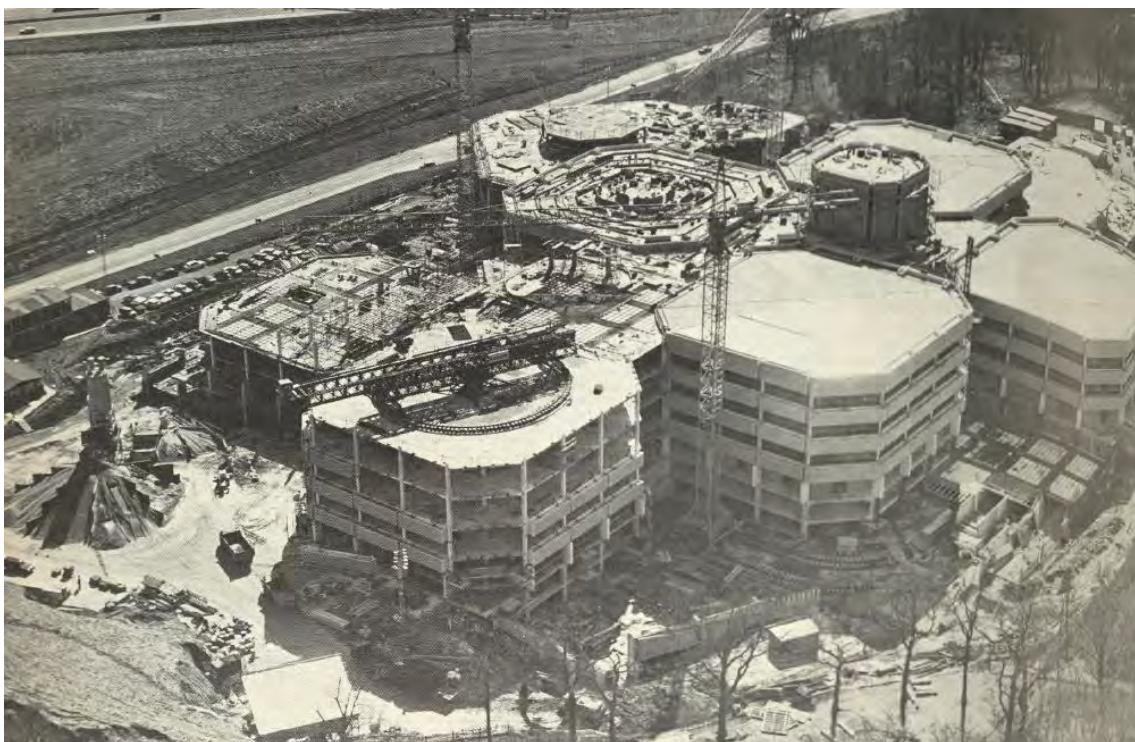
Photograph 11 Shire Hall Under Construction

- 4.10.3 A floor slab of reinforced concrete spanned the columns based on a square grid, with the column grid system was continued through the basement levels. Concrete mullions were then erected to form the vertical framing. It is understood that the construction of the structure required the pouring of the columns in careful layers. To achieve this the on-site team used a  $\frac{1}{4}$  in full-height Perspex shutter on one side of the column to provide control. This was later disbanded as skill grew and there was the revolution that the finish through the Perspex was different to that experienced by the naked eye. It has been termed a 'real lesson in concrete technology'. Photographs from May 1976 record the foundation works being undertaken, with photographs from February 1977 recording the construction of the octagonal pavilions and towers, with basement levels present. Due to the scale of the project, a concrete batching plant was set up on-site. Whilst elements of the structure were constructed off-site, some elements were finished under site conditions particularly where compaction was concerned.

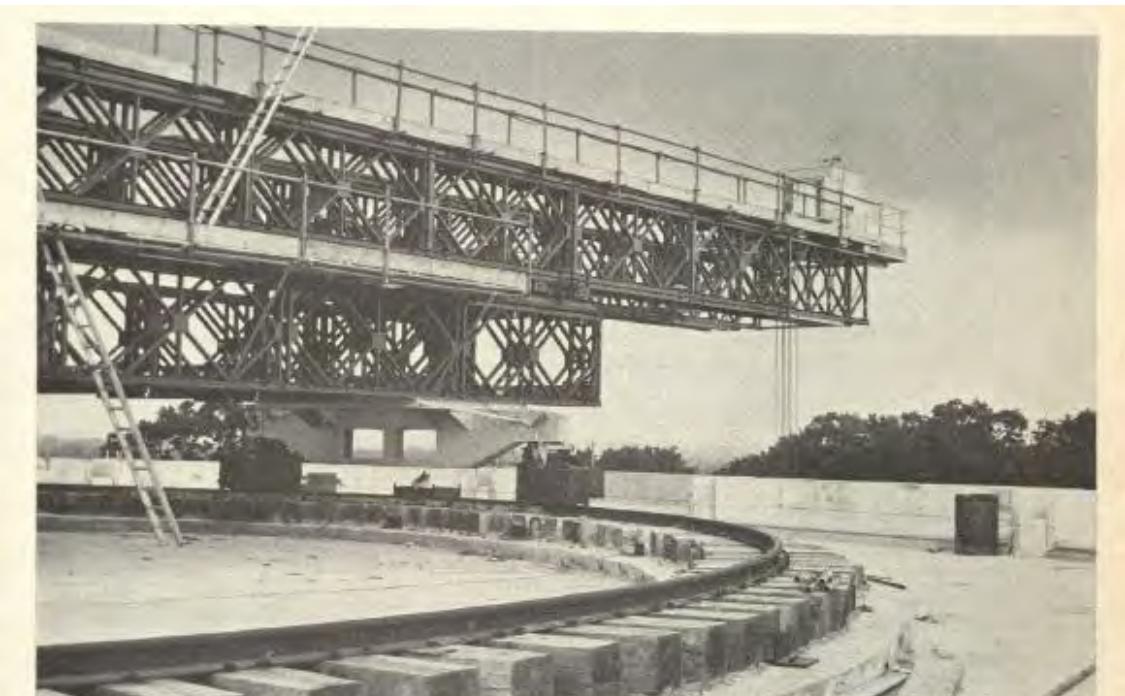
- 5.1.4 Safe working loads were identified at 24 tonnes with a maximum panel weight of 22.5 tonnes. The lifting beam weighed 1.5 tonnes with a maximum working radius of 24m. Overall the total weight was 105 tonnes with stability of 1.5 to 1 in service conditions.

- 5.1.5 The gantry operated at a hoisting speed of 7.2m per minute and maximum transversing trolley and slewing speeds were 11.43m per minute and 0.28 rpm.

*The Bailey bridge panel placer and concrete ring beam used for lifting the cladding panels.*

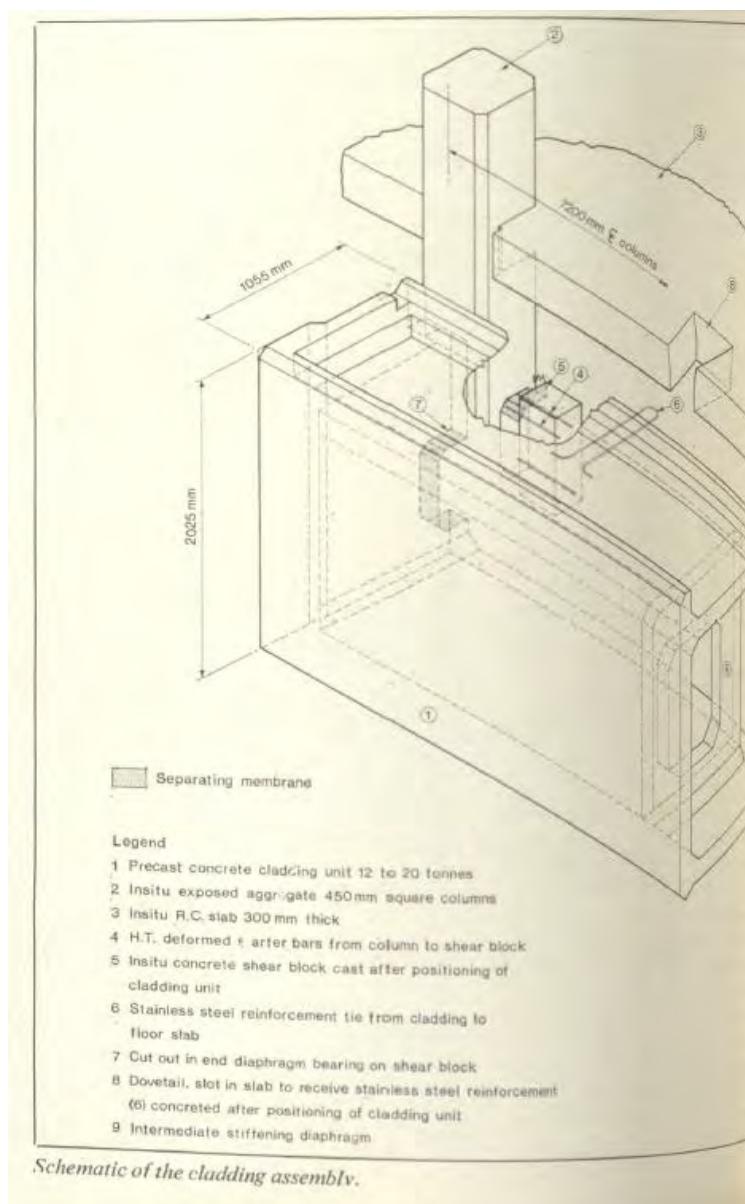
Photograph 21. Construction Methodology

5.2.2 The building was constructed of reinforced concrete slabs supported on external and internal columns, with large precast full bay concrete cladding. It was built on a square grid of 7.2m with 450mm bush hammered columns. Fixing procedures were designed in-situ to avoid close tolerances and they embodied high tensile deformed starter bars from column to in-situ concrete shear blocks cast after the panel has been positioned and held temporarily by tie bars. A dovetail joint through a slot in the 300mm thick slab force was created for the stainless-steel reinforcement bracket and was concreted in.

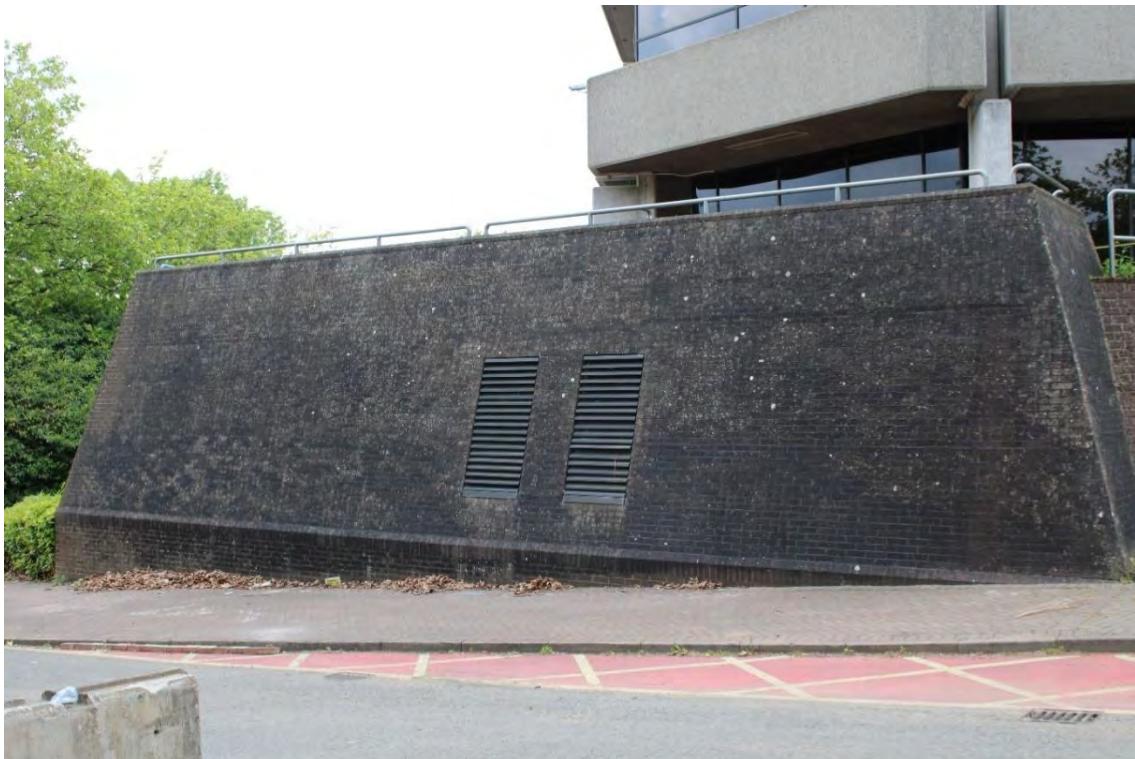
Photograph 29. Retaining Wall and Plinth

5.6.4 The building was formed of a reinforced in-situ concrete frame which extended from the Sub-Basement through to Third Floor. The concrete columns supporting the upper stories were angular, with the Ground Floor setback within the structural frame. The building was set on a brown brick plinth which features slated vents which form part of the air conditioning system. Buttresses were present along these retaining walls and steps leading from ground level to Basement were constructed of concrete with metal handrails.

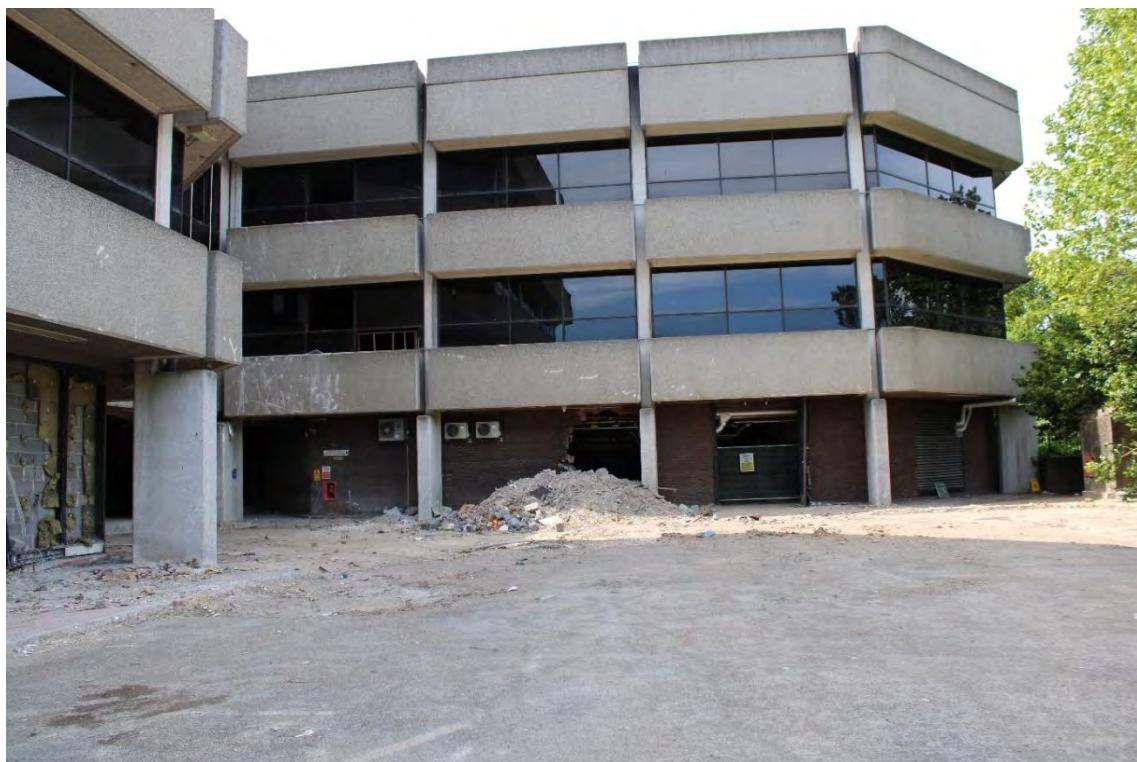
Photograph 30. Illustrative View of Pavilion

5.6.6 The Pavilions were set at equal intervals connected by narrow link corridors and service blocks. These contributed to the modular appearance of the building. The Pavilions comprised low-rise octagonal boxes of alternating smooth-texture concrete fascia and horizontal aluminium-framed glazing set flush in the concrete grid. They were identical on all elevations (fronts) without variation. The glazing was tinted preventing transparency, and incorporated deep vertical lines through rectangular windows extending the full width of the opening on each elevation of the pavilion and central core. It comprised six windowpanes per bay, with an additional two on the return for the corner bays. The windows were divided by the concrete fascias, and their placement accorded with each floor level internally in the pavilion. The corner concrete fascias had a chamfered element and projecting mullions articulated the panel joins and visually subdivided the elevations into regular bays. They interspersed the window bands and formed part of the building's overall concrete structural frame. The proportions of the fenestration were no doubt intended to be pleasing and were deliberately designed to contribute to the Brutalist architectural appearance.

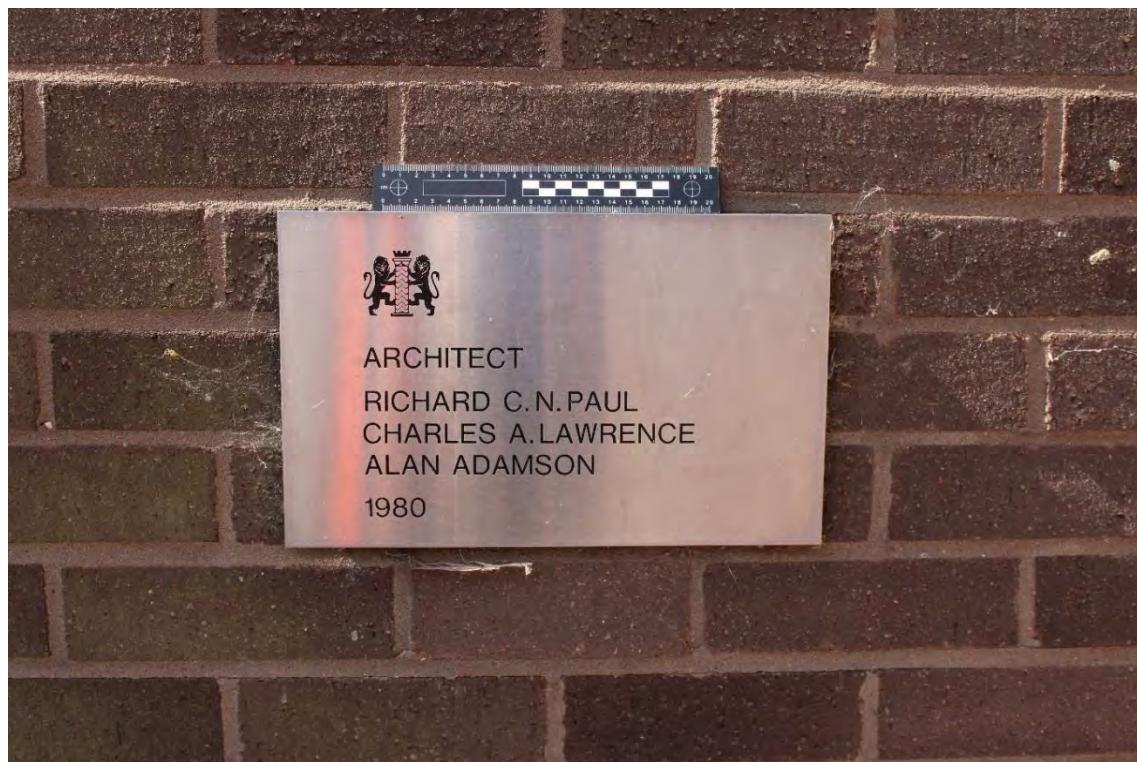
Photograph 31. Extant Civic Suite Signage

5.6.9 The Civic Suite was set apart from the Pavilions, connected to Pavilion E by a single height glazed link. The glazed link formed a projecting arm connecting with the northwest side of the Civic Suite. It was connected to the service / plant area in the southwest by a second projecting link corridor forming the southern extent of the building. Both the Civic Suite and this linking corridor were single storey in height, with exposed basement level and retaining wall. Although separated from the main body of the building (the Administrative Block), the Chamber formed an integral part of the complex. Whilst it could be described as subtly positioned in relation to the whole complex and building footprint, it formed an important focal point with associated main forecourt to the north which emphasised its former ceremonial and functional role. It is polygonal in plan and reflected a horizontal low-mass rise situated on a structural concrete frame. Whilst presenting double-height in form, the Ground Floor formed the exposed basement level which featured a stepped back curtain wall interspersed by access doors and large louvered grills used for mechanical ventilation. The external walls were clad in the concrete panels used across the complex with horizontal tinted glazing. The roof was hidden behind a concrete parapet with pyramidal roof lantern, with vertical emphasis to the vertical glazing which was angled towards the apex. The glazed link corridor with metal frame was accessed on both sides by single height double-doors. Adjacent to the door on the east elevation, situated approx. 150cm from the Ground Floor, was a metal sign inscribed with the following detail. The placement of this sign is deliberate given the function of this area as the Civic Suite.

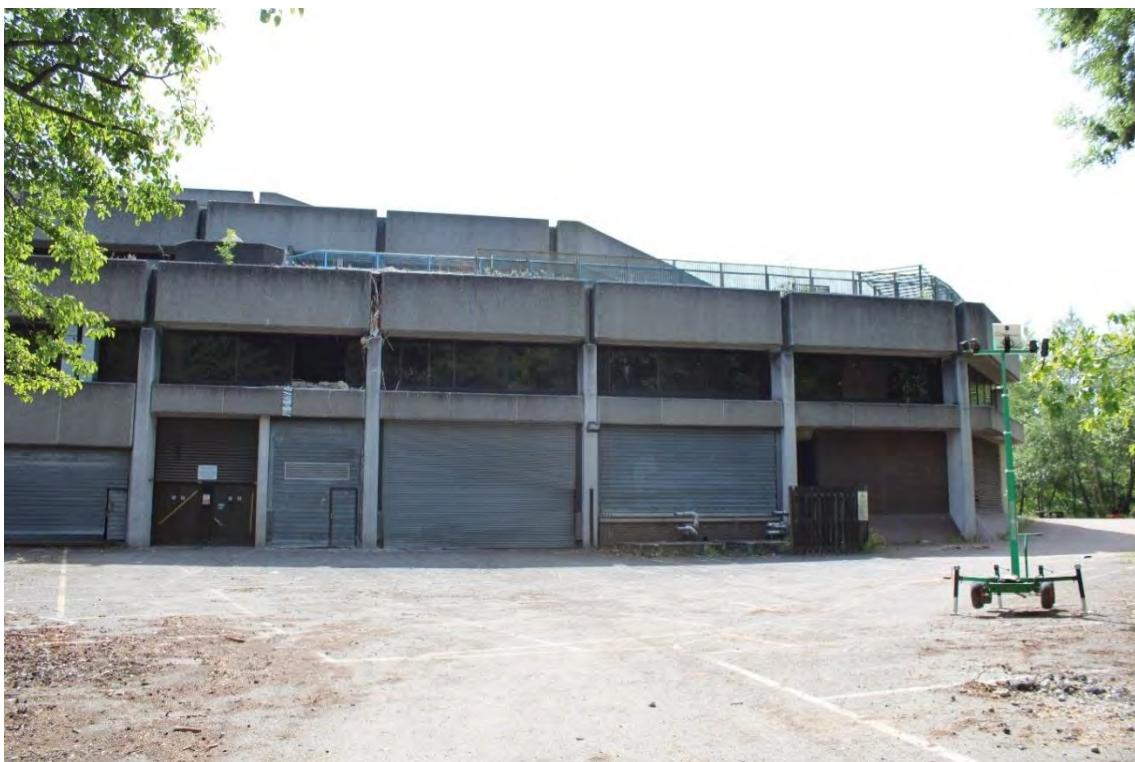
Photograph 32. Illustrative View of Plant Area

- 5.6.13 The western elevation of the Administrative Block comprised the exposed flanks of three interlinked octagonal pavilions, connected via recessed structure links to a central circulation and service spine. There was no formal approach on this site, with the Cost Engineer Road leading to the Plant Area in the southwest. The Plant Area was located adjacent to the southmost pavilion where the building footprint began to descend along the west facing slope. Two-storey in height and partially recessed into the landscape, this area of the building was low rise and rectilinear, with flat roof and functional character, and set back from the building line creating a stepped rear edge. Externally this area had a service yard with metal louvered doors of dark colour palette with powder-coated finish for plant ventilation, access hatches and screened delivery bays.

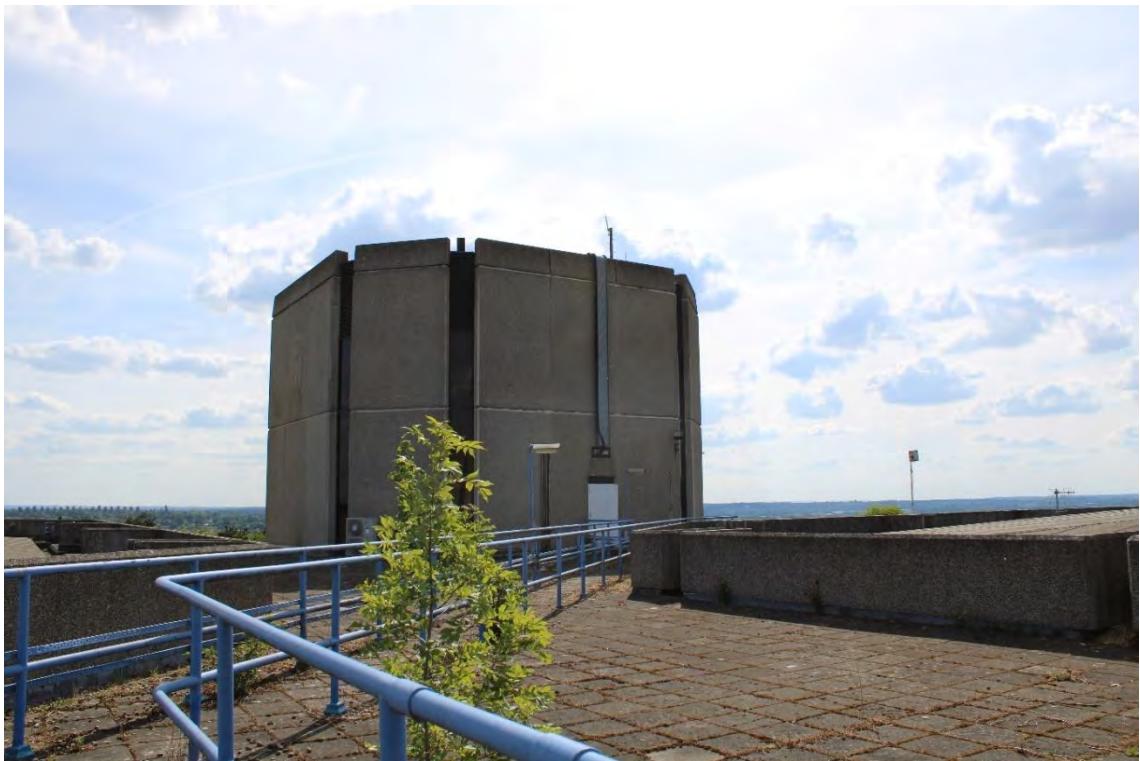
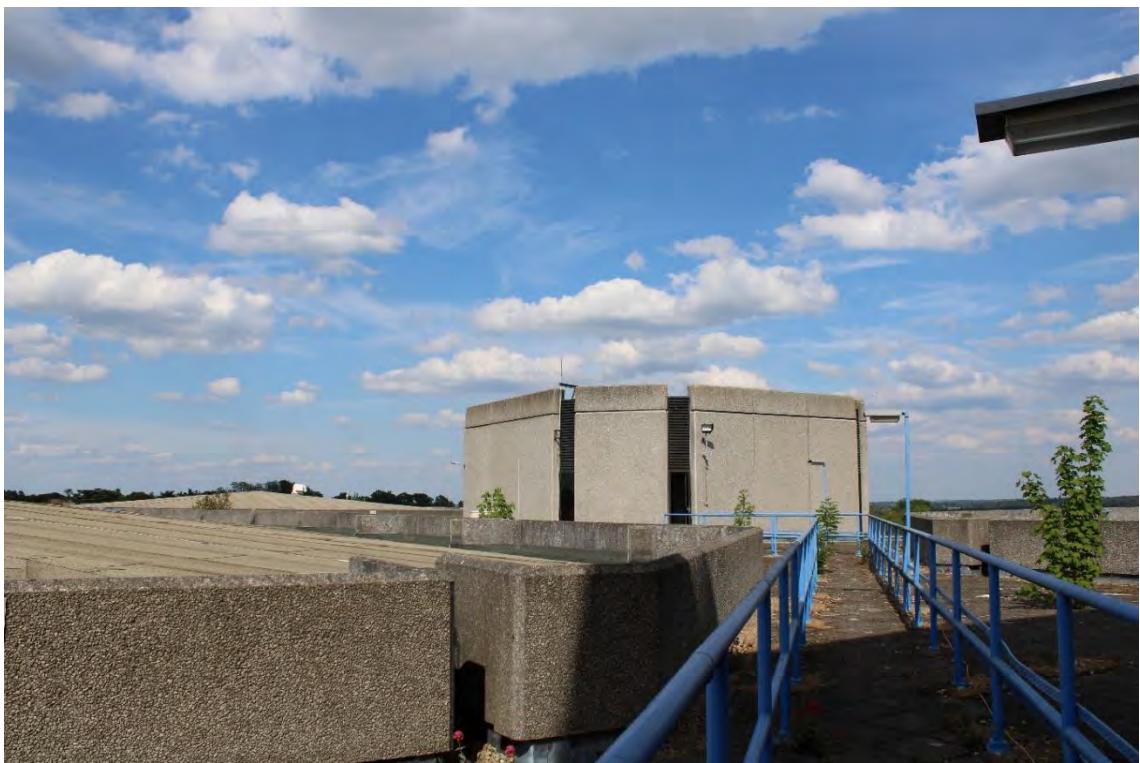
5.6.14 The Centre Cores were vertical shafts that rise above the lower connected parts (office space of the Administrative Block) to serve the upper floors. The Cores housed the vertical circulation including the lifts and service risers. As they extended beyond the pavilions and linked walkways, they formed prominent vertical elements that breaks the roofline. Octagonal in character, the exterior comprised large rectilinear concrete panels; the concrete panels on the short diagonal were smaller in size and connected by glazed links which extend the full length of the building on the two storey tower. Ventilation grills sat above the glazing on the single storey tower, with both comprising a concrete parapet and flat roof. The towers were located within a roof terrace, with designated walkway demarcated by metal railings painted blue.

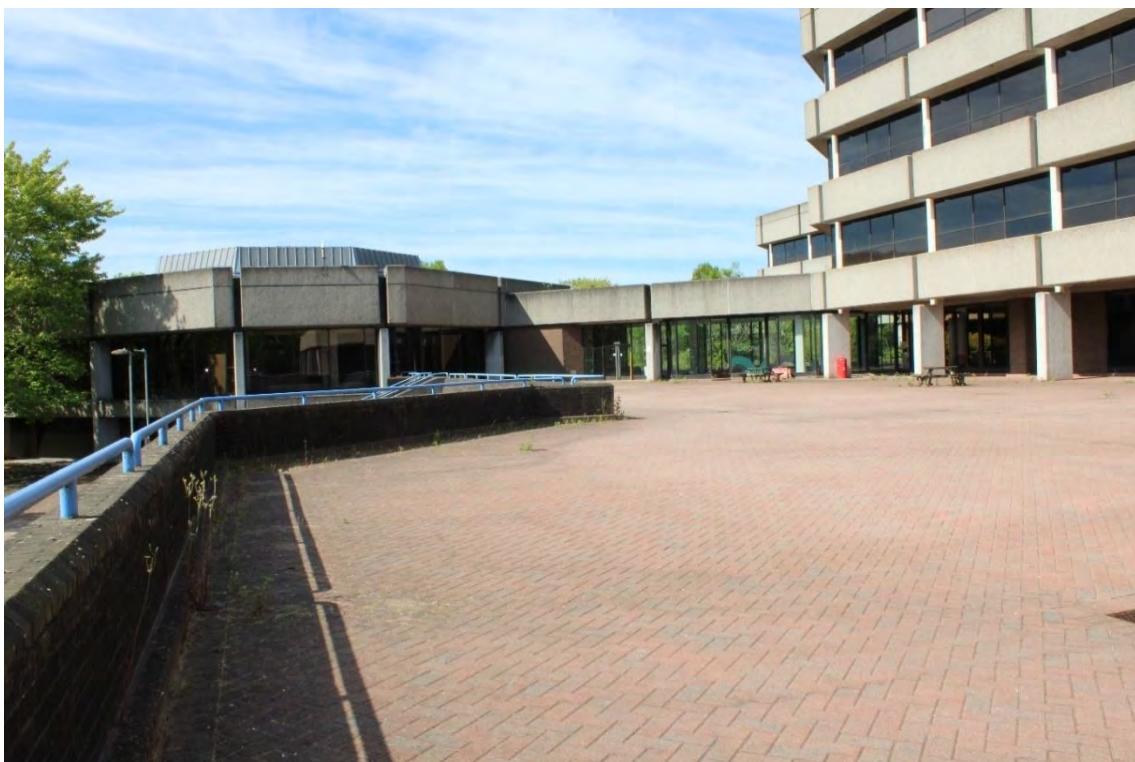
Photograph 36. Illustrative View of Civic Suite Exterior

5.7.3 The courtyard extended from the entrance of the building around its southeastern elevation to connect with the Civic Suite. This area was characterised by red brick set in a herringbone layout lined with a header bond pattern. Around the edges of the courtyard was a half-height brick wall topped with a tubular metal railing painted blue. The brick wall formed part of the upper storey of the building's brown brick plinth which was appreciable in its entirety from the lower level.

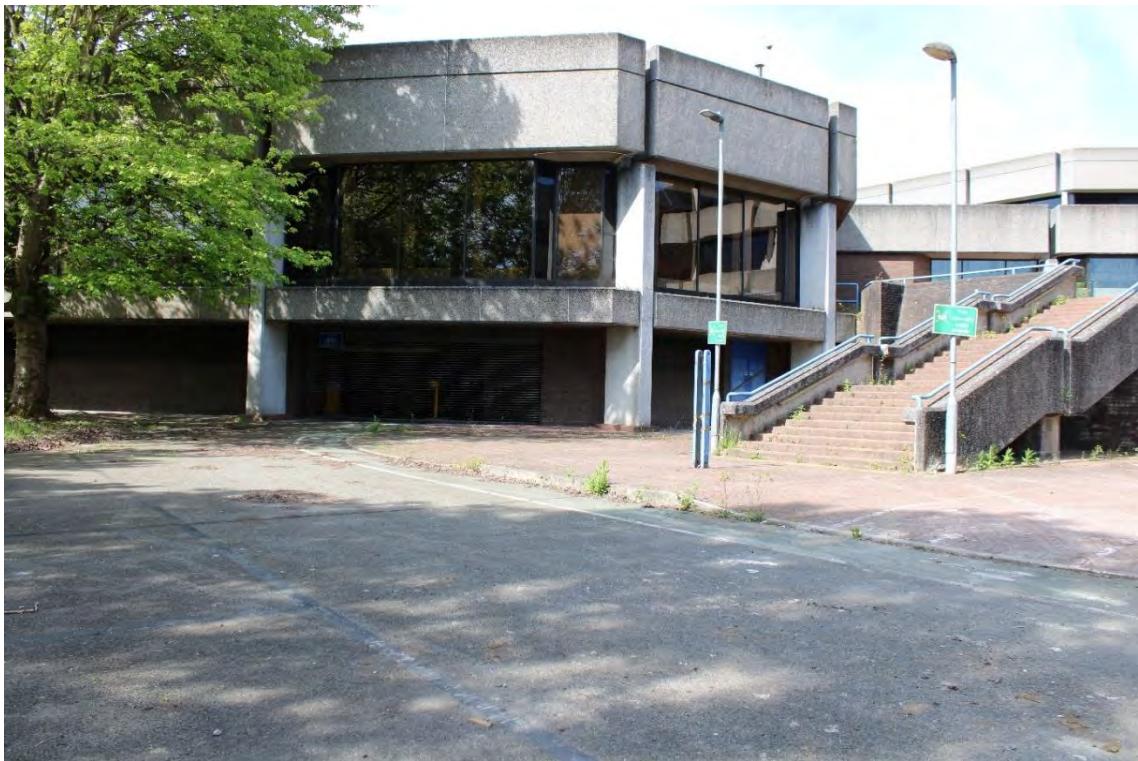
Photograph 37. Illustrative View of Civic Suite Exterior

- 5.7.4 Directly opposite the entrance to the Civic Suite was a single flight straight staircase, positioned offset from the centre of the courtyard, providing access to the lower storey, entrance to the basement car park and landscaped grounds. The balustrade was formed of solid concrete panels, which accord with those used on the building, with metal tubal handrails painted blue. The risers, nosing, stringer and landings comprised brick. Similar materials and layout continued on the lower terrace, with a louvred vents projecting from ground level.

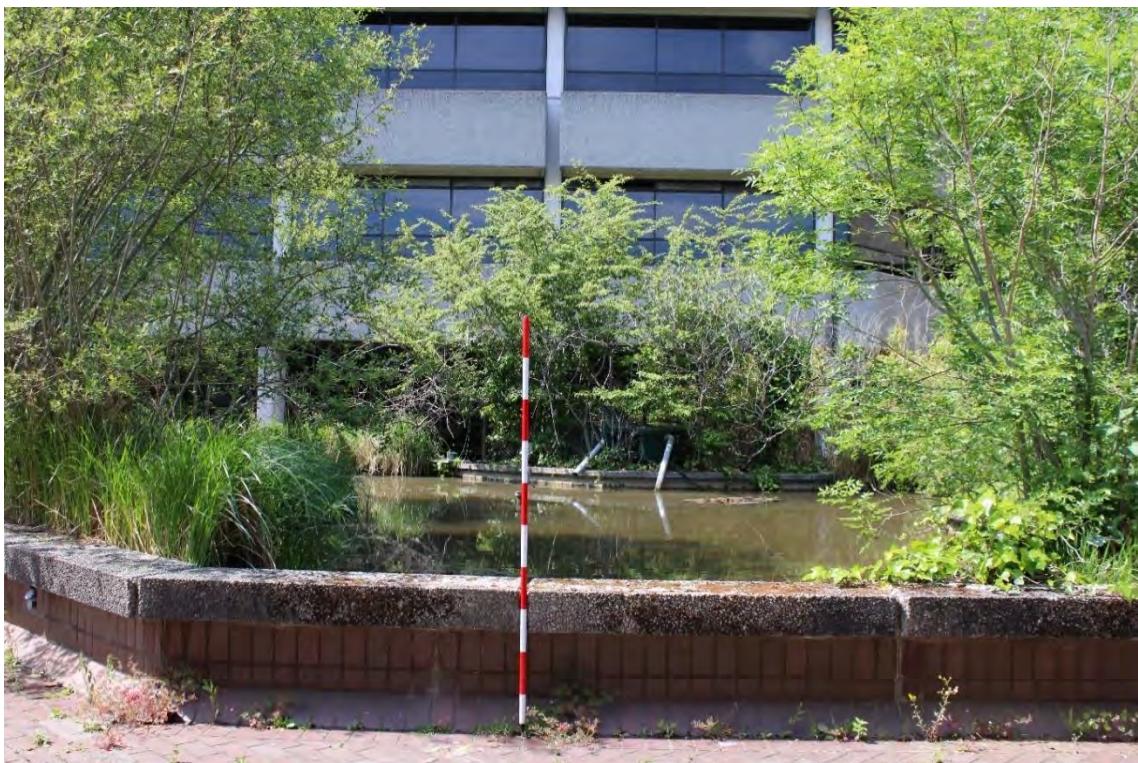
Photograph 38. Illustrative View of Civic Suite Courtyard

- 5.7.5 Hardstanding continued around the south of the building to large, landscaped ponds and grounds.
- 5.7.6 There was one internal courtyard located in the southeast extent of the Site, enclosed by the Civic Suite and its projecting links. This area was characterised by a central geometrically designed raised pond finished with bricks in sailor course and concrete. The courtyard was paved with brick and pebble paver. Decorative planting once characterised this area; at the time of survey, it was overgrown.

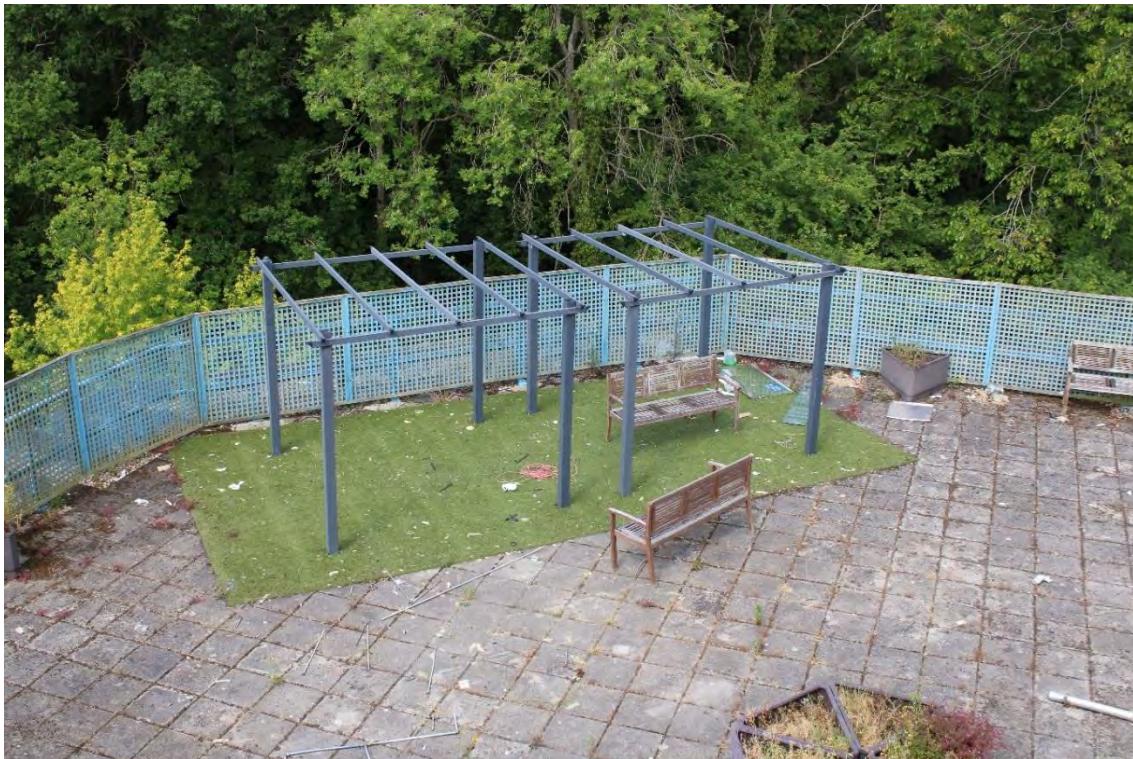
Photograph 39. Illustrative View of Second Floor Roof Space

5.8.2 The flat roof of the building on the Second Floor was intended to provide additional recreational space associated with the former canteen. It was paved with square concrete tiles and comprised seating, pergolas and raised decorative beds.

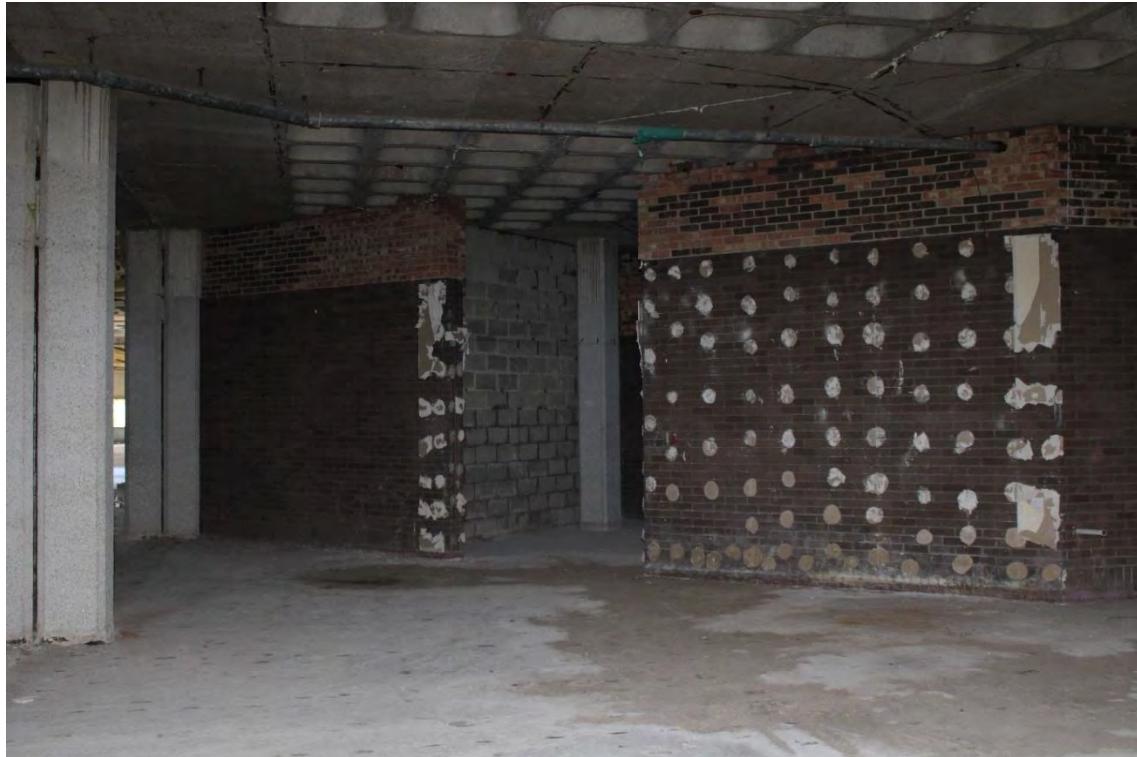
Photograph 40. Illustrative View of Dot and Dab Plaster

5.10.3 A diamond pattern brickwork of lighter brick observed around the Central Cores and on the pavilion staircases is likely the result of the practical use of available construction materials rather than an intentional decorative feature. As the building originally comprised suspended ceiling, through which the services ran, this suggests that this upper part of the walls was not a priority in terms of aesthetic considerations. The presence of these elements allows for a

clear distinction of where the ceiling was suspended to. Painting on the structural columns also demonstrates the heights of the suspended floors and ceilings.

5.10.4 The difference in brickwork and addition of a second lintel above existing internal openings also indicates a change during either construction or operation of the building, with the lowering of the suspended ceiling.

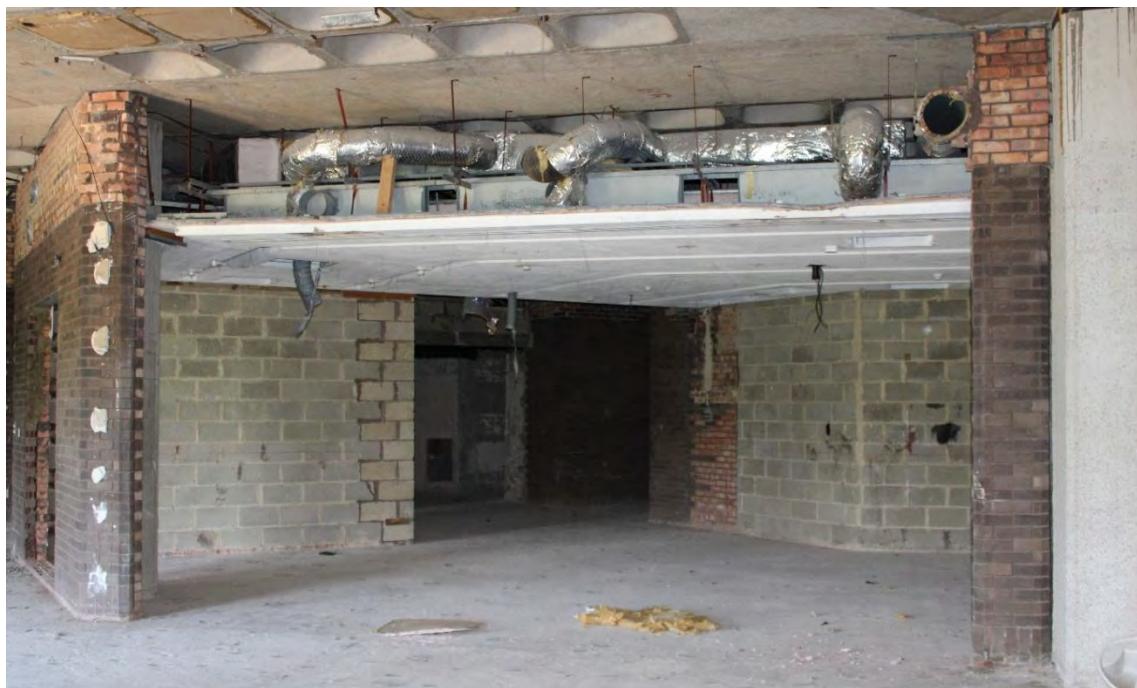
Photograph 42. Illustrative View of Suspended Ceiling

5.11.1 Throughout the building, evidence of former and in situ services was present, including drainage channels in the concrete floor slab, metal ductwork openings on internal walls, and associated pipework, wiring and ductwork suspended from the ceiling. It is understood that ceiling voids were implemented to facilitate the running of associated infrastructure as well as supporting the air and lighting system.

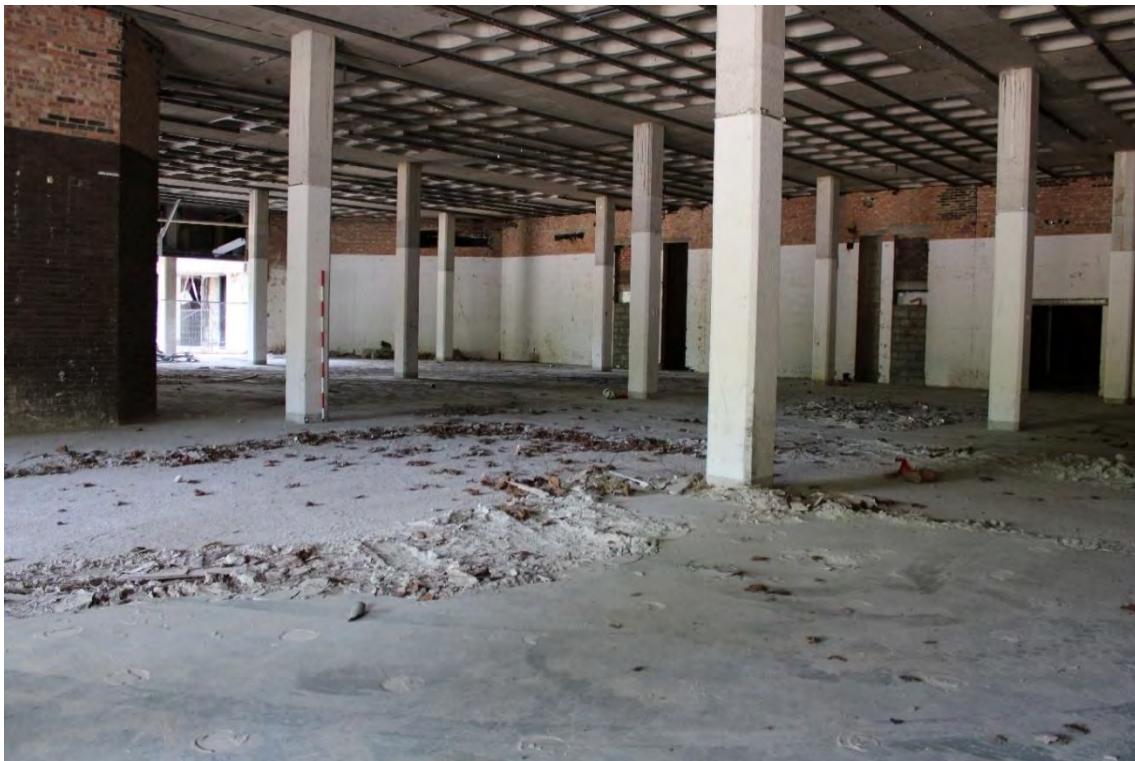
Photograph 43. Illustrative View of Ground Floor

5.12.2 The remainder of the Ground Floor was characterised by open space. A large service opening was present in Pavilion B, with exposed steel beam and concrete lintel.

5.12.3 Except for within the Civic Suite, no temporary stud partition walls survived on the Ground Floor.

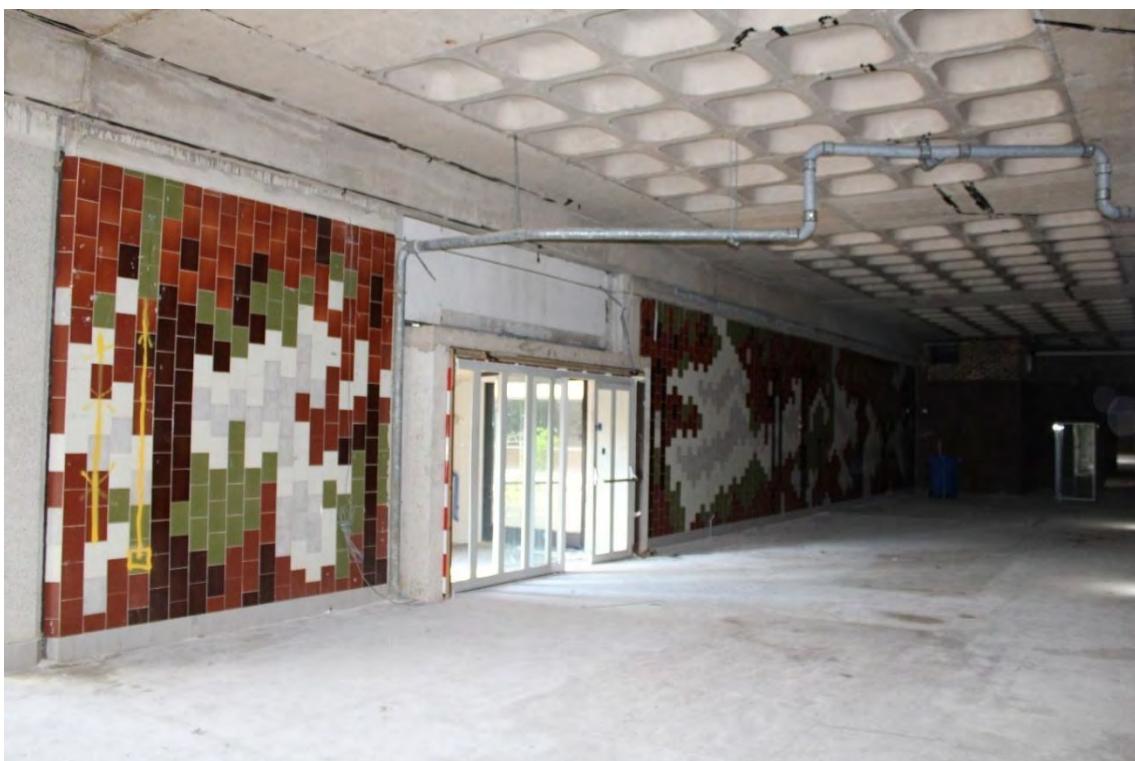
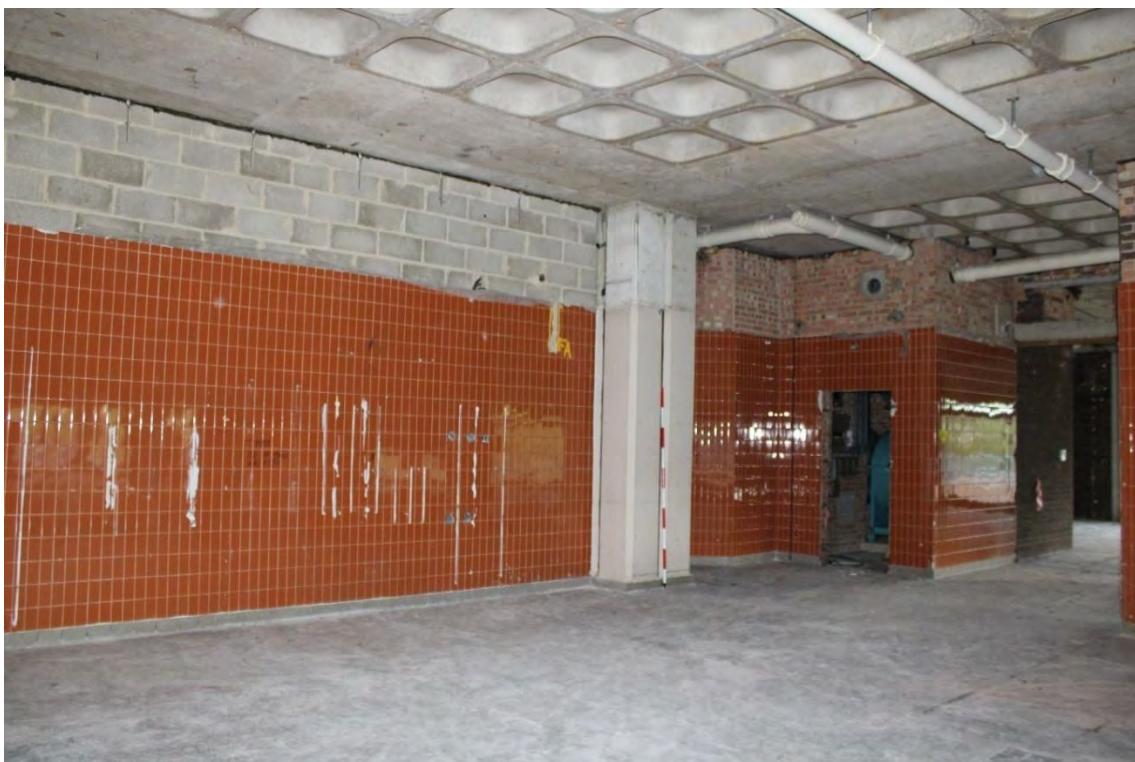
5.13.4 The southern extent of the First Floor was utilised as the kitchen (canteen), indicated by the presence of glazed ceramic tiles along the internal walls associated with the kitchen space and dining area. The colour palette was varied ranging from white and grey to green, terracotta and brown. The tiles along the western wall of Pavilion L are abstract in design. Within the canteen and kitchen areas, the ceramic tiles were terracotta throughout. A protruding staircase was present on the west elevation of Pavilion L providing access to the Ground Floor as well as the roof terrace. Comprising a glazed partition with double-door accompanied by modern fire exist signage, this was not accessed for safety reasons but comprises a lino floor and plastic blue handrail.

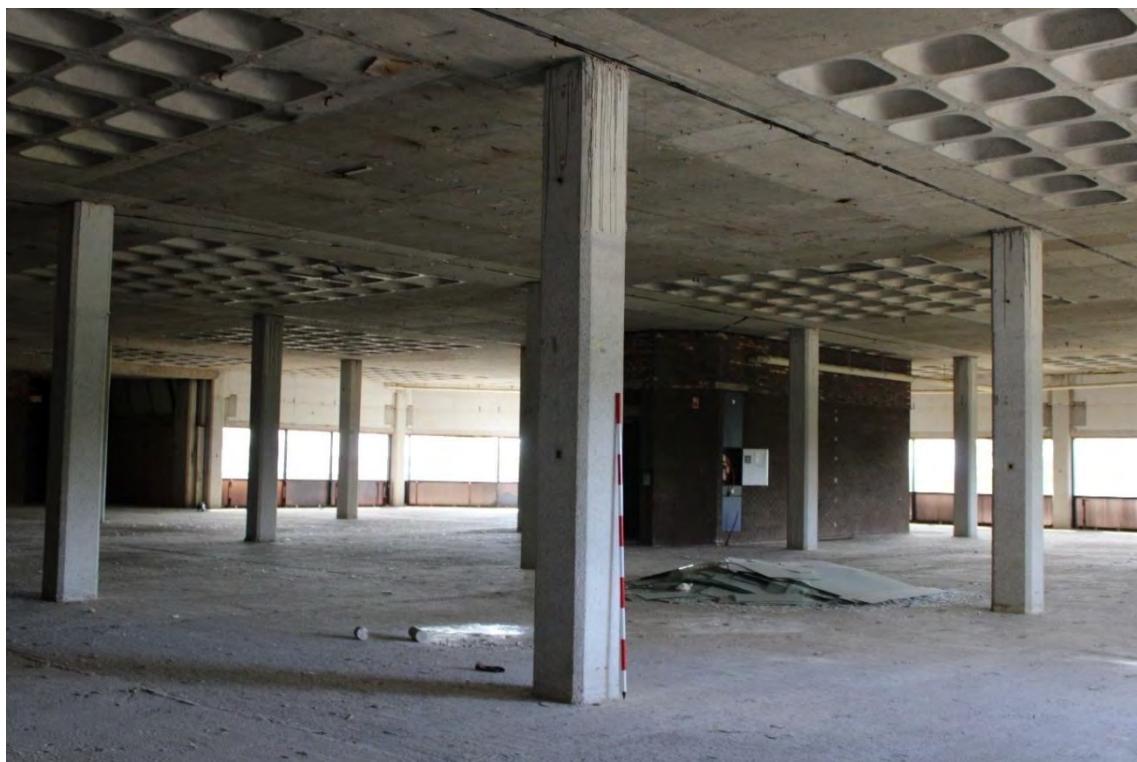
Photograph 47. Illustrative View of former Office Space

5.14.1 The Second Floor was designed to reflect the layout of the preceding floor, with the southern extent utilised as part of the office space. Historically subdivided, internal partitions had been removed resulting in a large cavernous open space interspersed by supporting square columns. The fabric on this floor reflected the preceding, with no additional material identified as part of the survey. The remains of the suspended ceiling fixings were visible on this floor. A roof terrace was provided in the south; no railing was present around this space suggesting it is unlikely to have been publicly accessible during building operation.

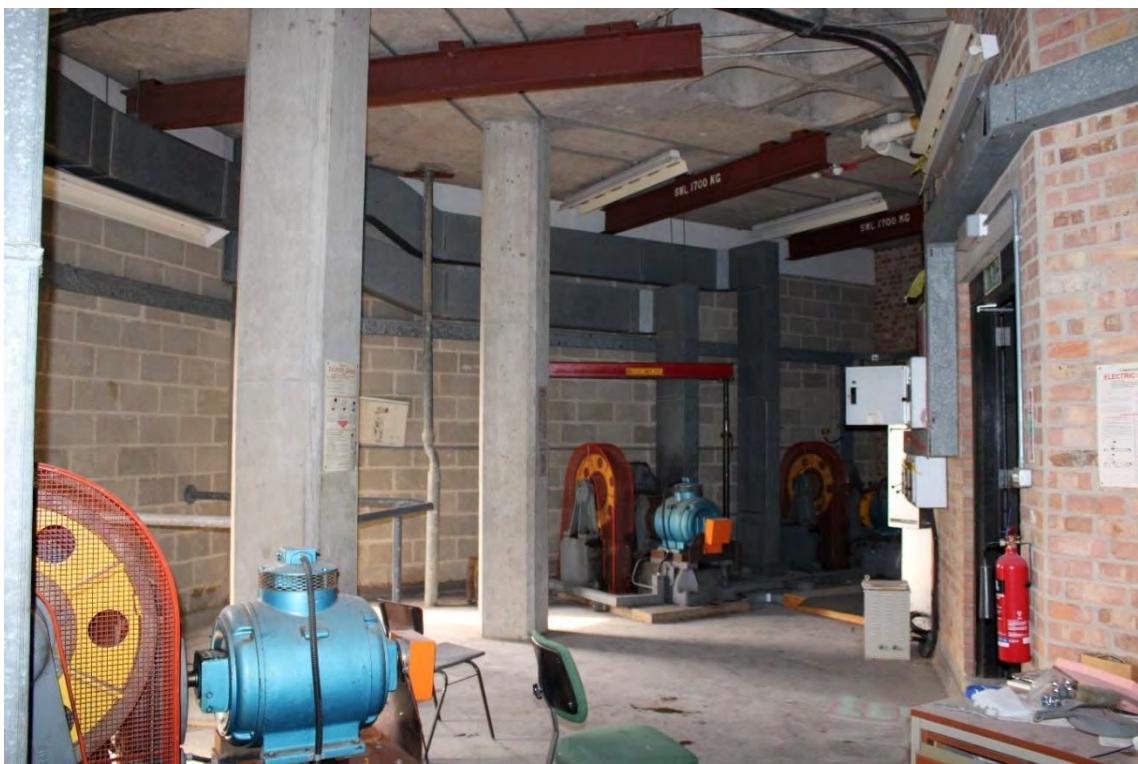
Photograph 48. Illustrive View of Lift Motor Room

5.16.3 In contrast to that in the northeast, the southwest tower was compartmentalised further to create office space using temporary lightweight partition walls and a suspended tile ceiling with built in louvered troffer lights and air conditioning system. Modern radiators and single wooden office doors with a vision panel were present. The Fifth Floor comprised a lift motor room, with hatch for uninstalled lift surviving in situ. Large supporting steel beams part extended across the ceiling. Equipment associated with the lifts comprised drive motor and generator, controller, disconnect switches and other auxiliary components.

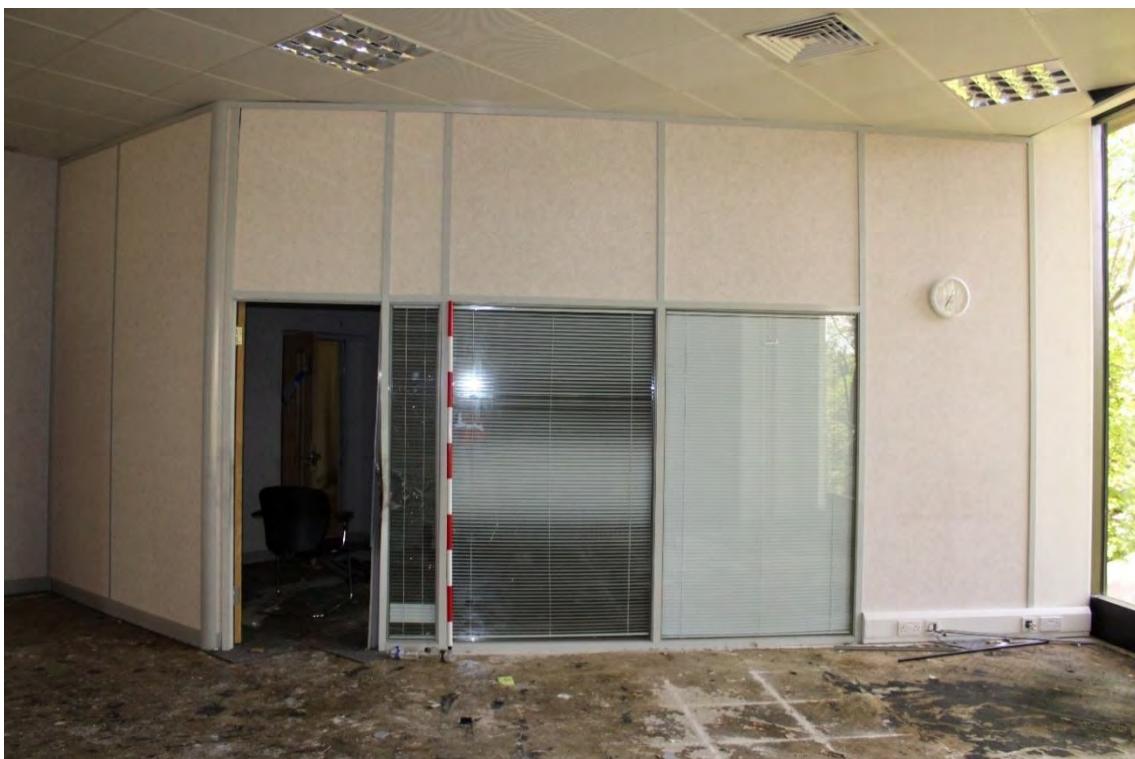
Photograph 50. Illustrative View of Stud Walling surviving in the Civic Suite

5.17.1 The Civic Suite was demarcated from the remainder of the building internally by the glazed link. The external perimeter of the Suite was characterised by the subdivision of space on the east and south side to create smaller individual rooms. Stud partition walls separated the space with three quarter height glazing panels used for light. A suspended floor was present in this area along with column radiators. Louvered troffer lights were present both in in-situ suspended ceilings (with fluorescent) and stored on the floor following removal. The in-situ suspended ceiling featured a grid system with ceiling tiles interspersed with air ventilation and fire safety systems. Several types of doors were present in the Civic Suite, including single office wooden doors and glazed partition double doors with transom in a metal frame. Both column and modern radiators were present in the Civic Suite.
