# SHINFIELD PARK

## Historic Building Recording

Prepared by Stantec  
December 2025

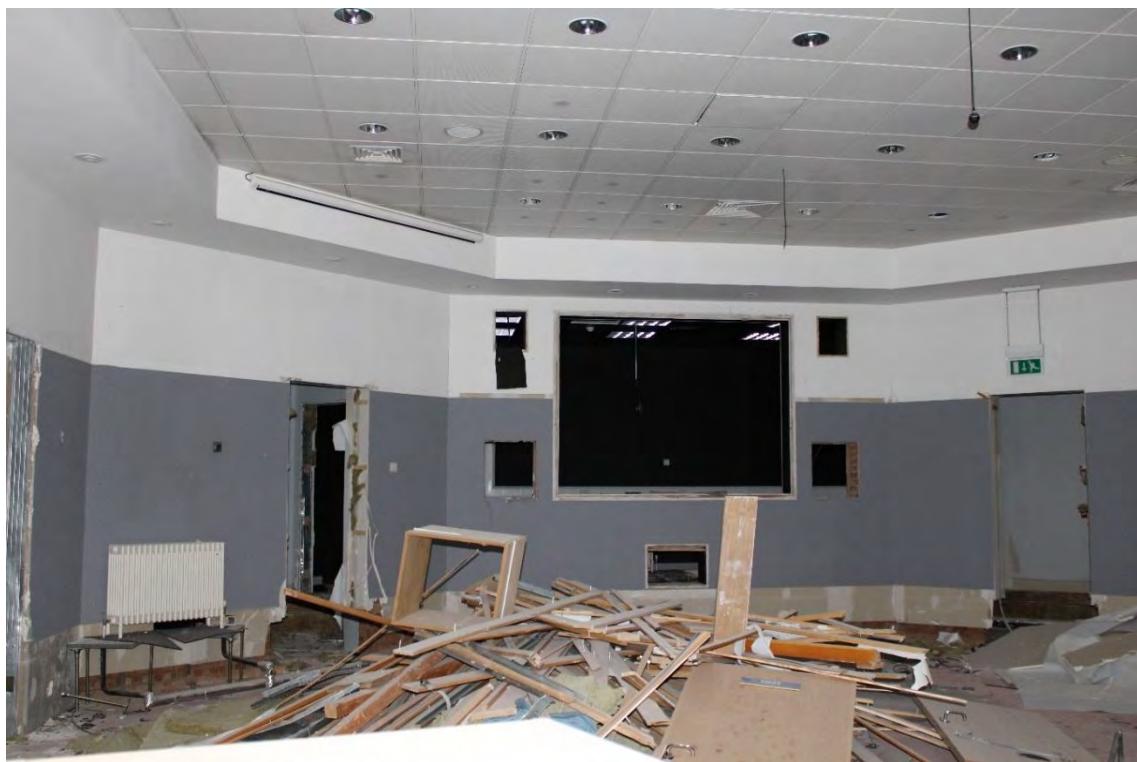
Photograph 51. Illustrative View of the former Council Chamber

5.17.2 The Civic Suite's core comprised the former council chamber which featured an unequal octagonal footprint with shorter corners, with both suspended floor and suspended tile ceiling. Projecting infrastructure and openings for speakers, projector and screen were present in the exterior walls with former public viewing gallery to the north and west. The main entrance was from the north which linked directly with entry funnelled through the glazed link, with secondary access afforded to the east and south.

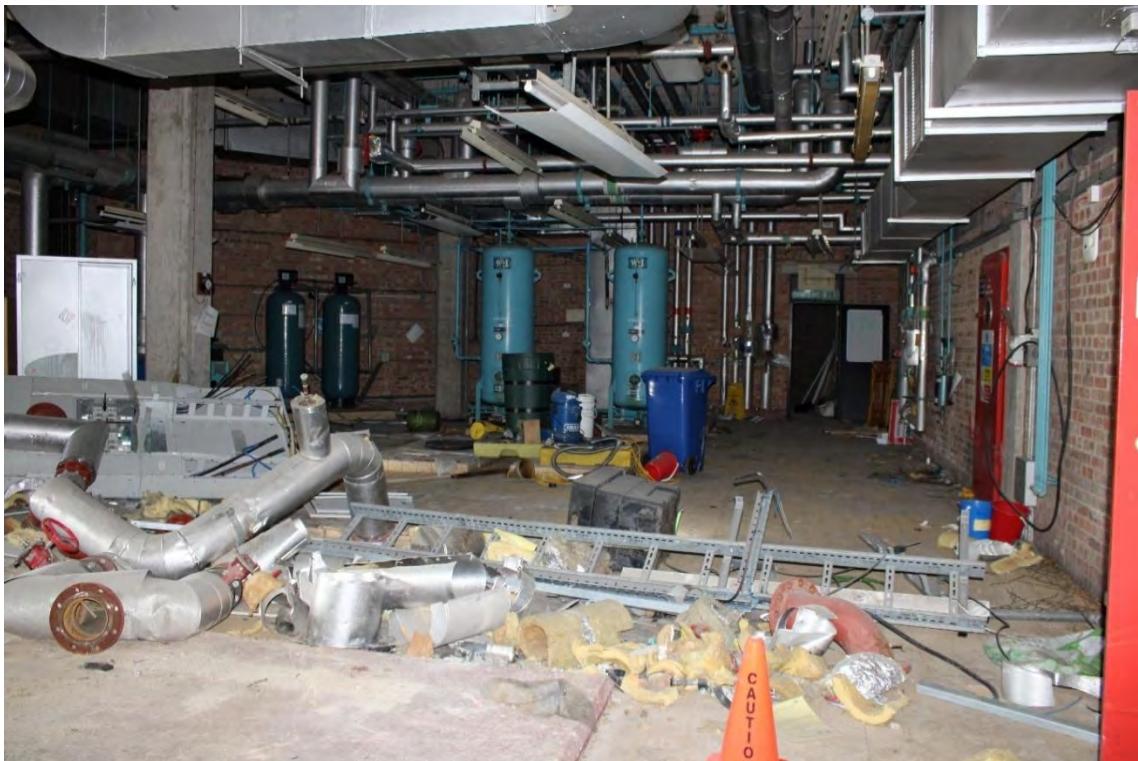
Photograph 52. Illustrative View of the Plant Area

- Air conditioning with these rooms comprising insulated panels and air locked metal bunker doors with external metal hinges and a round porthole at head height.
- Water and heating with large tanks and associated pipework, including the gas supply and instruction information attached to the exposed brickwork walls.
- Ventilation equipment including plant, soft baffles and associated ductwork.
- A storage room contained drive belts.
- Electrical equipment associated with the former telecoms including the private branch exchange (PBC) phone system.

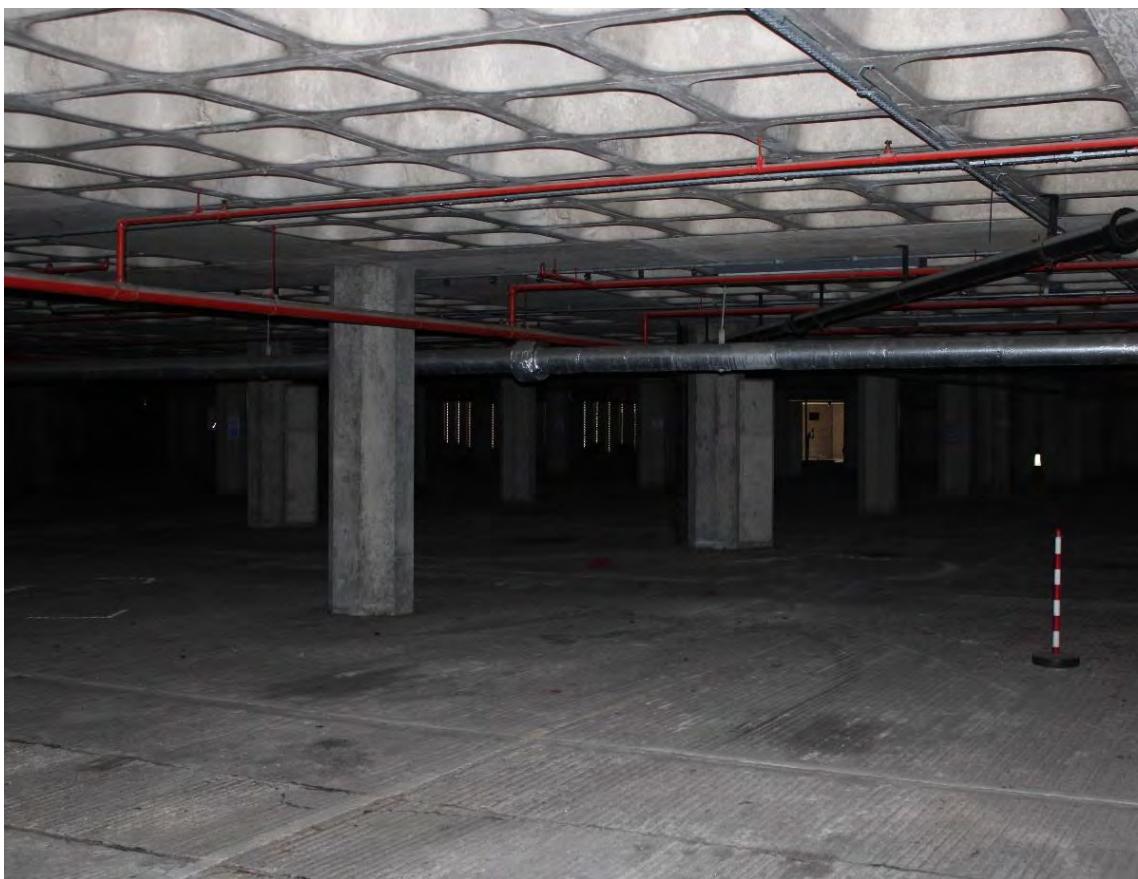
Photograph 55. Illustrative View of the Basement Car Parks

5.19.1 The Basement and Sub-Basement featured a series of storage and plant rooms in the southwest, with the remainder in use as sub-terranean car parks. The car parks were designed to provide parking for approx. 700 cars and constructed of the same materials to the same design as the remainder of the complex. There were two gated ramped vehicle entrances on each floor, one from east and one from the west. Each entrance featured associated direction signage, barriers and unmanned ticket machines. Throughout the floors signage demarcated designated spaces. Secure bicycle storage and plant comprising transformers, sub-stations, generators and diesel were present.

5.19.2 From the Basement a series of single flight staircases provided access to the terraces and Ground Floor.

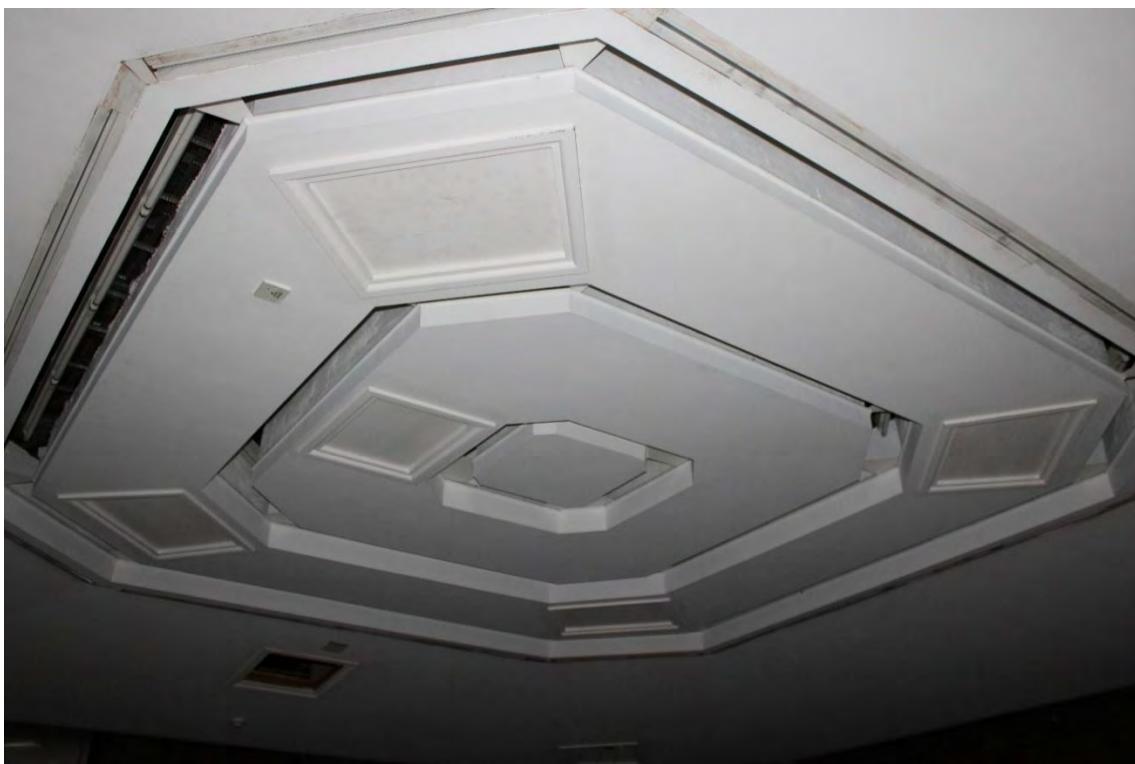
Photograph 56. Illustrative View of the Central Core Ceiling

5.20.1 The Central Core shafts were of octagonal footprint with shorter corners and comprise the central lifts and staircases. These areas also comprised the central bathroom facilities, although this infrastructure had since been removed and the space characterised by exposed concrete breezeblocks. On the upper floors the ceiling was suspended and featured a mass-produced octagonal relief with short corners. Fluorescent tube strip lighting was located on the inside perimeter with indents likely associated with air conditioning positioned centrally.

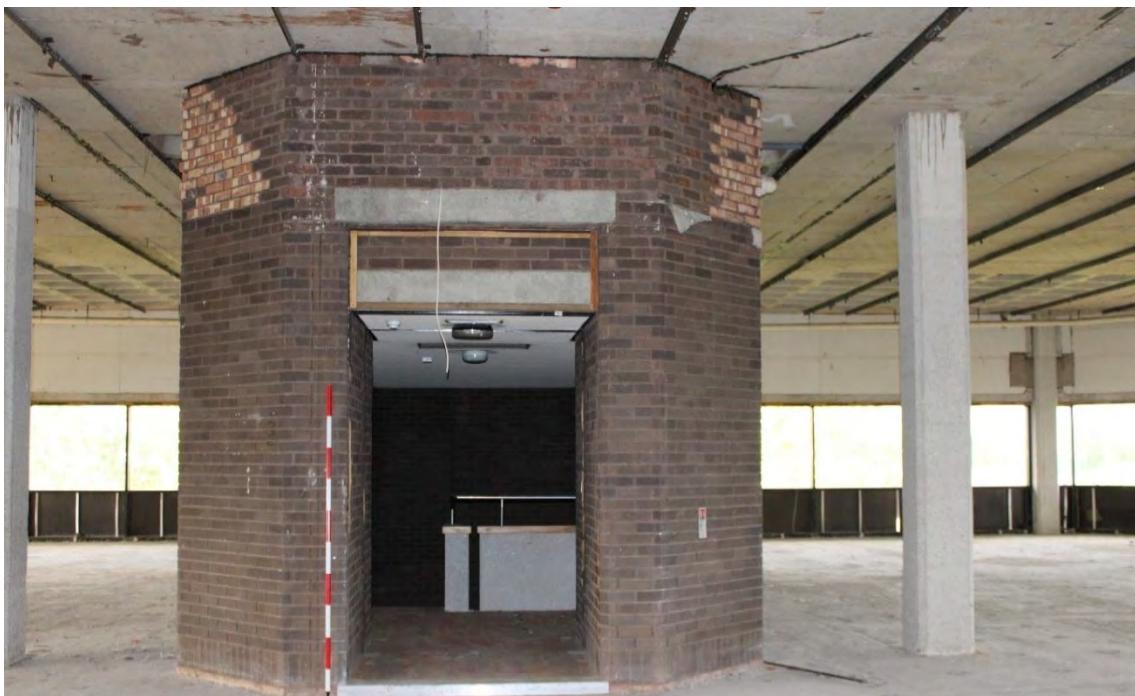
Photograph 57. Illustrative View of the Pavilion (Fire Escape) Staircase

5.20.2 Each Pavilion stairwell comprised an elongated octagonal with shorter edges plan. On the Ground Floor, the landing connects with external secondary access. On the First to Third Floors, internal access was afforded by a low level stepped double door opening, with central circular emergency light. The landing and staircase was constructed of concrete, with metal stair treads, brick balustrade and tubular metal handrail. In some locations, the balustrade was finished in white with a wooden handrail and raised metal tubular handrail inserted to increase the height of the balustrade.

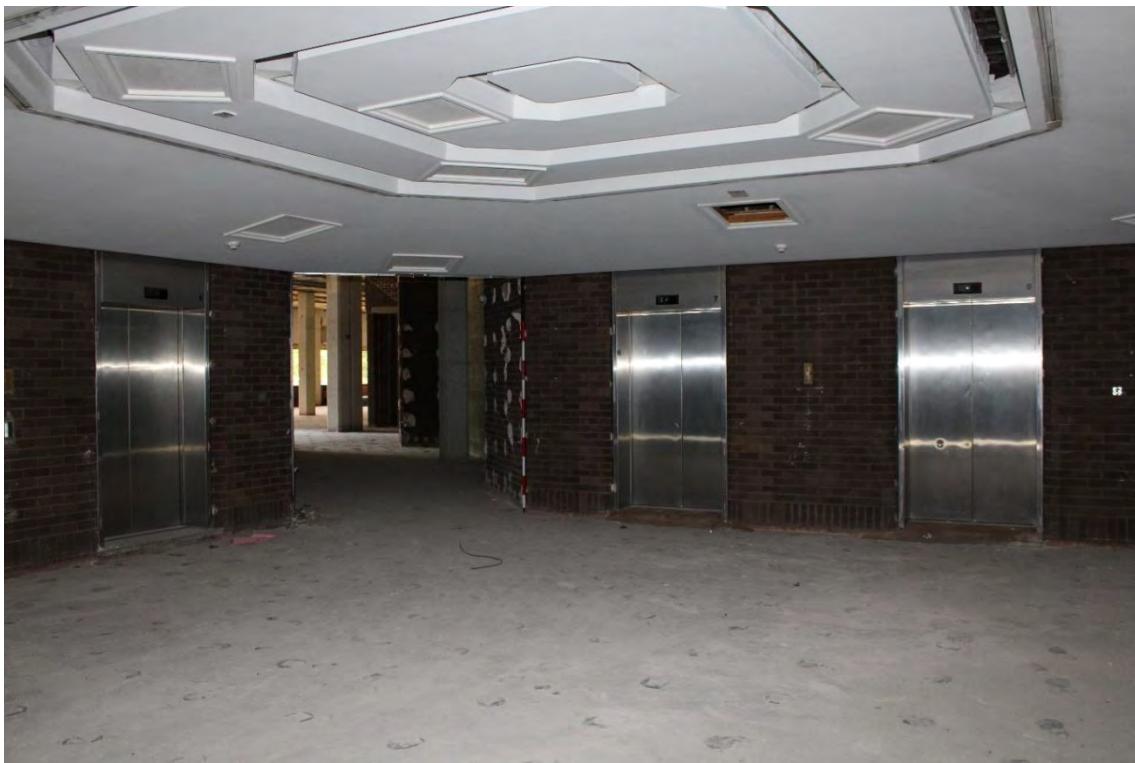
Photograph 58. Illustrative View of the Lifts

5.20.5 Lifts remained in-situ in the Central Cores at the time of survey. These comprised paired passenger lifts constructed of stainless steel with automatic central doors. The lifts were accompanied by rectangular panels with the call button in the centre. The uninstalled lift shaft comprised a vertical shaft which formed part of the symmetrical layout of the lifts. There was no lift mechanism, cab or associated control equipment. The absence of evidence such as structural reinforcements or lift call button recesses support the provision that this was never installed. Whilst the lift void was constructed, it was enclosed on each floor level, indicating that the decision to not install was likely made during the build phase. The space on each floor was empty at the time of survey. A goods (platform) lift was in situ in Pavilion F, built in red brick. It would have been used to facilitate inter-departmental communication accounting for the change in levels in this area. A single flight staircase constructed of concrete accompanied it.

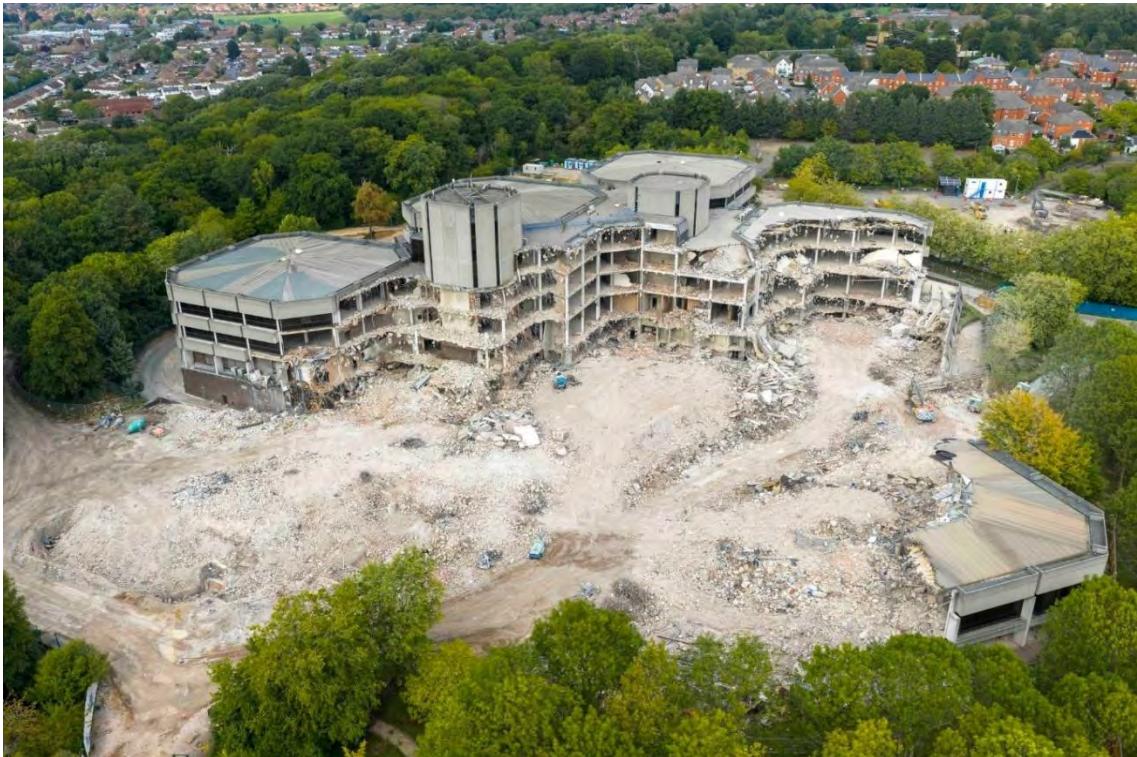
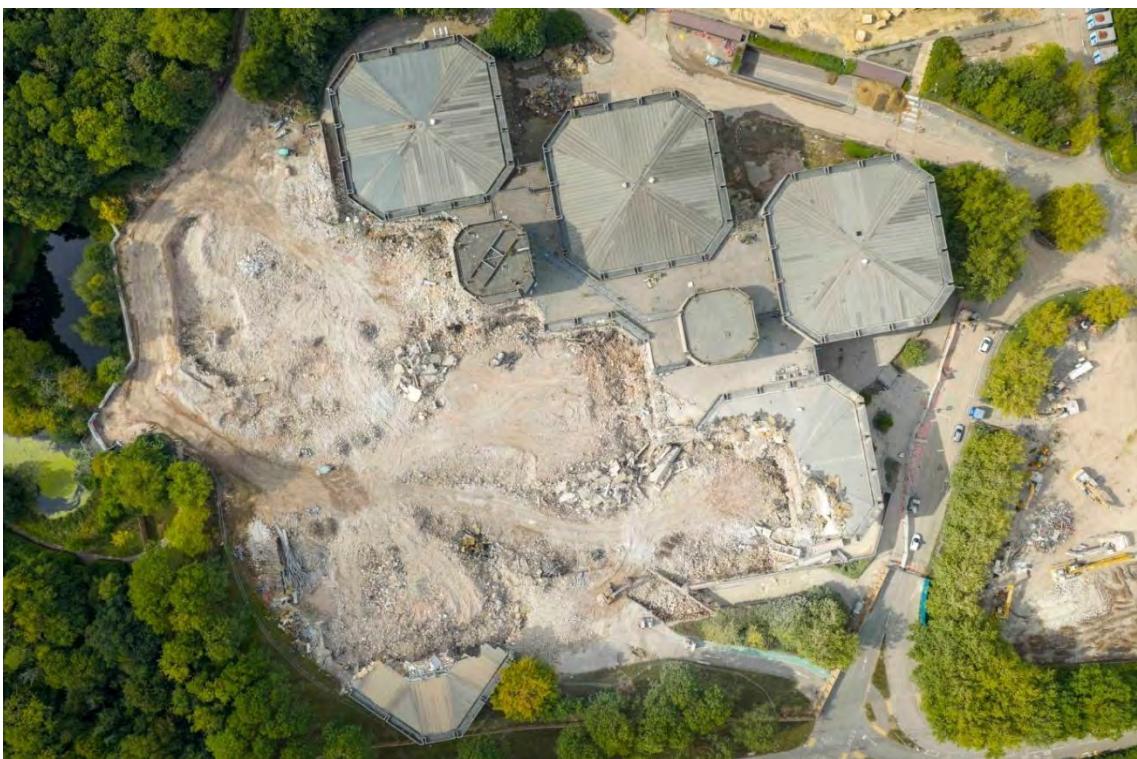
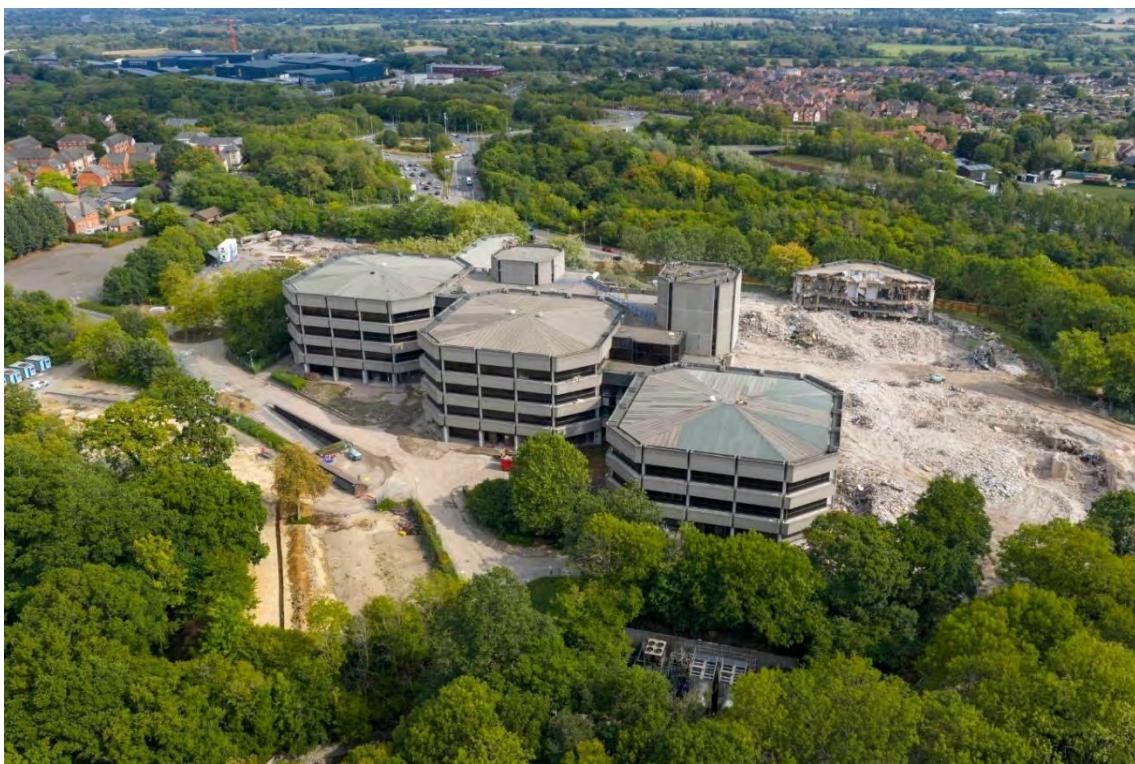
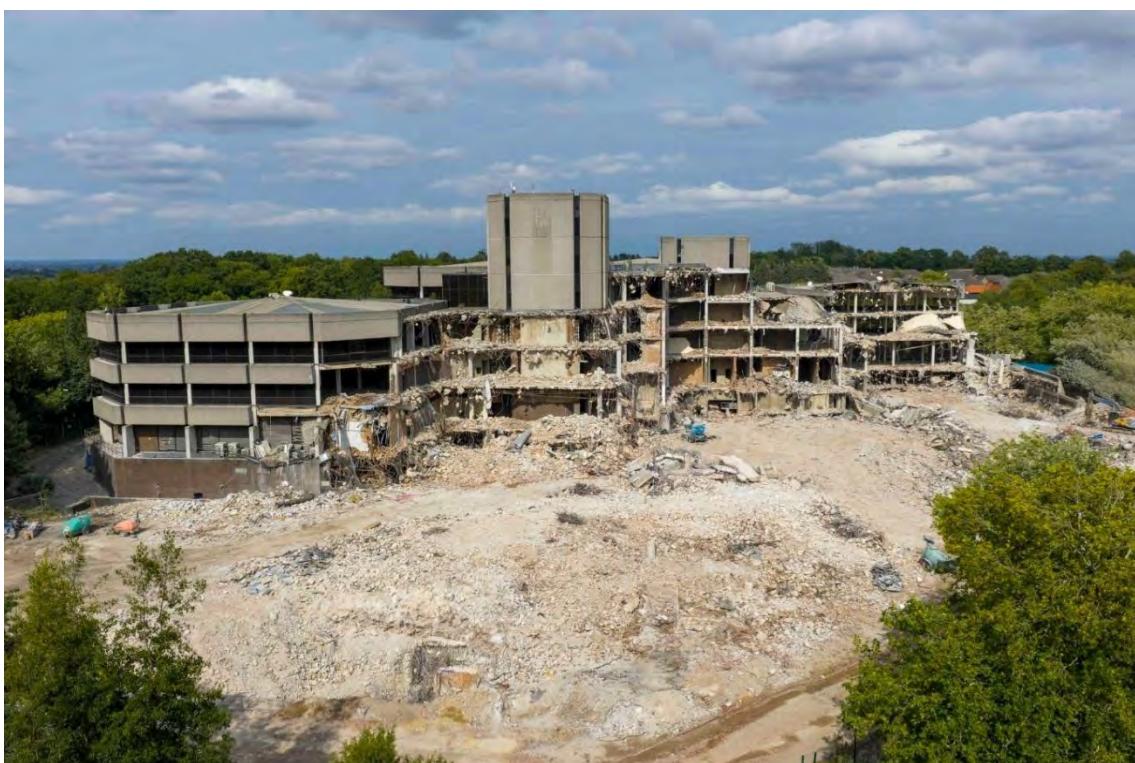
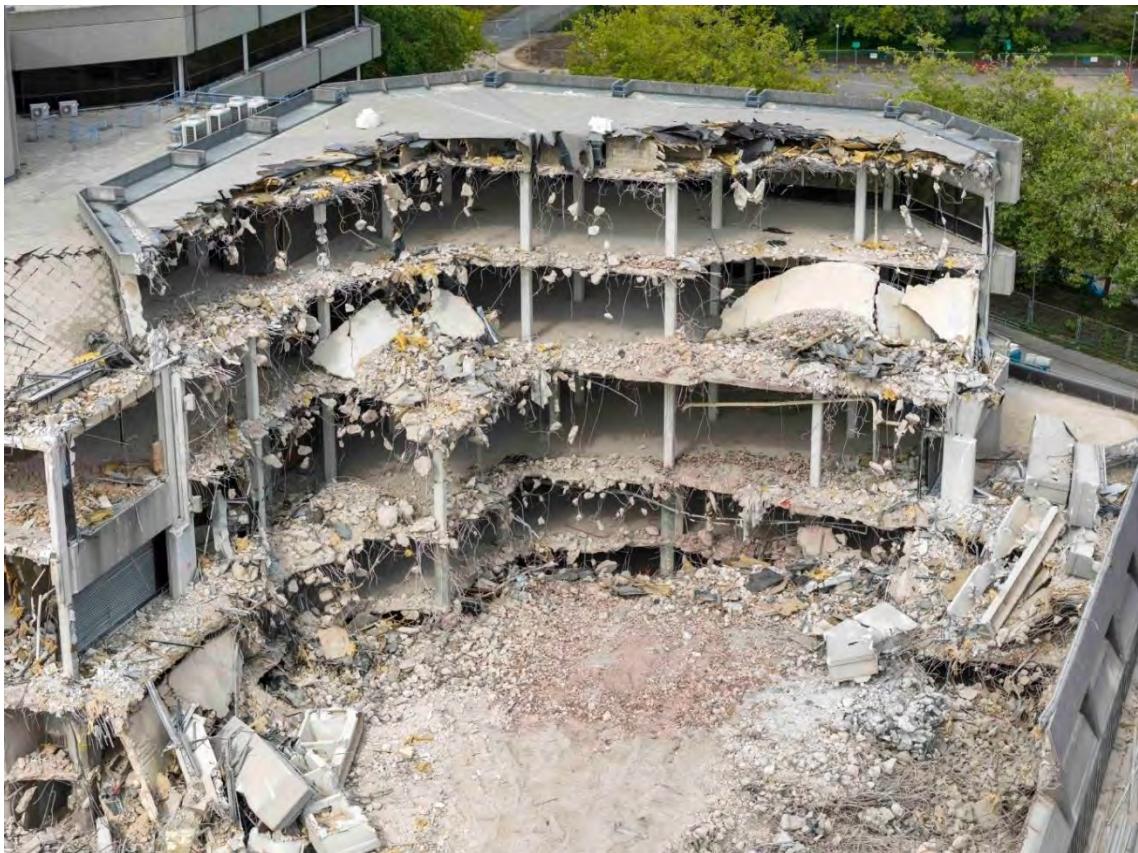
6.1.1 In September 2025 demolition of Shire Hall commenced, and the work is due for completion by the end of the year. The following photographs have been provided by the Client documenting the progress of the demolition works at the time of writing.
