# ARBORICULTURAL IMPACT ASSESSMENT

(INC. TREE SURVEY TO BS 5837:2012)

PROJECT - Avenue House

DOC. REF - P2947-AIA01 V2

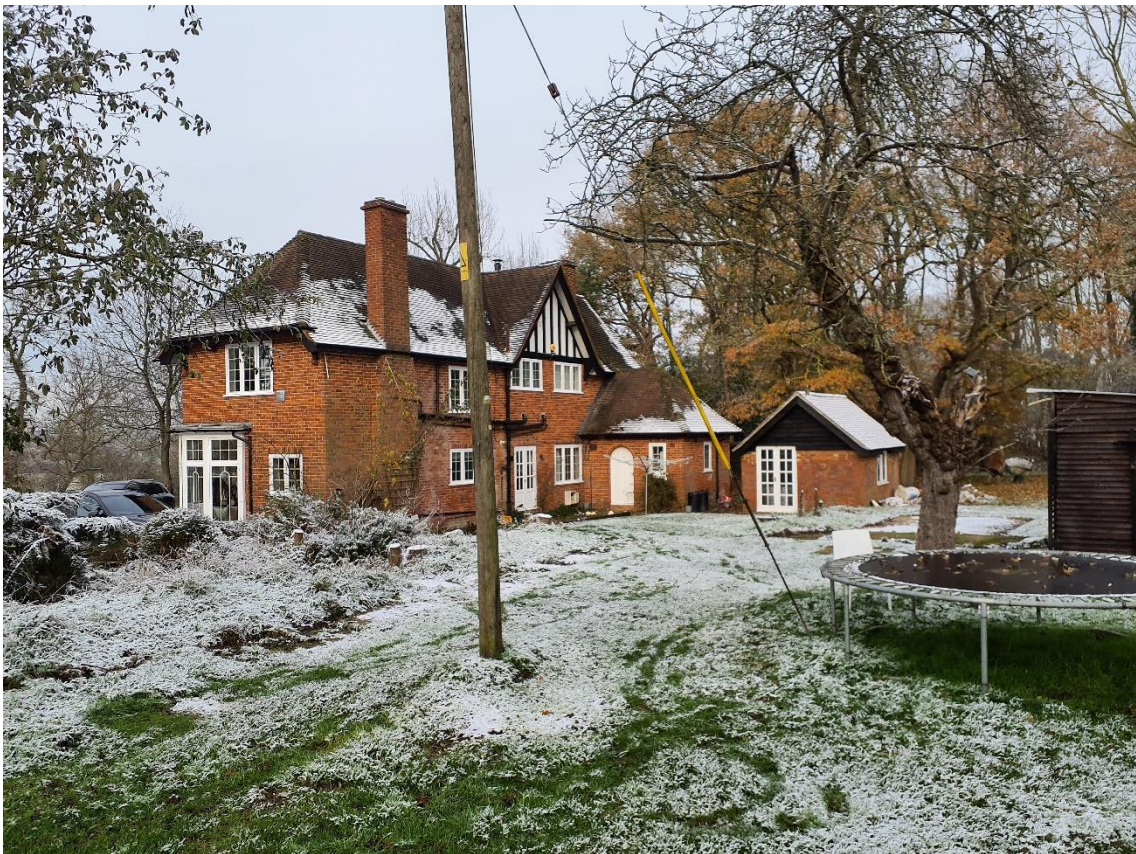
*Figure 3 – Looking northwards at the existing dwelling and the area for proposed extension.*

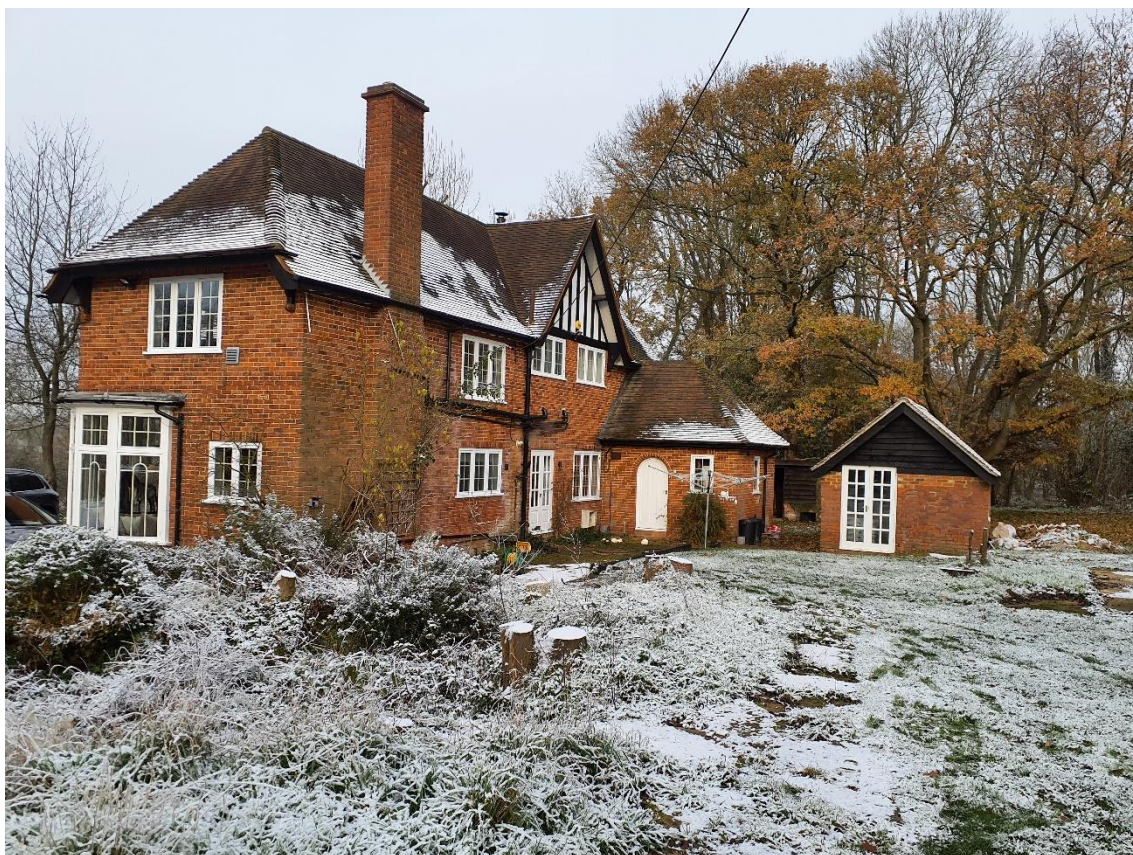
*Figure 4 – Looking northwards at the area for the proposed extension.*

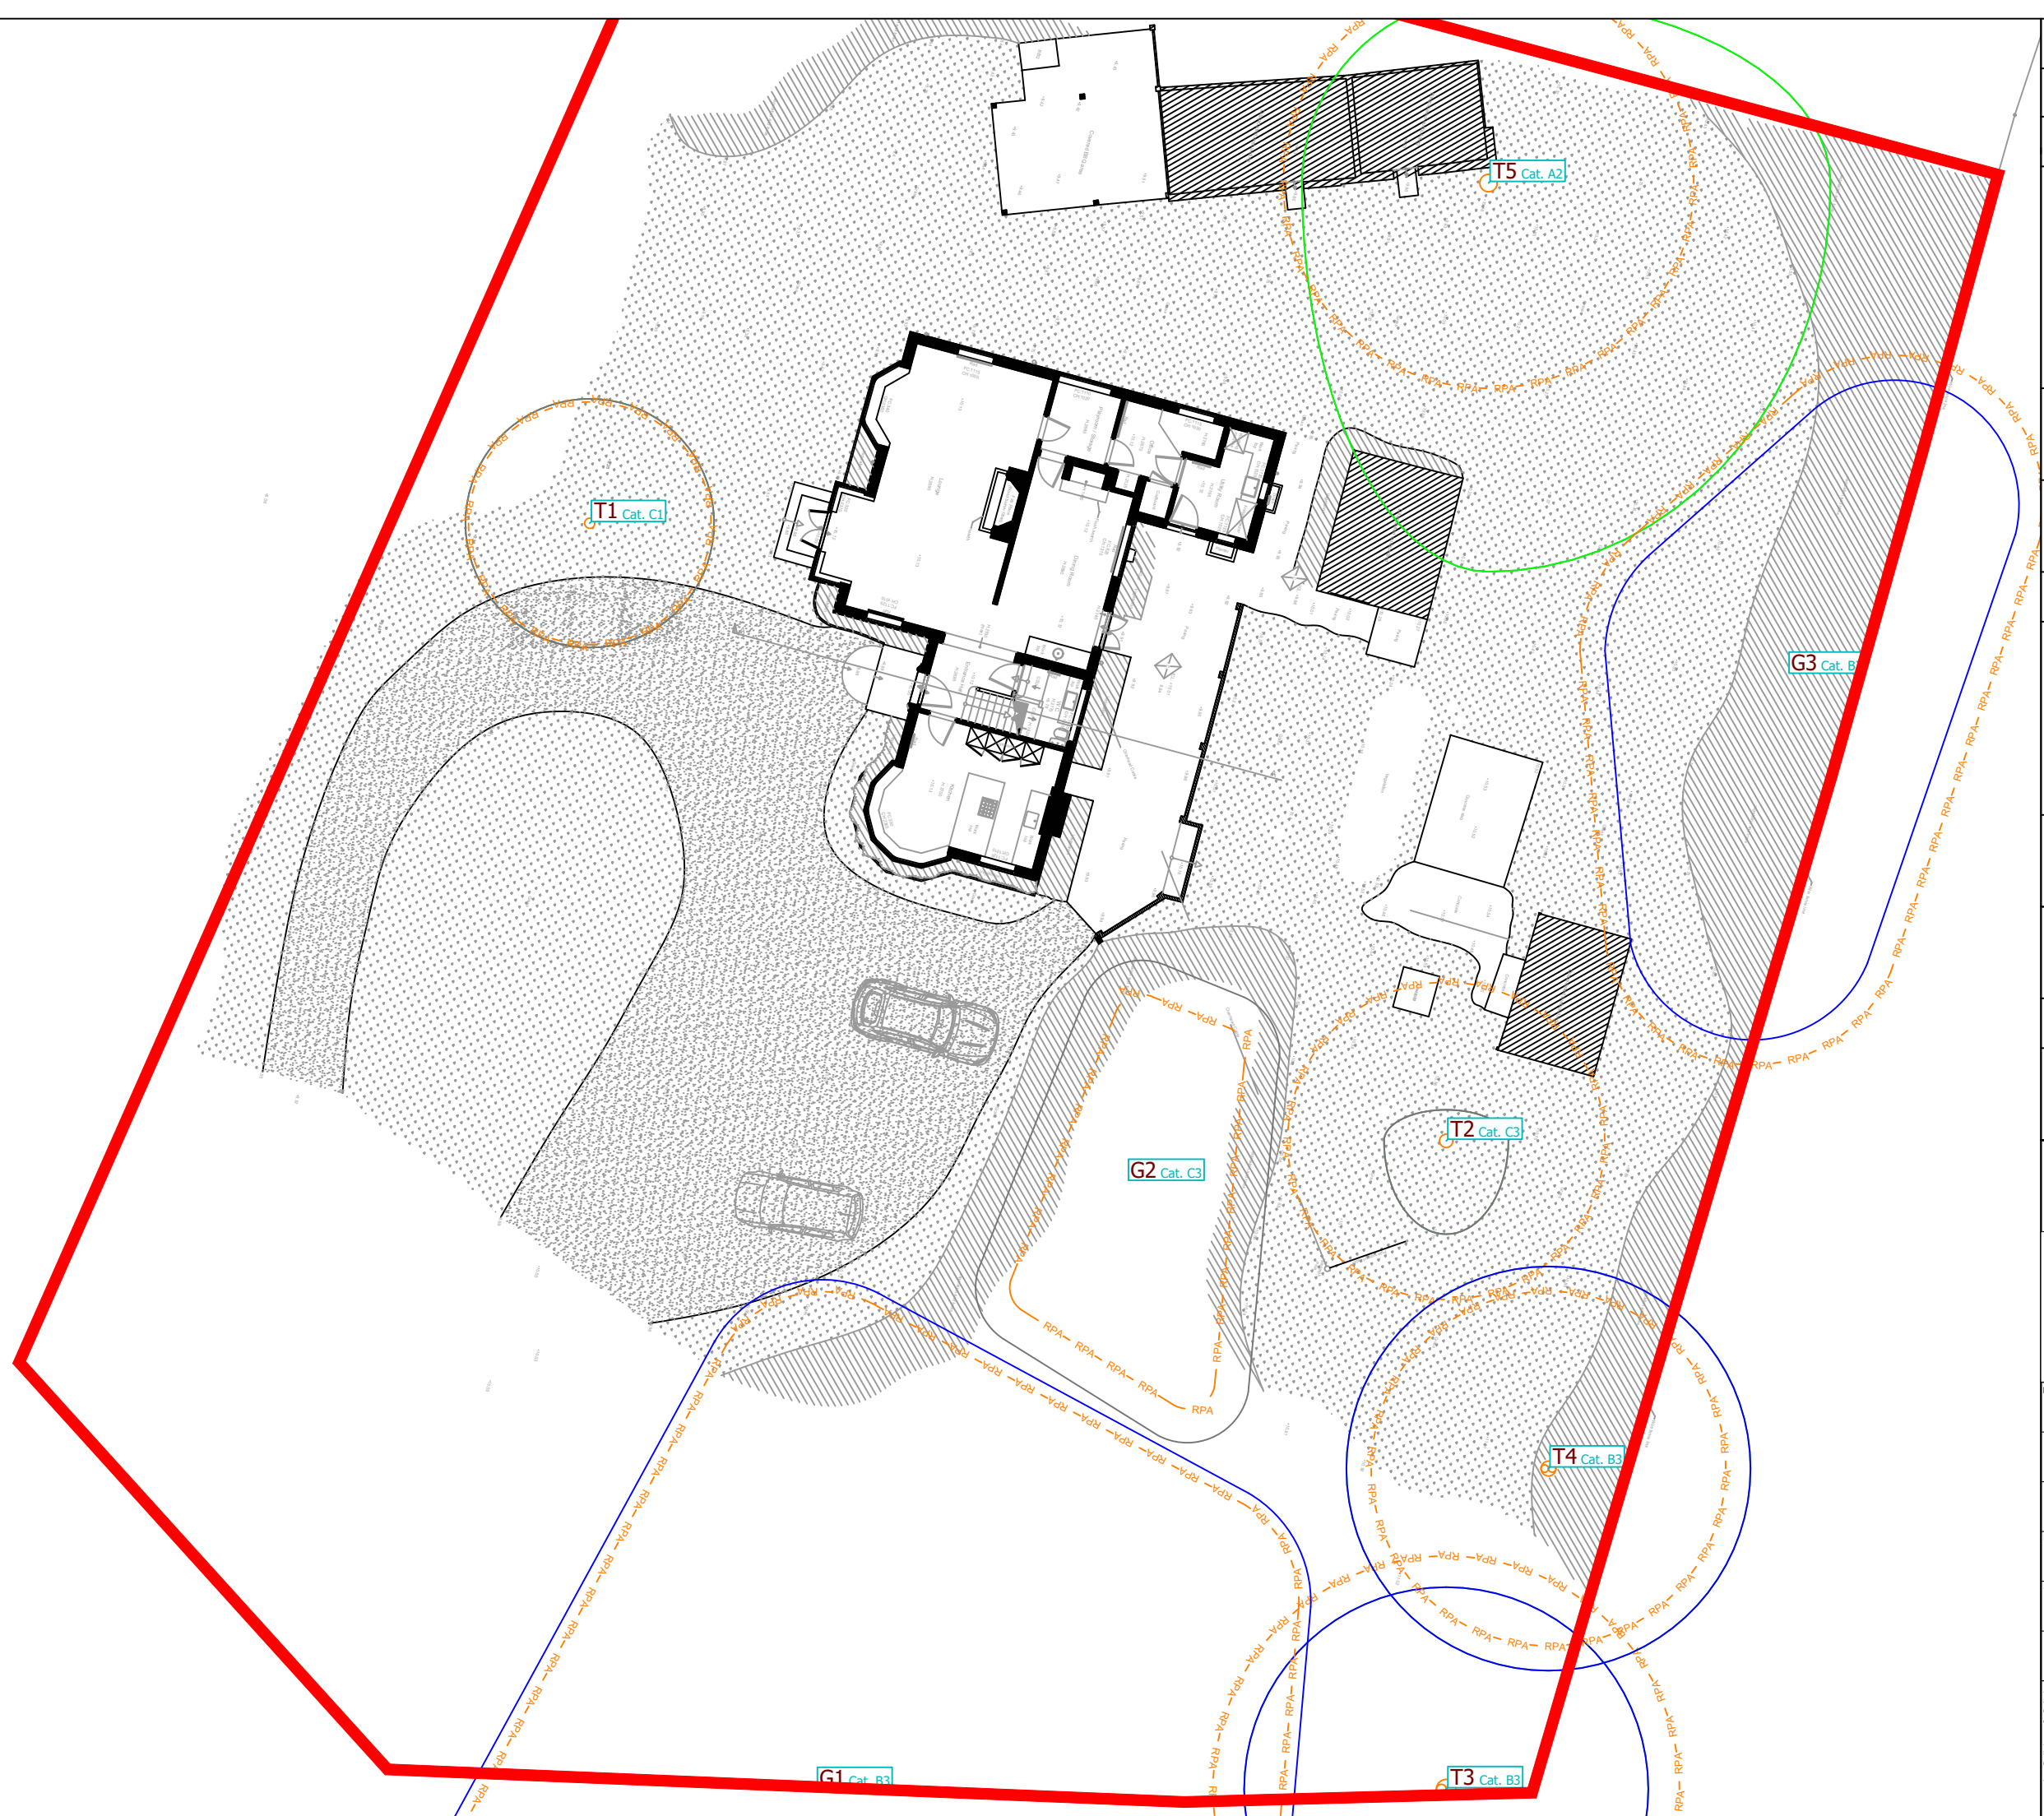
## ARB. SITE PLAN (EXISTING)

The trees considered significant within the context of the development are numbered and assigned a prefix of 'T' or 'G' to describe whether they are an individual or a group, and 'S' or 'H' for a shrub or hedge. Using this identification number, further information for each tree/group can be found within the survey schedule.

In order to avoid damage to the roots or rooting environment of retained trees, the Root Protection Areas (RPA's) should be plotted around each of the category A, B and C trees. This is a notional depiction of the minimum rooting area in m2 which should be left undisturbed around each tree. The RPA is calculated using the *British Standard BS 5837:2012 'Trees in relation to design, demolition and construction - Recommendations'*, unless otherwise stated within the survey schedule.

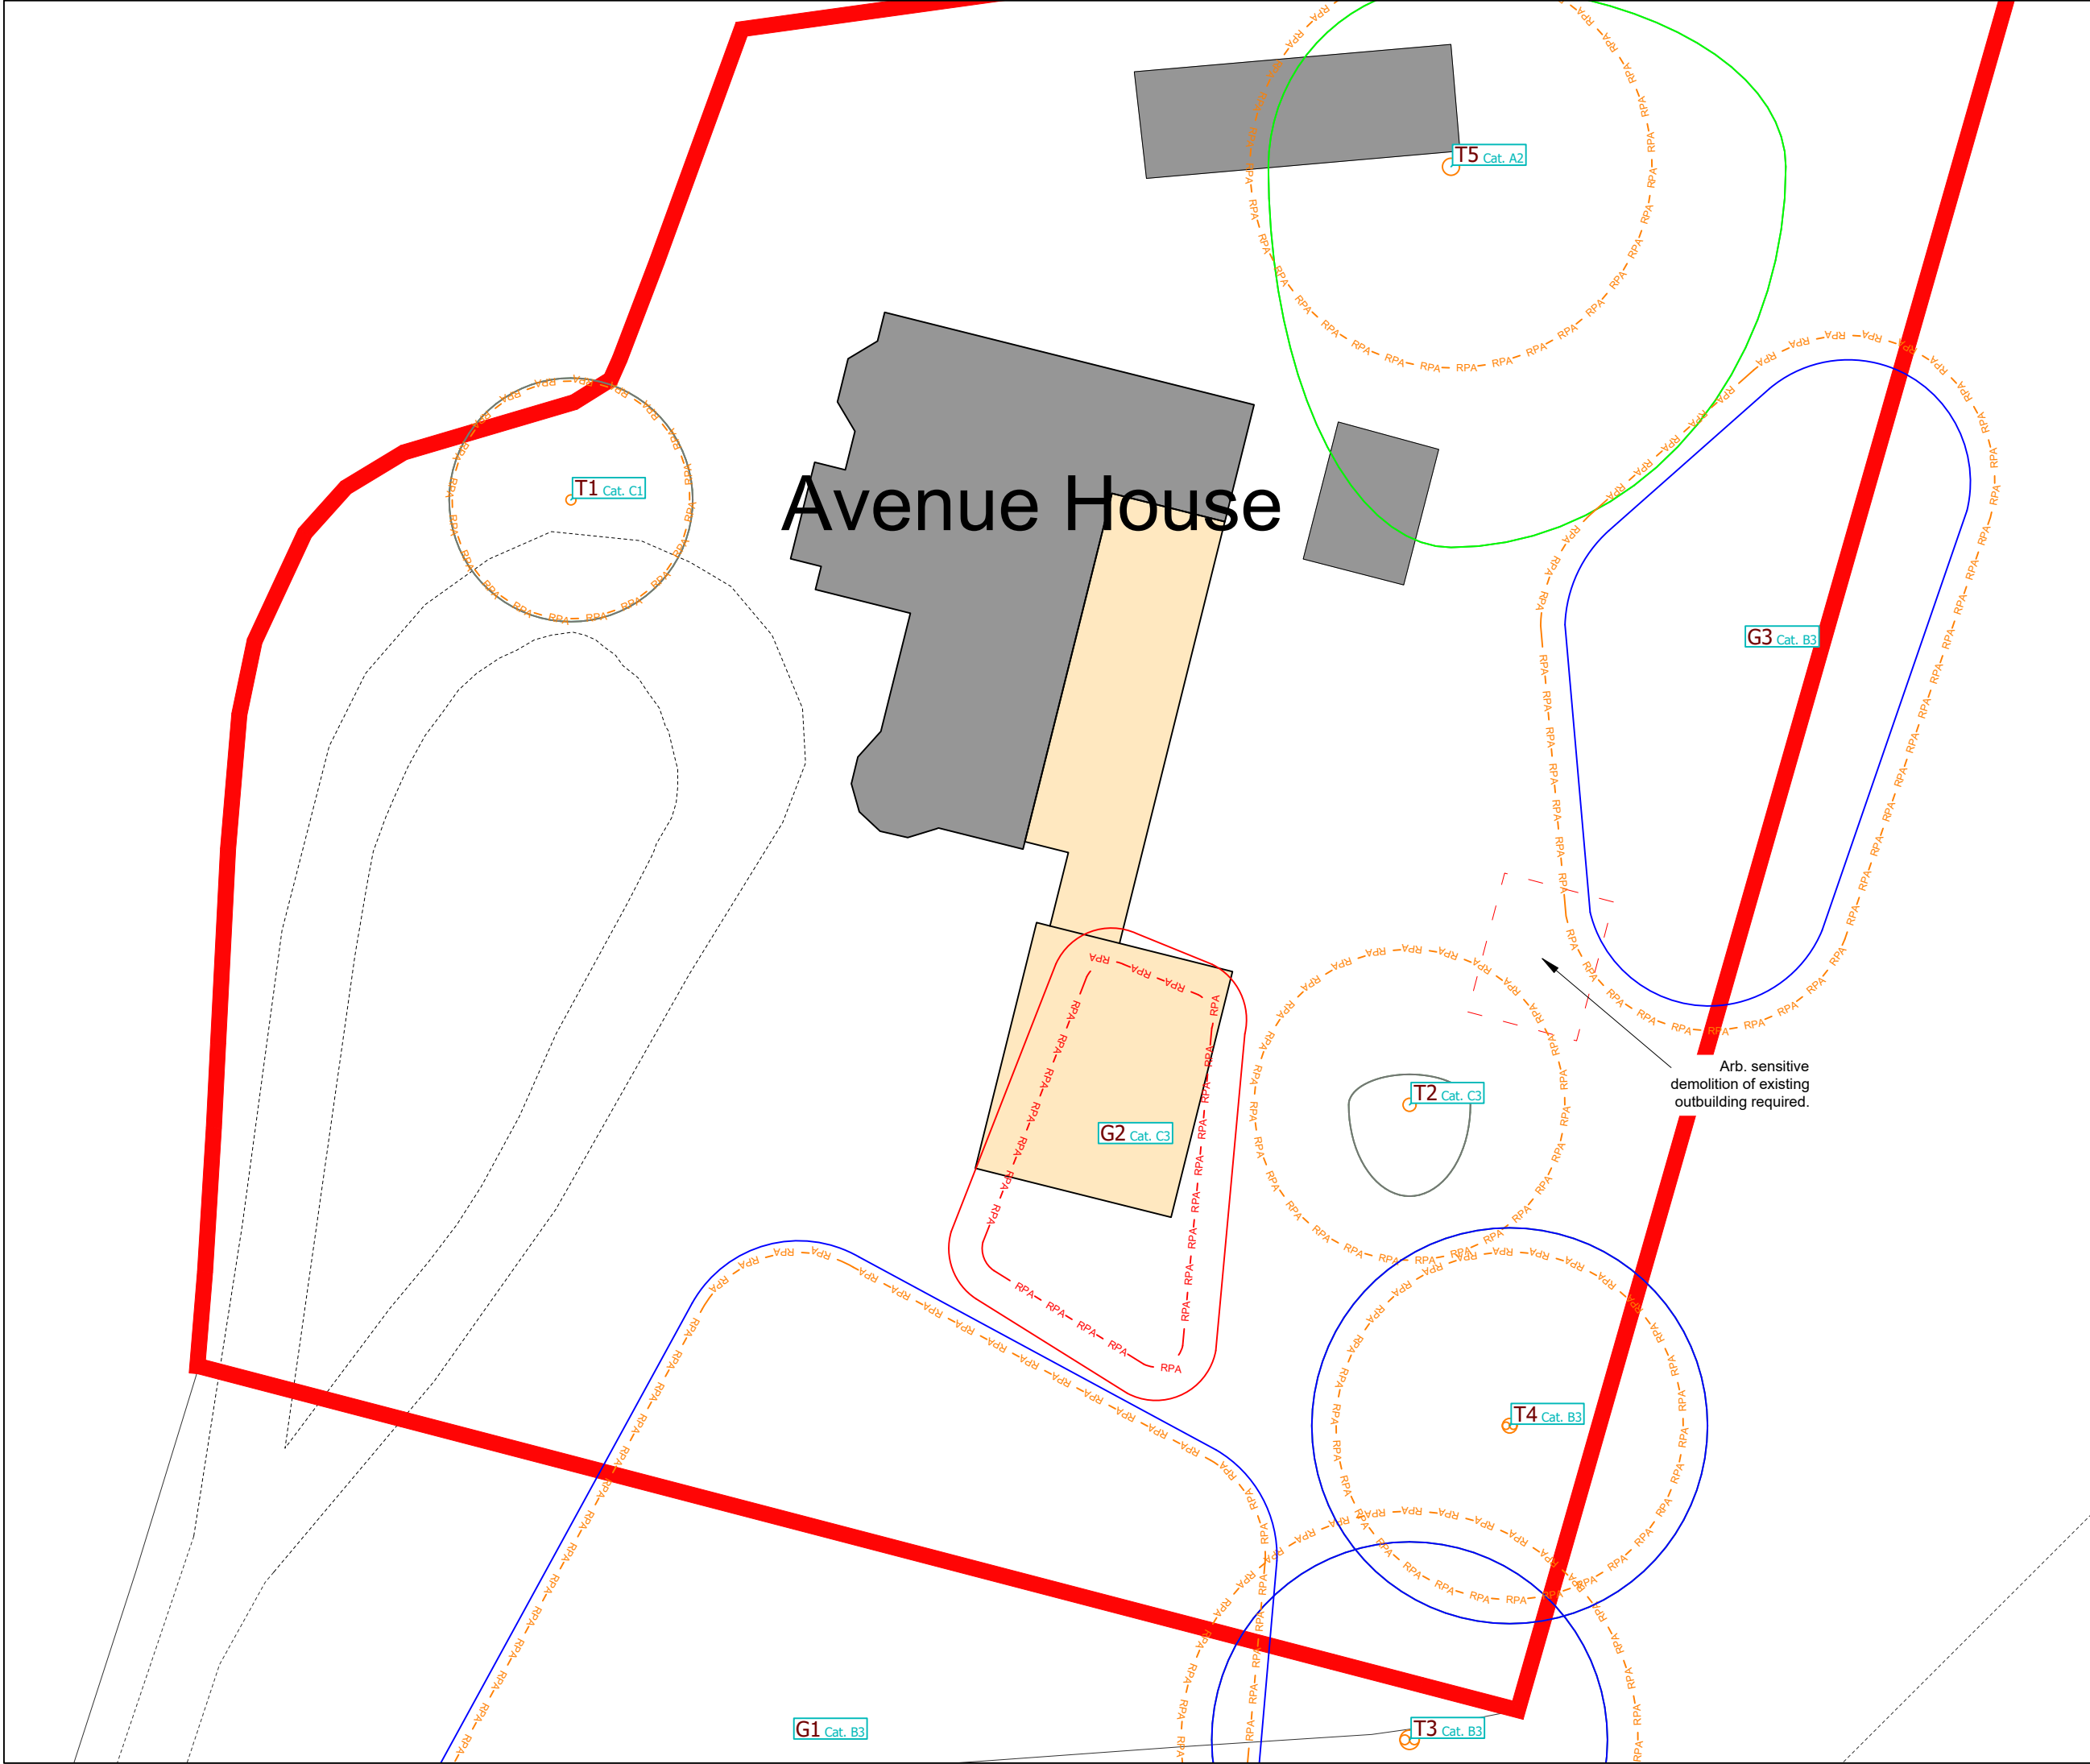
## ARB. SITE PLAN (PROPOSED)

The trees considered significant within the context of the development are numbered and assigned a prefix of 'T' or 'G' to describe whether they are an individual or a group, and 'S' or 'H' for a shrub or hedge. Using this identification number, further information for each tree/group can be found within the survey schedule.

In order to avoid damage to the roots or rooting environment of retained trees, the Root Protection Areas (RPA's) should be plotted around each of the category A, B and C trees. This is a notional depiction of the minimum rooting area in m2 which should be left undisturbed around each tree. The RPA is calculated using the *British Standard BS 5837:2012 'Trees in relation to design, demolition and construction - Recommendations'*, unless otherwise stated within the survey schedule.

| <b>Impact Appraisal &amp; Mitigation</b> | <p>Cat. C: - T3 (<i>Malus domestica</i>)</p> <p>Whilst the demolition of the existing outbuilding will not directly impact any retained tree, it has the potential to cause damage to T3 and G3 if done incorrectly.</p> |

- Any plant and vehicles engaged in demolition works must either operate from outside the RPA of all trees or from atop existing surfacing or temporary ground protection.

- Where within 3m of the crown of any trees' branches, the demolition should be undertaken inwards, within the footprint of the existing building (often referred to as "top down, pull back" demolition).

- If possible, when within an RPA, existing building foundations should be left in-situ, to avoid unnecessary rooting area disruption. Should the retention of the existing foundations be unfeasible, their removal must be accomplished via excavation on the internal edge of the foundations. Excavations on the outer edge of the foundations should be avoided.
