## **Clear View Cottage, Whistley Green**

Preliminary Ecological Appraisal and  
Bat Survey

Report ref: SWE-P25-0246-R1

**PROJECT DESCRIPTION:** Demolition of existing building and construction of a replacement dwelling.

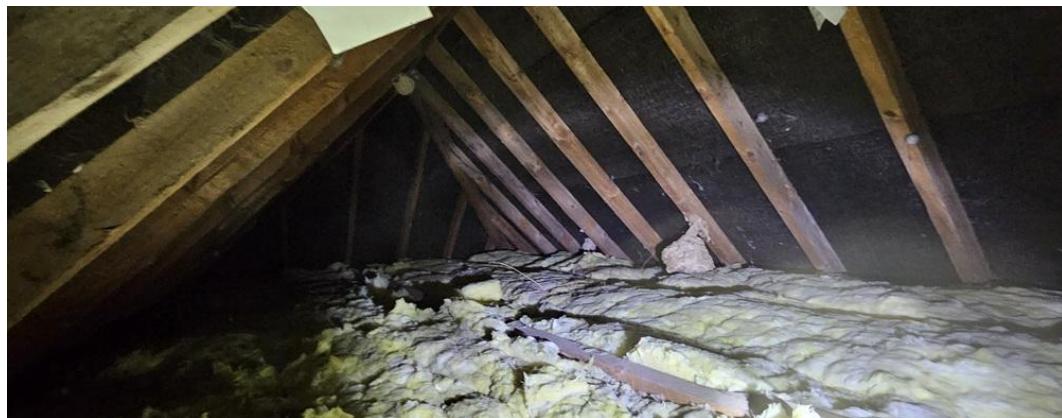
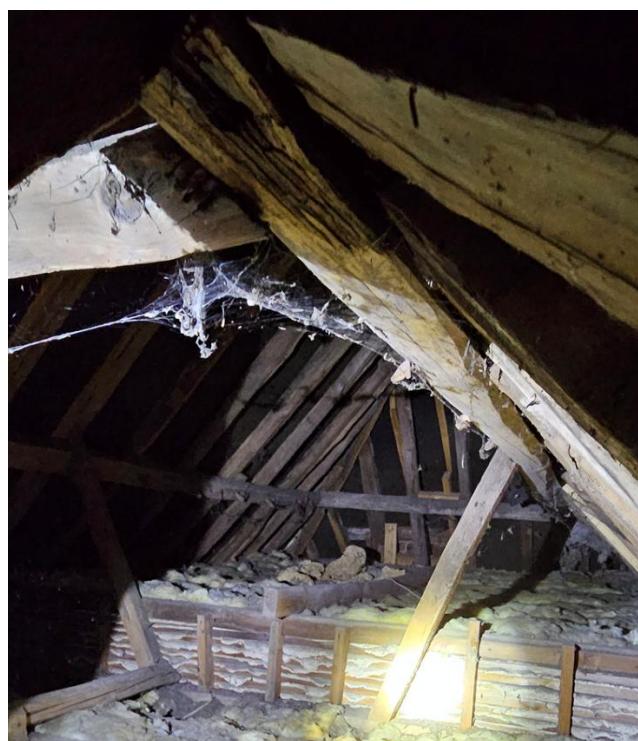
- 4.1 Clear View Cottage is a two storey, red brick building that has a multi-pitched roof covered with clay tiles. The largest roof void is present over the northern end of the building and it appears to have been extended at some point, with the western section having a clear span truss constructed from sawn timber, whilst the east section has a braced purlin truss constructed from timbers that appear to be markedly older.

- 4.2 An active wasps' nest was present in this void at the time of the survey which prevented a detailed survey being carried out. Nevertheless, no evidence of bats was found in proximity to the access hatch and the build-up of cobwebs within the void would also indicate that there has been a lack of movement generally. The presence of an active wasps' nest does, itself, also reduce the likelihood of bats roosting.
- 4.3 There is a second void at the centre of the building, but this was not accessed at the time of the survey. The third section of pitched roof at the southern end of the building is open to the roof internally and has been lined with fibreboard.

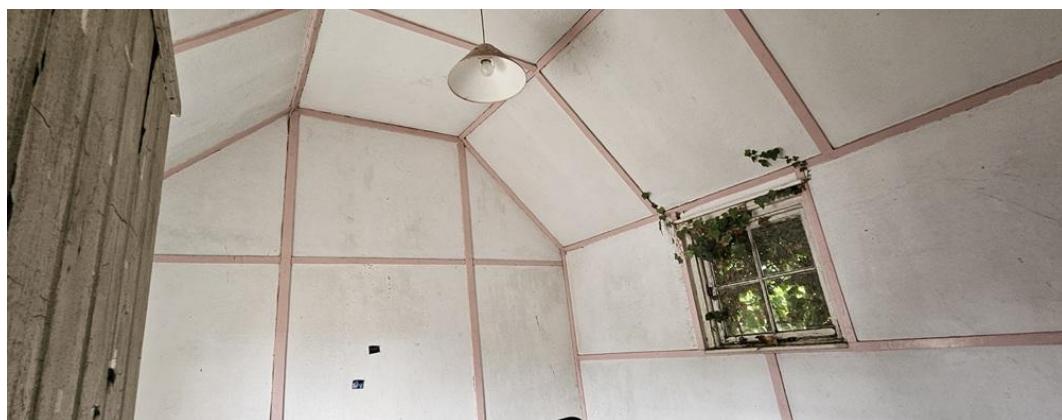
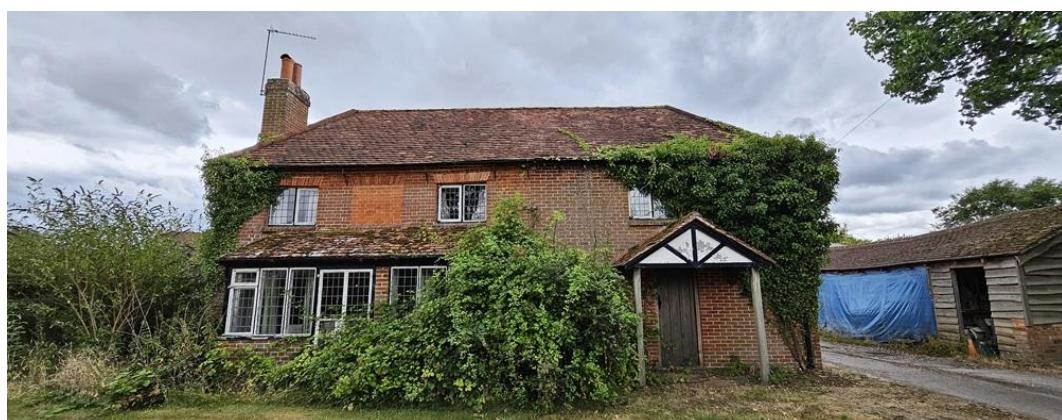
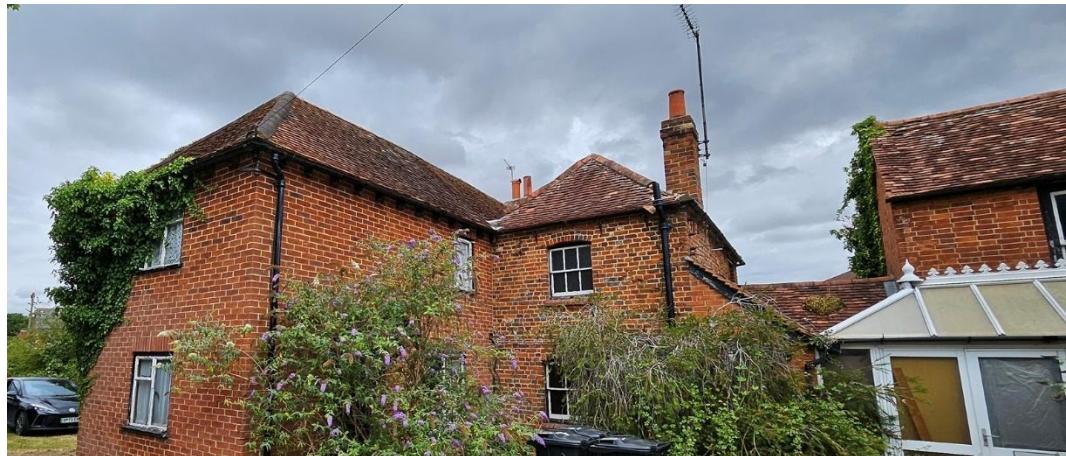
- 4.4 Externally, the principal roosting features noted were the roof tiles, many of which appeared to be traditional and so have an irregular shape that creates potential crevice type roosting opportunities below. A number of the roof and hip tiles were also raised or missing, providing further potential roosting opportunities, with the lead flashing also warped in places. The remainder of the building is generally well sealed, with the brickwork complete and the building lacking a soffit box at the eaves.

- 4.5 Overall, the building was assessed to have moderate roosting potential and no evidence of bat was found during the building survey.

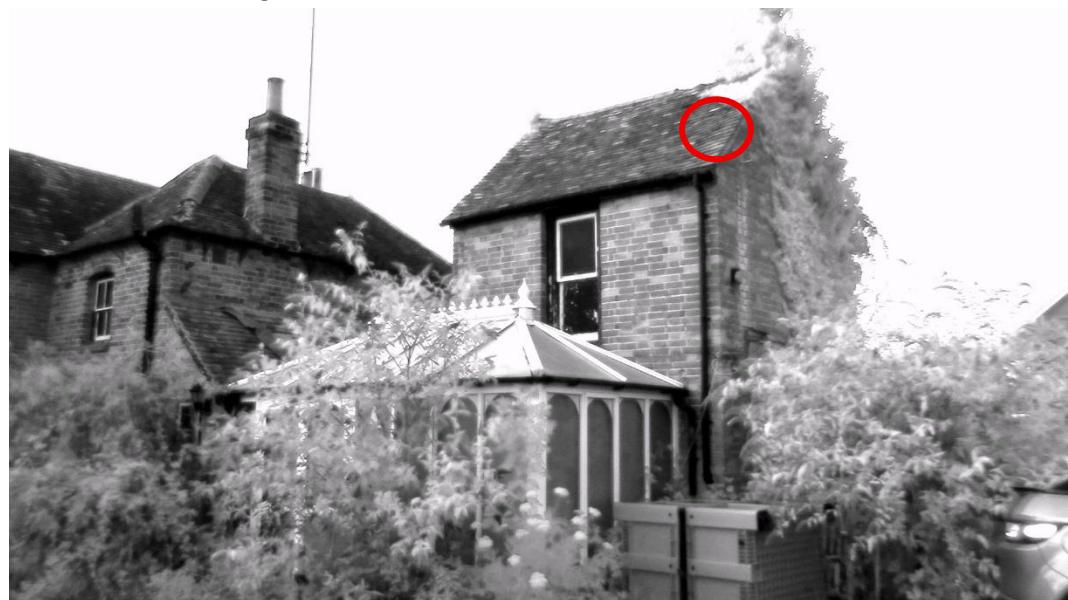
Location of bat emergence

- 4.7 A single emergence event was recorded during the dusk surveys. This was detected during the first dusk survey and involved a bat emerging from the eaves of the building at the southern end (see Drawing 0246-0610-1). Analysis of the recordings of the accompanying bat detector confirms that the bat was a soprano pipistrelle *Pipistrellus pygmaeus*.

- 6.2 The only evidence found of bats roosting in the existing building, was a single soprano pipistrelle bat that was recorded emerging from the corner of the building at dusk. As both dusk surveys were carried out during the peak survey season, the presence of a single bat would indicate that the roost is a non-maternity, day roost, most likely used by an individual male bat or a non-breeding female.
- 6.3 With reference to Table 3.2 of the UK Bat Mitigation Guidelines<sup>6</sup>, the value of a day roost used by a widespread species is restricted to the lowest geographic level. The identified roost is therefore assessed to have value at the site level only.

- 6.4 In order to reduce the regulatory burden for developments that affect low value roosts of the type assessed to be present within the building, Natural England operate a specific derogation licence known as the Bat Mitigation Class Licence. This operates to allow development affecting low value roosts to be licenced using a more streamlined and faster process. This in turn reduces delays and costs for the development. SWE is registered with Natural England to operate under the Bat Mitigation Class Licence, registration ref: RC102.

Whilst the identified roost will be removed due to the demolition of the building, under this licence there is no mandated requirement for compensatory roosting provision and none is therefore considered necessary. The installation of a bat box on a retained tree or the new building could, however, be provided as an enhancement.

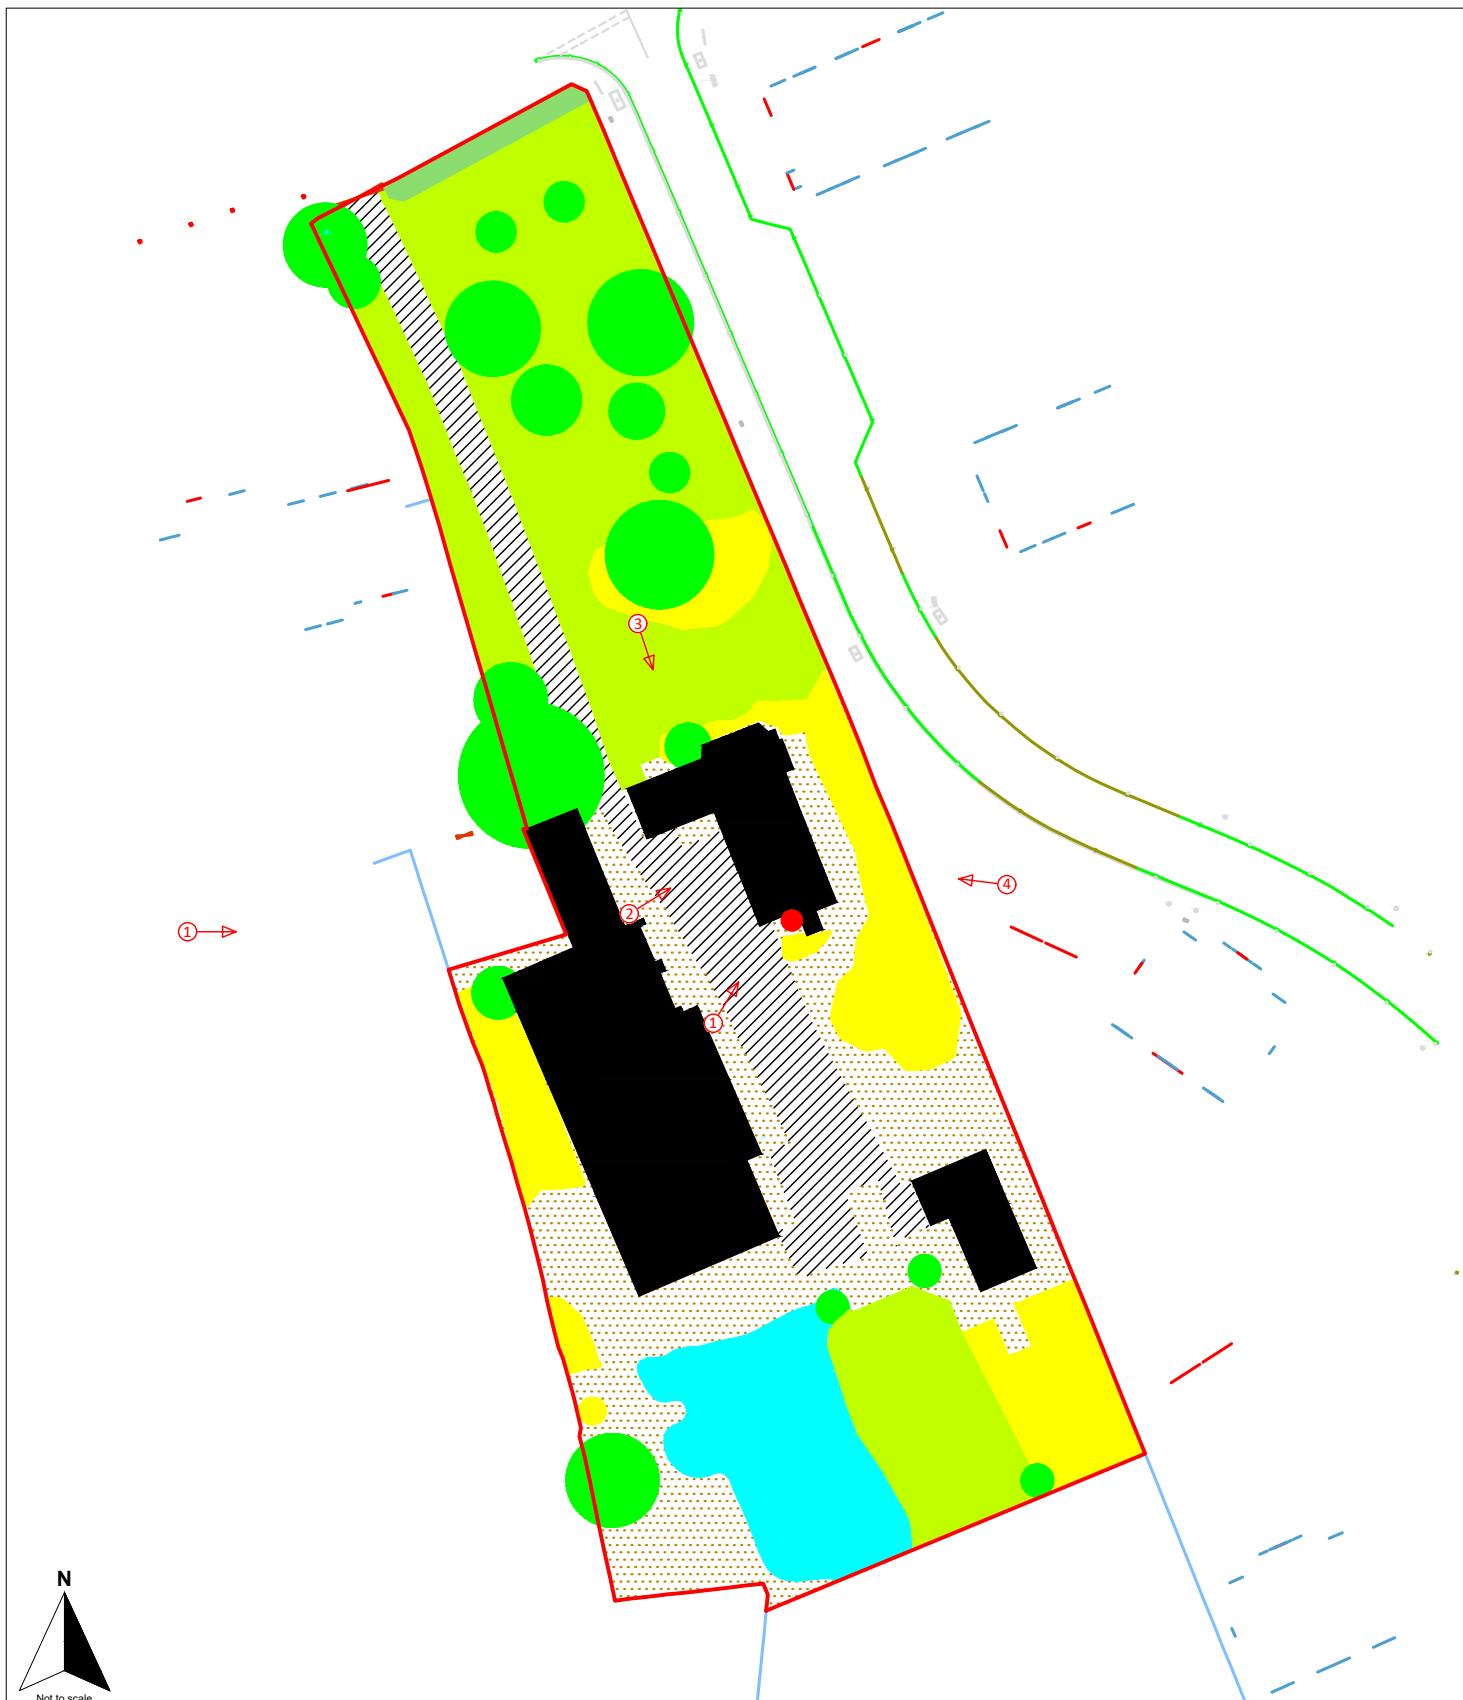
Title - Habitat map and bat survey

- 2.8 To achieve the necessary level of coverage, four Canon XA40 camcorders set to infrared (IR) mode were deployed around the building as shown on Drawing 0246-0610-1 and the same locations were used for both surveys for consistency. It was not possible to fully observe the east elevation of the building due to the presence of a fence along the site boundary. However, there is tall buddleia *Buddleja davidii* vegetation between the building and fence at this location which reduces the scope for roosting to occur in any event.

3.2 Each habitat is mapped on Drawing 0246-0610-1 and described in more detail below, with reference to the dominant or more notable species identified.

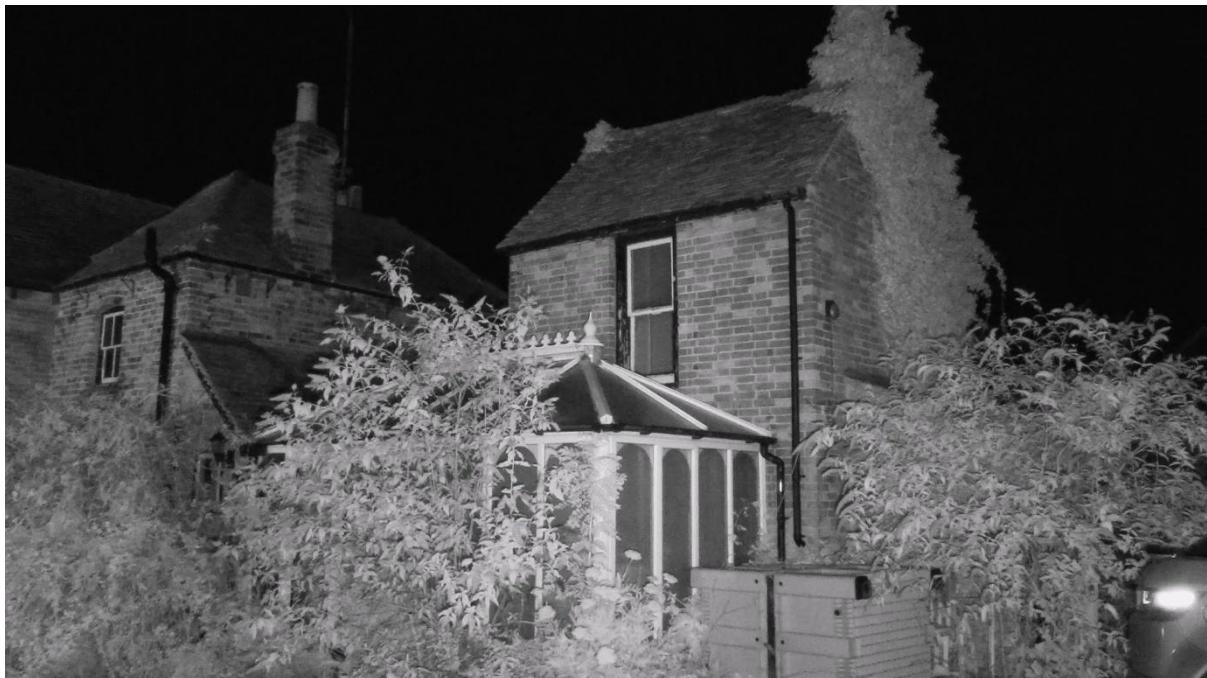
Location 1

- 4.6 The field of view for each camera is shown at Appendix 1, and the same locations were used for both surveys for consistency. The dusk surveys were carried out during optimal weather conditions, as detailed below.
