## Preliminary Roost Assessment

15, Hurst Road, Twyford, Reading, Wokingham RG10 0AG

Loft conversion.

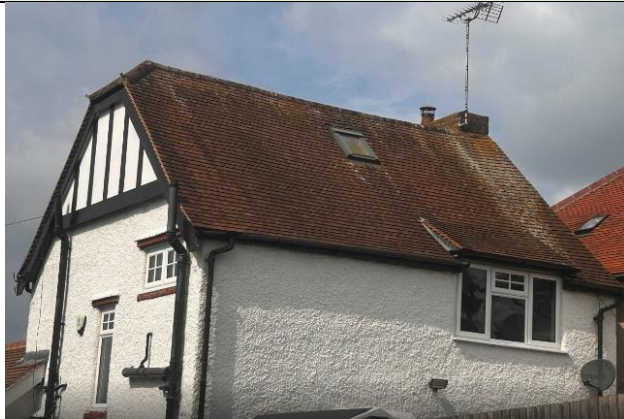
| Field survey results | | | |
|---|---|---|---|
| <p>Summary</p> <p>B1 is a detached dwelling with a clay tiled roof with a single Velux window. There is a single storey hipped extension to the south. The development will entail the removal of the roof to increase the pitch and create a dormer of the eastern elevation. The single storey extension will not be altered. The garden area is comprised predominantly of an amenity lawn, kept at a short sward height, with introduced shrubs. B1 has negligible value for roosting bats.</p> | | | |

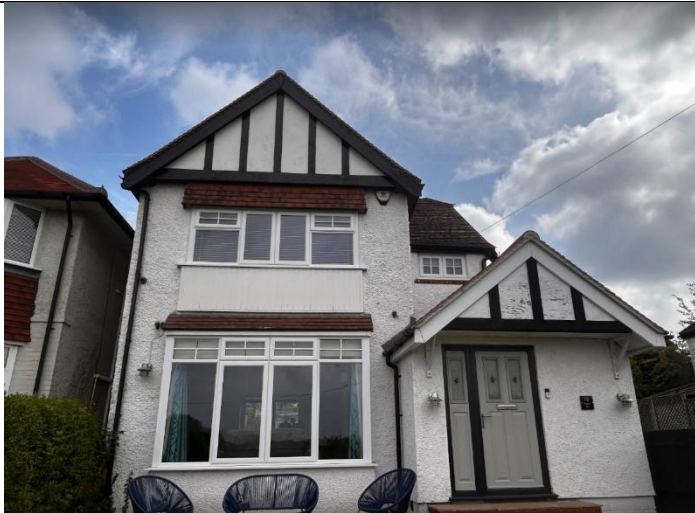
| Field survey results | | | |
|---|---|---|---|
| Walls | Rendered | Fully rendered and in good condition. | None. No suitable roosting features identified. |
| | | Figure 1: Western elevation | Figure 2: Northern elevation |

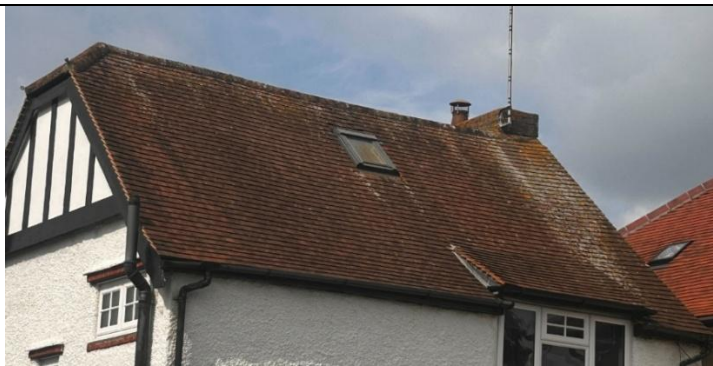
| Roof | Clay | <p>Tiles on the main roof are flush and in good condition, with no damaged or missing examples observed. Similarly, the ridge line is intact, with no lifted, damaged or missing tiles or mortar present. Mortar all intact along verges. The single storey extension contains one broken tile.</p> | <p>The main roof contains no suitable roosting habitat. The cracked tile on the side extension may provide low value roosting habitat for an individual or low number of crevice dwelling species, however this will remain unaffected by the development.</p> |
| | | <p>Figure 3: Roof of the eastern elevation</p> | <p>Figure 4: Broken tile on the southern elevation.</p> |

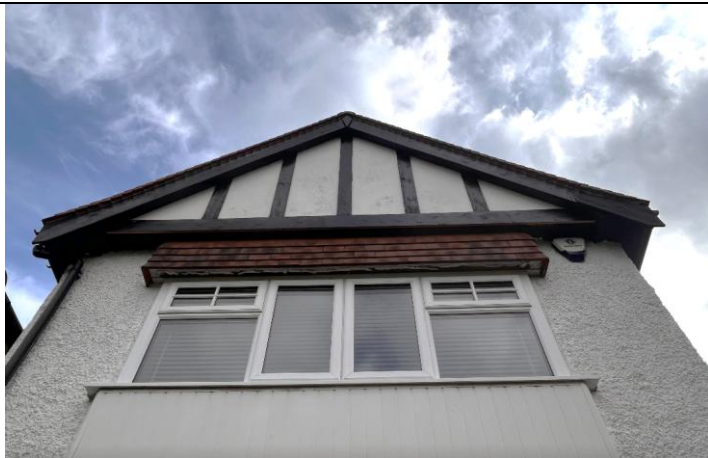
| Gable ends | Timber | <p>Tudor board cladding is located on the gables of the western and southern gables. The timbers are in good condition and are flush with the surface of the gable</p> | <p>None. No suitable roosting features identified.</p> |

| | | Figure 5: Western gable. | Figure 6: Southern gable |

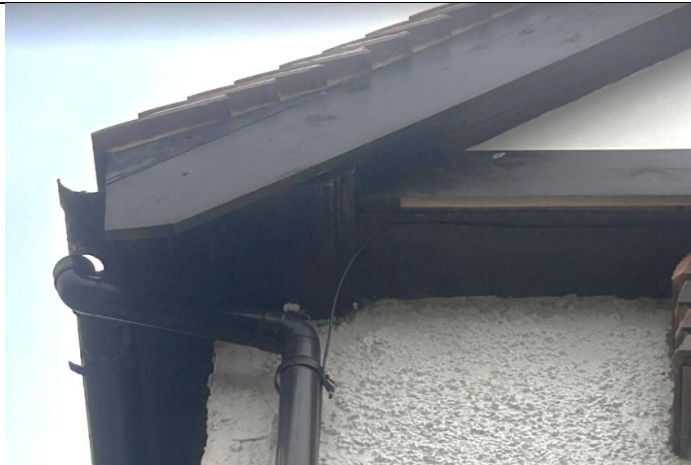
| Eaves | Timber soffit boxes | Tight fitting and well sealed, with rendering applied flush to the edges of the soffits. | No suitable roosting habitat identified. |

| | | Figure 7: Example of the soffit boxes attached to the main roof. | Figure 8: Fascia and soffits on the porch. |

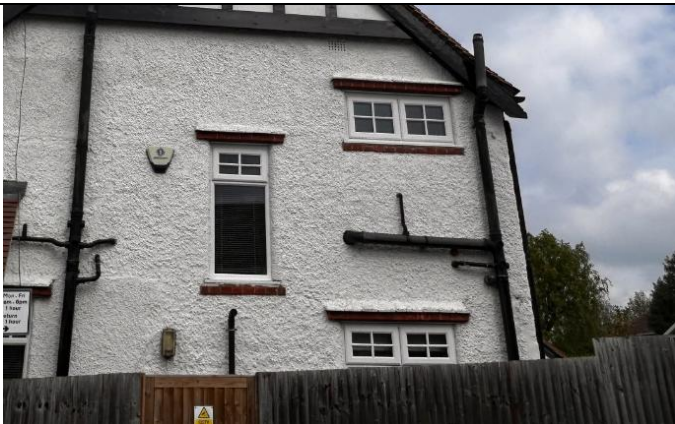
| Windows / door frames and lintels | PVC | Tight fitting. | No suitable roosting habitat identified. |
| | | Figure 9: Windows in the southern elevation | Figure 10: Windows and doors on the western elevation |

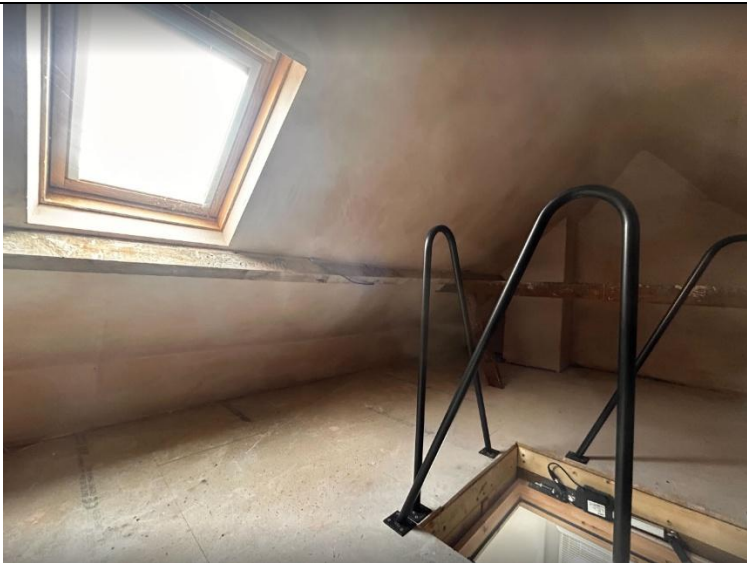
| Internal voids | Attic space | Plastered (approx. 2 years prior) and in good condition.<br>The area is extremely well lit via the velux window. | Exposed beams could provide bats with suitable roosting habitat for void dwelling species; however, no access points could be identified, and the area is very well lit. No bats or evidence of bats was observed. |

| | | Figure 11: Internal void, and light source. Facing south. | Figure 12: Internal void, facing east. |
