## Preliminary Roost Assessment

2, Cedar Close, Wokingham, Berkshire, RG40 1EA

Proposed single storey side and rear extension, first floor front extension, single storey front extension to form a porch plus replacement of flat roof to existing single storey rear extension to monopitch roof with 3 no. rooflights, alterations to fenestration and internal alterations.

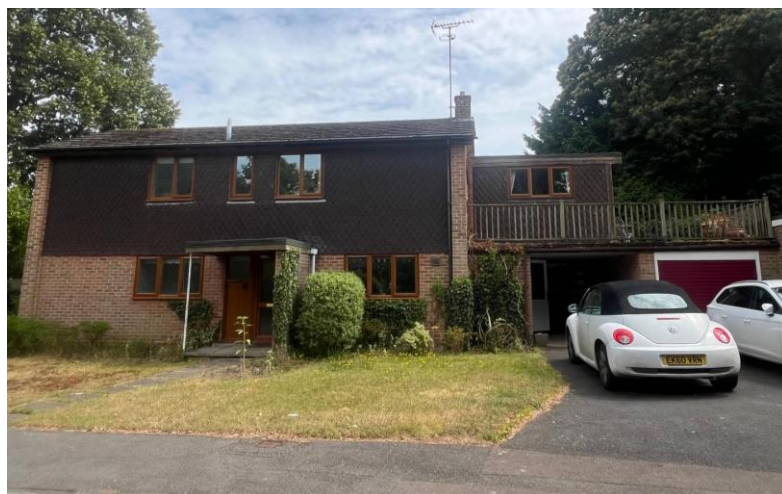
| <p>B1 is a two storey brick built residential dwelling with a gabled pitched roof clad in clay tiles. A car port and single garage were present on the south-western elevation. An extension is present above the car port with a flat roof clad in bitumen felt with hanging tiles on the front and timber cladding at the side and rear. Hanging tiles were present across the front of B1.</p> <p>No evidence of roosting bats was found internally or externally during the survey.</p> <p>B1 is assessed to have <b>moderate</b> habitat value for roosting bats.</p> | | | | |

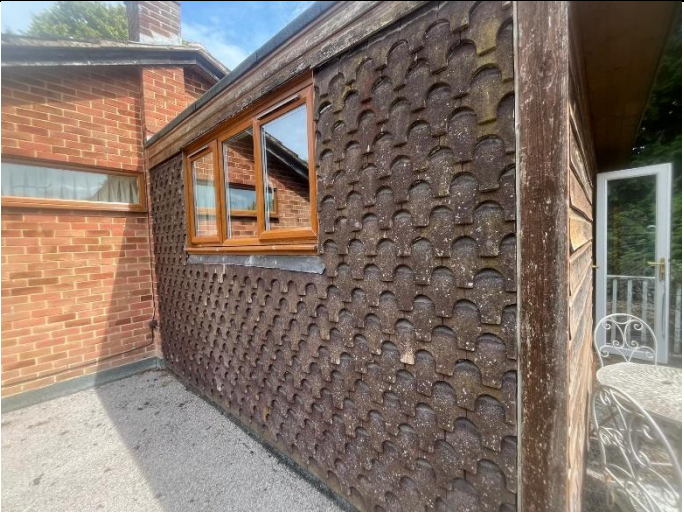
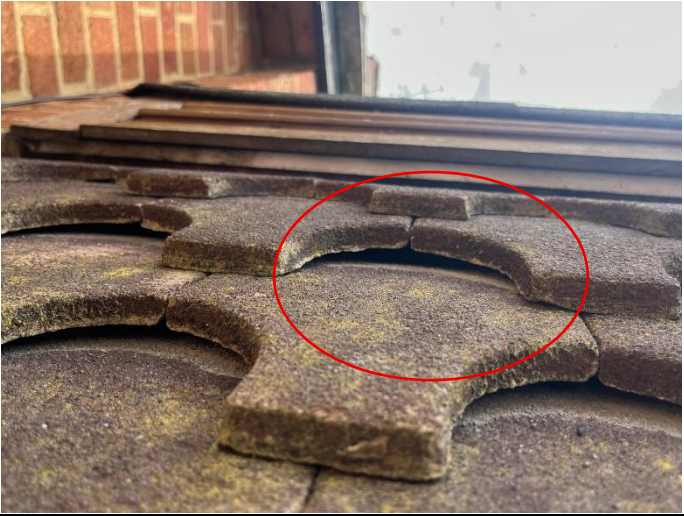
| Feature | Materials | Condition/description /suitability | Photographs |
|---|---|---|---|
| Walls | Clay hanging tiles on front elevation. | <p><b>Condition/description</b></p> <p>Numerous gaps within the hanging tile.</p> <p><b>Suitability/access/evidence of bats</b></p> <p>Gaps within hanging tiles provide ideal roosting habitat for crevice dwelling bats. No evidence found but recent and current rain would wash this away externally.</p> | |

| <i>Recommendations</i> | <p>Two bat emergence surveys are required during the active bat season (optimal May to August, suboptimal September) to confirm presence or likely absence of a bat roost in the building. Although three surveys are recommended due to the historic evidence of a common pipistrelle day roost (2019), an additional two surveys are deemed acceptable providing they produce similar results to the 2019 surveys.</p> <p>Both surveys should be completed during the optimal survey period May to August inclusive and surveys should be spread at least three weeks apart.</p> <p>Infra-red cameras should be used as an aid outside the building.</p> <p>Three surveyors are required to provide full coverage of the building from the outside.</p> |

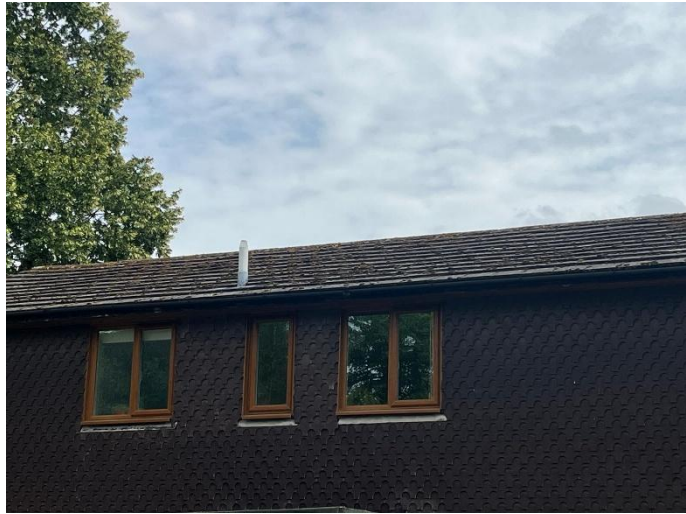
| Roof | Clay | <p><b>Condition/description</b><br/>Gabled roof appears in excellent condition.</p> <p><b>Suitability/access/evidence of bats</b><br/>No lifted tiles or gaps that could provide roosting opportunities for crevice dwelling bats, or access into the roof space.</p> | |

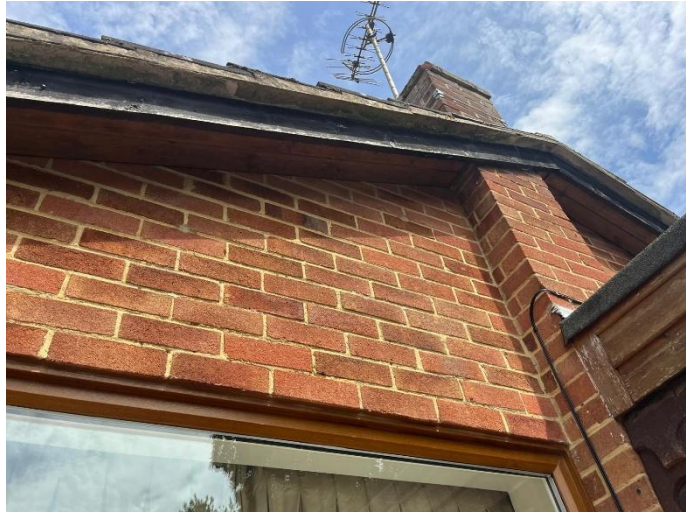
| Eaves | Overhanging | <p><b>Condition/description</b><br/>No gaps/crevices observed on the wall tops.</p> <p><b>Suitability/access/evidence of bats</b><br/>No roosting opportunities observed.</p> | |

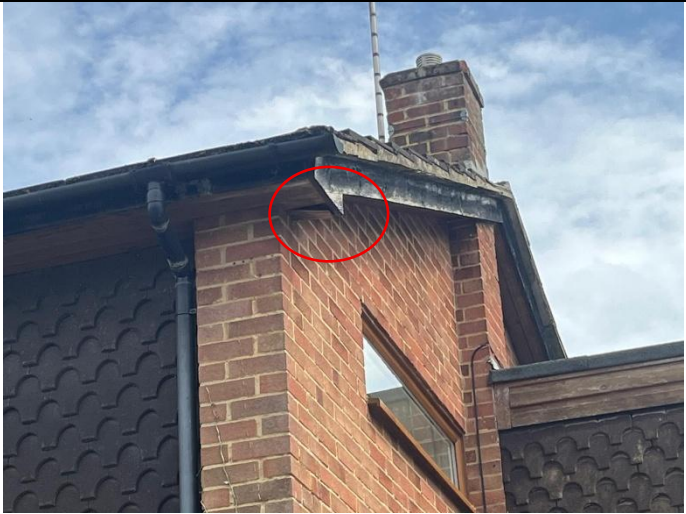
| Barge boards/fascia boards | Timber | <p><b>Condition/description</b><br/>The soffit boxes appear to be in good condition, however there is one gap on the corner of the north-western elevation.</p> <p><b>Suitability/access/evidence of bats</b><br/>The gap could provide roosting habitat for crevice dwelling bats, and access into the roof structure.</p> | |

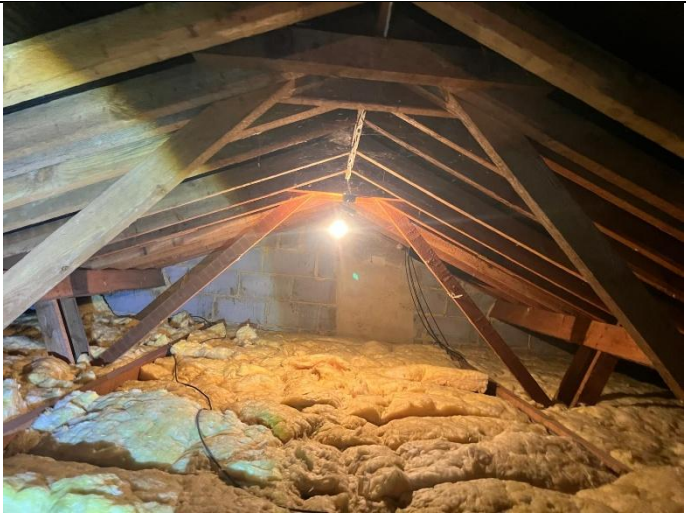
| Internal voids | Bitumen felt, timber rafters and ridge beam. | The loft is lined with bitumen felt insulation which appears to be in excellent condition with no obvious gaps into the loft space. No natural light was observed entering the loft indicating that it is well sealed. The loft floor was insulated with mineral wool insulation which was carefully checked for any signs of bat evidence. The brickwork at both gable ends was well sealed with no gaps suitable for crevice dwelling bats. | |
