## Preliminary Roost Assessment

3 Pinewood Avenue, Crowthorne, Berkshire, RG45 6RS

This report is prepared to inform a planning application with the Wokingham Borough Council. The proposal is described as:  
Two story extension and renovation of existing dwelling.

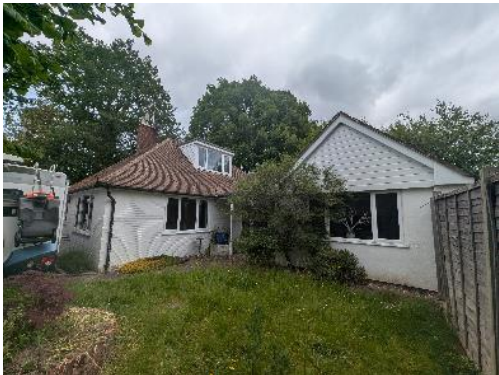
| Field survey results | |
|---|---|
| B1 - overview | <p>B1 (Fig 1) is a multi hipped and gabled residential dwelling constructed of partially rendered brick and mortar with a clay tile clad roof. There are dormer windows to the north of B1 in addition to a flat roof porch area to the west. Two chimneys are present, one on the northwestern elevation and one on the southeastern elevation.</p> <p style="text-align: center;"><b>Fig 1</b></p> |

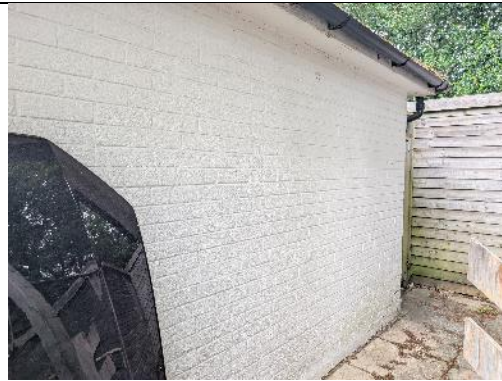
**Fig 2**

| Field survey results | |
|---|---|
| B1 – exterior | The brick and mortar walls appear to be in good condition (Fig 2), leaving no gaps. The windows and doors appear to be tightly fitting and in good condition (Fig 3), leaving no gaps. The lead flashing around the southeastern chimney is lifted in places (Fig 4), providing a suitable roosting feature for individual crevice dwelling bat species. |

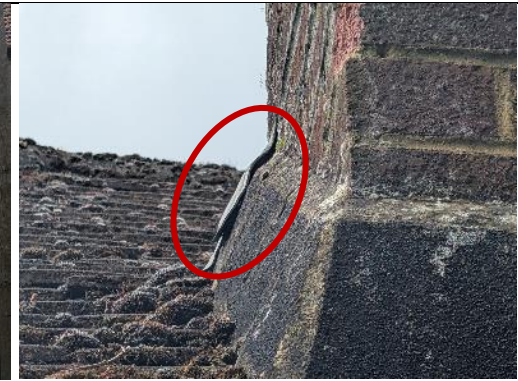
**Fig 4**

B1 has been assessed to provide **moderate** suitability for roosting bats. Lifted flashing and missing mortar provide a suitable roosting feature for individual crevice dwelling bat species, with access to the soffit boxes and lifted and missing roof tiles provide a suitable roosting feature for a higher volume of crevice dwelling bat species. Lifted tiles combined with damaged loft lining provide a potential point of access to the loft void, though no suitable roosting features were identified for crevice dwelling bat species internally and no evidence of roosting bats was identified.

| <i>Recommendations</i> | <p>Two bat emergence/re-entry surveys are required on B1 during the active bat season (May – September) to confirm presence/likely-absence of bats roosting in or on the building. These survey visits should be completed during the optimal survey period mid-May to August inclusive. The survey visits should be at least three weeks apart.</p> <p>Three surveyors and an additional unmanned camera are required to provide full coverage of the building's elevations to look for emerging/re-entering bats. An infrared camera should also be employed per surveyor as part of the survey to support in the identification of roost access points, if present.</p> |

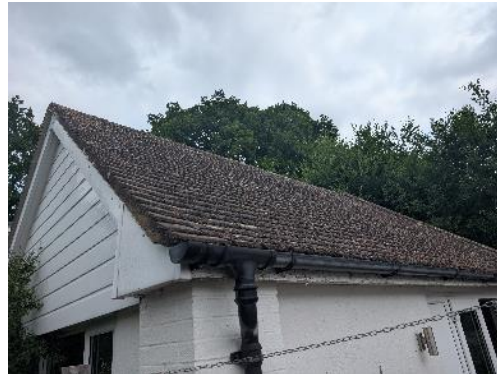
**Fig 5**

While the majority of roof tiles appear to be tightly fitting and in good condition (Fig 5), there are a small number of lifted (Fig 6) and missing (Fig 7) tiles. These provide a suitable roosting feature for crevice dwelling bat species in addition to a potential point of access to the loft void.

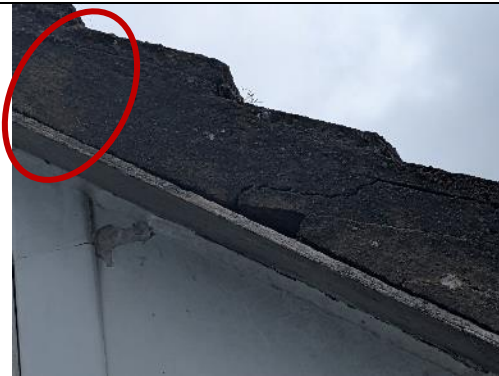
**Fig 8**

There is a small amount of missing mortar at the southwestern gable end (Fig 8), providing a suitable roosting feature for individual crevice dwelling bat species. There is an area of lifted flashing by the flat roof (Fig 9), providing a suitable roosting feature for individual crevice dwelling bat species.

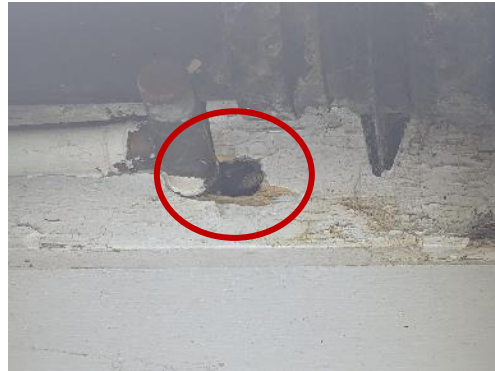
**Fig 10**

There are two holes in the soffit box, one on the eastern elevation (Fig 10) and one on the western elevation by the flat roof (Fig 11). This provides a suitable roosting feature for crevice dwelling bat species, in addition to a potential point of access to the loft void.

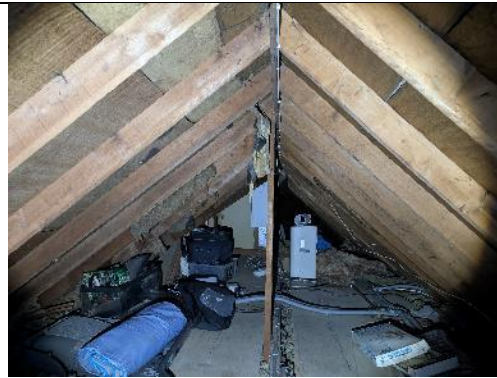
**Fig 12**

The U-shaped loft void within B1 (Fig 12) measures ~15m long, 10m wide and between 1.5 and 2.5m tall at various locations throughout the void. At the time of the survey, the loft was 21 degrees Celsius with 53% humidity. The majority of the void is boarded. The loft lining is damaged (Fig 13) and sagging (Fig 14) in places, exposing the roof tiles and providing a potential point of access to the loft void.

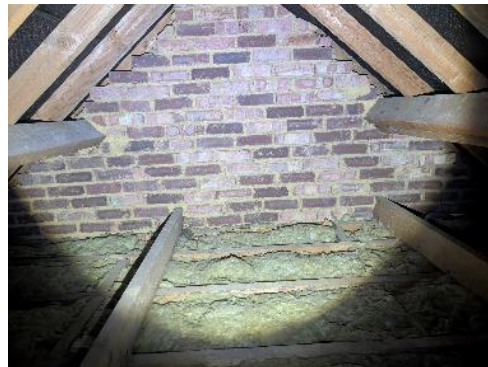
**Fig 15**

The brick and mortar gable end appears to be in good condition (Fig 15), leaving no gaps.

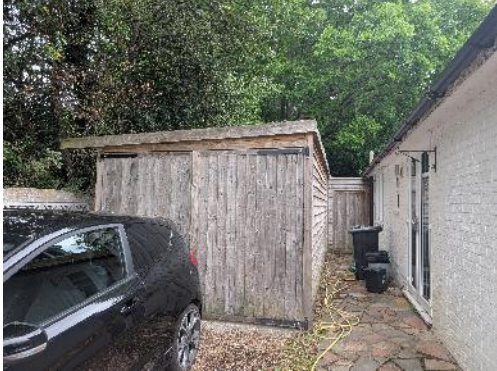
| B2 – summary and suitability | <p>B2 (Fig 16) is a multi-gabled timber shed to the northeast of site which will not be directly impacted by the proposed works. While no roosting features were identified externally, lifting on the timber walls provide a suitable point of access to the interior of B2.</p> <p style="text-align: center;"><b>Fig 16</b></p> <p>B2 is therefore considered to provide <b>low</b> suitability for roosting bats.</p> |
