### **PHASE 2 CHEMICAL AND CONTAMINATION ASSESSMENT REPORT**

**STUART H CARRUTHERS (CARTA DEVELOPMENTS)**

**LAND ADJACENT TO HIGHFIELD PARK**

**ARBORFIELD, WOKINGHAM, RG2 9PP**

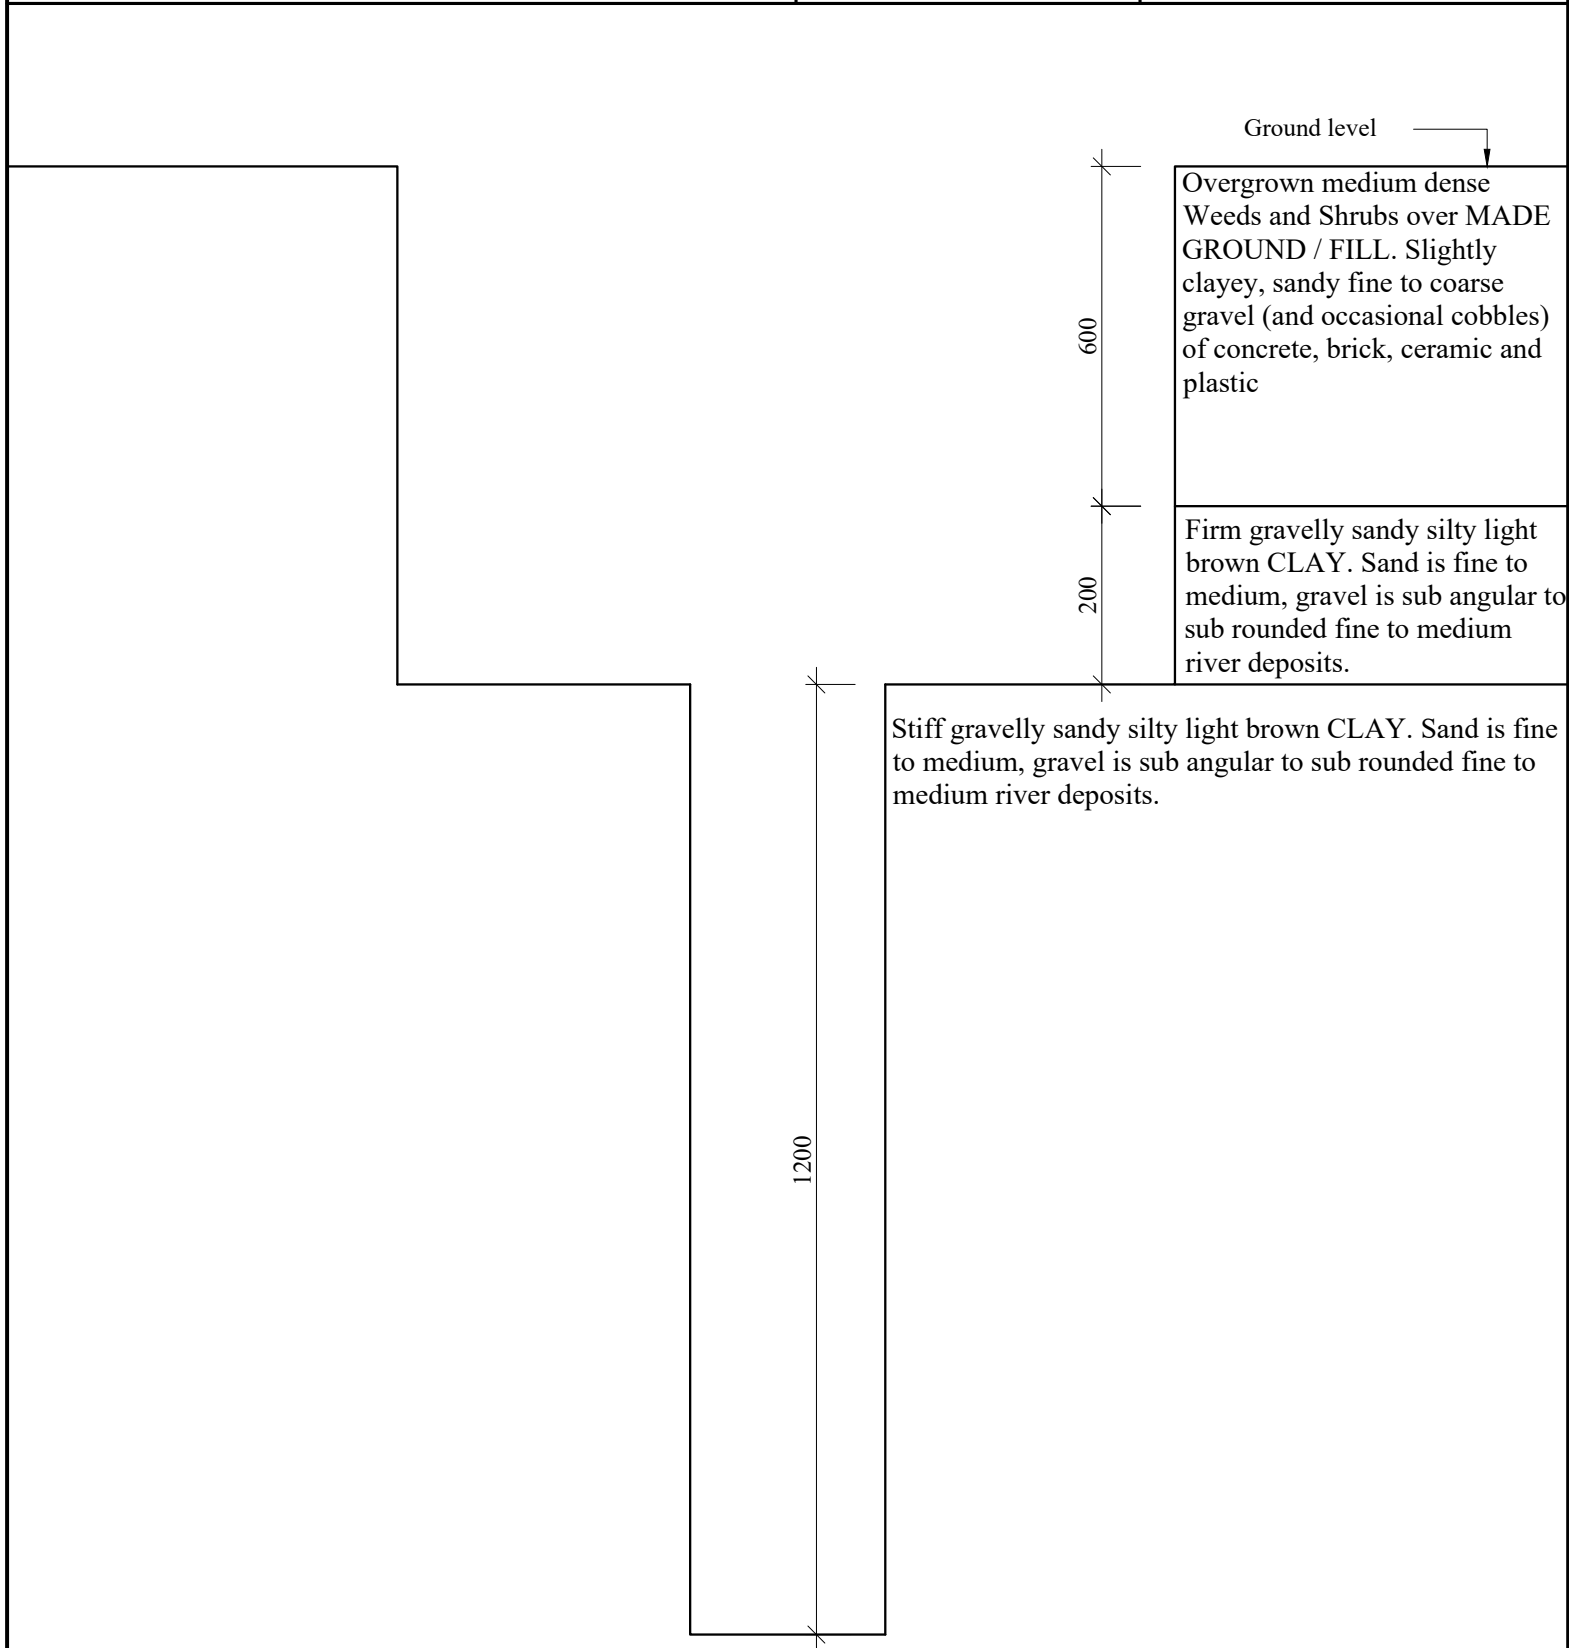
| <b>Location:</b> Land adjacent to Highfield Park<br>Arborfield, Wokingham, RG2 9PP | <b>Job No:</b> 3630 | <b>Trial Pit No:</b> TP2 | <b>Weather:</b> Fine |

| <b>Remarks:</b> Trial Pit completed to 0.8m<br>Borehole completed to 2.0m | Key:<br><b>D</b> Small disturbed sample<br><b>B</b> Bulk disturbed sample<br><b>U</b> Undisturbed sample (U100)<br><b>N</b> Standard Penetration Test Blow Count | <b>J</b> Jar sample<br><b>V</b> Pilcon Vane (kPa)<br><b>M</b> Mackintosh Probe<br><b>W</b> Water Sample |

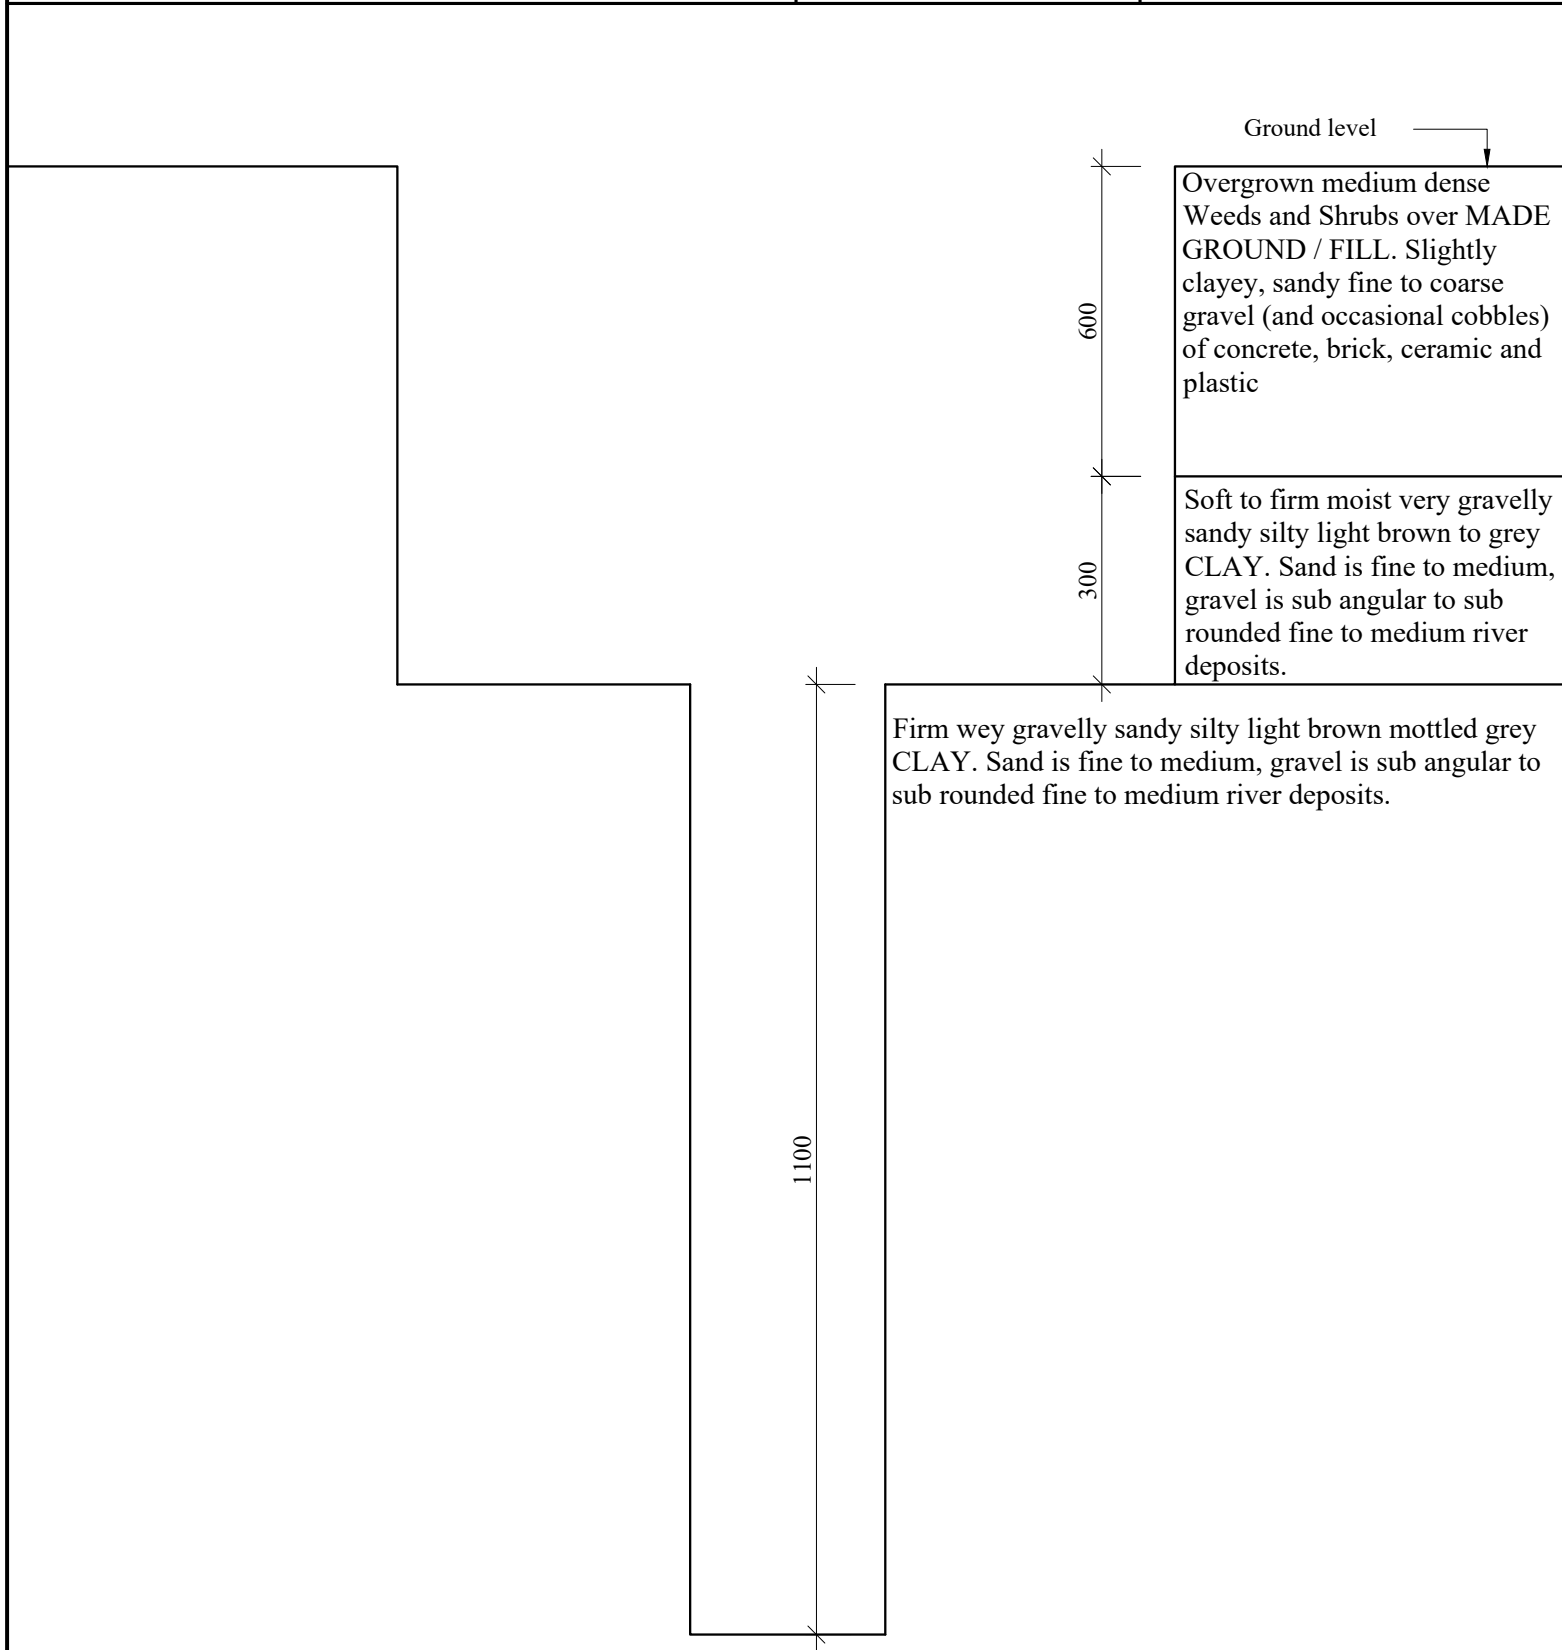
| <b>Location:</b> Land adjacent to Highfield Park<br>Arborfield, Wokingham, RG2 9PP | <b>Job No:</b> 3630 | <b>Trial Pit No:</b> TP4 | <b>Weather:</b> Fine |

| <b>Remarks:</b> Trial Pit completed to 0.9m<br>Borehole completed to 2.0m<br>Wet from 0.9m - water standing at 1.5m on completion | <b>Key:</b><br><b>D</b> Small disturbed sample<br><b>B</b> Bulk disturbed sample<br><b>U</b> Undisturbed sample (U100)<br><b>N</b> Standard Penetration Test Blow Count | <b>J</b> Jar sample<br><b>V</b> Pilcon Vane (kPa)<br><b>M</b> Mackintosh Probe<br><b>W</b> Water Sample |

Ground water was observed in Trial Pit 4 only. It should be noted that groundwater levels may change due to seasonal or other variations such change in water level of adjacent water bodies. Consequently, future excavations or boreholes may show the presence of groundwater at different depths. Surface water run-off from rainfall may also enter excavations or boreholes during construction or fieldwork.

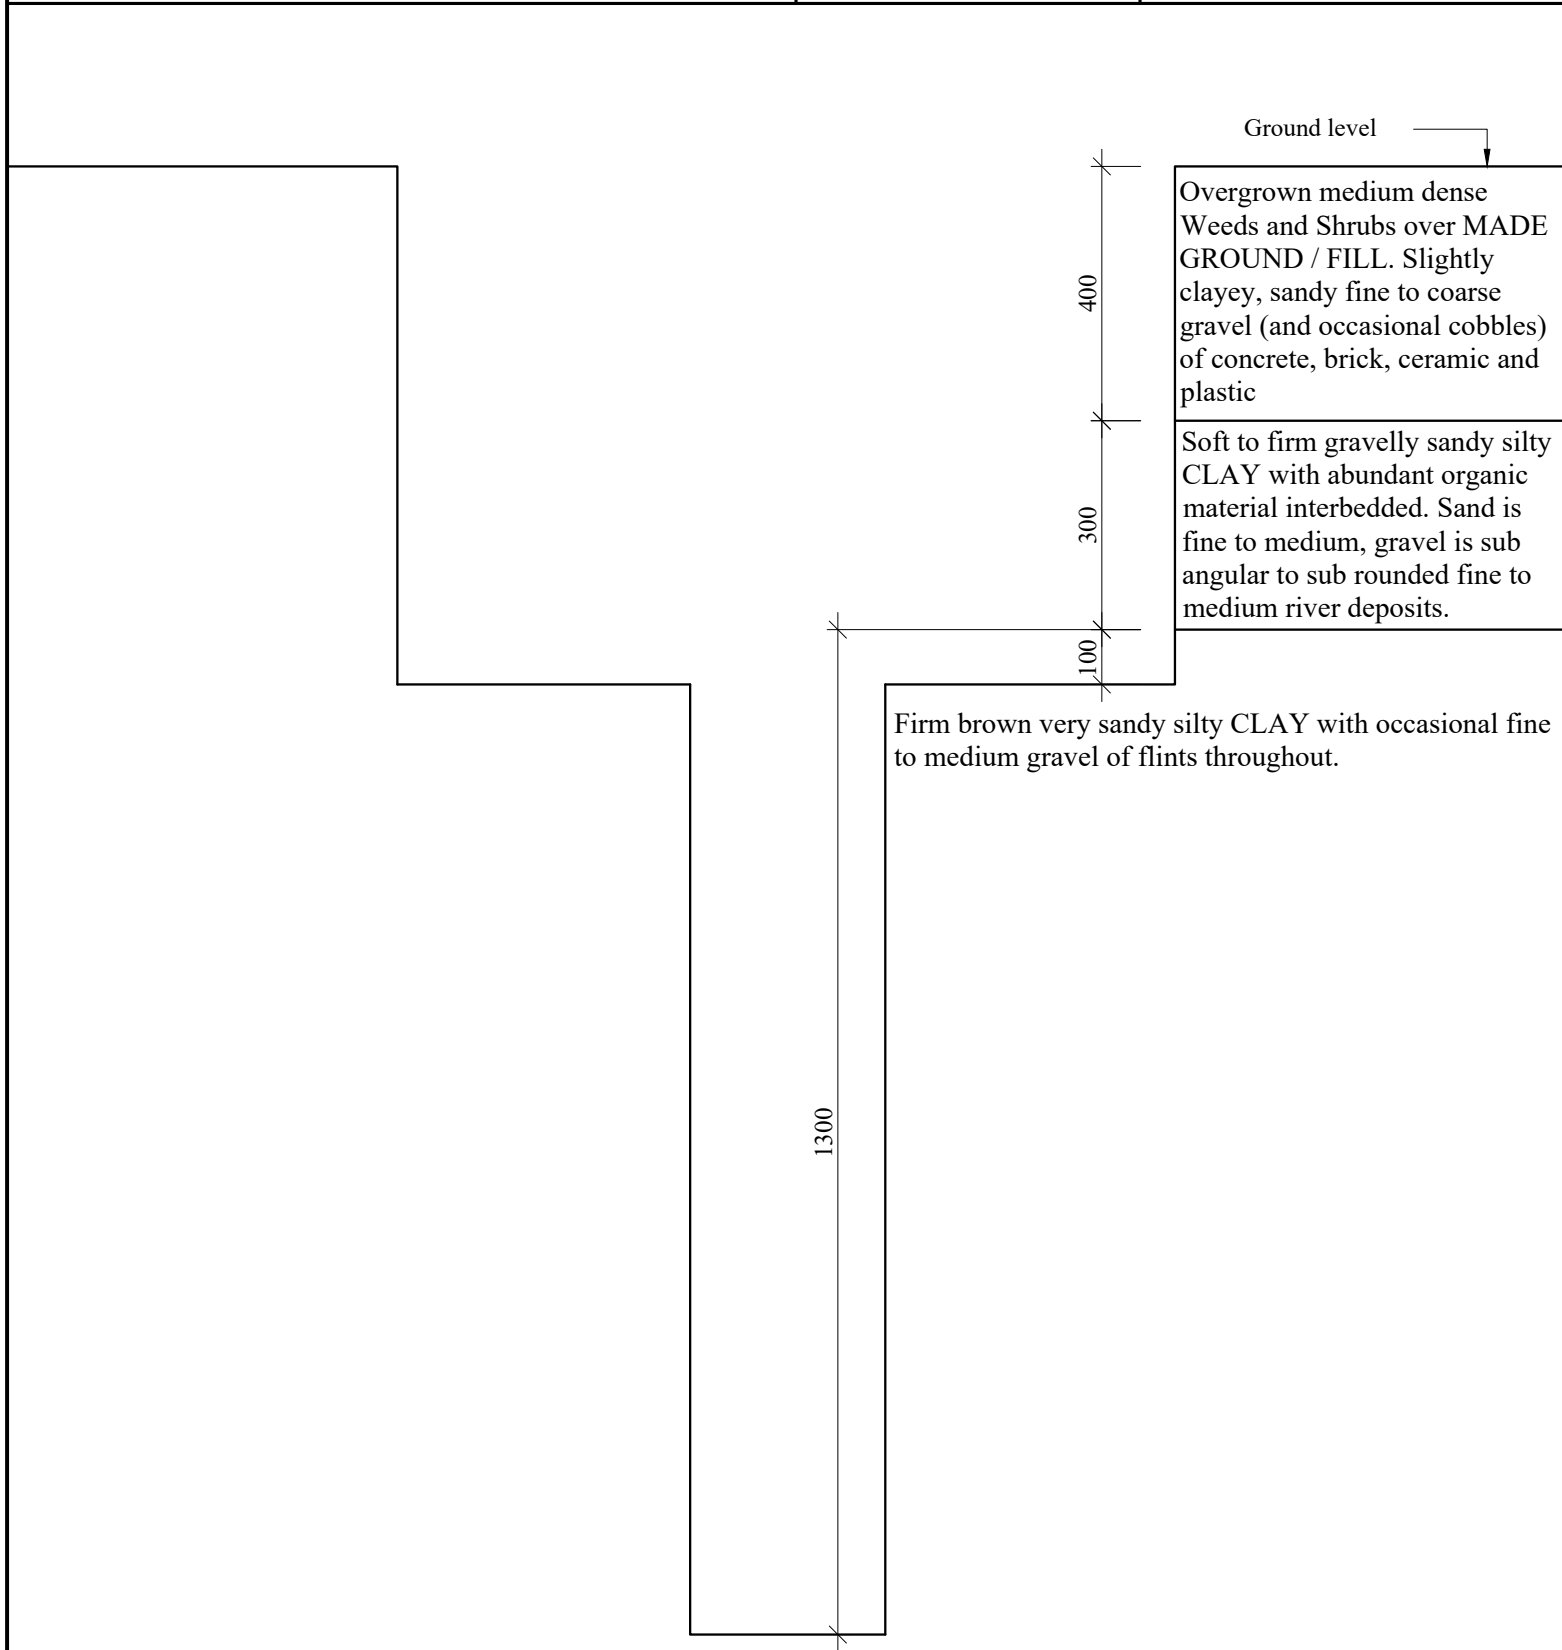
| <b>Location:</b> Land adjacent to Highfield Park<br>Arborfield, Wokingham, RG2 9PP | <b>Job No:</b> 3630 | <b>Trial Pit No:</b> TP10 | <b>Weather:</b> Fine |

**Remarks:** Trial Pit completed to 0.8m  
Borehole completed to 2.0m
