# Preliminary Roost Assessment

Spring Copse, Julkes Lane, Arborfield, Reading RG2 9JJ

This report is prepared to inform a planning application with Wokingham Borough Council. This proposal can be described as “the construction of a brick-built garage to replace the existing garage and adjacent timber shed”.

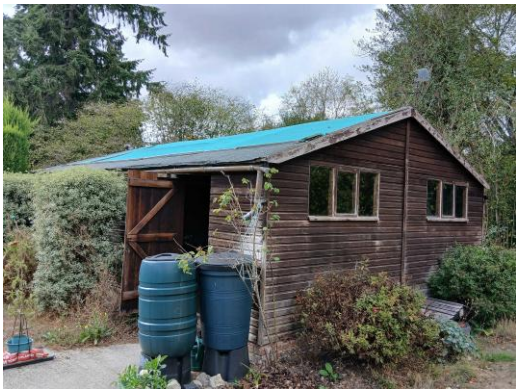
B1 is a detached, single-storey timber-framed garage with a gabled roof clad in bitumen felt. The structure is single-skinned, and the internal space is well sealed, with no gaps, cracks or access points identified that would allow bats to enter the building or access any internal voids. No evidence of bats (e.g. droppings, staining or feeding remains) was recorded during the inspection.

In line with Bat Conservation Trust Good Practice Guidelines (Collins, J (Ed) 2023), B1 is assessed to have **negligible** habitat value for roosting bats, as no features likely to be used by bats at any time of the year were identified.

Northern elevation of B1.

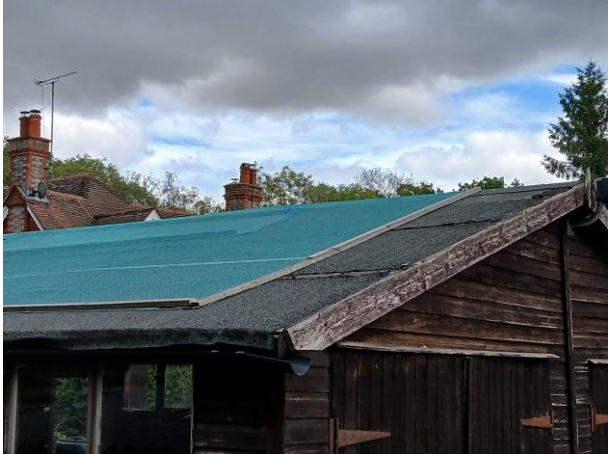
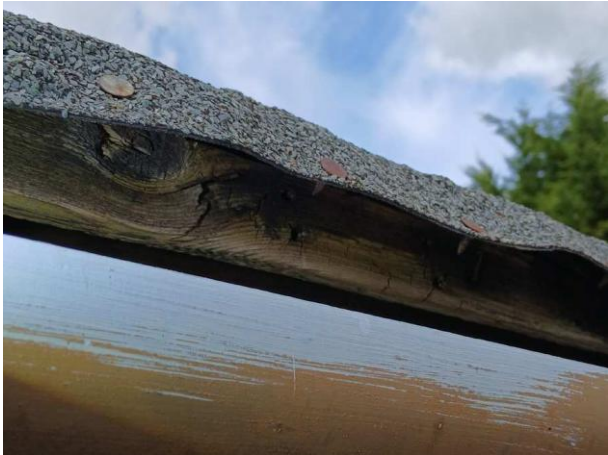
| Roof | Bitumen felt | <p><b>Condition/description</b></p> <p>The roof structure comprises timber boards overlaid with bitumen roofing felt. The felt covering appears continuous and in good condition. A small superficial gap is present along the entirety of the roof edge (~10mm wide and ~10mm deep) where the bitumen felt is lifted. This gap does not provide access to the roof or to the internal garage spaces.</p> <p><b>Suitability/access/evidence of bats</b></p> <p>The superficial lifting on the roof edge identified is shallow and does not offer sufficient shelter, protection, or appropriate microclimatic conditions (including stable temperature and humidity), as it is exposed to external weather conditions and temperature fluctuations. Furthermore, it does not provide access to the internal garage space. As such, this roof feature is considered to provide negligible suitability for roosting bats.</p> | <p>Western roof of B1.</p> <p>Eastern roof edge of B1.</p> |

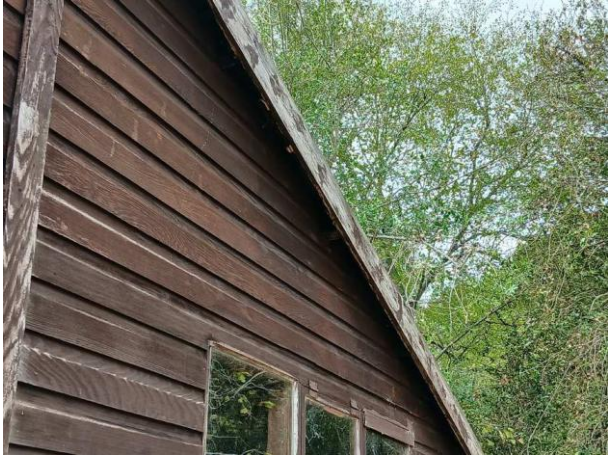
| Barge boards | Timber | <p><b>Condition/description</b><br/>The timber bargeboards of B1 are in good condition with no gaps.</p> <p><b>Suitability/access/evidence of bats</b><br/>No bat roosting features or access points were identified.</p> | <p><i>Bargeboard on the northern elevation of B1.</i></p> |

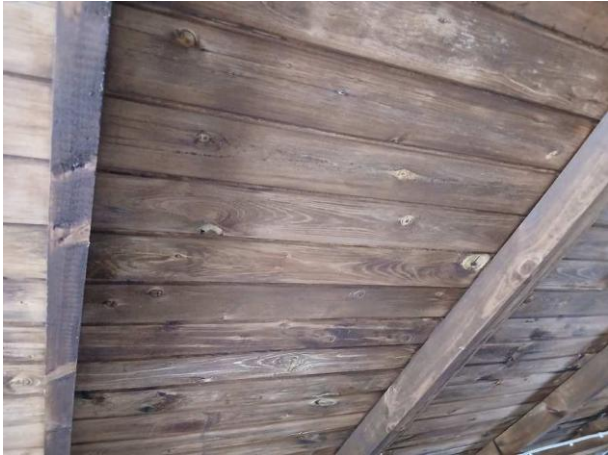
| Internal space | Timber rafters | <p>The internal space of B1 is accessible and measures 8.5m in length, 5.5m in width, and 3m in height.</p> <p>The timber roof is in good condition and well-sealed. The timber rafters could present a feature.</p> <p>Windows on the western and eastern elevation allow high levels of natural light into the internal space. The garage doors on the southern elevation are in poor condition, presenting gaps that could create suitable access points into the internal space. However, the conditions created by the windows and doors result in a bright, exposed and thermally unstable</p> | <p><i>Timber roof of B1 in good condition.</i></p> |

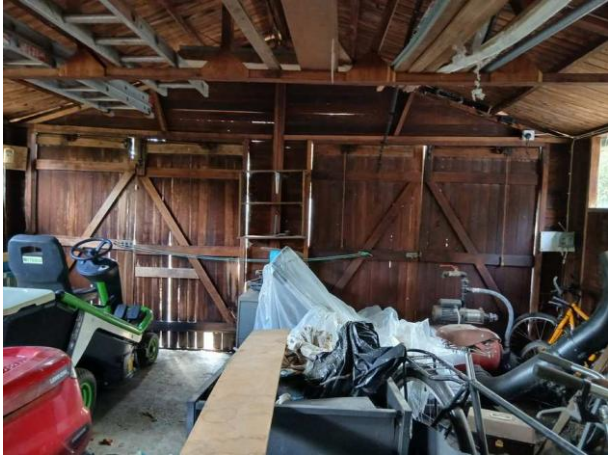
| | | <p>environment, which is unsuitable for roosting bats, as bats typically favour dark, sheltered spaces with relatively stable microclimatic conditions.</p> <p>No evidence of roosting bats was identified within this void.</p> <p>Temp: 26.5°C // Humidity: 54%</p> | <p>Garage doors on the southern elevation of B1.</p> |

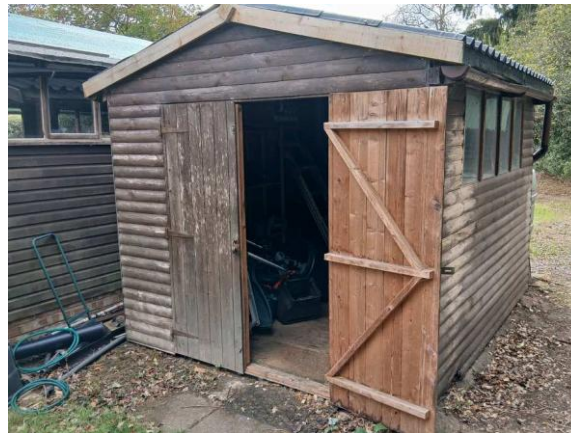
B2 is a detached, single-storey timber-framed shed with a gabled roof clad in bitumen felt. The structure is single-skinned, and the internal space is well sealed, with no gaps, cracks or access points identified that would allow bats to enter the building or access any internal voids. No evidence of bats (e.g. droppings, staining or feeding remains) was recorded during the inspection.

In line with Bat Conservation Trust Good Practice Guidelines (Collins, J (Ed) 2023), B2 is assessed to have **negligible** habitat value for roosting bats, as no features likely to be used by bats at any time of the year were identified.

*Eastern elevation of building B2.*
