## Preliminary Roost Assessment

74 Waterloo Road, Wokingham, RG40 2JF

A two-storey side extension, a first-floor extension over the existing garage and changing of the dormers

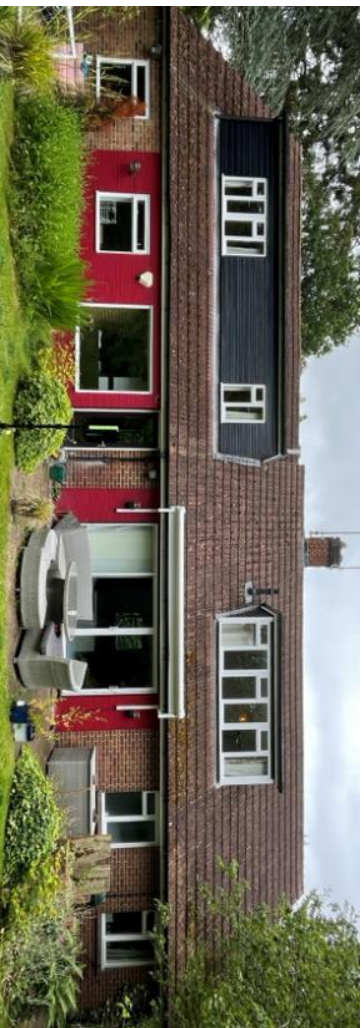
| <i>Summary of Survey Findings</i> | <p><b>B1 Exterior</b></p> <p>B1 is a detached single-storey brick-built building with a converted 1<sup>st</sup> floor, with a cross-pitched and gabled roof clad in interlocking concrete roof tiles. The roof tiles are in very good condition with no raised tiles under which bats could roost. The doors and windows are timber framed and appear in excellent condition with no suitable bat roosting sites. Additionally, there is one skylight on the eastern elevation which is in good condition and well-sealed into the roof with no gaps within the roof tiles around the skylight. The brickwork around the building appears in excellent condition with no gaps or cracks within which crevice-dwelling bats could roost. There are UPVC and wood soffits and barge boards around the building which are generally in good condition. There is one chimney located on the roof of the building. The brickwork on the chimney is in good condition. There is lead flashing around the base of the chimney which is flat and without gaps. The brick gable ends are in very good condition with no gaps around the tops of the gable ends. There are dormer window extensions on the eastern and western elevations of the building. The dormer windows are clad in wood weatherboarding which is in good condition with no gaps that are suitable for roosting bats.</p> |

Photo 1: the western elevation of B1.

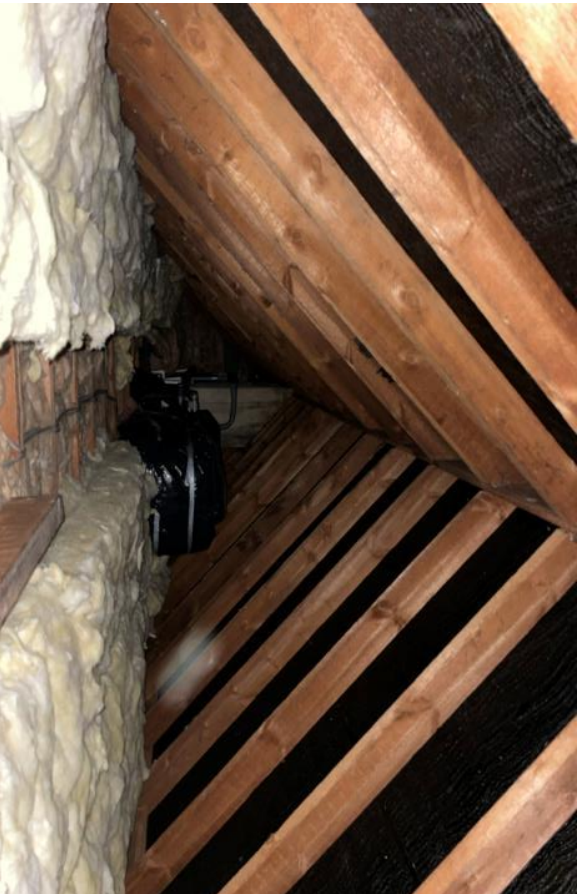
| | <p><b>B1 Interior</b></p> <p>There is one loft space within the main roof void of B1. The roof structure is built from modern timber beams including the ridge beam. The roof is lined with bitumen felt which is in good condition with no gaps or tears. The floor of the loft space is lined with mineral wool insulation and there are timber boards in places. There are cobwebs around the ridge beam and roof to floor cobwebs which could indicate a lack of internal flying activity from void dwelling bats, such as brown long-eared bats. No daylight enters the loft space which indicates that it is well sealed.</p> <p><b>Foraging and commuting habitat</b></p> <p>The site and its surrounding area provide suitable habitat for bats to forage, roost and commute due to the mix of open gardens and corridors of trees and hedges connecting the habitat areas. Additionally, there is a woodland which could be utilised by foraging and commuting bats, to the east.</p> |

Photo 4 : the loft space within B1.
