287 Nine Mile Ride  
Finchampstead  
Wokingham  
Berkshire  
RG40 3NS

# Preliminary Roost Assessment

Report ref.: R2856\_PRA\_a

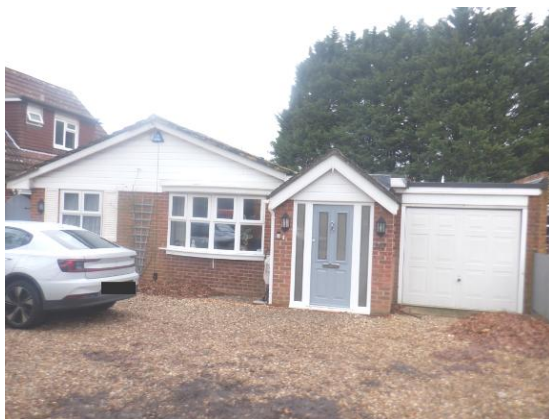
**5.2.2** The property was a detached brick built residential bungalow with an attached garage on its eastern elevation (**Photographs 1 - 2**).

*Photograph 1. Front elevation of the property, viewed from the south.*

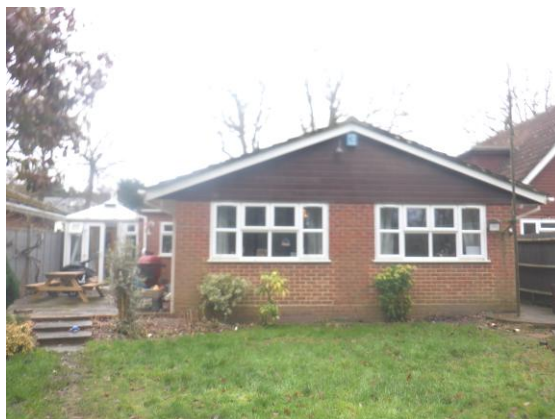
*Photograph 2. Rear elevation of the property, viewed from the north.*

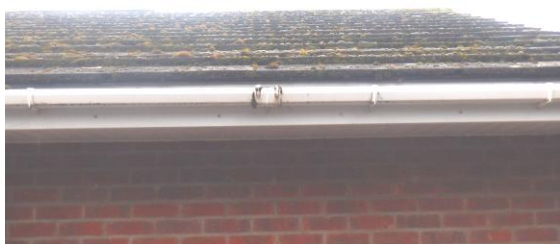
- 5.2.3** The main pitched roof of the bungalow was covered by flat concrete tiles that weretightly fitted and covered by moss (**Photograph 3**). The pitched front porch and flat-roof garage were covered by fully sealed clay roof tiles and bitumen felt respectively (**Photographs 4 & 5**).

*Photograph 3. Flat concrete roof tiles (east elevation).*

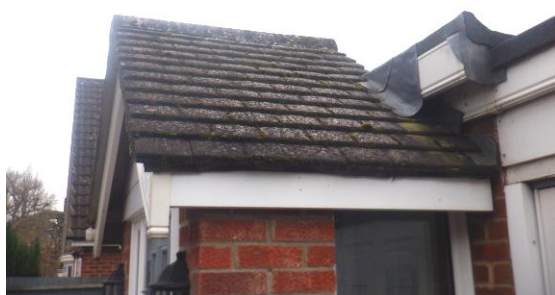
*Photograph 4. Sealed clay roof tiles (east elevation).*

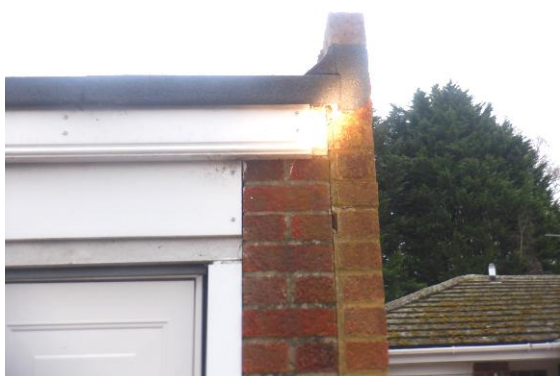
*Photograph 5. Sealed bitumen felt (front elevation).*

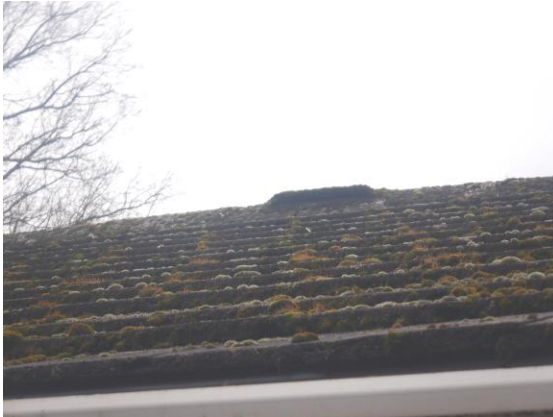
- 5.2.4** Whilst the ridge mortar and verge mortar along the rear elevation was fully intact, the verge mortar along the front gable was partially missing and upon close inspection, allowed access between the internal roof lining and concrete tiles across the whole pitched section of the roof (**Photographs 6 - 9; Target note 1**). During an endoscopic check of the

*Photograph 6. Ridge mortar intact (east elevation).*

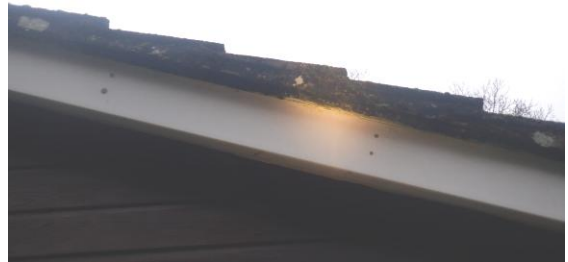
*Photograph 7. Verge mortar fully intact (rear elevation).*

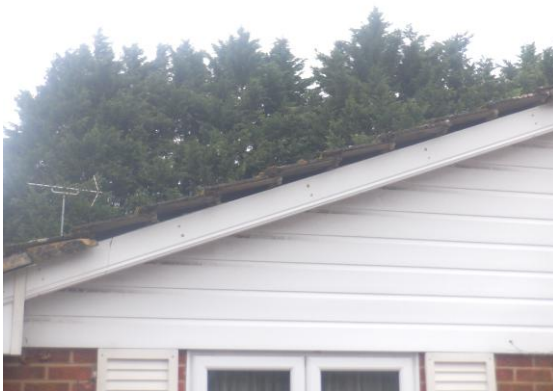
*Photograph 8. Missing verge mortar across the front gable (front elevation).*

**6.2.2** The survey evidence shows that there has been a bat roost in the past, before the recent damage to the verge mortar. Therefore, the second-storey extension should incorporate features that provide continued access points/roosting sites for pipistrelle bats to ensure retention of a roost. For example, by incorporating an integrated bat box (such as an Ibstock enclosed bat box, Habibat bat box, or a suitable functional equivalent) at the apex of the proposed front gable (see proposed location in **Appendix 4**).

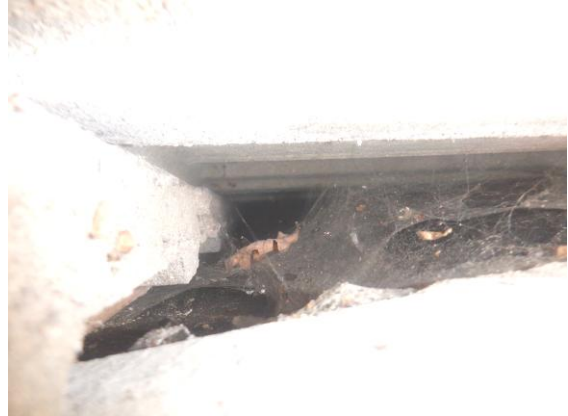
*Photograph 9. Open gap between roof lining and concrete roof tiles.*

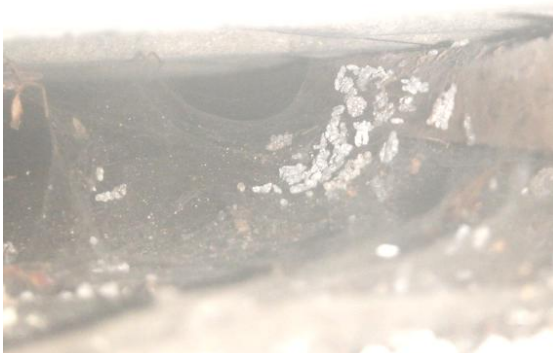
feature, approximately 50 – 100 small-sized decayed bat droppings were observed within one of the slots (**Photograph 10**). Whilst a slight gap was situated between the uPVC fascia and verge mortar across the front porch, close inspection showed the feature to be superficial (**Photograph 11**).

*Photograph 10. Approximately 50 – 100 small-sized bat droppings behind the front gable (front elevation).*

- 6.1.1** Approximately 50 – 100 small-sized decayed bat droppings resembling those typically deposited by the pipistrelle (*Pipistrellus* spp.) were observed during an endoscopic check of the front gable. It is likely that the feature was optimal and utilised when the front verge mortar was mostly intact, however, since the feature is now entirely exposed to the elements (discussions with the client confirm the mortar fell out in storms over winter), it is considered now to be of negligible suitability for roosting bats (**Photographs 8 – 10; Target note 1**). The endoscopic check confirmed an absence of roosting bats currently, and its unsuitability for future use by bats in its current state. Heavily cobwebbed gaps were situated under the verge mortar and behind the uPVC fascia along the front porch but close inspection with a high-powered torch confirmed these features to be superficial with no evidence of use by roosting bats (**Photographs 10, 13 & 14**).

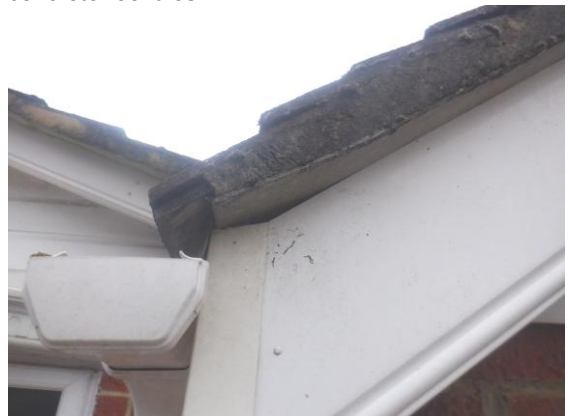
*Photograph 11. Superficial gap between uPVC fascia and verge mortar (front elevation).*

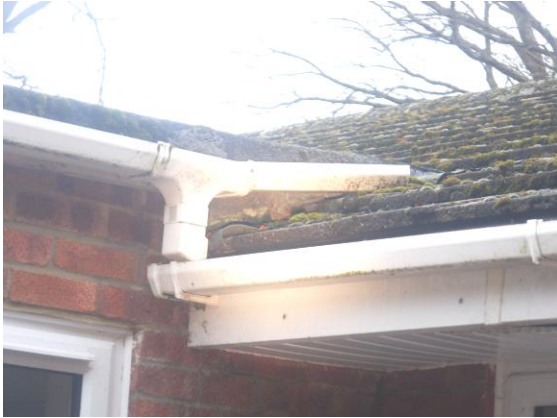
**5.2.5** The junction between the flat roof garage and pitched roof of the bungalow was fully sealed (**Photograph 12**). Furthermore, the front gable and rear gable were clad with uPVC and timber panels respectively, both of which fully sealed to the uPVC soffit (**Photographs 13**). Whilst slight gaps were situated at the apex of the front porch and behind its uPVC

*Photograph 12. Junction between flat roof and pitched roof fully sealed (east elevation).*

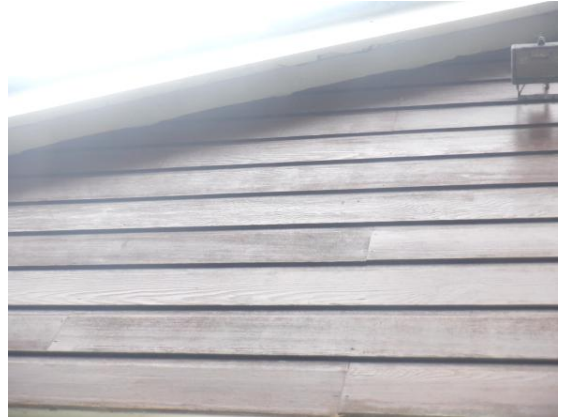
*Photograph 13. Timber panels sealed along the edges of the gable (rear elevation).*

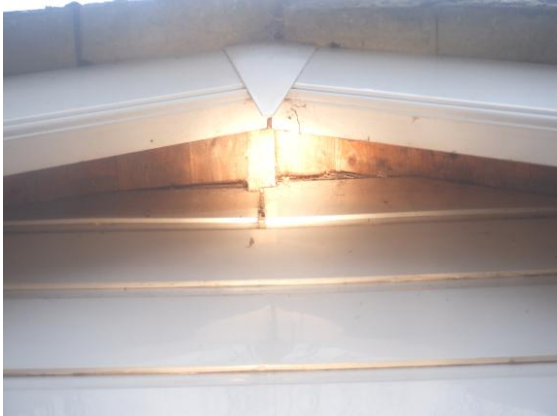
fascia, these heavily cobwebbed gaps were closely inspected and confirmed to be superficial with no signs of use by roosting bats (**Photographs 14 & 15**).

*Photograph 14. Heavily cobwebbed gap at apex of porch (front elevation).*

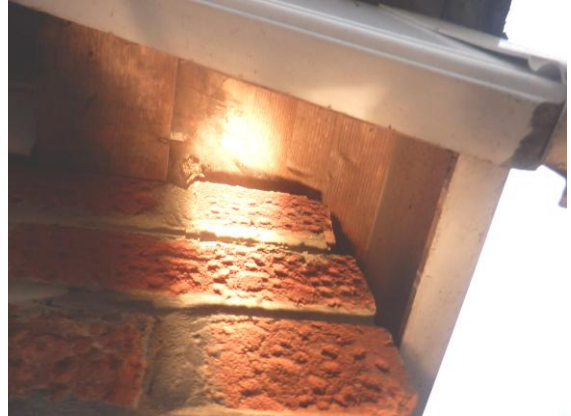
*Photograph 15. Heavily cobwebbed gap behind uPVC fascia (front elevation).*

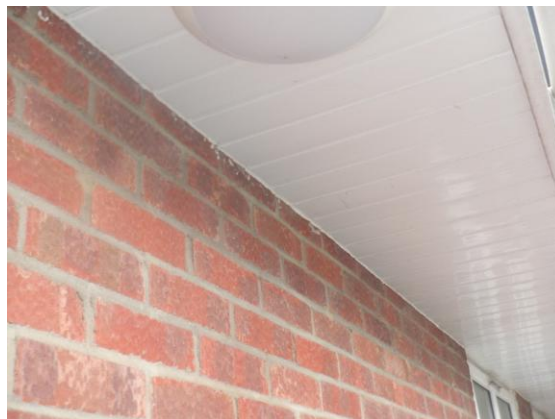
- 5.2.6** The uPVC soffit was sealed to the brickwork walls of the bungalow across all elevations (**Photograph 16**).

*Photograph 16. uPVC soffit sealed to brickwork wall (west elevation).*

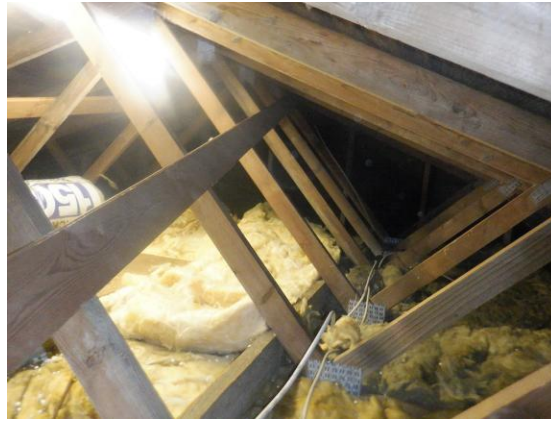
- 5.2.7** The building had one roof void that covered its footprint, accessible via a ground-floor loft hatch. The void was of trussed rafter construction with an approximate floor-to-ridge height

of 0.5 metres (**Photograph 17**).

*Photograph 17. Void of trussed construction.*

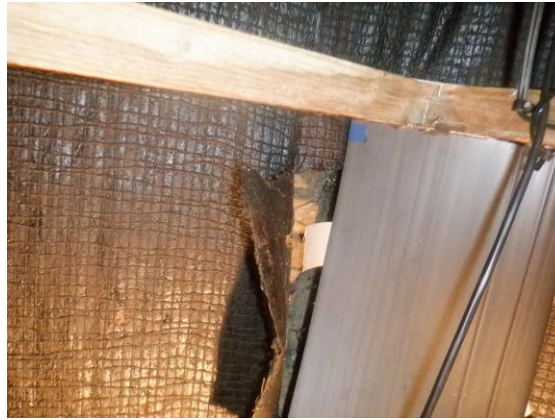
- 5.2.8** The roof was lined by Type 1F bitumen felt that was mostly intact other than one large tear along the ridge where the concrete roof tiles were visible (**Photograph 18; Target note 2**).

*Photograph 18. Large tear in bitumen felt with roof tiles visible.*

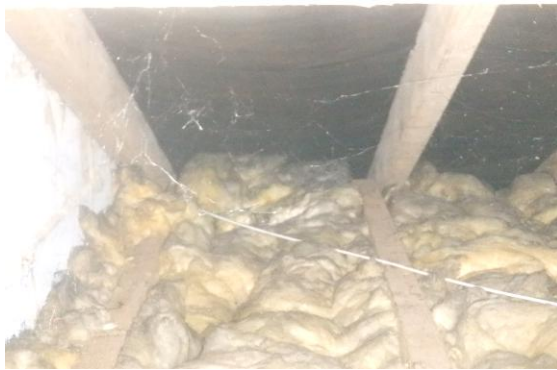
- 5.2.9** The floor was boarded over fibreglass and vermiculite insulation which did not fill all the eaves, allowing access to the uPVC soffit in places (**Photograph 19**). The front blockwork gable was fully sealed to the timbers and whilst the rear gable was partially inaccessible, it was clad with bitumen felt that was also sealed to the timbers (**Photographs 20 & 21**).

*Photograph 19. Open eaves with access to the uPVC soffit.*

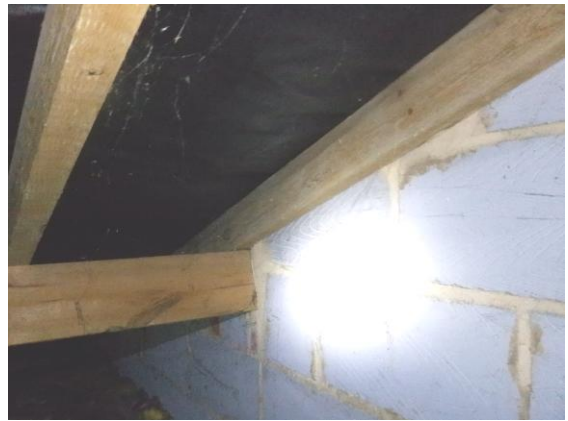
*Photograph 20. Timbers sealed to front blockwork gable.*

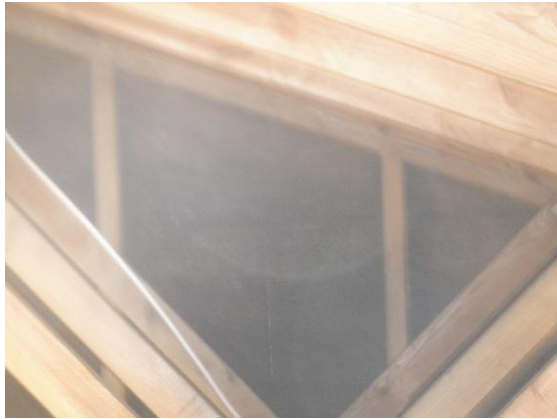
*Photograph 21. Rear gable clad with bitumen felt and sealed to timbers.*

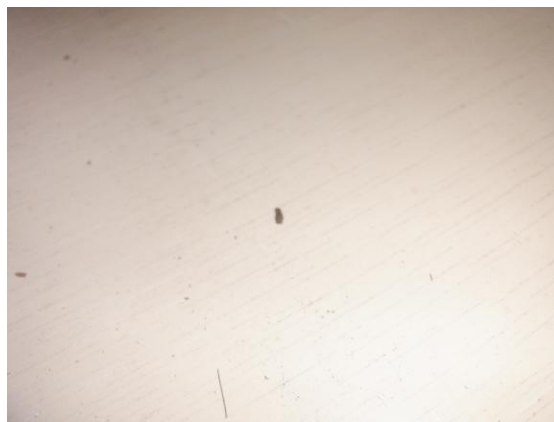
**5.2.10** Mouse droppings were scattered throughout the void (**Photograph 22**).

*Photograph 22. Scattered mouse droppings.*

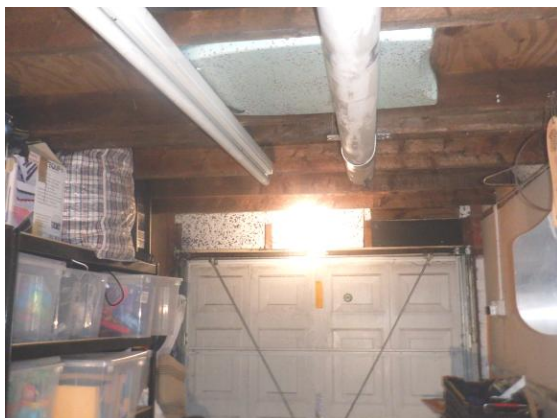
**5.2.11** The flat-roof garage had a boarded ceiling that was fully sealed to the painted brickwork walls and polystyrene along its edges (**Photographs 23 & 24**).

*Photograph 23. Garage with boarded ceiling sealed to polystyrene panels.*

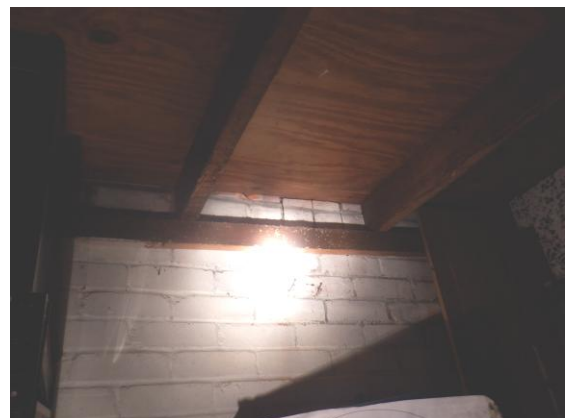
*Photograph 24. Timber panels sealed to the painted brickwork walls (garage).*

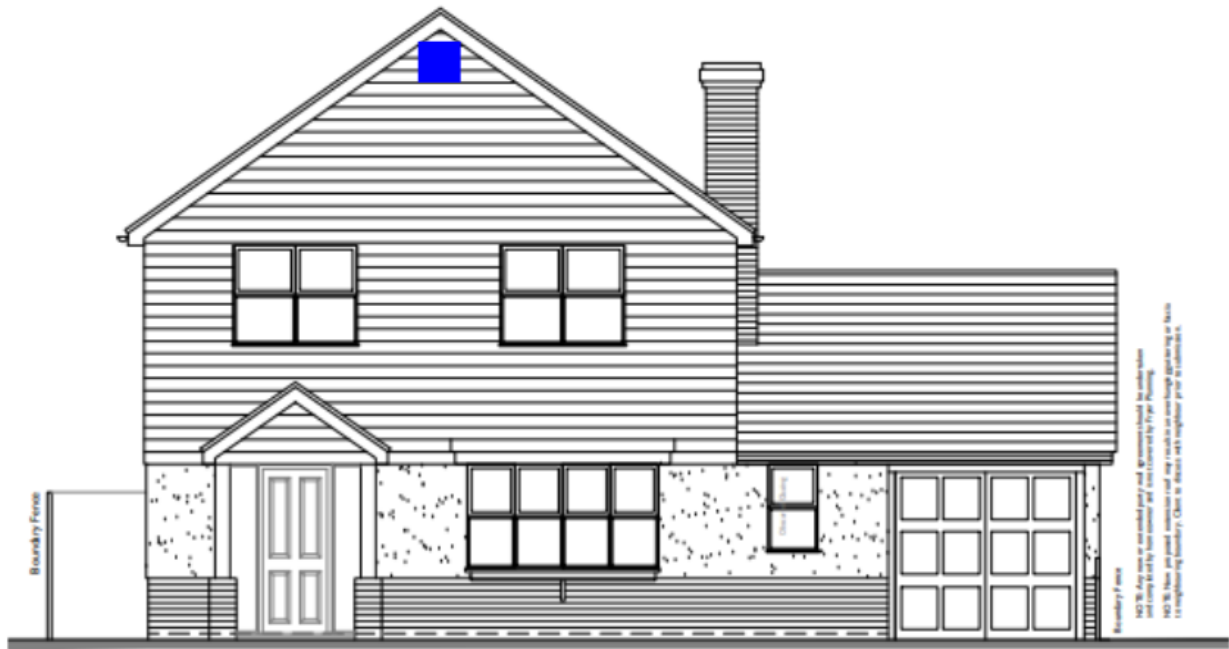
APPENDIX 4 – BAT ROOST PROVISION

Integrated bat box
