**BS5837:2012**

## **Arboricultural Method Statement**

**Site 2: Piggott School,  
Twyford Rd,  
Wargrave,  
Reading,  
RG10 8DS**

**15 August 2023**

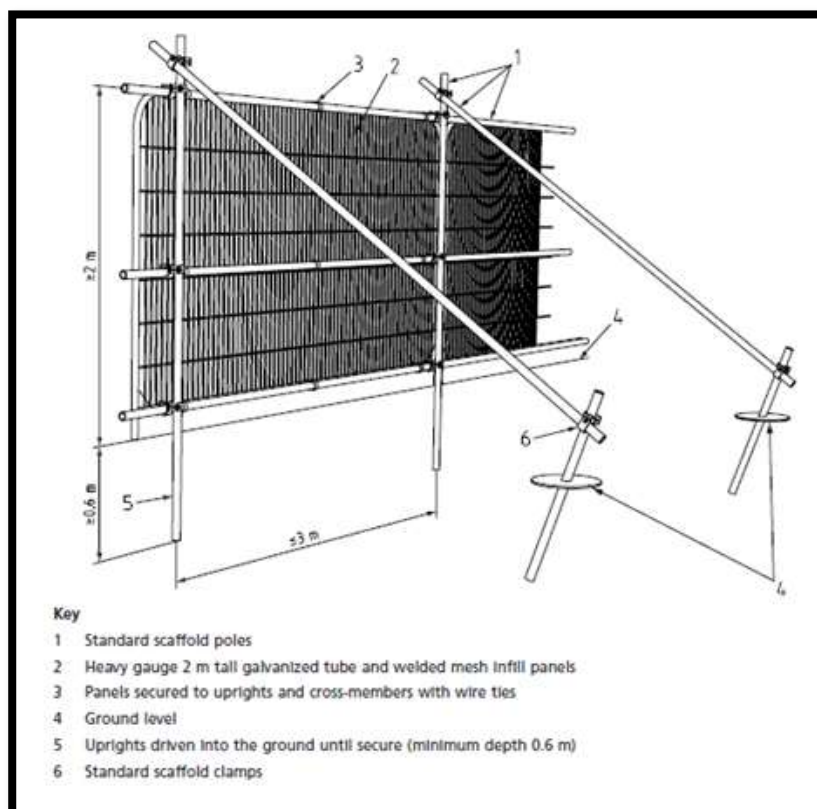
Default specification: To comprise either 2.4m wooden site hoarding; or a 2.3m high scaffold framework, well braced to resist impacts, with uprights to be spaced at a maximum of 3.0m intervals and driven into the ground by a minimum of 600mm. On to this, standard anti-climb welded mesh panels are to be securely fixed to each other with at least two scaffold clamps and to the scaffold frame work with wire.

Figure 2: BS5837:2012 - Figure 2, Default specification for protective barriers.

Protective barrier fencing should be appropriate for the intensity and proximity of the development to protect trees where development activity is in close proximity.

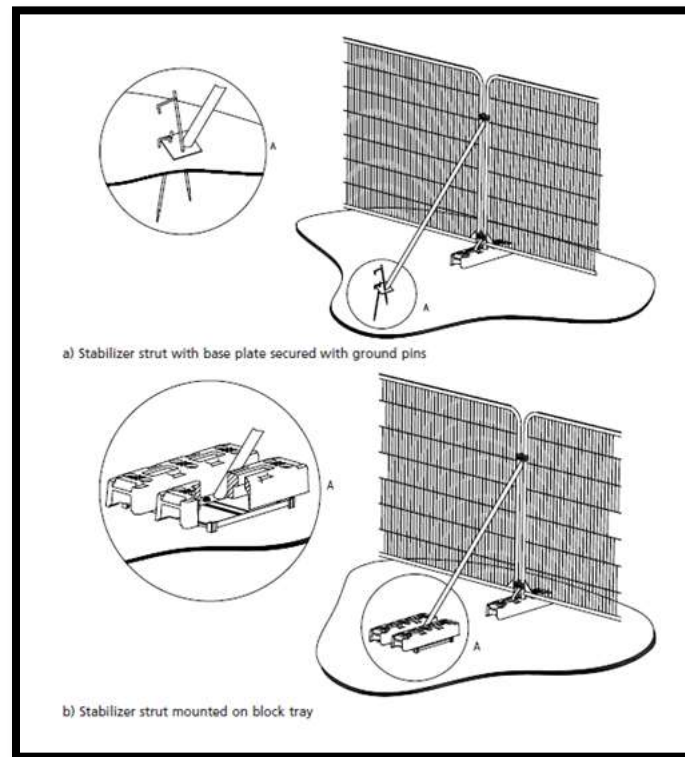
**Secondary specification:** To comprise of 2m tall welded mesh panels on rubber or concrete feet. Panels are to be joined together using a minimum of two anti-tamper couplers, installed so that they can only be removed from inside the fence. The panels should be supported on the inner side by stabiliser struts, which should be attached to a base plate and secured with ground pins.

Figure 3: BS5837:2012 - Figure 3, Examples of above-ground stabilising systems.
