## **PRELIMINARY ECOLOGICAL APPRAISAL (DBW) AT 10 SOUTH CLOSE WOKINGHAM**

**Prepared for:  
Mr J Pietrzak  
10 South Close  
Wokingham  
RG40 2DJ**

**22 April 2025**

**Ref: SPH/PEA-25/15.04**

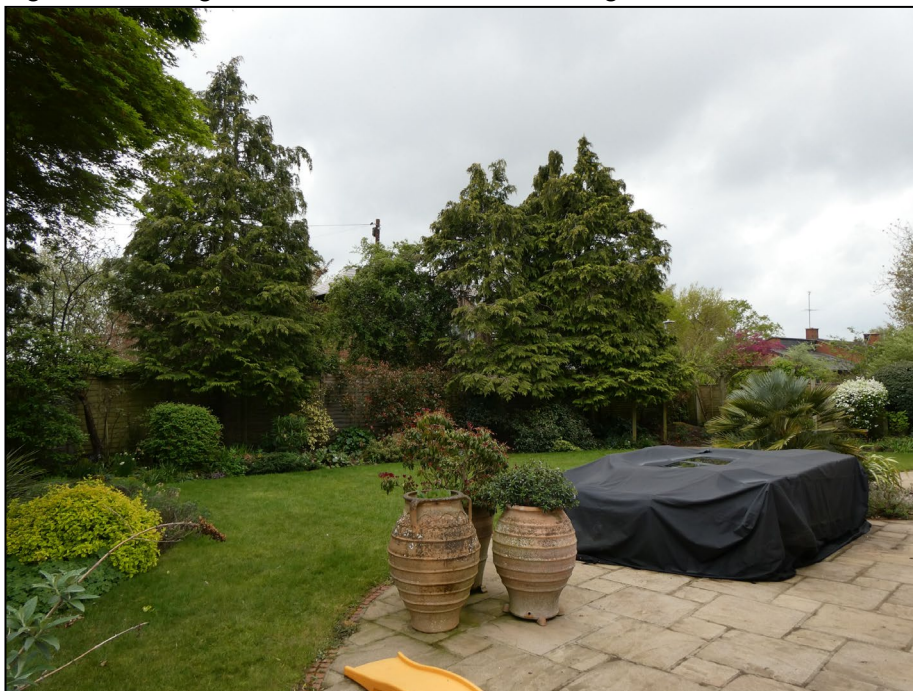
Figure 3. Rear garden. 10 South Close, Wokingham. 15.04.25

The application site comprises a detached, brick-built 2 storey property with attached garage. The remainder of the site comprises a driveway/parking area and front garden with lawn and flower beds/shrubs, see cover photograph. The rear garden contains a patio and is mainly laid to lawn with a number of shrubs and mature trees throughout, see Figures 3 below. The site itself offers good foraging and commuting habitat for bats and there is good ecological connectivity to bat foraging and commuting habitat in the wider landscape.

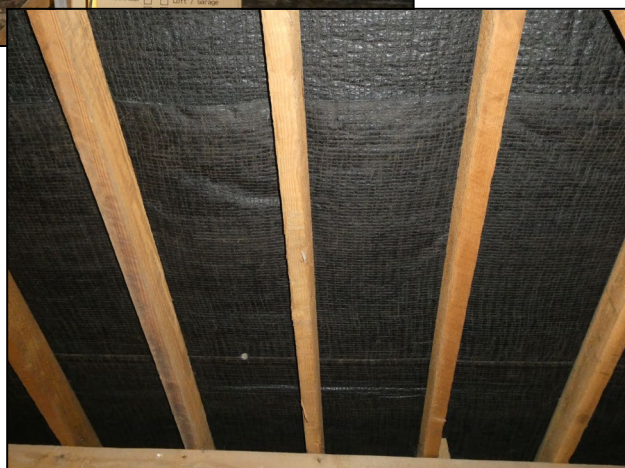
Figure 11. Example of loft space and bitumen lining to tiles. 10 South Close, Wokingham. 15.04.25

The loft space was accessed via steps through a hatch and is in a good condition internally. The loft is uncluttered, lit, partially boarded and insulated, see Figure 12 below. The roof tiles are lined with bitumen felt, all of which is in a good condition with no rips or tears, see Figure 12 below.
