Highview  
Basingstoke Road  
Spencer's Wood  
Reading  
RG7 1AL

# Preliminary Roost Assessment

Report ref.: S2791\_PRA\_a

October 2024

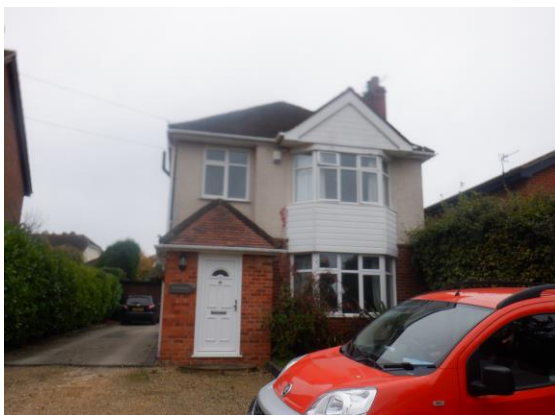
*Photograph 1. Front of property viewed from east.*

**5.2.3** The roof was covered by clay tiles that were occasionally lifted with crumbling mortar along the ridge and northwestern hip (**Photographs 3 & 4; Target notes 1, 2 & 3**). The verge mortar on the front gable was fully intact and a hip tile on the north-eastern corner was coming away from the roof (**Photograph 5; Target note 4**).

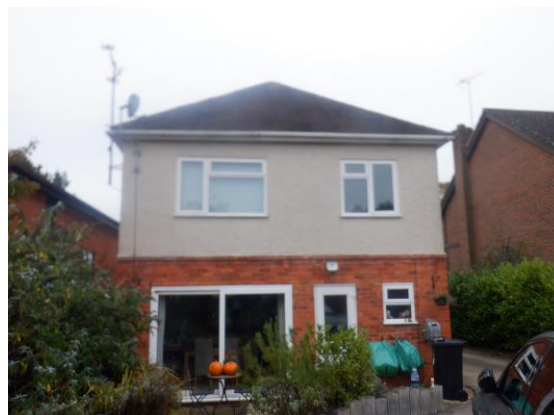
*Photograph 2. Rear of property viewed from west.*

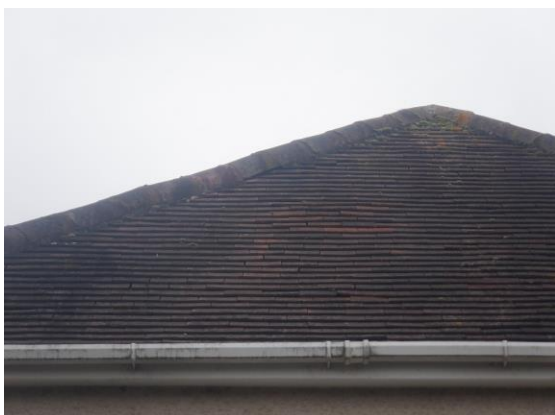
*Photograph 3. Raised roof tiles and crumbling hip mortar (rear elevation).*

- Occasionally lifted roof tiles on the main roof and front porch (**Photographs 3 & 9; Target notes 1 & 5**);
- Crumbling ridge and hip mortar (**Photographs 3 & 4; Target notes 2 & 3**);
- A raised hip tile (**Photograph 5; Target note 4**);
- Torn bitumen felt roof lining and unlined sections of the roof (**Photographs 11 & 12; Target notes 6 & 7**); and
- Open eaves with access to the uPVC soffit (**Photograph 13; Target note 8**)

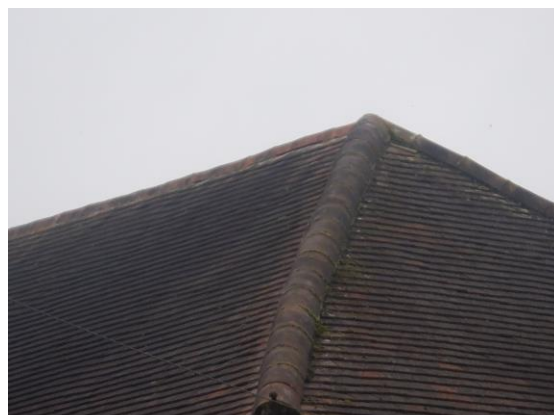
*Photograph 4. Crumbling ridge mortar (south elevation).*

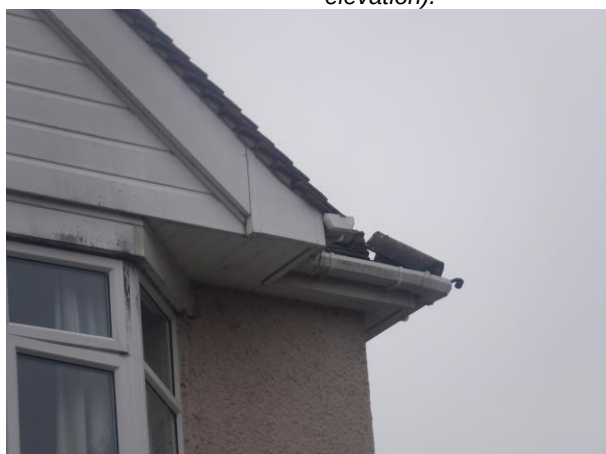
*Photograph 5. Hip tile coming away from roof (front elevation).*

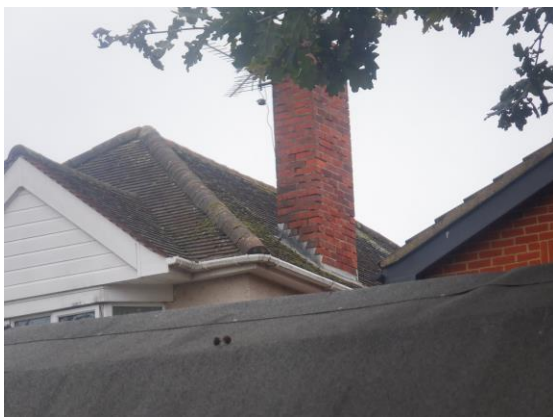
**5.2.4** The lead flashing along the base of the chimney was flat to the brickwork and roof tiles (**Photograph 6**). Furthermore, the uPVC cladding was tight on the front gable and the uPVC soffits were tight to the rendered wall across all elevations (**Photographs 7 & 8**).

*Photograph 6. Lead flashing sealed at base of chimney (north elevation).*

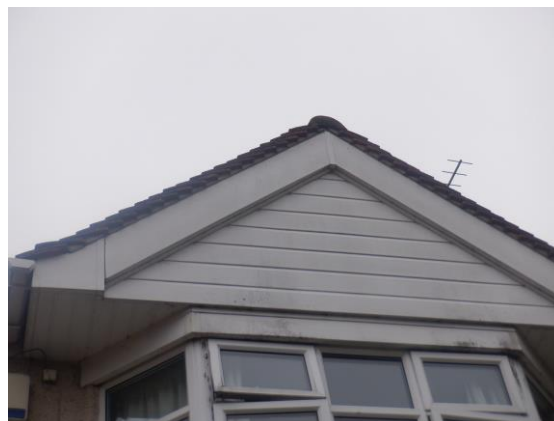
*Photograph 7. Front gable fully sealed (front elevation).*

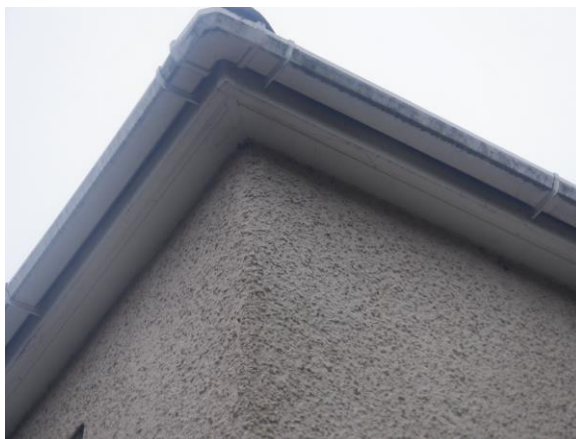
*Photograph 8. uPVC soffit sealed to the rendered wall (rear elevation).*

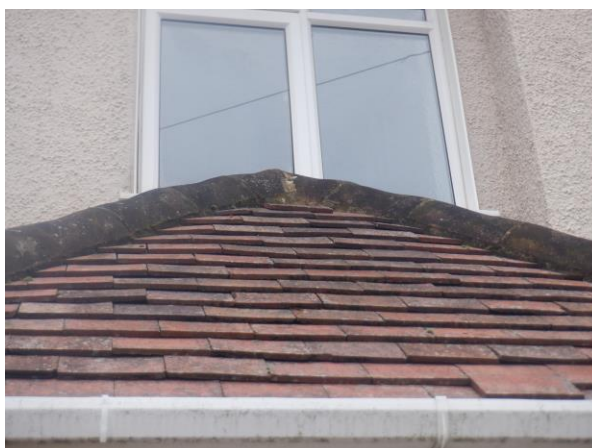
- 5.2.5** The clay roof tiles on the front porch were occasionally slightly lifted and the hip mortar was intact (**Photograph 9; Target note 5**).

*Photograph 9. Clay tiles lifted on front porch (front elevation).*

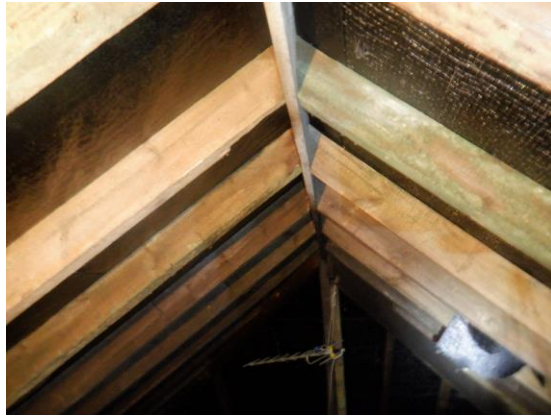
- 5.2.6** There was one roof void which covered the second-storey footprint of the building which was accessible via a loft hatch on the first floor and was used for storage. The void was of hipped construction, with an approximate floor-to-ridge height of 2 metres at its highest point and the rafters were cobweb-free throughout (**Photograph 9**).

*Photograph 10. Roof void of hipped construction with a cobweb free ridge.*

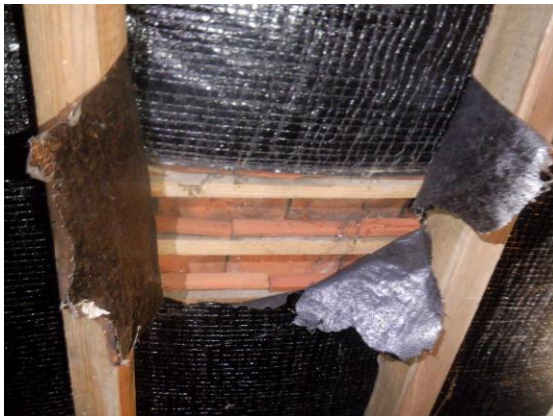
- 5.2.7** The western end of the roof was lined with bitumen reinforced felt that was occasionally torn with the roof tiles visible (**Photograph 11; Target note 6**). The eastern end of the void was unlined, with some loose and torn plastic sheeting in place and daylight visible between the roof tiles and along the ridge (**Photograph 12; Target note 7**).

*Photograph 11. Tear in bitumen felt at the western end of the void, with roof tiles visible (roof void).*

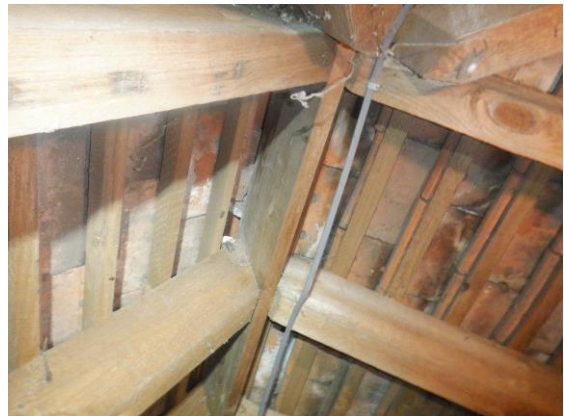
*Photograph 12. Unlined roof at the eastern end (roof void).*

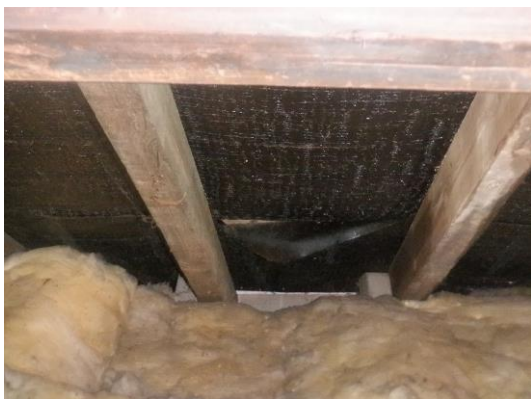
- 5.2.8** The floor was centrally boarded over fibreglass and vermiculite insulation that did not fill the eaves, allowing access to the uPVC soffit throughout the void (**Photograph 13; Target note 8**). Internally the uPVC cladding of the front gable was fully sealed to the internal timbers (**Photograph 14**).

Photograph 13. Open eaves with access to uPVC soffit.

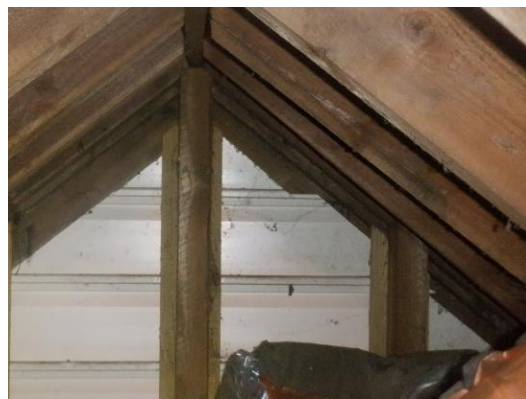
Photograph 14. uPVC cladding sealed to internal timbers.

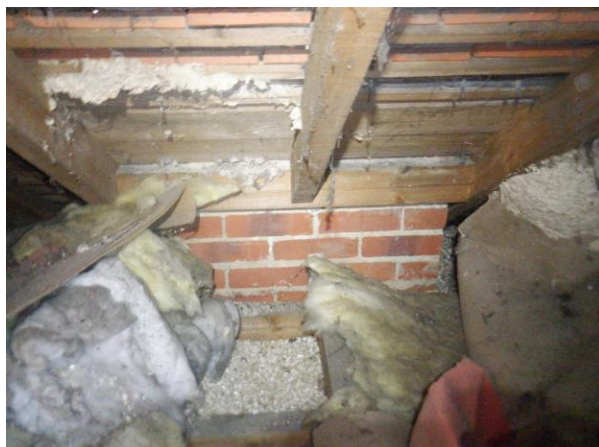
- 5.2.9** A large wasp nest was situated at the base of the brickwork chimney, mostly preventing access to a slight gap between the chimney and timbers (**Photograph 15**).

Photograph 15. Wasp nest at the base of the brickwork chimney.

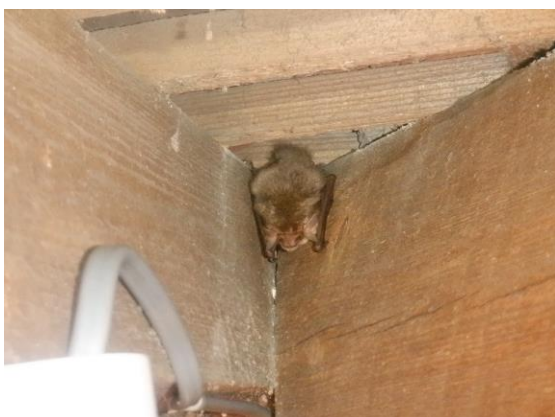
- 5.2.10** A brown long-eared (*Plecotus auritus*) bat was observed roosting where the eastern hips connected to the ridge with a pile of approximately 70 – 80 medium-sized bat droppings clustered beneath (**Photographs 16 & 17**). A further approximate of 50 medium-sized bat droppings were distributed along the ridge and on stored items within the west section of the void (**Photographs 18 & 19**).

Photograph 16. One brown long-eared bat roosting within the void.

- 6.2.1** The observation of a roosting brown long-eared (*Plecotus auritus*) bat at the ridge of the eastern hipped end and the approximately 120 – 130 medium-sized bat droppings, resembling those typically deposited by long-eared species (*Plecotus* spp.), within the roof void of the house is consistent with the void being used as a transitional/summer day roost. The location of the roosting *P. auritus* and droppings correspond with the raised roof tiles and crumbling ridge mortar observed externally where the roof is internally unlined.

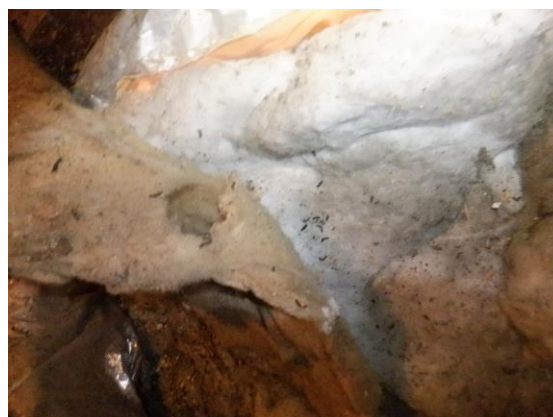
Photograph 17. Approximately 70 – 80 medium-sized bat droppings clustered beneath eastern hip.

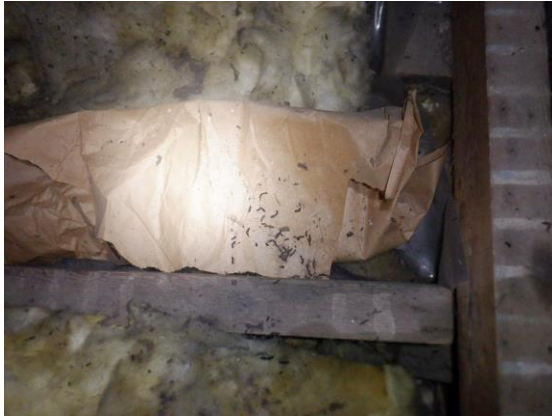
*Photograph 18. Approximately 50 medium-sized bat droppings clustered beneath the ridge.*

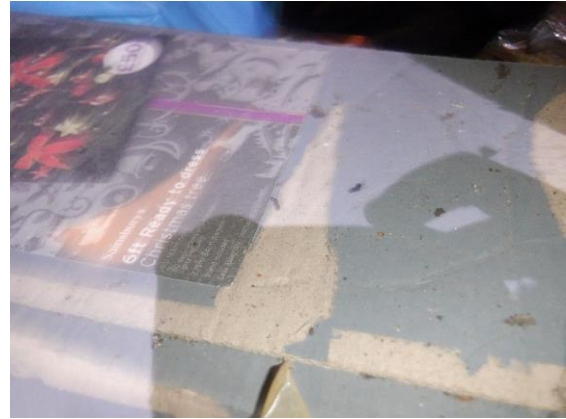
*Photograph 19. Medium-sized bat droppings scattered on stored items.*
