## **Bat Assessment Report**

**77 Elm Road**

**Earley  
Reading  
Berkshire  
RG6 5TB**

22-217  
March 2023

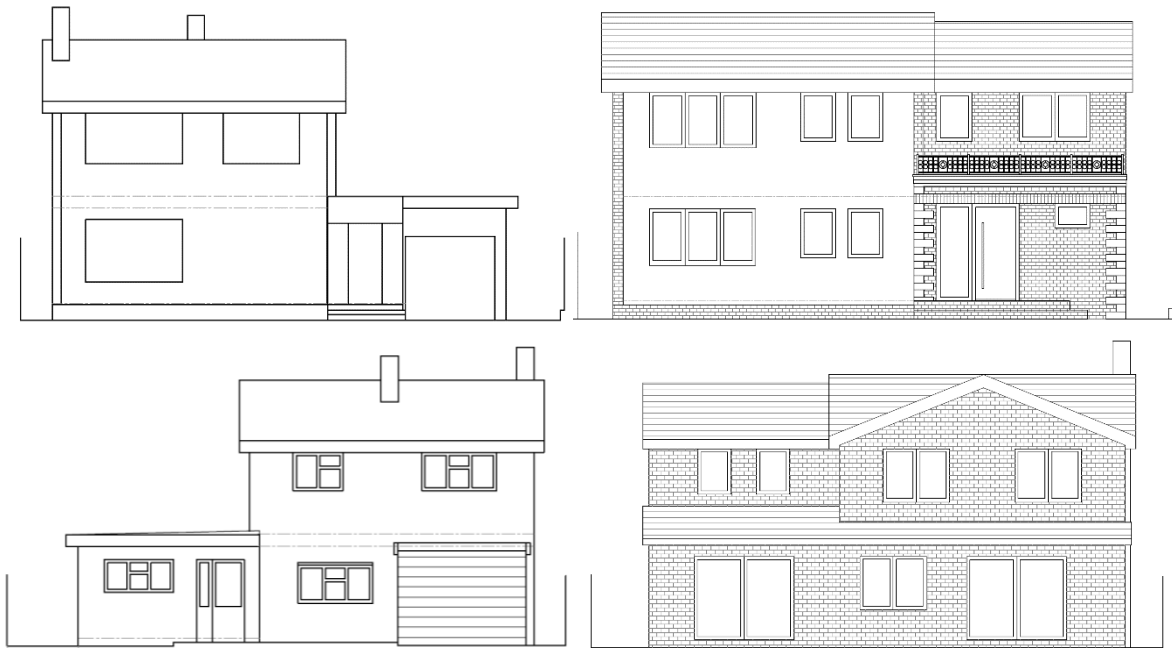
**FIGURE 3: SHOWING THE EXISTING (LEFT) AND PROPOSED (RIGHT) PLANS.**

- 1.12 The proposal is for two-storey extension works to the northeast and northwest elevations.

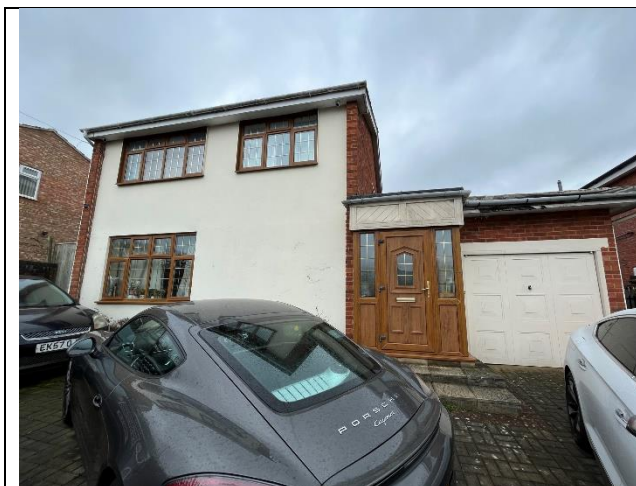
**Photograph 1:** The front elevation.

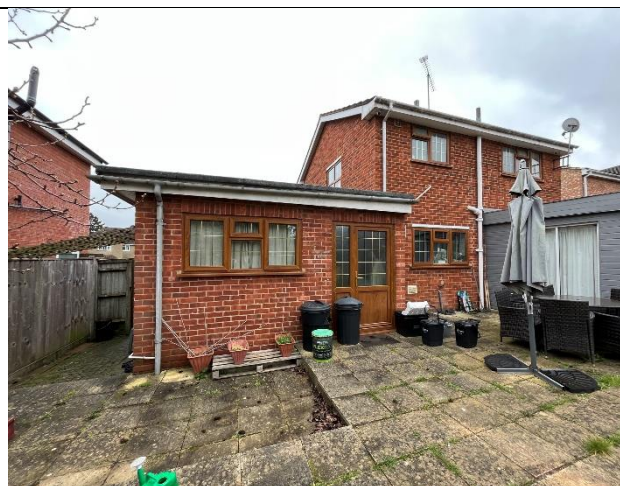
**Photograph 2:** The rear elevation.

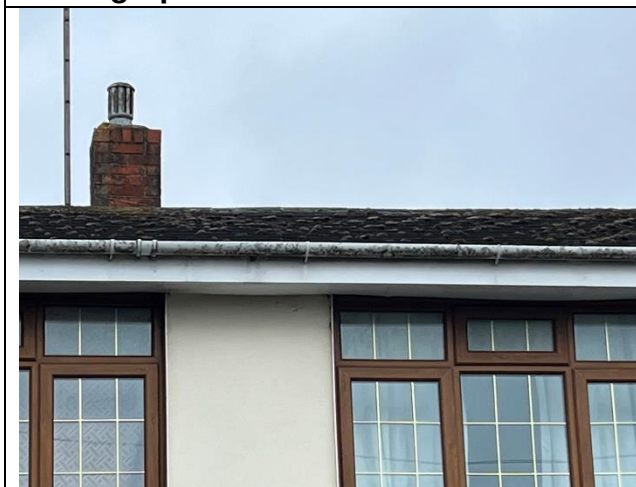
- 4.1 The building subject to survey is a two-storey, brick-built dwelling within a single-storey garage on the northeast elevation. The main house supports a gabled roof with clay roof tiles and the garage supports a bitumen felt covered flat roof. Externally the building was recorded to be tight fitting with no gaps suitable for bat access noted.
- 4.2 Internally a single roof void is present above the two-storey section of building. The void is wood framed with bitumen felt lining. The void is fitted with electric lighting and is in active use for storage. Cobwebbing was recorded at the apex throughout the void and no evidence of bats or potential bat access points were observed.

**Photograph 3:** Tight fitting roof tiles and soffits.
