**Outbuildings at 236 Reading Road  
Winnersh  
Berkshire**

# **Preliminary Roost Assessment**

Report ref.: R2990\_PRA\_a

**July 2025**

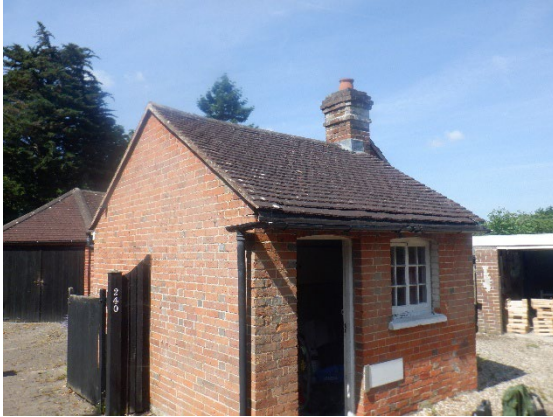
**5.2.2** The bathhouse was a small, pitched roofed structure attached to a larger section of the building in separate ownership that extended to the south west (**Photograph 1**).

*Photograph 1. Bathhouse viewed from the north east with garage in rear of photograph to the west. .*

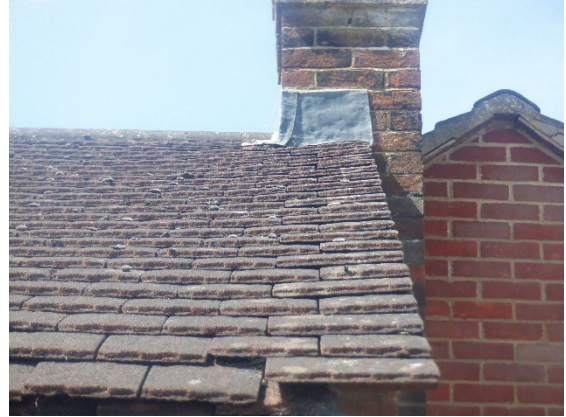
*Photograph 2. Slightly separated verge tiles at the north western end of the roof; no bat evidence during endoscopic inspection.*

**5.2.3** The pitched roof was covered with flat, concrete tiles, which were mainly in place and tightly fitted; the ridge tiles were all in place and tightly fitted also (**Photograph 4**). The tiles were slightly separating at the north western and south eastern gable ends; these showed no evidence of the presence of bats during a close, endoscopic inspection (**Target notes 2 & 3; Photographs 2 & 5**).

- 6.1.3 The bathhouse was a small building that had features including gaps below slightly raised verge tiles and beneath lead flashing at the chimney base, of low potential for crevice dwelling bat species, such as the locally recorded common pipistrelle (*P.pipistrellus*); however, a close endoscopic inspection of these showed no evidence of bats and as such it is considered unlikely that the building supports roosts. Internally, the building had a small, inaccessible void with slight gaps between the ceiling and walls, and showed no evidence of the presence of bats and as such is considered unlikely to support bats that make use of open voids, such as brown long eared bat (*P. auritus*).

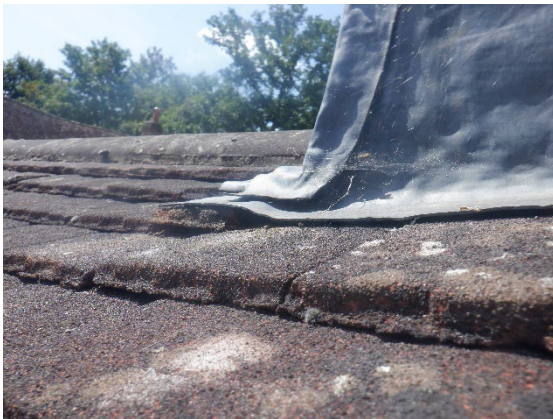
**5.2.4** The lead flashing at the base of the chimney at the north western corner, was raised slightly but this showed no evidence of the presence of bats during an endoscopic inspection (**Target note 1; Photograph 3**). The eaves on the building's front (north eastern) side were open and largely cobwebbed (**Photograph 6**).

*Photograph 3. Gap under lead flashing at base of chimney at the north western end; no evidence of bats during endoscopic inspection.*

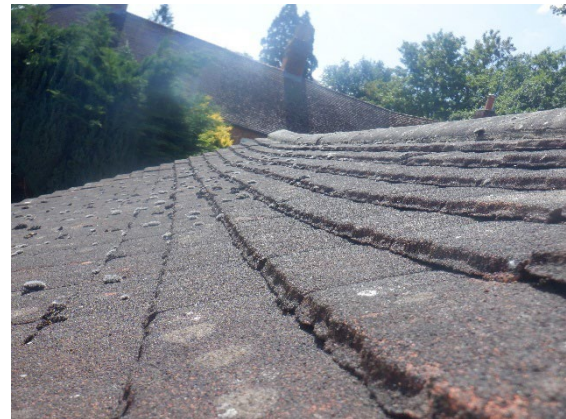
*Photograph 4. Tightly fitted concrete roof and ridge tiles on most of the roof.*

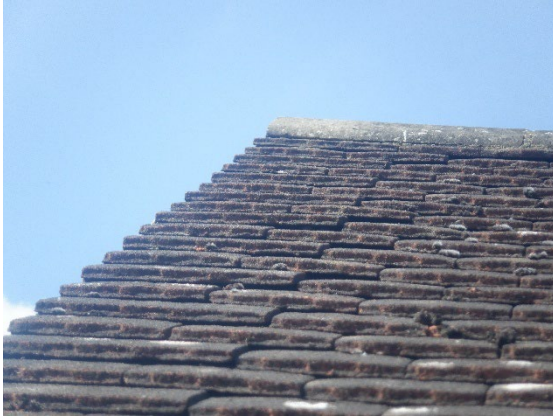
*Photograph 5. Slightly separated verge tiles at the south eastern end of the roof; no evidence of bats during an endoscopic inspection.*

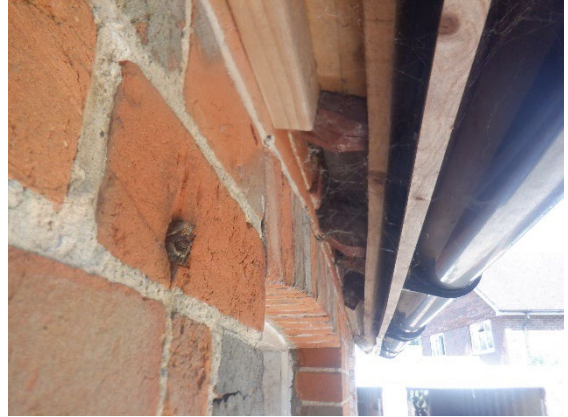
*Photograph 6. Open eaves on north eastern side largely cobwebbed.*

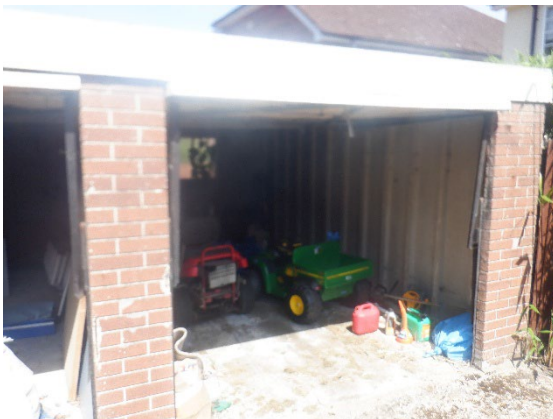
- 5.2.5** The garage was a prefabricated, concrete structure with a corrugated sheet roof. The double garage had ornamental brick pillars between the up-and-over doors to the front (eastern) side and the roof line was formed of uPVC fascias.

*Photograph 7. Garage viewed from the front (east) showing up-and-over doors and dividing pillars.*

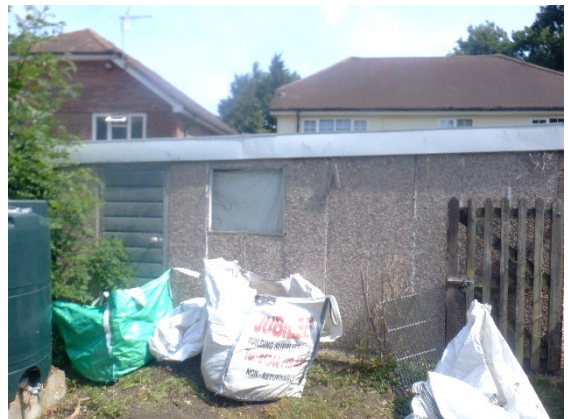
*Photograph 8. The garage viewed from the side (south) showing the prefabricated concrete panels and uPVC fascias.*

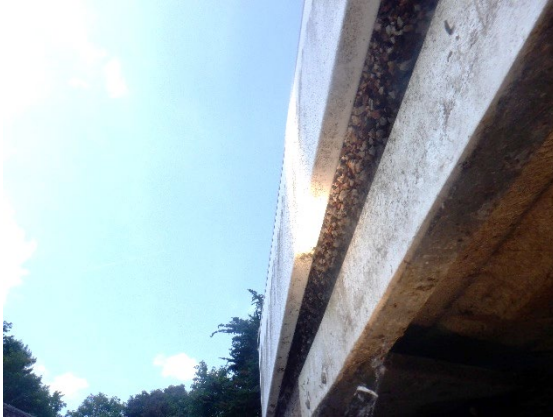
- 5.2.6** There were large gaps between the uPVC fascias and wall to the front (**Target note 5; Photograph 9**) and to the side (**Target note 4; Photograph 10**), which were unsuitable for bats.

*Photograph 9. Large gap behind fascia (eastern side)*

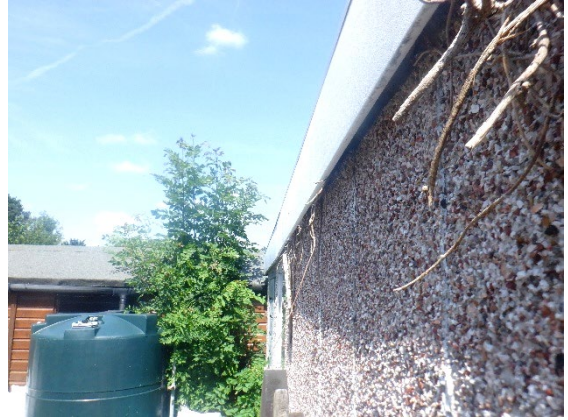
*Photograph 10. Large gap behind fascia (southern side).*

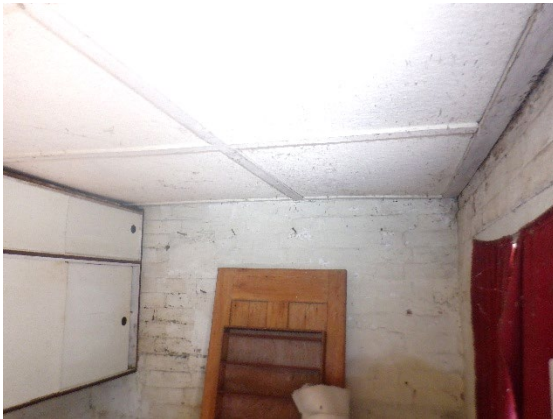
- 5.2.7** The interior of the bathhouse was used for household storage and had painted, brick walls and a hardboard ceiling (**Photograph 11**). There was a slight gap between the ceiling and wall within the building (**Target note 6; Photograph 12**). No evidence of the presence of bats was found in the building.

*Photograph 11. The interior of the bathhouse showing hardboard ceiling and painted brick walls.*

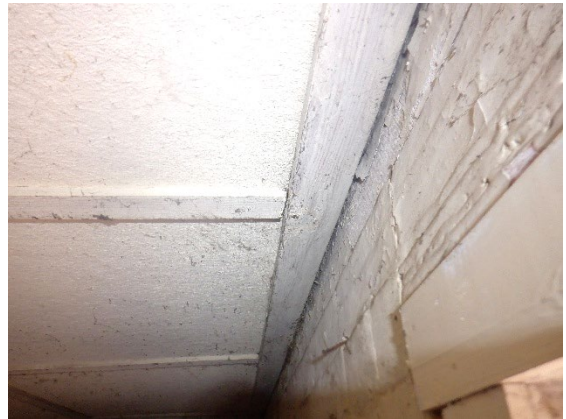
*Photograph 12..Slight gap between board ceiling*

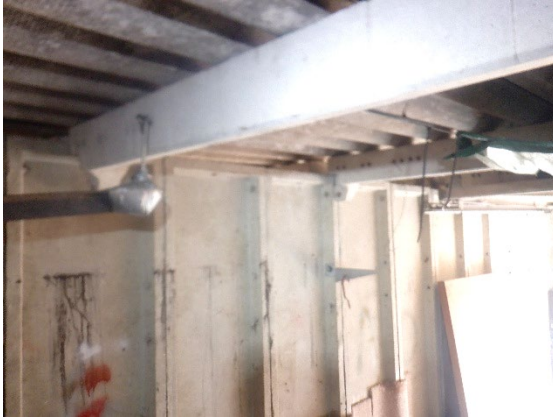
- 5.2.8** The garage was used for household storage. The pre-fabricated concrete walls were of simple construction and lacked any crevices suitable for roosting bats. Similarly, the concrete roof frame and corrugated sheet roof lacked any roosting opportunities for roosting bats; daylight was visible between the corrugated sheet roof and wall to the rear (**Target note 7; Photograph 14**). No bats or evidence of bats was visible in the garage.

*Photograph 13. The garage's prefabricated concrete walls, frame and corrugated sheet roof.*

- 6.1.4 The garage was a simply constructed, pre-fabricated structure with a sheet roof that lacked any sheltered crevices suitable for bats, and as such it is highly unlikely to support roosting bats. Therefore, the property has been assigned negligible potential suitability for bats overall (see **Appendix 1** for potential suitability categories).

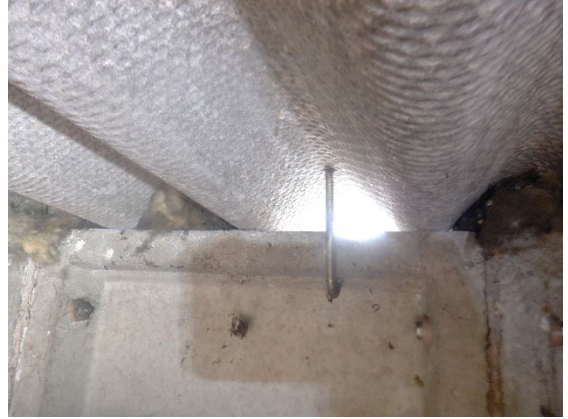
*Photograph 14. Daylight between corrugated sheets and walls.*
