Phase 2 Site Investigation

NEIGHBOURHOOD CENTRE, HOGWOOD FARM (FINCHWOOD PARK DEVELOPMENT)

PHASE 2 GEOTECHNICAL AND GEO-ENVIRONMENTAL SITE INVESTIGATION

Appendix 1 Exploratory Hole Location Plan, Drawing Reference: 41623/031 Rev A

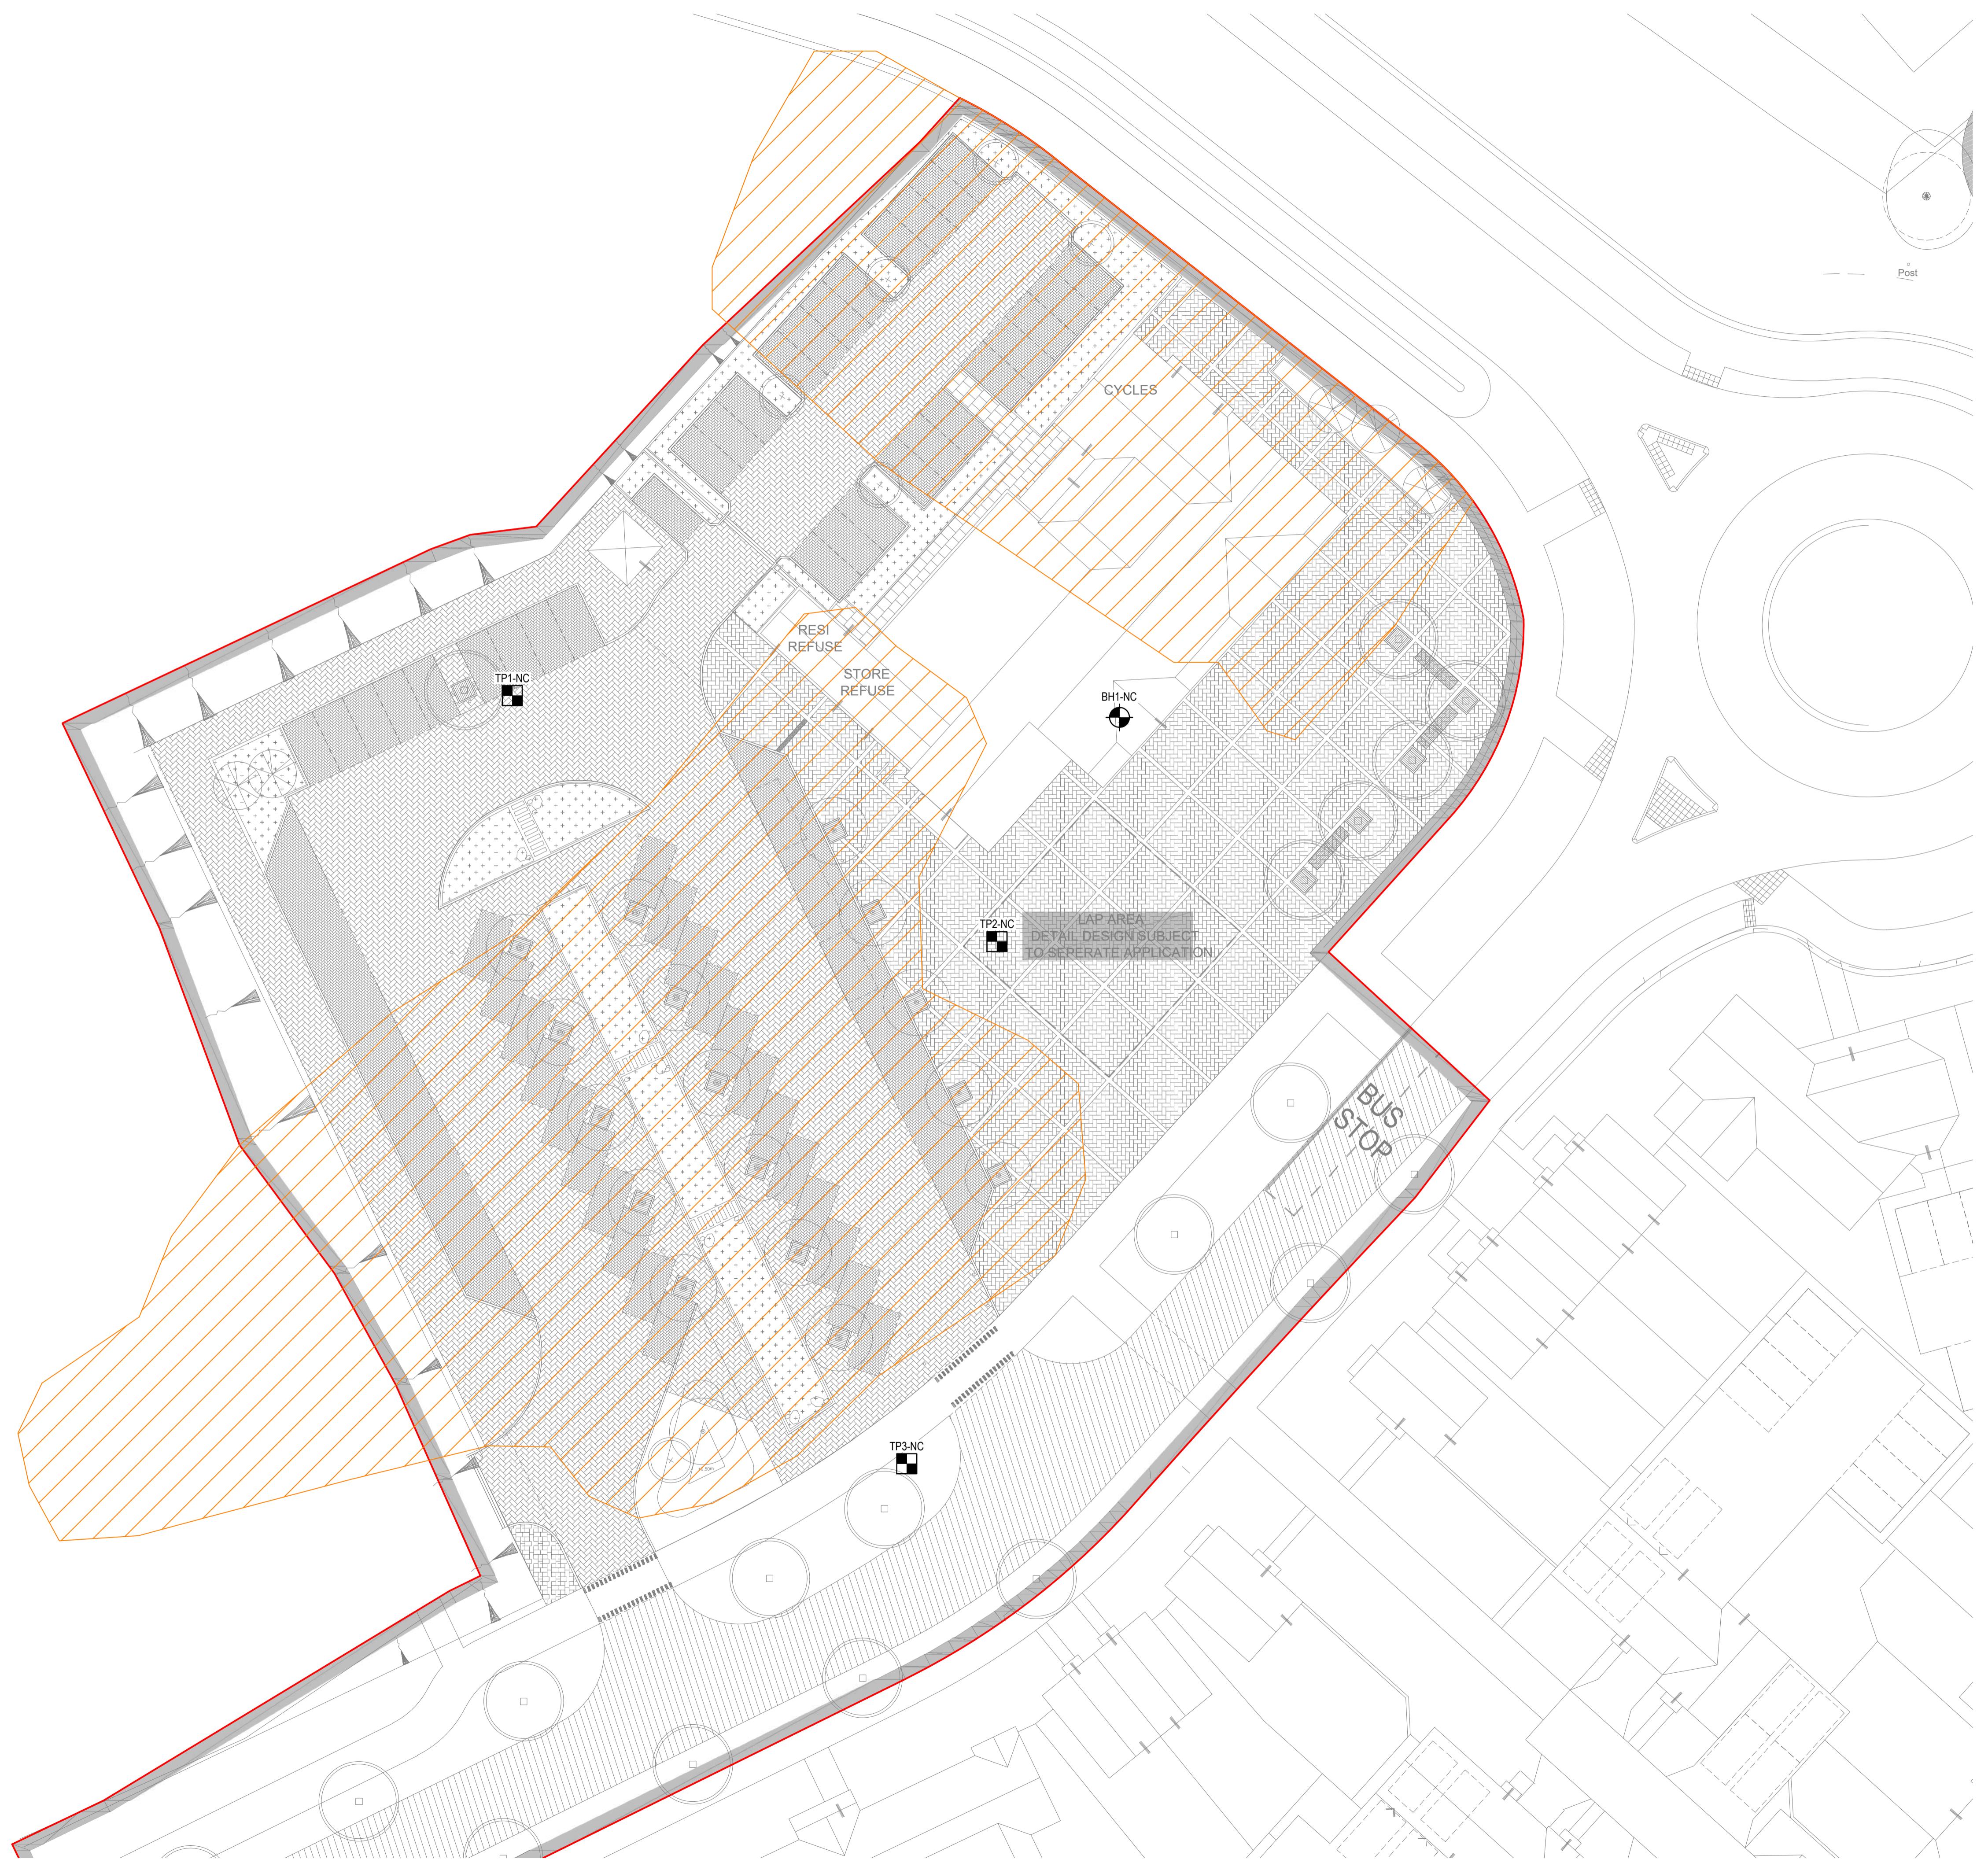
- Site boundary.
- Approximate location of trial pit completed by Eastwood Consulting Engineers on 06.08.2025.
- Approximate location of cable percussion borehole completed by Eastwood Consulting Engineers on 06.08.2025 & 07.08.2025.
- Approximate extent of material stockpile on site.

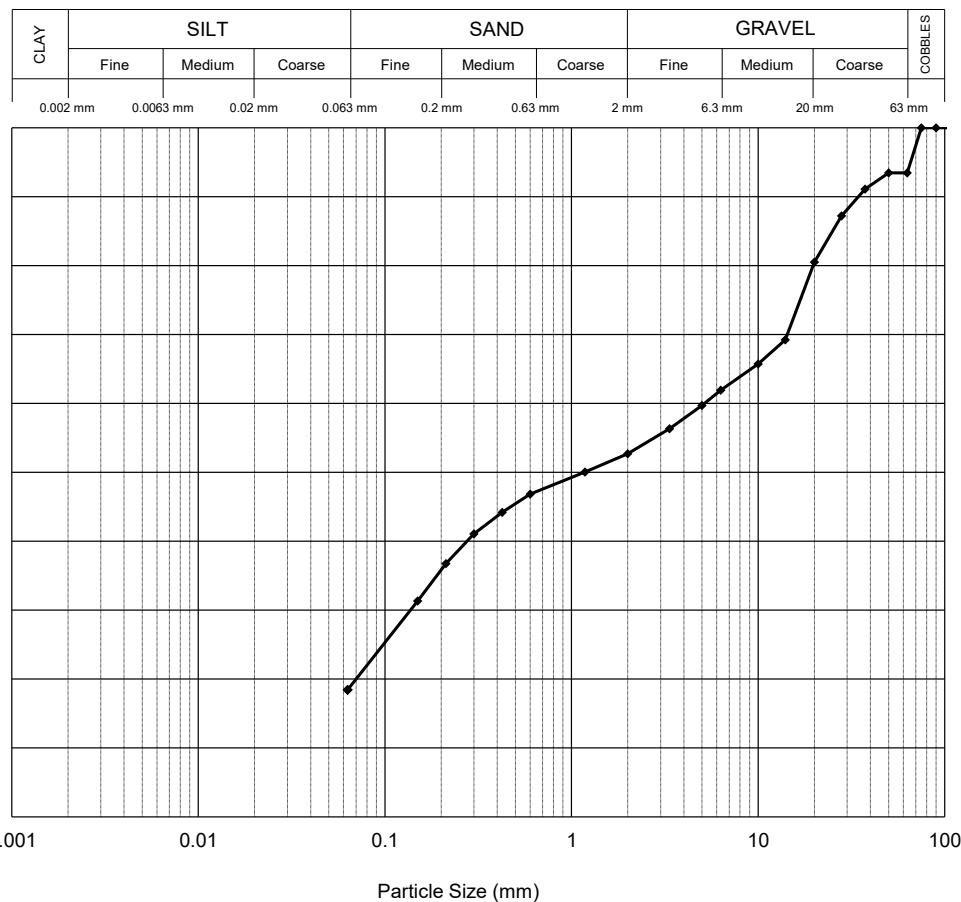
PARTICLE SIZE DISTRIBUTION

BS EN ISO 17892-4 : 2016 : Clause 5.2 - Wet Sieve

Sieve	
Size	% Pass
200.0 mm	100
125.0 mm	100
90.0 mm	100
75.0 mm	100
63.0 mm	93
50.0 mm	93
37.5 mm	91
28.0 mm	87
20.0 mm	81
14.0 mm	69
10.0 mm	66
6.30 mm	62
5.00 mm	60
3.35 mm	56
2.00 mm	53
1.18 mm	50
600 µm	47
425 µm	44
300 µm	41
212 µm	37
150 µm	31
63 µm	18

Particle Proportions	
Cobbles	6.6
Gravel	40.7
Sand	34.3
Silt & Clay	18.4

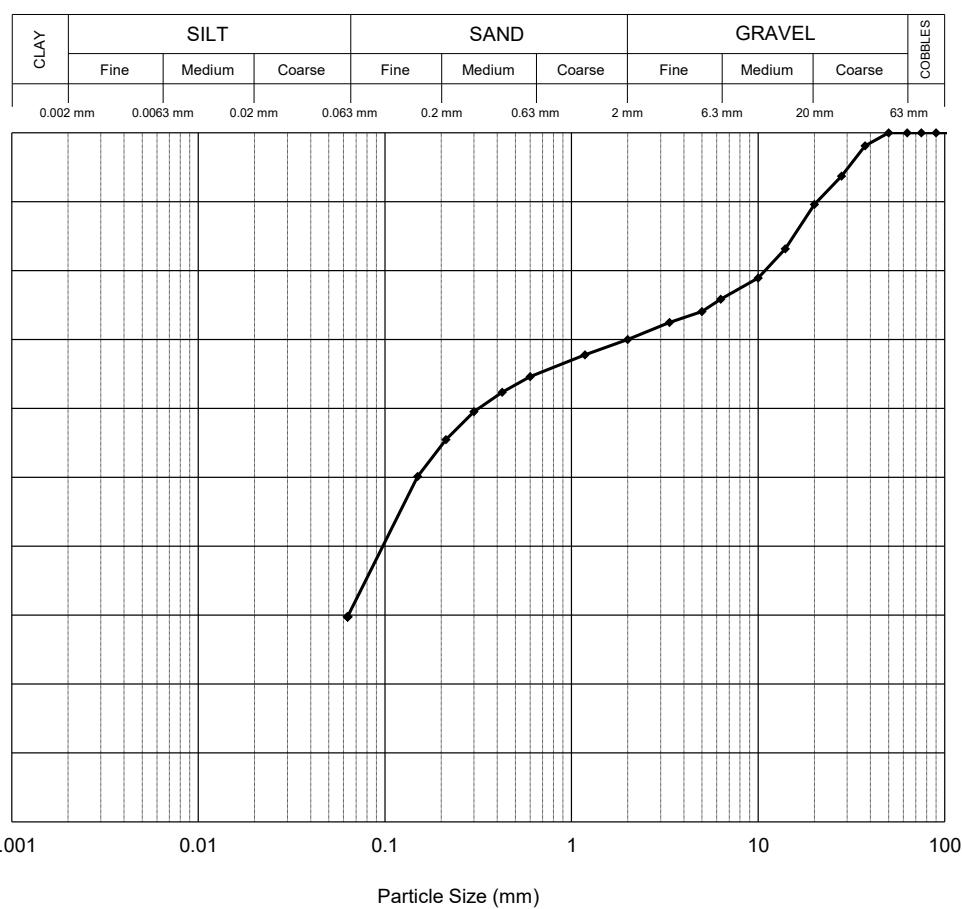
BS EN ISO 17892-4 : 2016 : Clause 5.2 - Wet Sieve

Sieve	
Size	% Pass
200.0 mm	100
125.0 mm	100
90.0 mm	100
75.0 mm	100
63.0 mm	100
50.0 mm	100
37.5 mm	98
28.0 mm	94
20.0 mm	90
14.0 mm	83
10.0 mm	79
6.30 mm	76
5.00 mm	74
3.35 mm	72
2.00 mm	70
1.18 mm	68
600 µm	65
425 µm	62
300 µm	60
212 µm	55
150 µm	50
63 µm	30

Particle Proportions	
Cobbles	0.0
Gravel	30.0
Sand	40.3
Silt & Clay	29.7

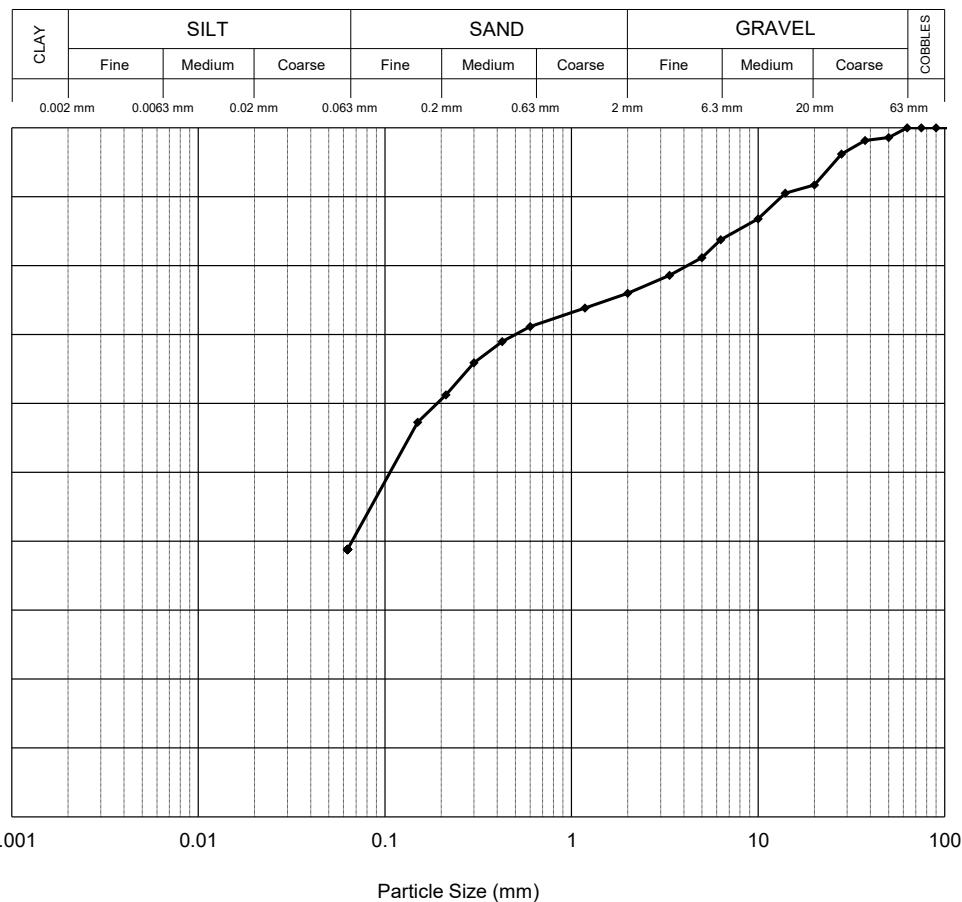
PARTICLE SIZE DISTRIBUTION

BS EN ISO 17892-4 : 2016 : Clause 5.2 - Wet Sieve

Sieve	
Size	% Pass
200.0 mm	100
125.0 mm	100
90.0 mm	100
75.0 mm	100
63.0 mm	100
50.0 mm	99
37.5 mm	98
28.0 mm	96
20.0 mm	92
14.0 mm	90
10.0 mm	87
6.30 mm	84
5.00 mm	81
3.35 mm	79
2.00 mm	76
1.18 mm	74
600 µm	71
425 µm	69
300 µm	66
212 µm	61
150 µm	57
63 µm	39

Particle Proportions	
Cobbles	0.0
Gravel	24.0
Sand	37.2
Silt & Clay	38.8

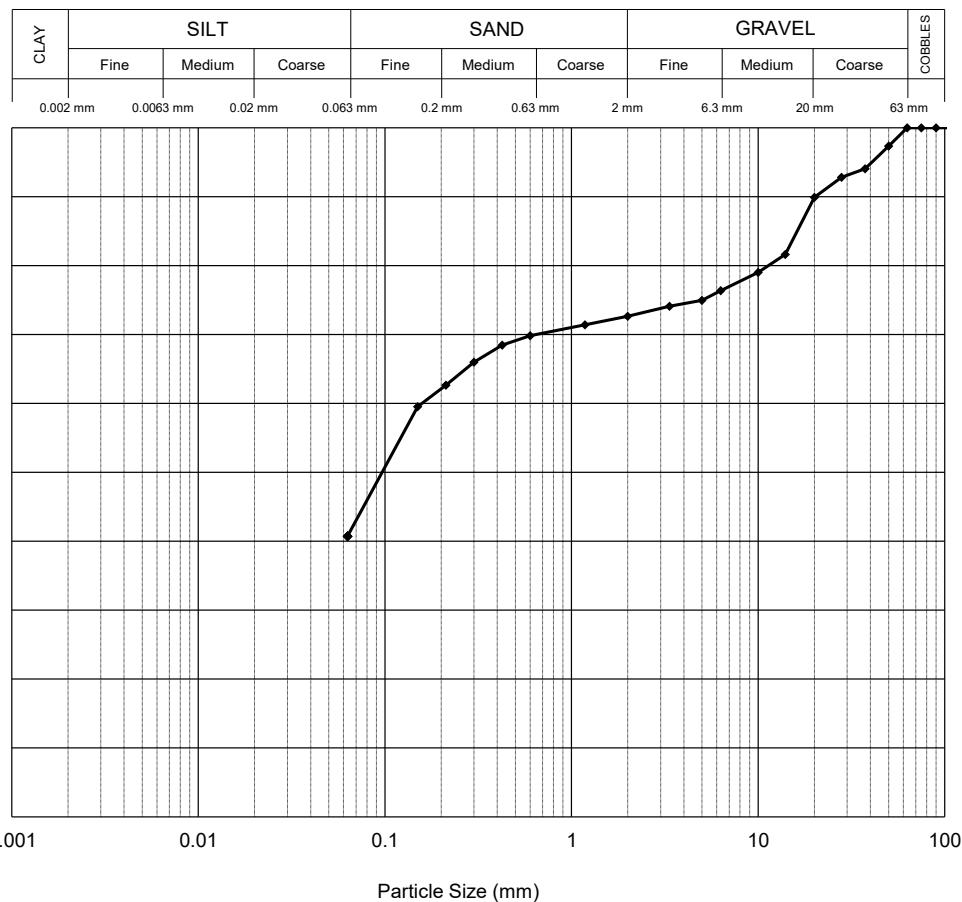
PARTICLE SIZE DISTRIBUTION

BS EN ISO 17892-4 : 2016 : Clause 5.2 - Wet Sieve

Sieve	
Size	% Pass
200.0 mm	100
125.0 mm	100
90.0 mm	100
75.0 mm	100
63.0 mm	100
50.0 mm	97
37.5 mm	94
28.0 mm	93
20.0 mm	90
14.0 mm	82
10.0 mm	79
6.30 mm	76
5.00 mm	75
3.35 mm	74
2.00 mm	73
1.18 mm	71
600 µm	70
425 µm	68
300 µm	66
212 µm	63
150 µm	60
63 µm	41

Particle Proportions	
Cobbles	0.0
Gravel	27.3
Sand	31.9
Silt & Clay	40.8

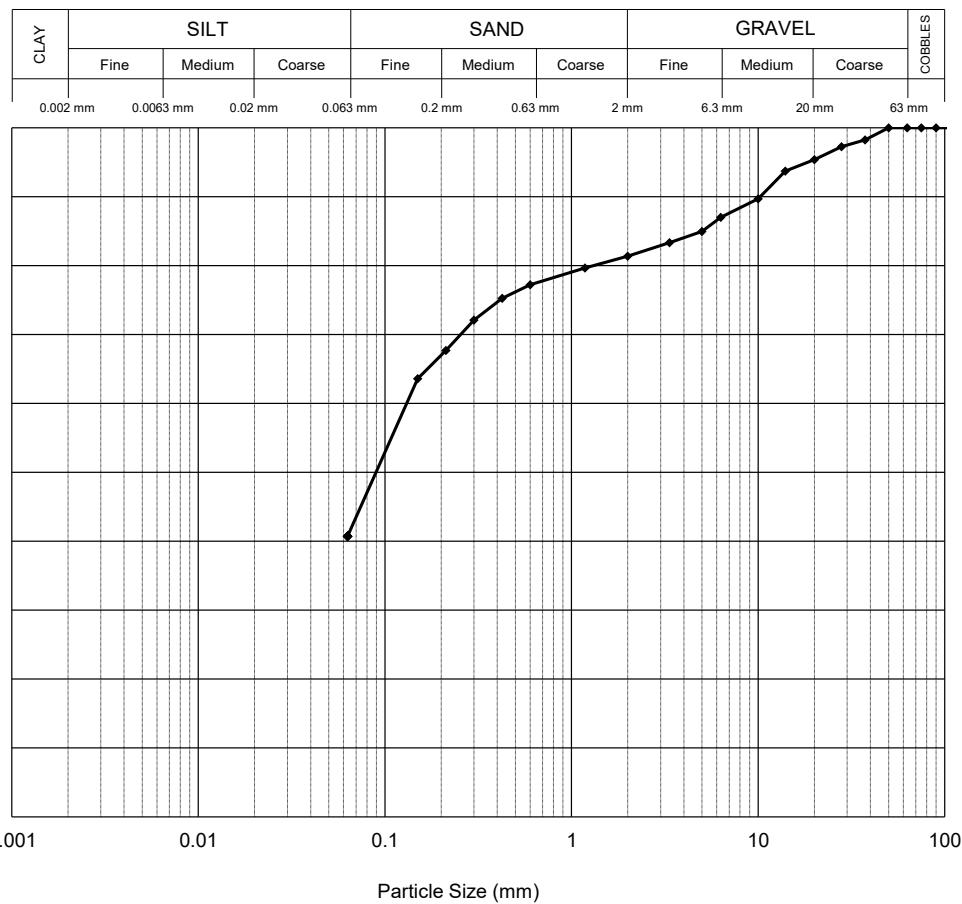
BS EN ISO 17892-4 : 2016 : Clause 5.2 - Wet Sieve

Sieve	
Size	% Pass
200.0 mm	100
125.0 mm	100
90.0 mm	100
75.0 mm	100
63.0 mm	100
50.0 mm	100
37.5 mm	98
28.0 mm	97
20.0 mm	95
14.0 mm	94
10.0 mm	90
6.30 mm	87
5.00 mm	85
3.35 mm	83
2.00 mm	81
1.18 mm	80
600 µm	77
425 µm	75
300 µm	72
212 µm	68
150 µm	64
63 µm	41

Particle Proportions	
Cobbles	0.0
Gravel	18.6
Sand	40.6
Silt & Clay	40.8

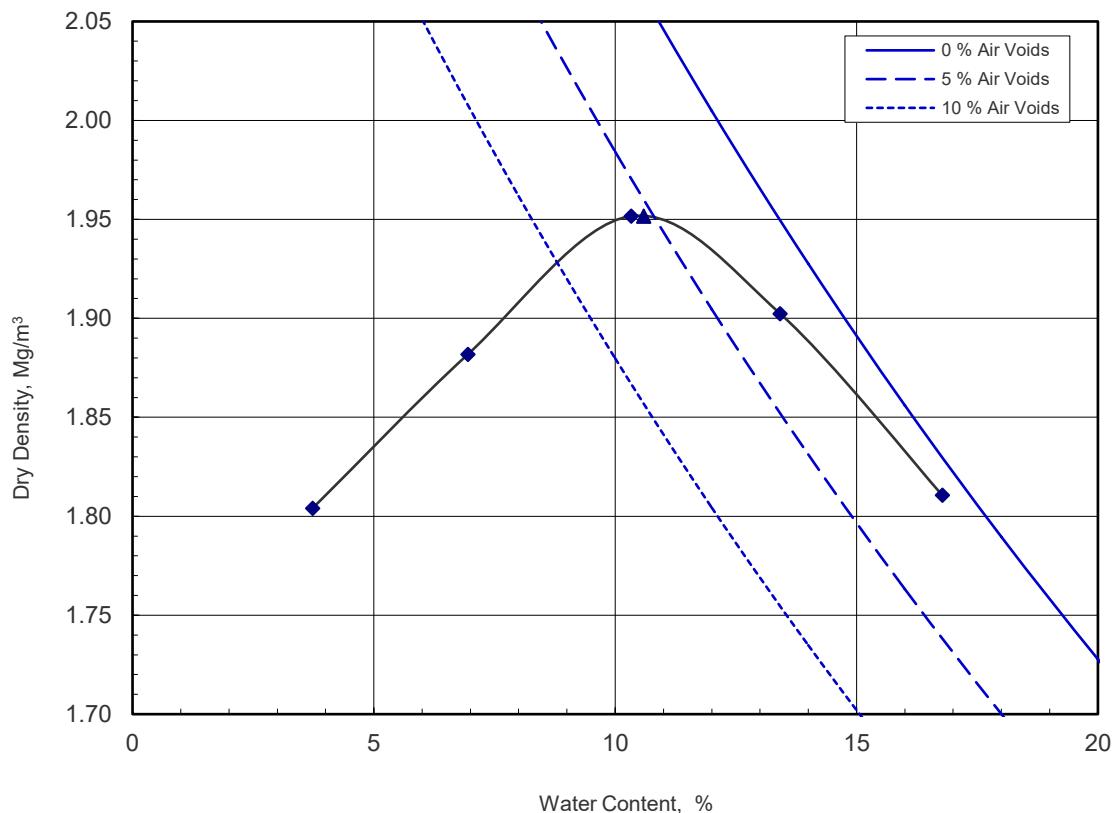
WATER CONTENT / DRY DENSITY RELATIONSHIP

Maximum Dry Density Mg/m³ 1.95

Optimum Water Content % 10.6

Determination	1	2	3	4	5
Water Content %	3.7	6.9	10.3	13.4	16.8
Dry Density Mg/m³	1.80	1.88	1.95	1.90	1.81

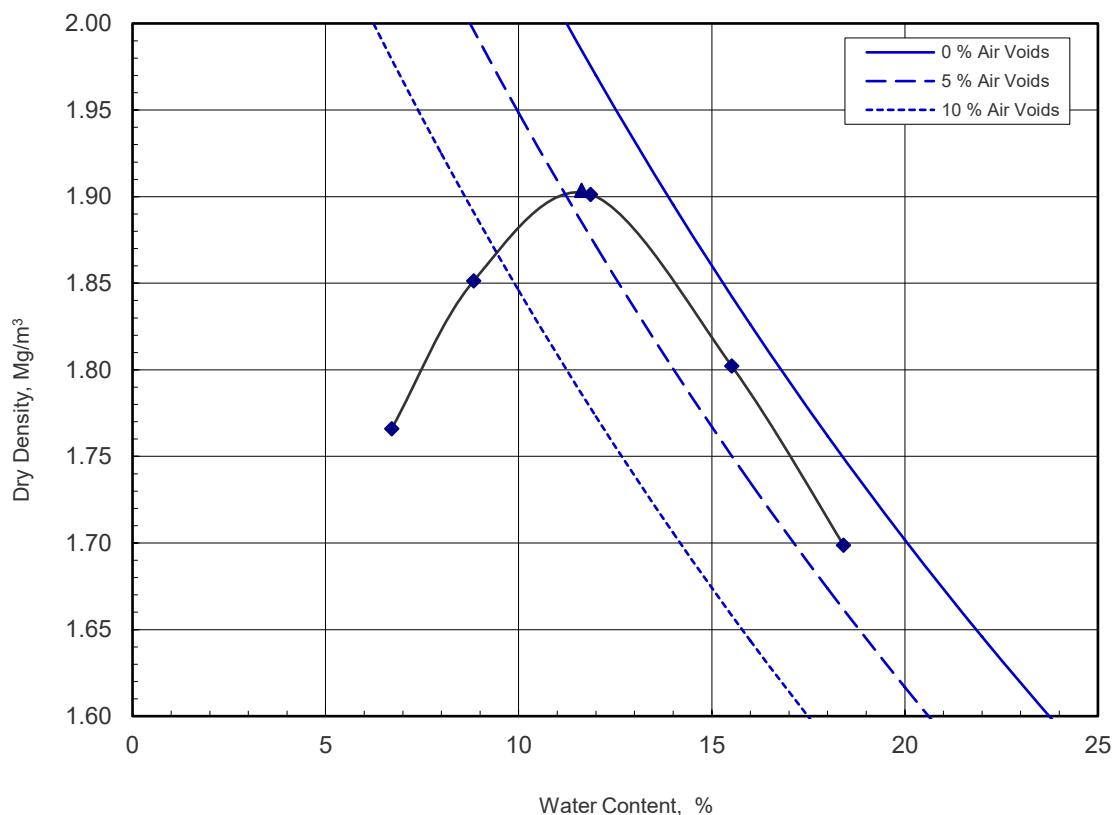
WATER CONTENT / DRY DENSITY RELATIONSHIP

11.6

Determination	1	2	3	4	5
Water Content %	6.7	8.8	11.9	15.5	18.4
Dry Density Mg/m³	1.77	1.85	1.90	1.80	1.70

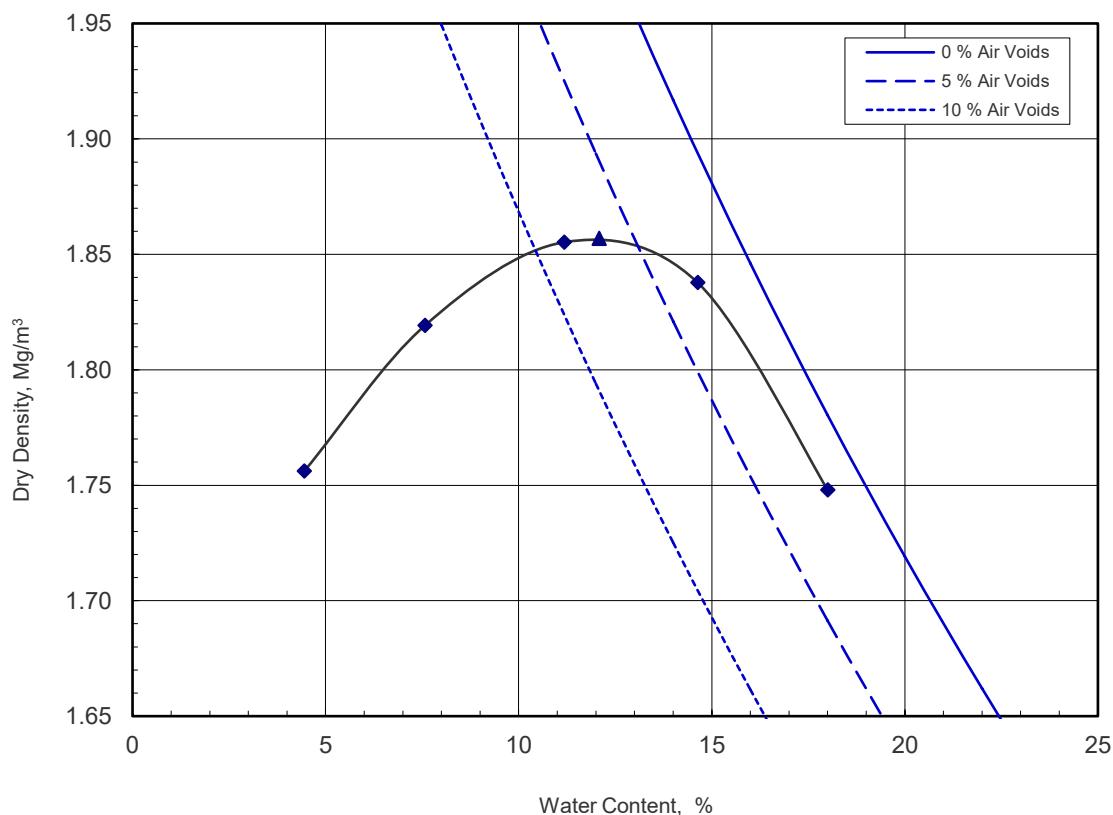
WATER CONTENT / DRY DENSITY RELATIONSHIP

12.1

Determination	1	2	3	4	5
Water Content %	4.5	7.6	11.2	14.6	18.0
Dry Density Mg/m³	1.76	1.82	1.86	1.84	1.75

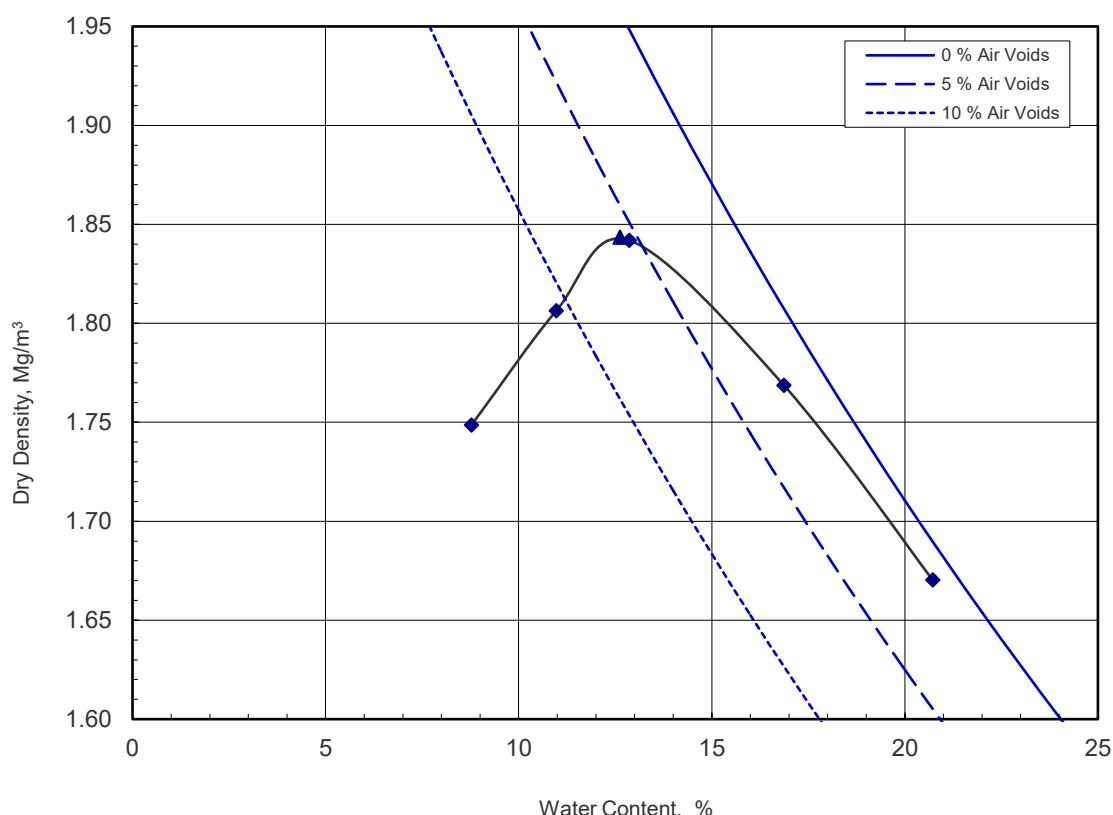
12.6

Determination	1	2	3	4	5
Water Content %	8.8	11.0	12.9	16.9	20.7
Dry Density Mg/m³	1.75	1.81	1.84	1.77	1.67

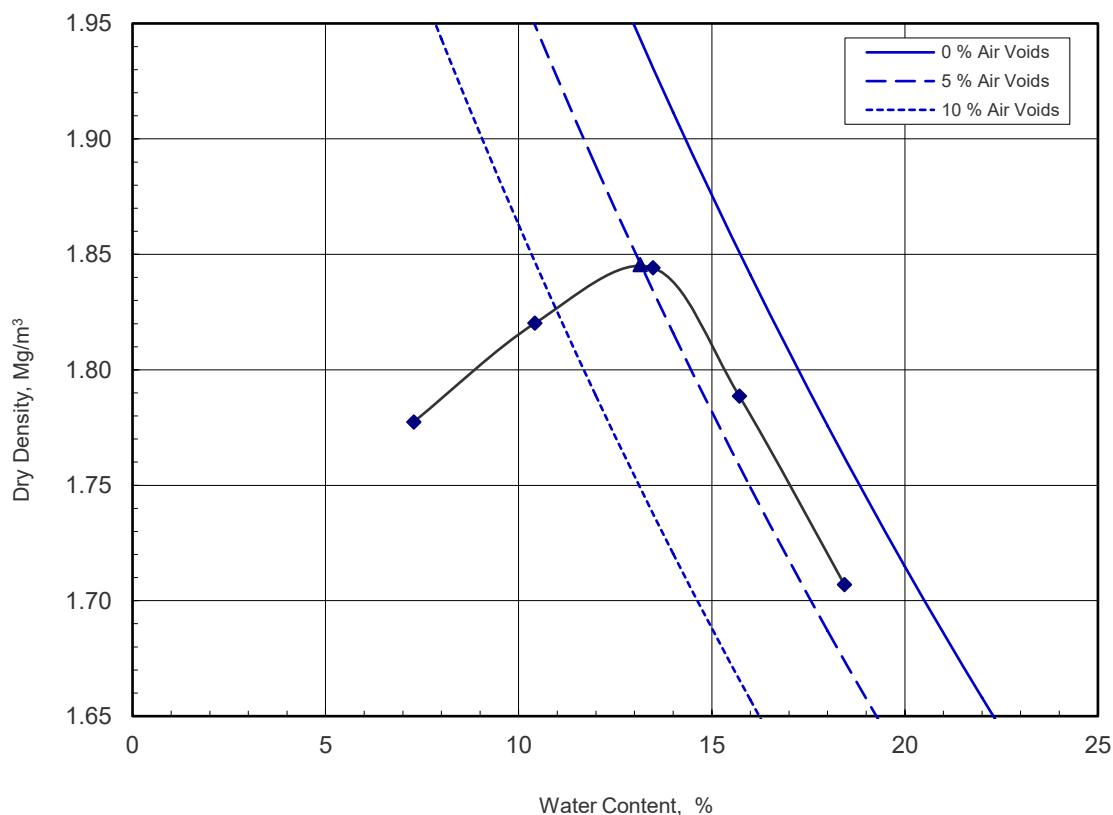
WATER CONTENT / DRY DENSITY RELATIONSHIP

13.1

Determination	1	2	3	4	5
Water Content %	7.3	10.4	13.5	15.7	18.4
Dry Density Mg/m³	1.78	1.82	1.84	1.79	1.71

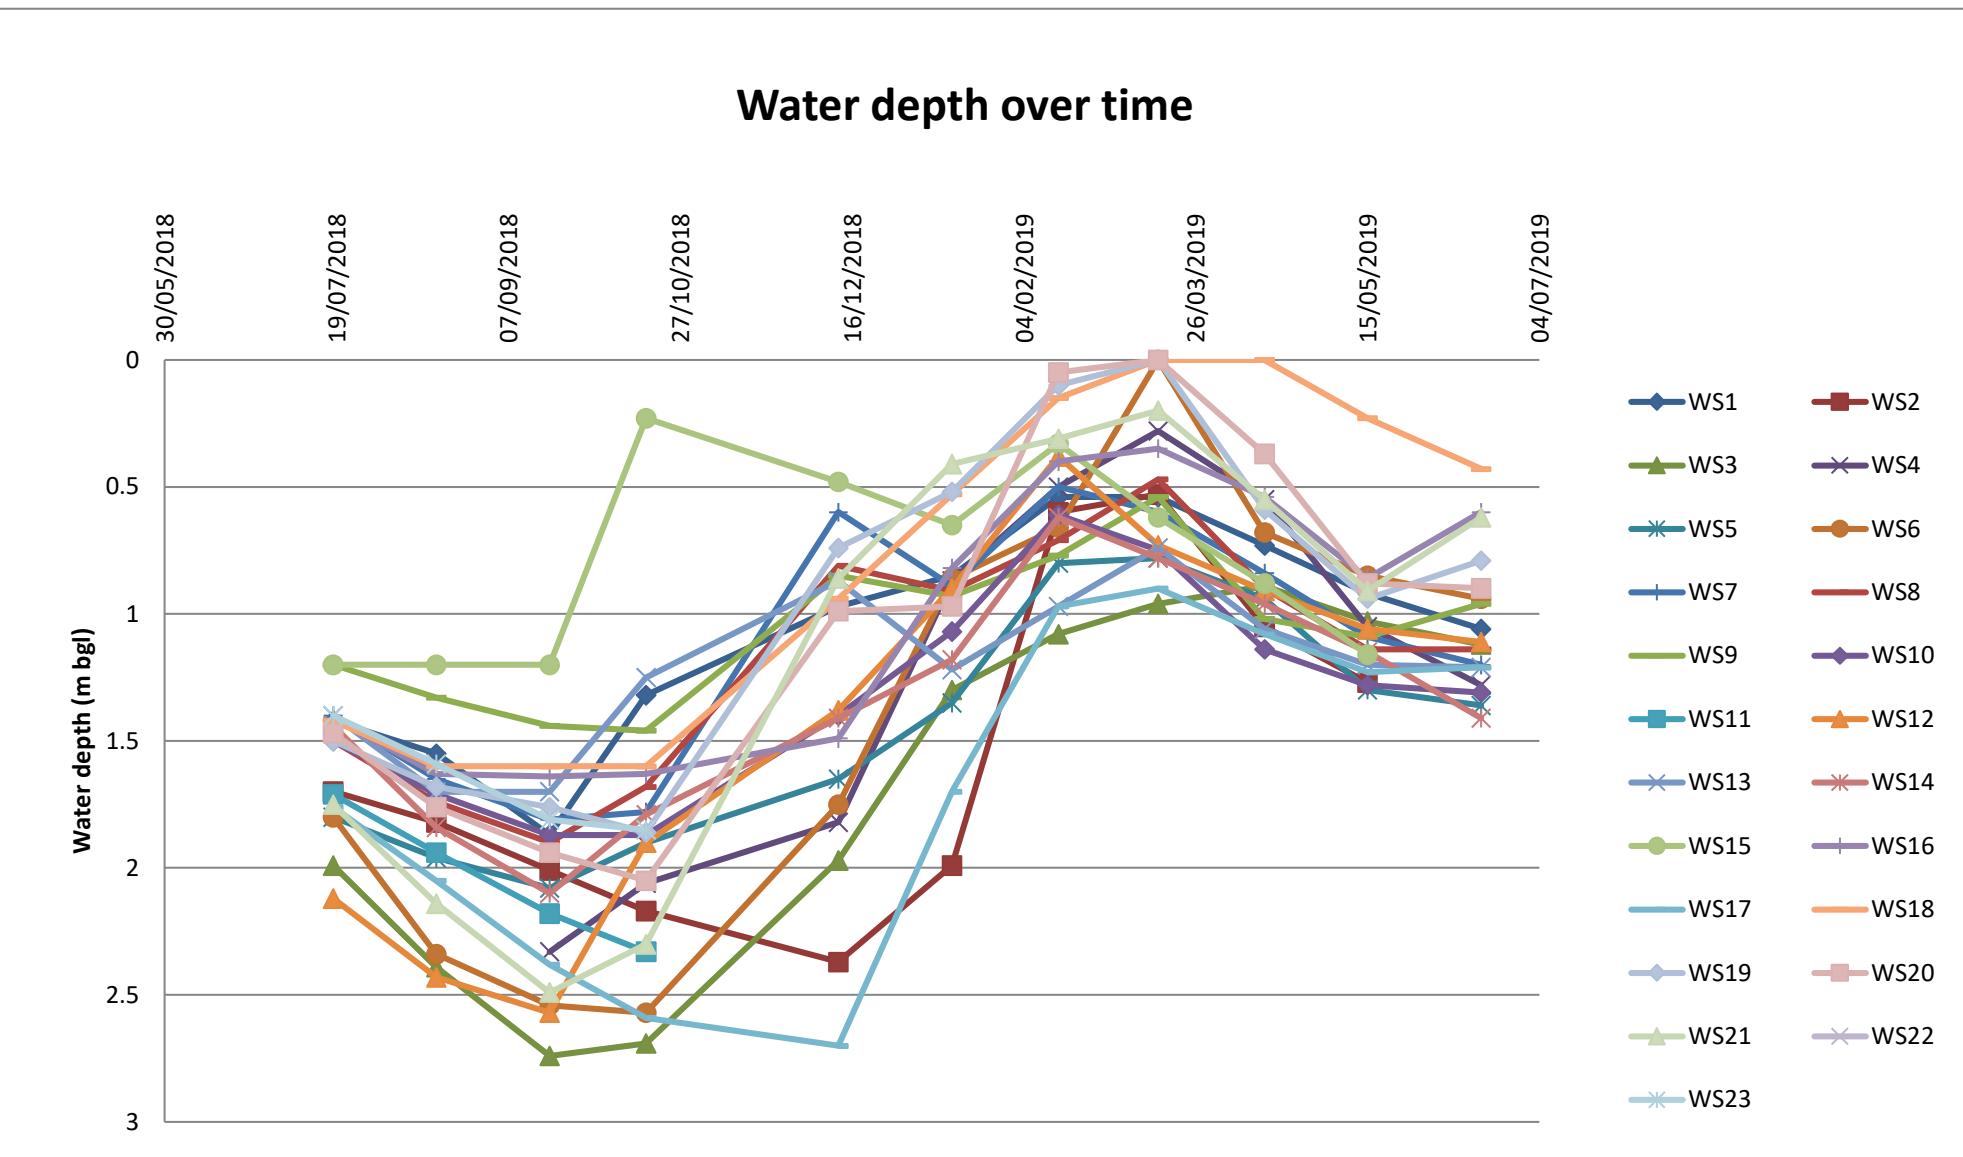
their deepest in September 2018 where they were found to be between 1.2 m and 2.7 m bgl. The levels then rose to a peak in March 2019 where the levels were found to be between 0.0 m and 0.96 m bgl. As expected, the levels then fell towards June 2019, although small rises were recorded in a few wells between May and June.

shallowest towards the end of the winter period/beginning of spring and deepest towards the end of the summer period/beginning of autumn. The water levels were observed to be relatively shallow, with water recorded at the surface on a few occasions in a small number of wells. Contour plans have been produced which indicate the groundwater is flowing towards a surface water drain/stream which exits the centre of the southern boundary of the site and flows towards the Blackwater River. The values recorded are considered to be representative of the true groundwater, and not a perched water table.

WS2 - Destroyed/buried

WS15 - Dry (silted up to 1.15 m)
