# Verification Report

101212/VR/002

## Matthewsgreen Farm, Emmbrook

Report Type : Verification Report

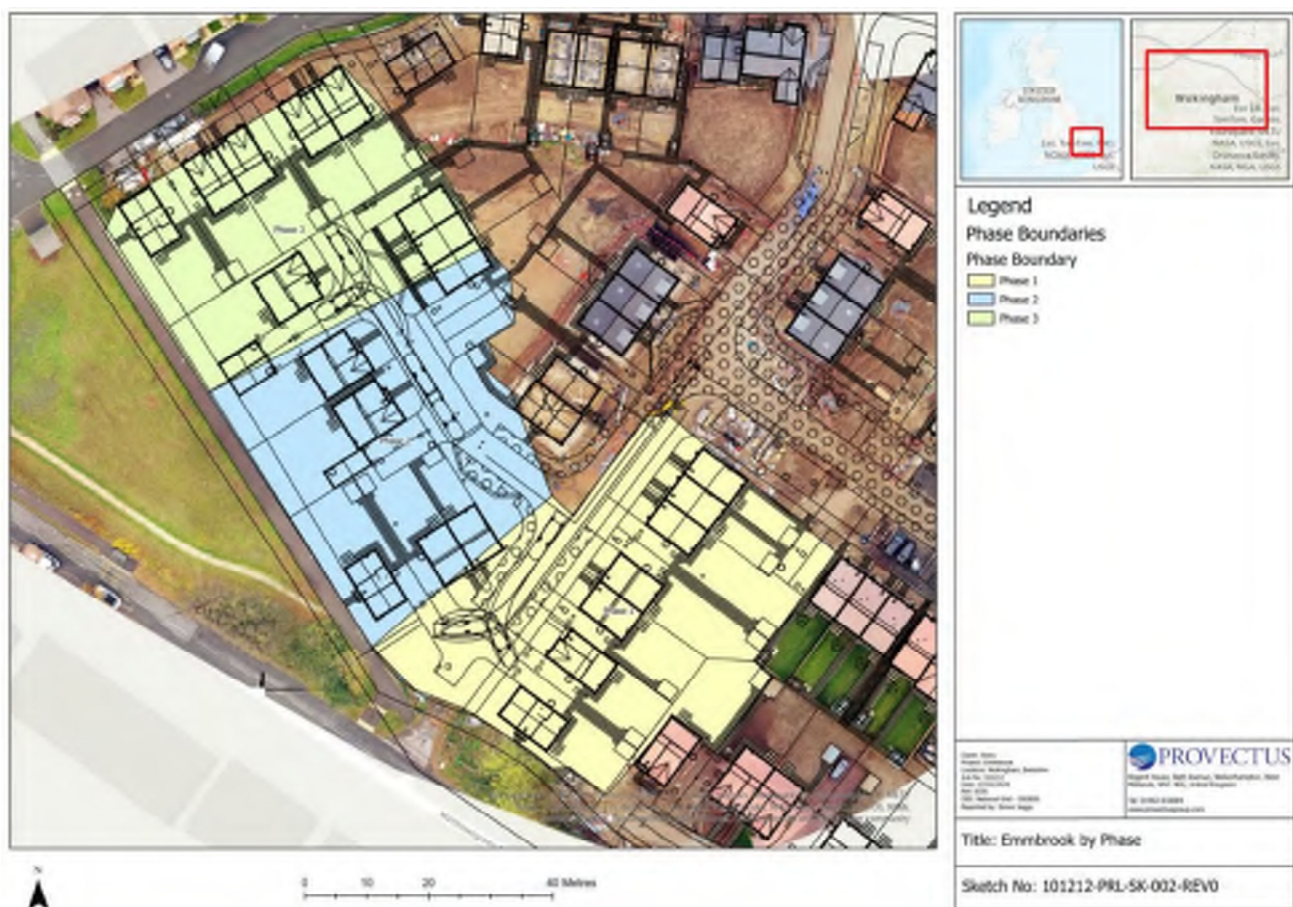
**Figure 1a - PRL phase plan vs site development plan Phases 1 – 3 initial Works**

The development site was initially divided into three phases, a fourth phase was introduced during the works. Phase 4 covered the rest of the site to the east of Phases 2 and 3, the extent of which is shown in Figure 1a. The site was excavated from Phase 1 through to Phase 4 as shown on Sketch 101212-PRL-SK-002-REV1 contained in Appendix A and Shown as Figure 1b.

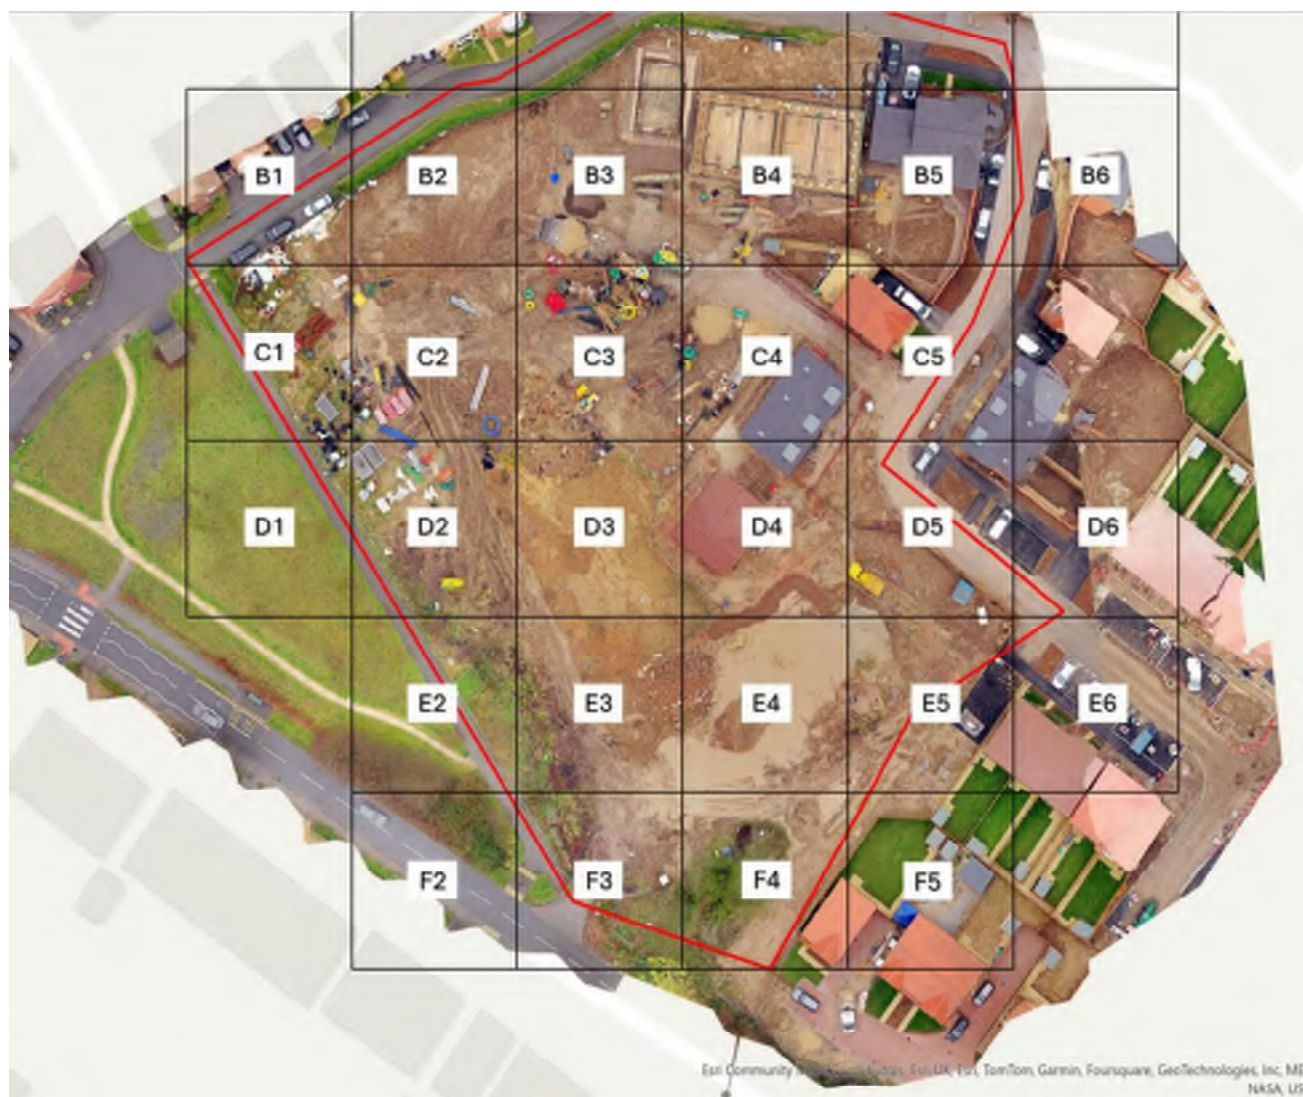
**Figure 2 – PRL site drawing with grid square allocations**

The site was also divided into 20x20 m grid squares as shown in Figure 2 below.

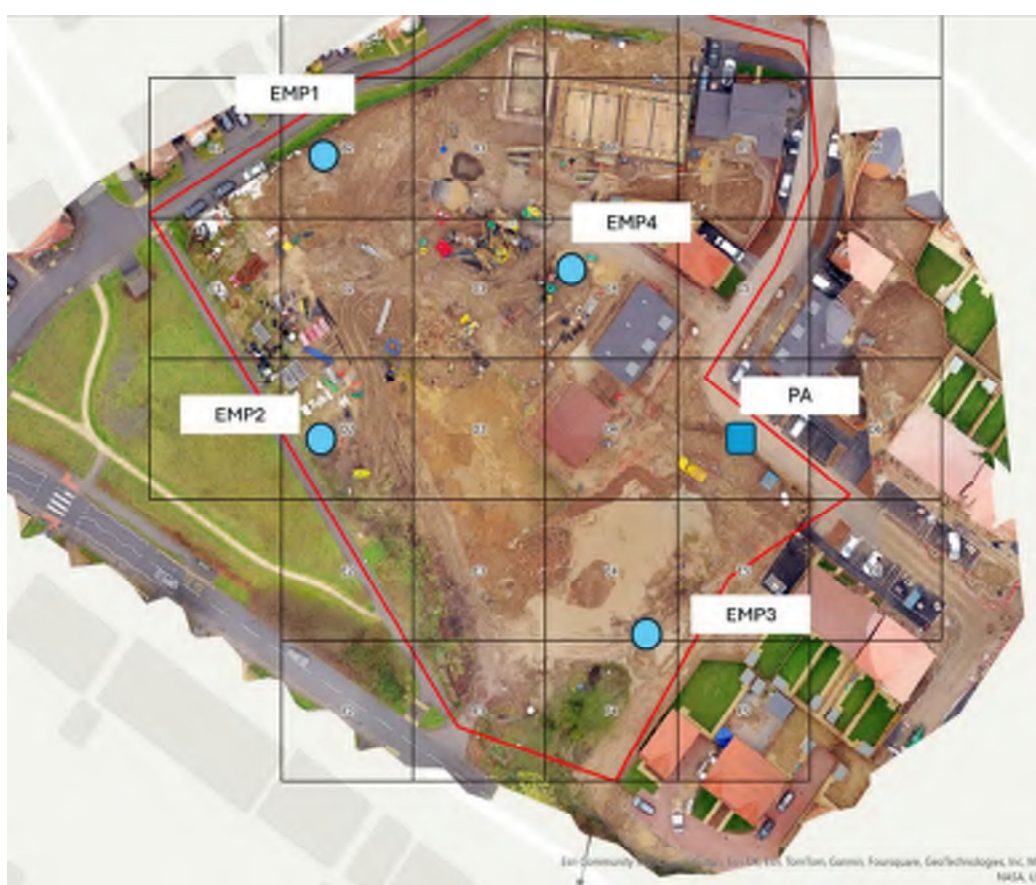
**Figure 4 – Environmental Monitoring Point Locations**

In addition to the daily monitoring, fortnightly dust deposition monitoring via Frisbee Gauge was carried out at the four boundary locations. No results exceeded the trigger level of 200mg/m<sup>2</sup>/day.

A drawing displaying the location of the monitoring locations are presented in Figure 4 below. In addition, road sweepers were deployed to reduce the debris on surrounding highways and reduce the risk of dust.

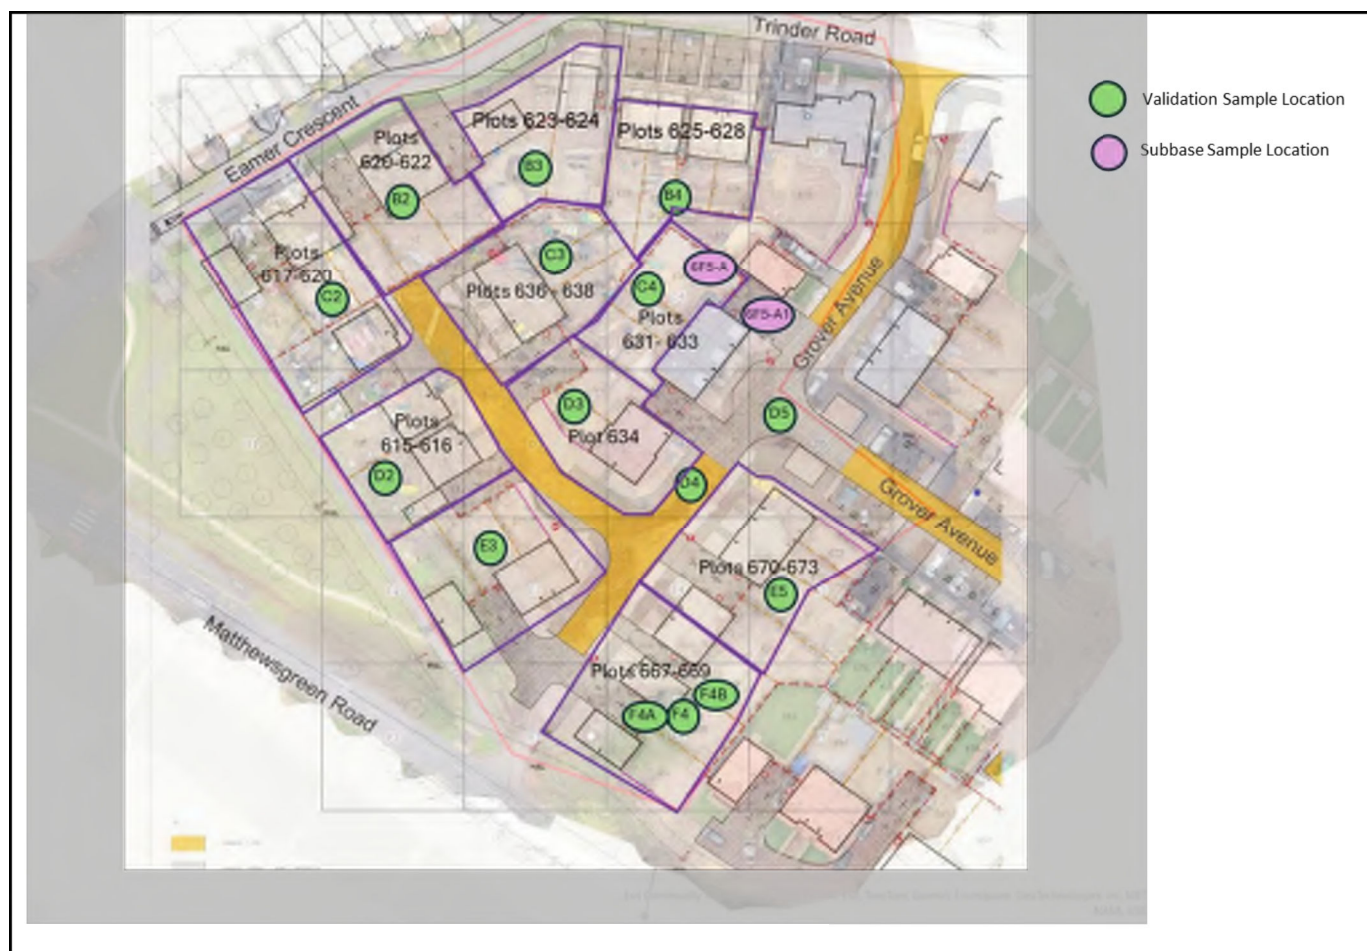
**Figure 5 – Validation Sample Location Plan**

All 13 samples were screened against Geo-Environmental Remediation strategy and verification plan GE20647/RSVPv2.0/AUG22 with no exceedances. Further, all samples showed no variations of asbestos and successfully met vapour limit requirements

Remediation and reduced level excavation works were completed in Phase 1, the plots were validated using the 20m Grid, see Figure 5 in Section 5 of this report. The Phase 1 area was handed over to Buxted Ltd on 20/03/2024.

Remediation and reduced level excavation works were completed in Phase 2, the plots were validated using the 20m Grid, see Figure 5 in Section 5 of this report. The Phase 1 area was handed over to Buxted Ltd on 12/04/2024.

Remediation and reduced level excavation works were completed in Phase 2, the plots were validated using the 20m Grid, see Figure 5 in Section 5 of this report. The Phase 1 area was handed over to Buxted Ltd on 26/04/2024.

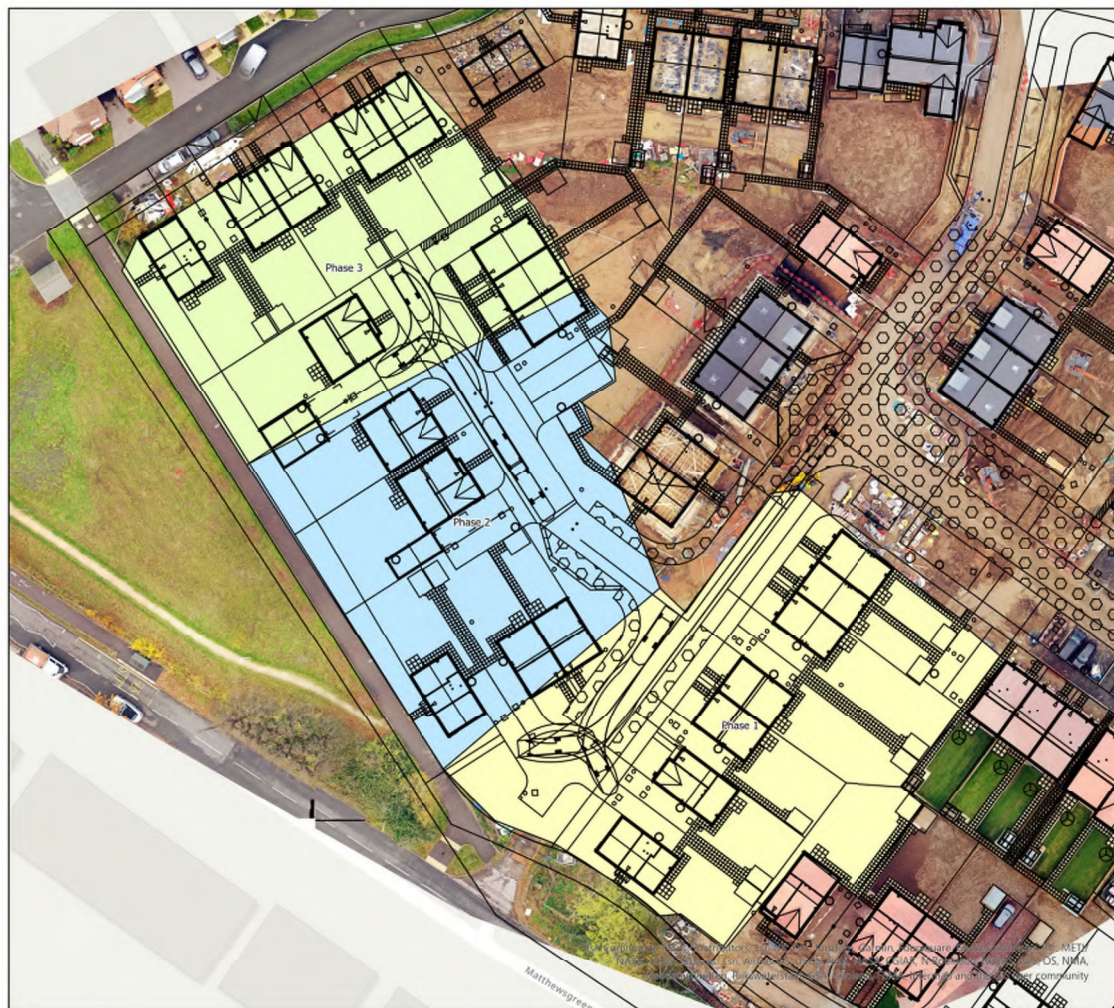
**Sketch No: 101212-PRL-SK-002-REV0**

**Title: Emmbrook by Phase**

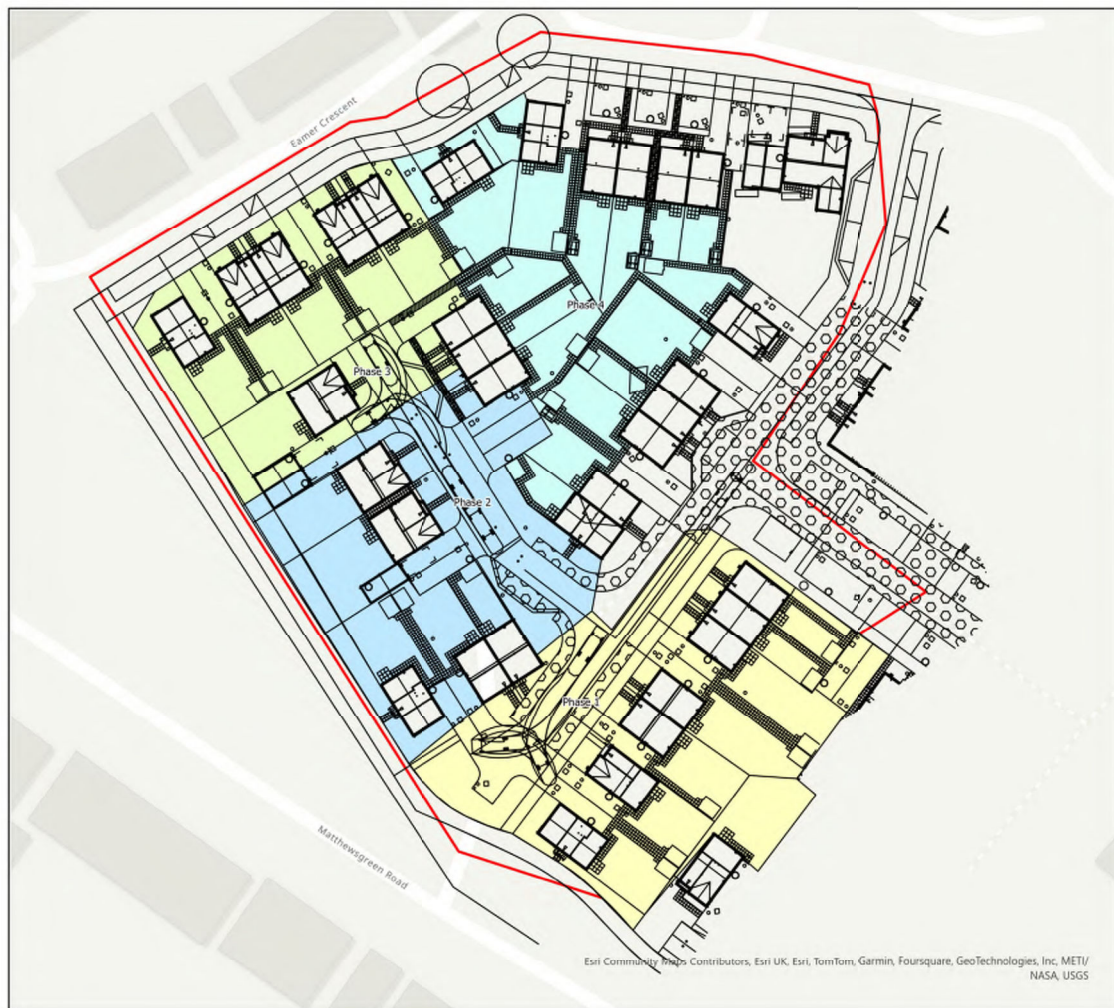
**Sketch No: 101212-PRL-SK-002-REV1**

**Title: PRL Phase drawing**

All control measures are limited to this area only. A fourth phase was introduced during the works comprising of an extension to the original reduced level dig in an area adjacent to the east of phase 2 and phase 3. The extents of these areas are depicted in drawing 101212-PRL-SK-002-REV1 - Appendix A.

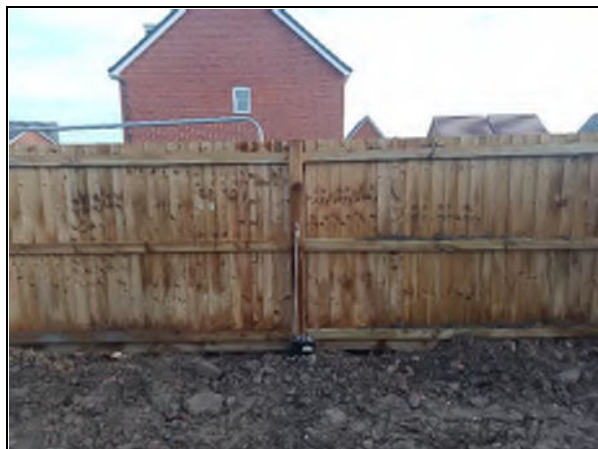
Photograph No.560696 –  
Site Perimeter Near Site Entrance - Far Source Pump 121

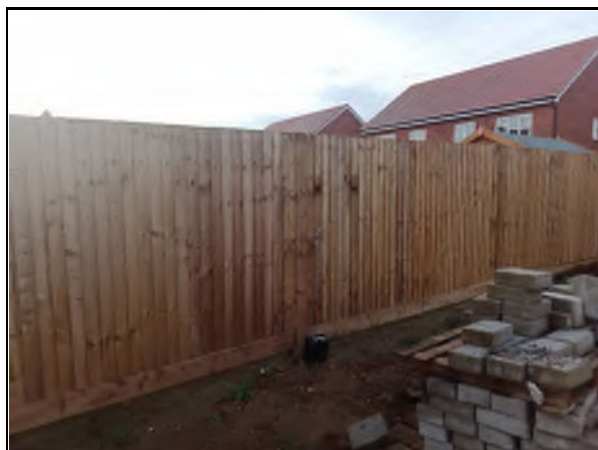
Photograph No.560697 –  
Monitoring Point Three - Far Source Pump 122

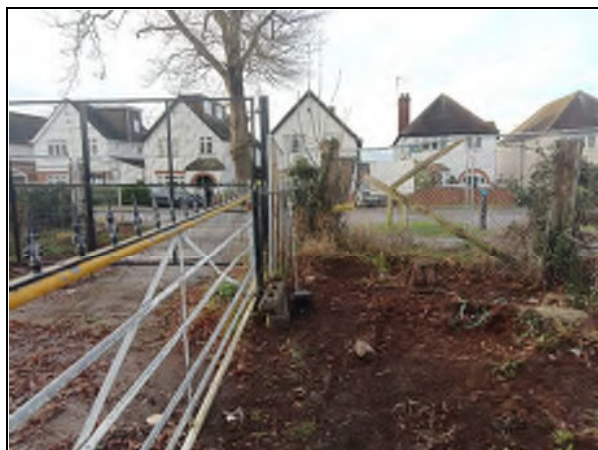
Photograph No.560698 –  
Site Perimeter Adjacent Pathway - Far Source Pump 136

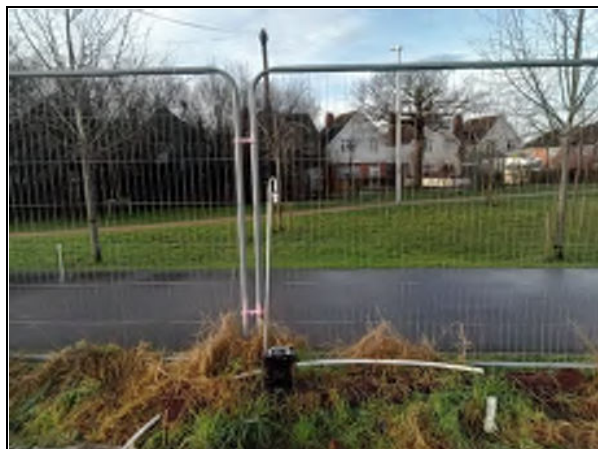
Photograph No.560699 –  
Monitoring Point Two - Far Source Pump 175

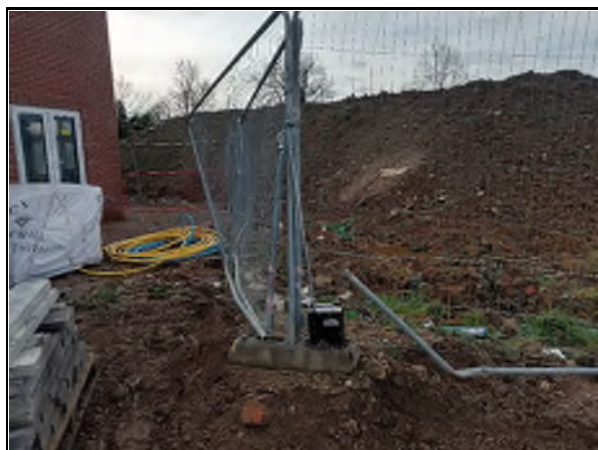
Photograph No.560700 –  
Monitoring Point Four - Far Source Pump 121
