## “Carlisle Lodge” Forest Road, Binfield. RG40 5SA

### ECOLOGY

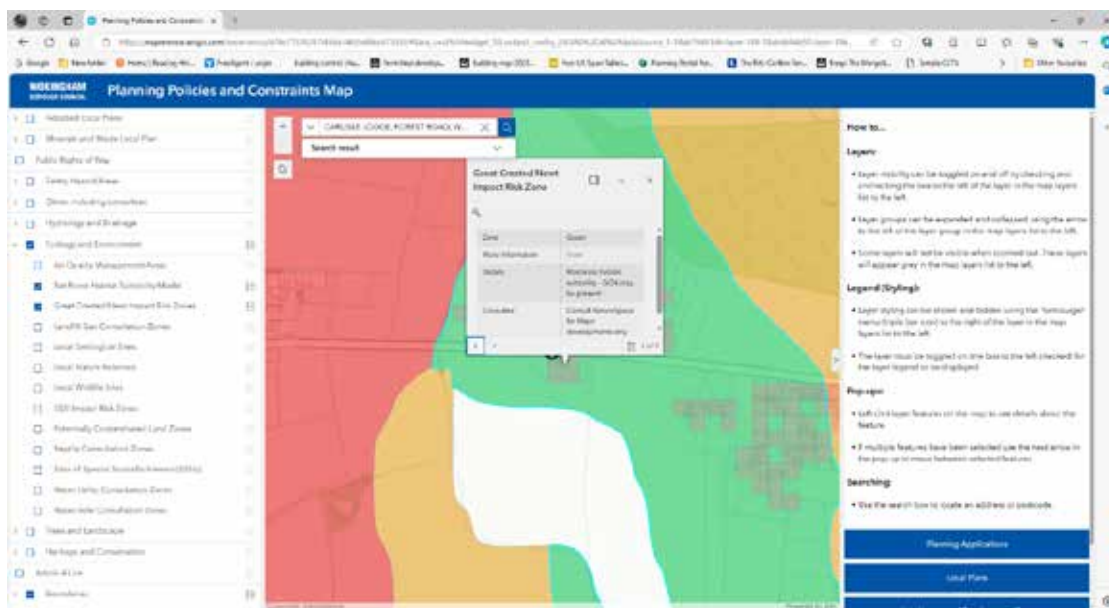
constraints Map (Great Crested Newts)

The constraints map also suggests that there is a moderate chance of Great Crested Newts, and consultation should be made with Nature England for Major Developments only.

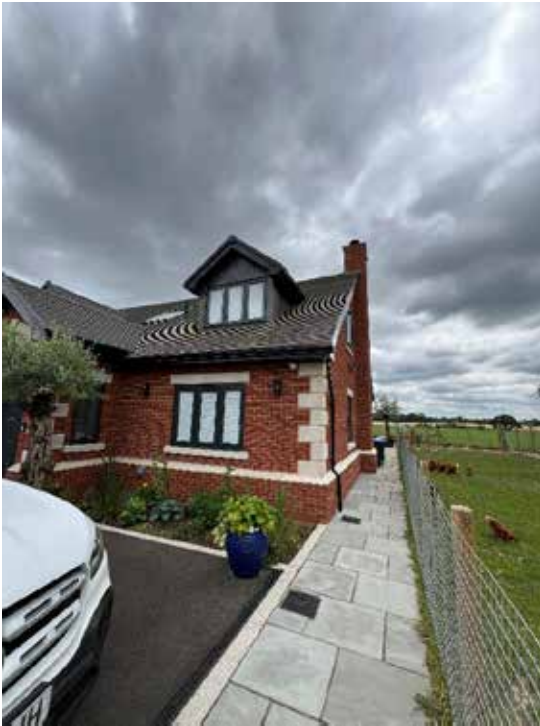
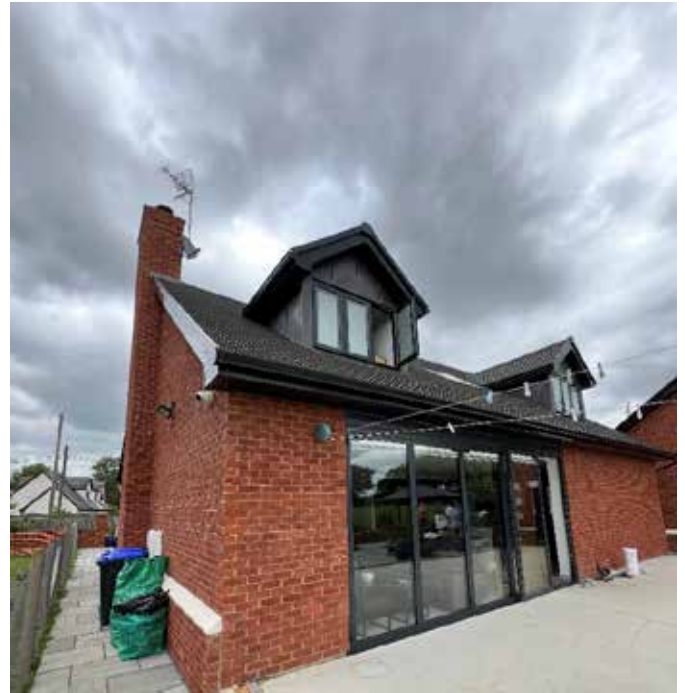
Photos below show Confirmation of sealed eaves and roof tiles to show no opportunity for bats activity

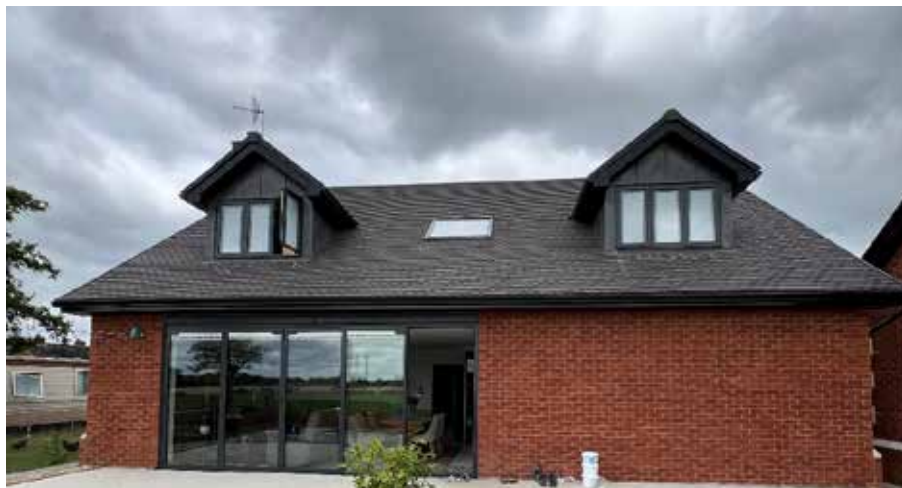
The construction has no gaps and is in very good condition allowing no opportunity for roosts

The eaves and verge detailing is clean and no gaps are present, the walls are brick face work and there is no cladding to the building.

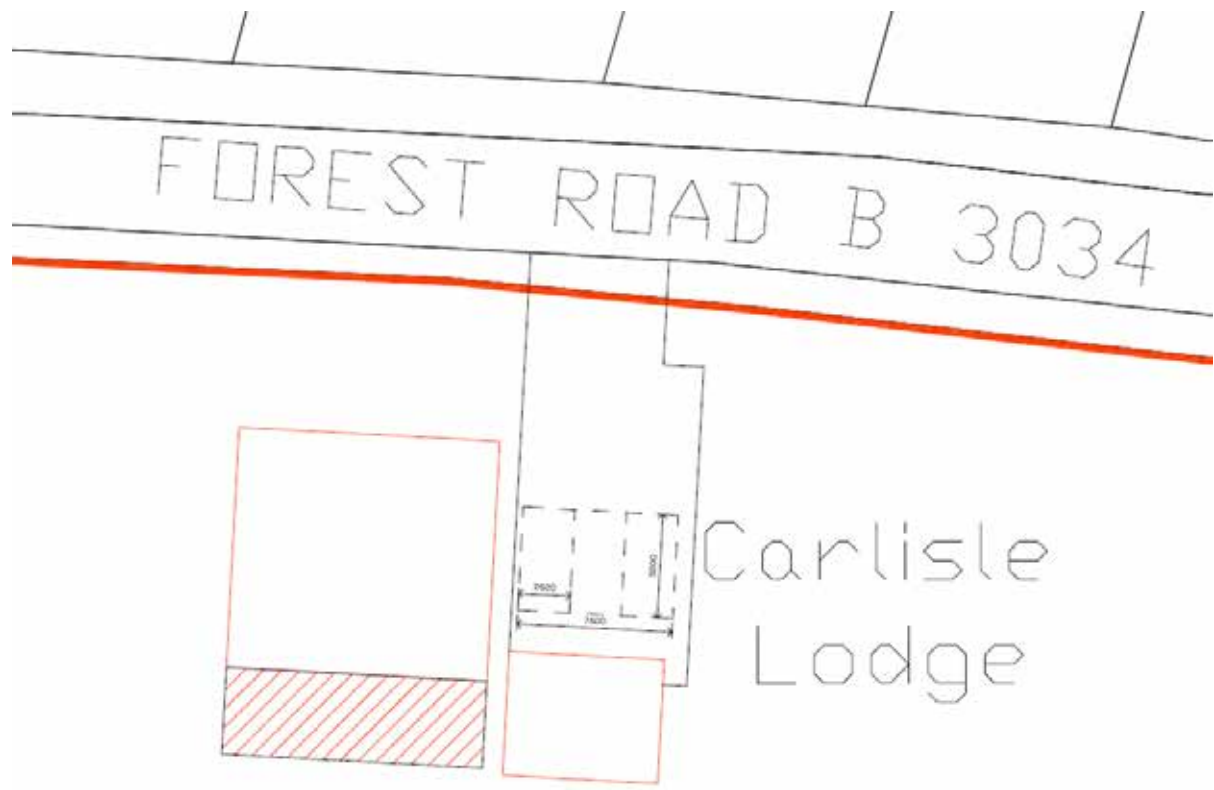
The application relates to a rear extension with no additional bedrooms and with the existing parking arrangements not being affected by the proposals, with a detached double garage and driveway parking as shown below:
