## **PRELIMINARY ECOLOGICAL APPRAISAL (DBW) AT 5 WALDEN AVENUE ARBORFIELD**

**Prepared for:  
Mr B Chikkanna  
5 Walden Avenue  
Arborfield  
Reading  
RG2 9HR**

**6 March 2025**

**Ref: SPH/NP/PEA-25/25.02**

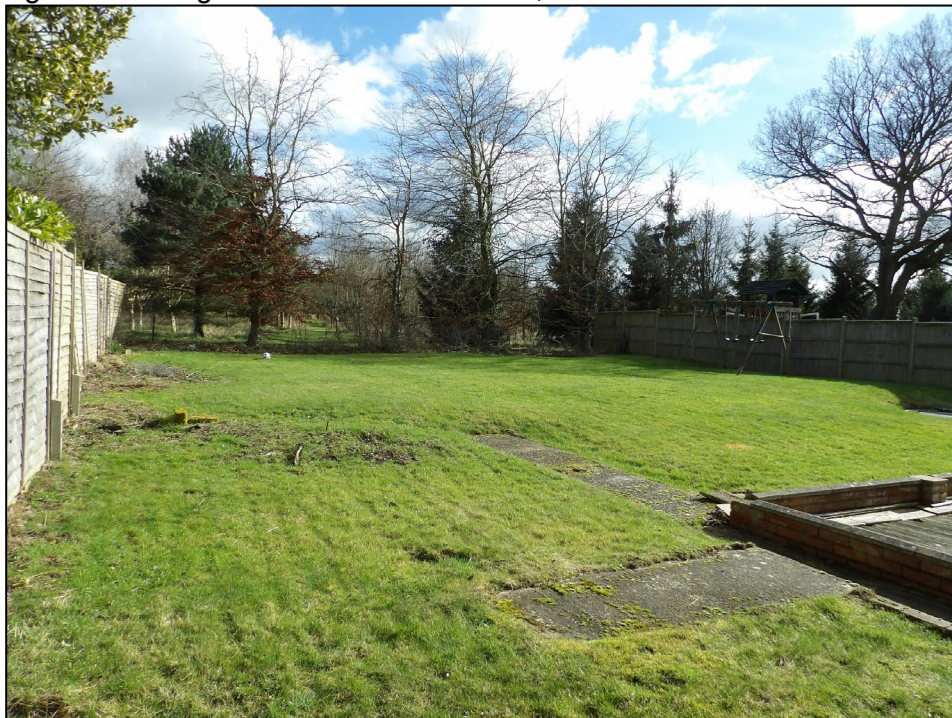
Figure 3. Rear garden. 5 Walden Avenue, Arborfield. 25.02.25

The application site comprises a detached, brick-built and part rendered/painted dwelling with attached garage and detached outbuilding. The remainder of the site comprises a gravelled driveway/parking area, a front garden that is mainly laid to lawn (see cover photograph) and a rear garden, which is mainly laid to lawn with patio area and mature tree mainly on the rear boundary, see Figure 3 below. The site itself offers some foraging and commuting habitat for bats and there is excellent ecological connectivity to the wider landscape.

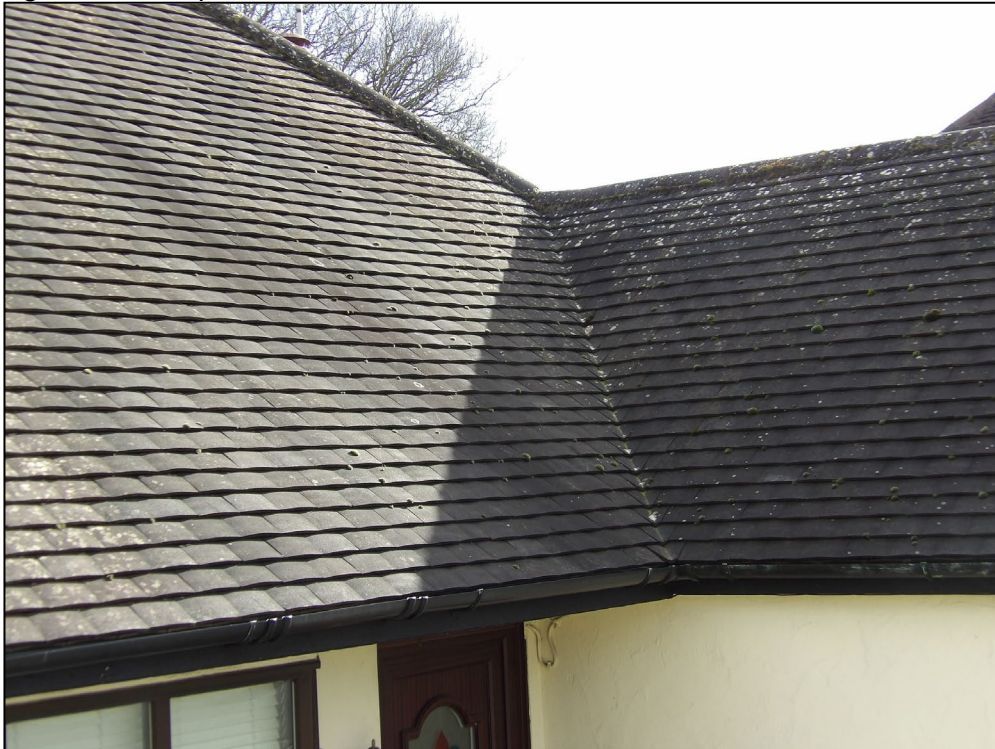
Figure 4. Example roof tiles. 5 Walden Avenue, Arborfield. 25.02.25

The property is a detached, brick-built and part rendered/painted building that is in a good condition externally. The multi pitched roof of the property is covered in tiles, none of which were missing or broken, see Figure 4 on page 9. Despite the roof tiles having a slight convex profile it is not felt that the gaps are large enough to be exploited by crevice dwelling bat species. The ridge and hip tiles all well cemented in with no missing mortar (see Figure 5 on page 9) and the verges and valleys are sealed offering no roosting potential, see Figure 6 on page 10. There are a couple of rear, single storey extension with flat rooves covered in well fitted bitumen felt with no rips or tears that could be exploited by bats, see Figure 7 on page 10. The majority of the wooden fascias are all tightly fitted with no gaps however, there are gaps between the wall plate and fascias on the 2 flat roof extensions which could allow crevice dwelling bat species roosting opportunities or allow bats to climb up and over the wall tops and into the loft space, see Figure 8 on page 11. The lead flashing around both chimney stacks is well fitted with no gaps. On the rear elevation is a dormer window, the roof of which is covered in well fitted tiles with no missing mortar from the ridge tiles and the sides covered in hanging tiles, all of which are well fitted providing no roosting opportunities, see Figure 9 on page 11.

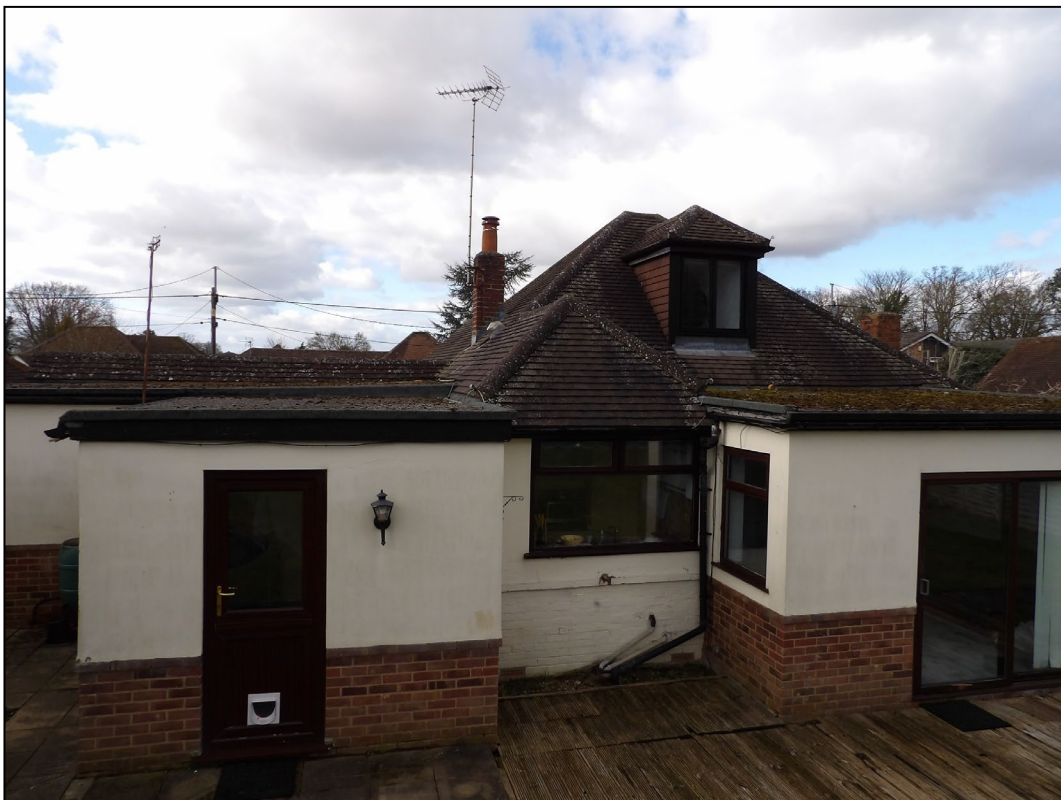
Figure 7. Rear, flat roof extensions. 5 Walden Avenue, Arborfield. 25.02.25

No bats or evidence of bats were recorded externally on the property, garage or outbuilding although there were gaps within the fascias on the flat roof extensions of the property and rear roof of the outbuilding which could provide potential roosting opportunities for bats externally or provide access into the building for roosting bats.

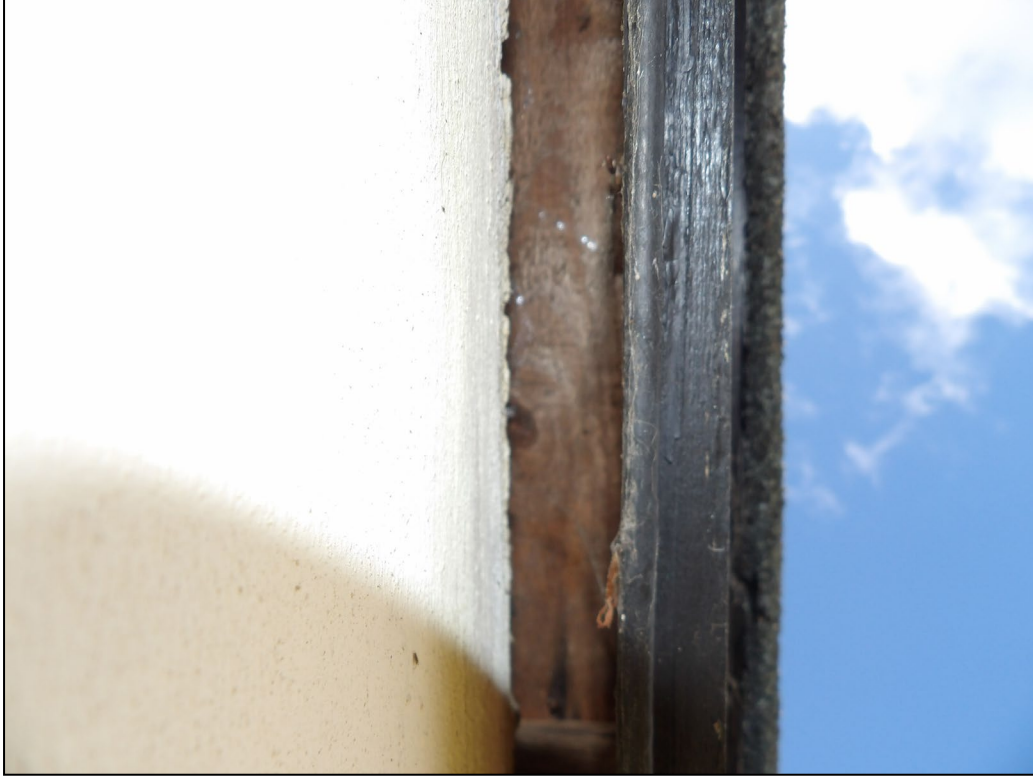
Figure 8. Example gap between fascia and wall plate on rear extensions. 5 Walden Avenue, Arborfield. 25.02.25

No bats or evidence of bats was recorded during the survey. However, there are a small number of gaps within the fascias on the flat roof extensions of the property and rear roof of the outbuilding which provide crevice like features suitable for bats to roost and may provide access into the buildings for bats and the presence or absence of bats could not be determined.

Based on the Bat Workers Manual and the Bat Surveys Good Practice Guidelines, one dusk emergence survey needs to be undertaken on the property and outbuilding, between May and August, in order to establish the presence or absence of roosting bats in these buildings. The features identified will require 2 survey positions all equipped with bat detectors and night vision cameras and 1 survey position equipped with a night vision camera only in order to cover the potential bat roosting features.

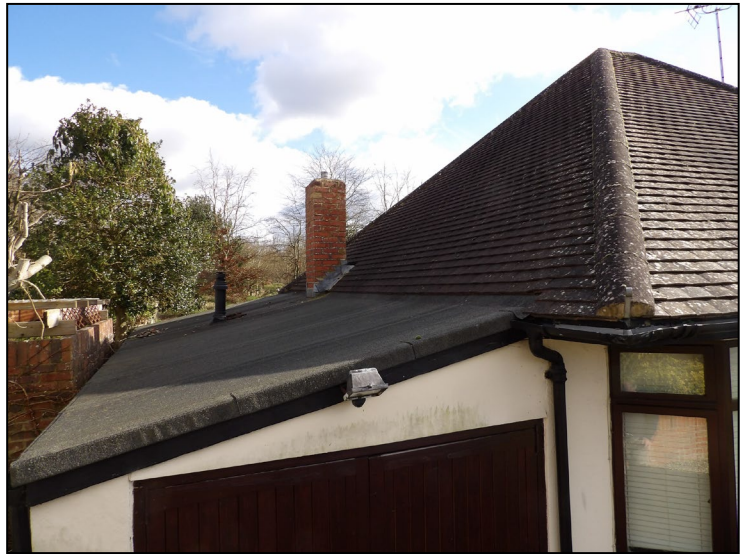
Figure 10. Bitumen covered roof of garage/ensuite. 5 Walden Avenue, Arborfield. 25.02.25

The attached garage/rear ensuite is also constructed of brick that has been rendered and painted and is also in a good condition. Its mono pitched roof is covered in well fitted bitumen felt with no rips or tears or gaps what could be exploited by crevice dwelling bat species, see Figure 10 on page 12.

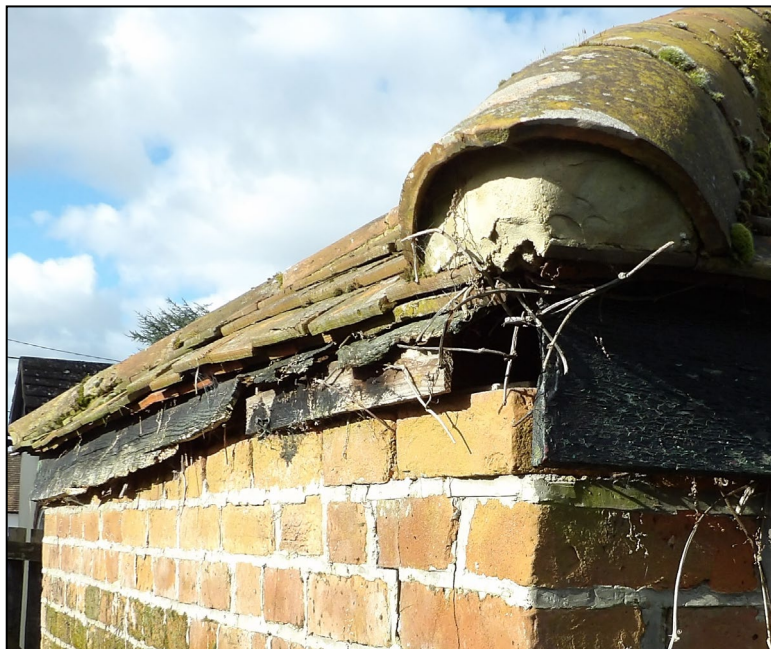
Figure 12. Rear view of moved tiles and rotten fascia on outbuilding. 5 Walden Avenue, Arborfield. 25.02.25

The single storey outbuilding is constructed of bricks with a hipped roof, see Figure 11 on page 12. The majority of the clay roof and ridge tiles are flush with no gaps or missing mortar however, on the bottom of the rear elevation the tiles have moved and the wooden fascia is rotten – these features could be exploited by crevice dwelling bat species, see Figure 12 on page 12.

No bats or evidence of bats was recorded during the internal inspection of the under eaves storage areas or outbuilding however on the outbuilding there are gaps on the rear elevation which could allow bats access into the building.

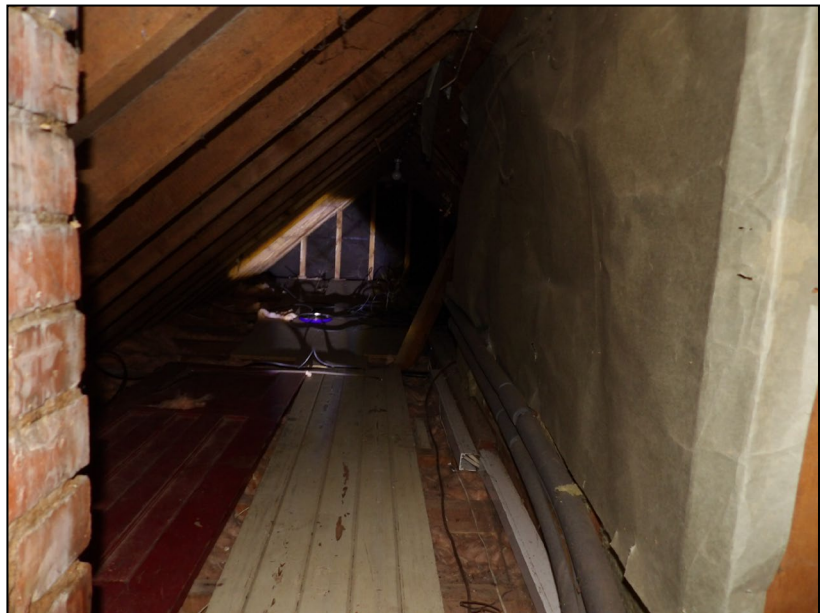
Figure 13. Example under eaves storage area. 5 Walden Avenue, Arborfield. 25.02.25

The majority of the loft space has been converted into habitable accommodation leaving under eaves storage areas which were accessed through doors. The under eaves storage areas are uncluttered, not lit, partially boarded and insulated, see Figure 13 below. The roof tiles are lined with a membrane all of which that could be seen appeared to be tightly fitted and had no rips or tears in which roosting bats could utilise, see Figure 14 below. The garage/ensuite do not have any loft space. The roof of the garage is clad in well fitted timber and the ensuite is plastered and painted and neither have any features in which roosting bats could exploit internally, see Figure 15 on page 14. Internally the outbuildings roof is open to the rafters and the tiles unlined, see Figure 16 on page 14.
