## Bat Emergence and Re-Entry Surveys (BERS) – Interim Report

66 Arbor Lane, Winnersh, Wokingham, Berkshire, RG41 5JD

“complete renovation including new roof of main dwelling”

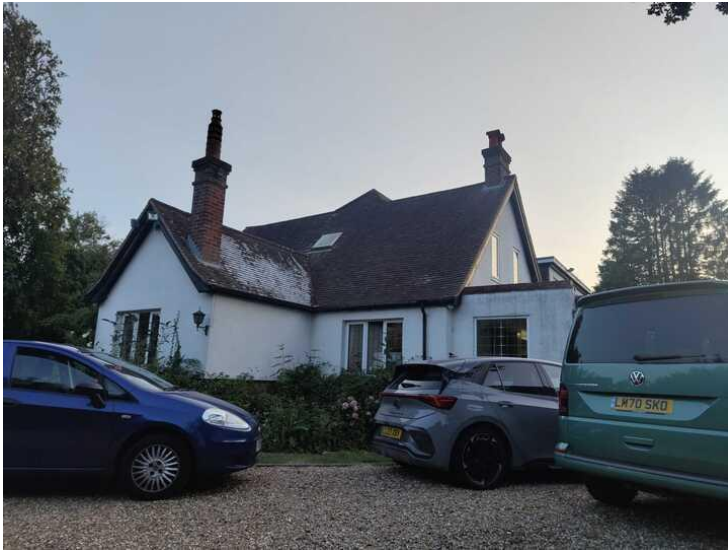
| Roost reference | Species and numbers | Roost type | Structure reference | Roost location | Access point | Dimensions (for lofts/ internal voids) |
|---|---|---|---|---|---|---|
| Surveyor 1 | | <b>No emergences or re-entries observed</b> | | | Full elevation photo showing surveyor's view. | |
| | | <p>Summary of general activity:</p> <p>Species – Soprano pipistrelle, common pipistrelle, noctule</p> <p>Flight paths – NE&lt;&gt;SW to the south-east of B1</p> <p>Foraging areas – No key foraging areas identified</p> <p>Activity began at 21:00 with a soprano pipistrelle heard and seen heading south-west, to the east of B1. Additional passes along this route were heard and seen as follows: a common pipistrelle heading south-west at 21:03, common pipistrelles heading north-east at 21:10, 21:27, 21:28, soprano pipistrelles heading north-east at 21:19 and 21:35. Common and soprano pipistrelle activity was heard not seen throughout the survey, with</p> | | | | |

| | <p>the final soprano pipistrelle activity at 21:59 and the final common pipistrelle activity at 22:13.</p> <p>At 21:07, a bat was seen not heard passing from the east through the garden north of B1, heading north. Based on the size of the individual, and activity recorded by other surveyors around this time, this was likely a soprano pipistrelle.</p> <p>Between 21:14 and 22:08, noctule activity was sporadically heard not seen.</p> | |

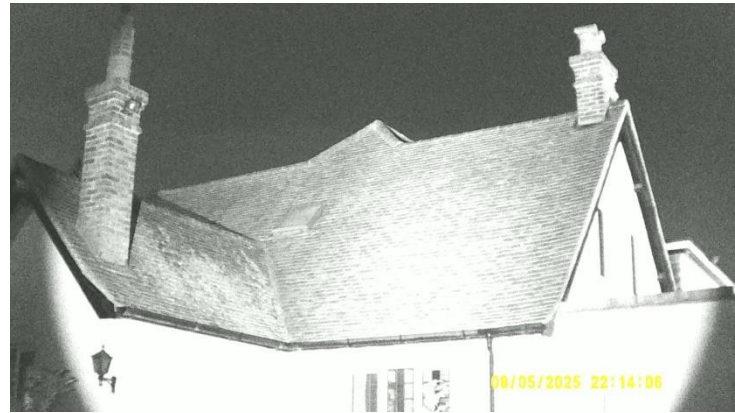
| <p><i>IR position 1</i><br/> <i>One Nightfox Whisker</i><br/> <i>IR camera + one</i><br/> <i>Nightfox XB5 PRO IR</i><br/> <i>torch</i></p> | <p>Camera position: observing the north and east elevations of B1</p> <p>Emergences observed: No</p> <p>No emergences were observed, and the footage was in line with the observations of surveyor 1 with no additional activity.</p> | <p>Screenshot of darkest part of survey.</p> |

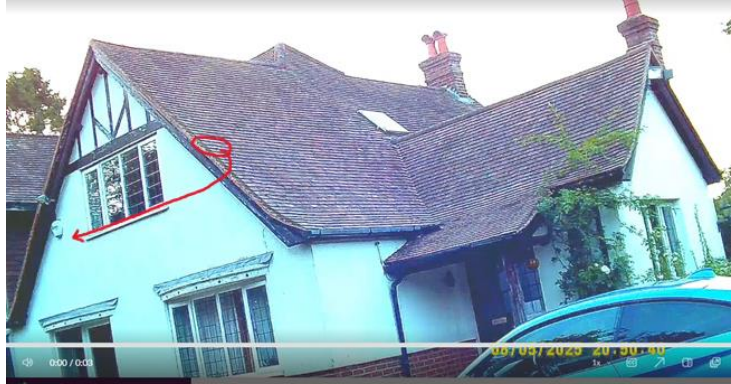
| <p><i>Surveyor 2</i></p> | <p><b>Emergence observed -</b><br/> <b><u>Soprano pipistrelle roost 1:</u></b><br/> <b>Number: 1</b><br/> <b>Time(s): 20:49</b><br/> <b>Location of access point(s):</b> Lifted tile on the east elevation of B1<br/> <b>Direction(s) of travel on emergence:</b> South</p> | <p>Full elevation photo showing surveyor's view.<br/> Emergence point marked on image.</p> |

| | <p>Species ID confirmed on site</p> <p>Summary of general activity:<br/> Species – Common pipistrelle, soprano pipistrelle, noctule, myotis sp.<br/> Flight paths – NE&lt;&gt;SW to the south-east of B1<br/> Foraging areas – Garden to the south of B1</p> <p>The first bat activity recorded was a soprano pipistrelle which <b>emerged from beneath a lifted tile on the eastern elevation at 20:49.</b></p> <p>Frequent soprano pipistrelle and common pipistrelle foraging and commuting activity was observed for the remainder of the survey, with flight lines north-east to south-west across the southeastern elevation, and foraging taking place in the garden to the south of B1.</p> <p>Noctule activity was distantly heard not seen at 21:39 and then sporadically heard not seen for the remainder of the survey.</p> <p>Myotis sp. activity was heard not seen at 22:04 and 22:13.</p> | |

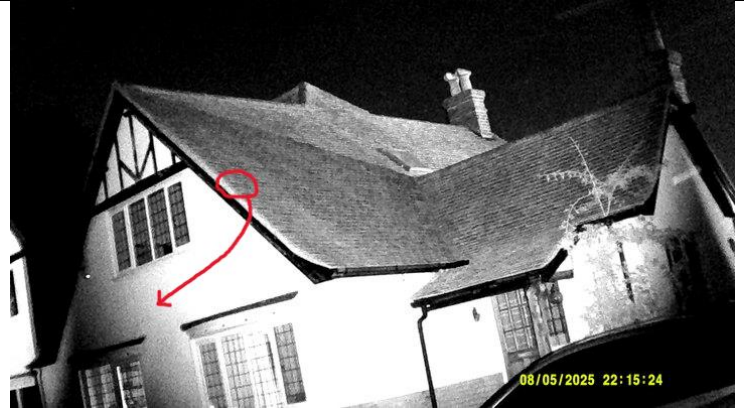
| <p><i>IR position 2</i><br/> <i>One Nightfox Whisker</i><br/> <i>IR camera + one</i><br/> <i>Nightfox XB5 PRO IR</i><br/> <i>torch</i></p> | <p>Camera position: observing south and east elevations of B1</p> <p>Emergences observed: Yes</p> <p><b><u>Soprano pipistrelle roost 1:</u></b></p> | <p>Screenshot of darkest part of survey. Emergence point marked on image.</p> |

| | <p><b>Number of emergences:</b> 1</p> <p><b>Time(s):</b> 20:49</p> <p><b>Location of access point(s):</b> Lifted tile on the east elevation of B1</p> <p><b>Direction(s) of travel on emergence:</b> South</p> <p>Species ID confirmed on site</p> <p>The emergence observed by surveyor 2 was confirmed, and all other footage was in line with the observations of surveyor 2 with no additional activity.</p> | <p>08/05/2025 22:15:24</p> |

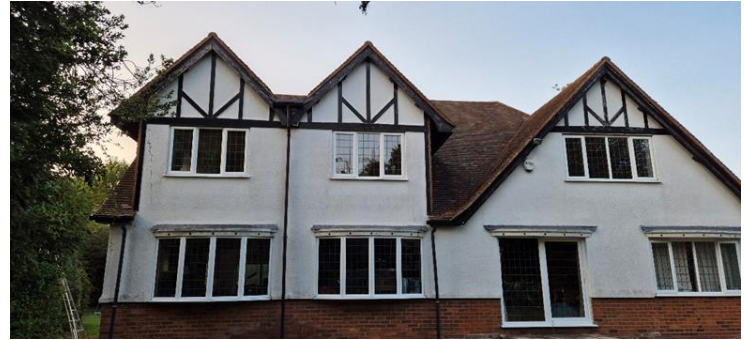
| Surveyor 3 | <p><b>No emergences or re-entries observed</b></p> <p>Summary of general activity:</p> <p>Species – Common pipistrelle, soprano pipistrelle, myotis sp.</p> <p>Flight paths – NE&lt;&gt;SW to the south-east of B1, N&lt;&gt;S to the west of B1</p> <p>Foraging areas – No key foraging areas identified</p> <p>Activity began at 21:02, with a soprano pipistrelle heard and seen passing east to west to the south of B1. At 21:27 a soprano pipistrelle was heard and seen heading north along the west elevation of B1. At 21:27 and 21:29, soprano pipistrelles were heard and seen passing to the south-east of B1, heading both north-east and south-west. Soprano pipistrelle activity was also heard not seen frequently between 21:03 and 22:03.</p> | <p>Full elevation photo showing surveyor's view.</p> |

| | <p>At 21:36 a common pipistrelle was heard and seen passing west over B1. Common pipistrelle activity was heard not seen between 21:16 and 21:55.</p> <p>At 22:03 a myotis sp. bat was heard not seen. At 22:12, a myotis sp. bat was heard and seen passing along the tree line to the south of the site, heading west.</p> | |

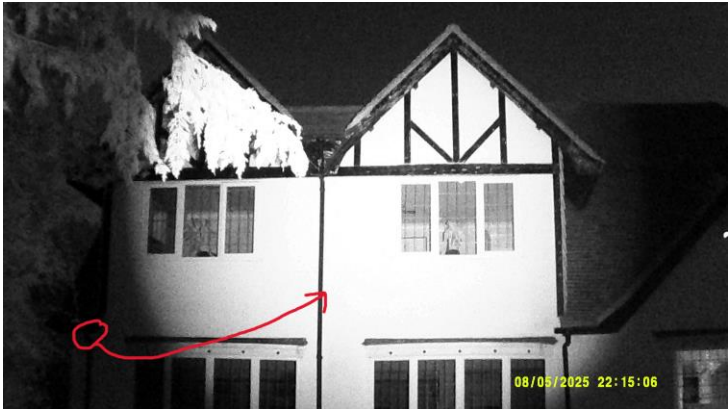
| <p><i>IR position 3</i><br/> <i>One Nightfox Whisker</i><br/> <i>IR camera + one</i><br/> <i>Nightfox XB5 PRO IR</i><br/> <i>torch</i></p> | <p>Camera position: observing the south elevation of B1<br/> Emergences observed: Yes</p> <p><b>Emergences observed -</b><br/> <b><u>Soprano pipistrelle roost 2:</u></b><br/> <b>Number of emergences:</b> 1<br/> <b>Time(s):</b> 21:04<br/> <b>Location of access point(s):</b> gap under lifted tile on the west end of south facing elevation<br/> <b>Direction(s) of travel on emergence:</b> East</p> <p>The surveyor did not observe the emergence, and the emergence was confirmed in IR review. This emergence lines up with soprano pipistrelle calls heard not seen by the surveyor. No other species calls were observed at this time, and therefore the individual was determined to be a soprano pipistrelle.</p> <p>Additional foraging by common and soprano pipistrelles was observed in the garden to the south of B1, between 21:14 and 21:44, in line with surveyor heard not seen observations.</p> | <p>Screenshot of darkest part of survey. Emergence point marked on image.</p> |

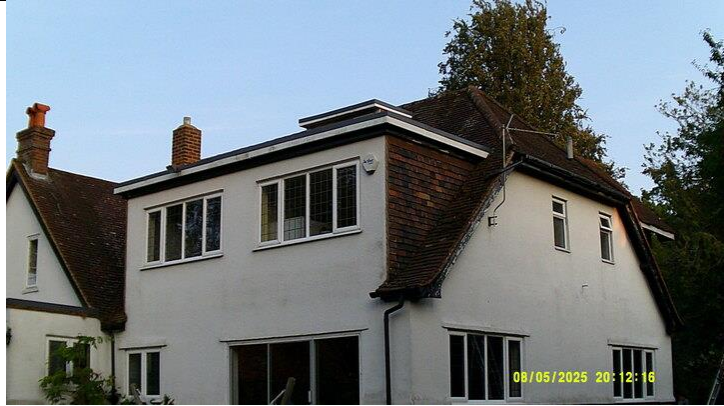
| Surveyor 4 | <b>No emergences or re-entries observed</b> | Full elevation photo showing surveyor's view. |

| | <p>Summary of general activity:<br/> Species – Common pipistrelle, soprano pipistrelle, noctule<br/> Flight paths – Along the west elevation of B1<br/> Foraging areas – Along the west elevation of B1</p> <p>Activity began at 20:49 with a soprano pipistrelle heard and seen passing north along the west elevation of B1. Between 20:57 and 21:34, frequent foraging by both common and soprano pipistrelle was heard and seen to the west and north-west of B1. Common and soprano pipistrelle activity was heard not seen between 21:00 and 21:48.</p> <p>Noctule activity was heard not seen at 21:14, 21:21 and 21:23. At 21:33 a noctule was heard and seen passing along the west boundary of the site, heading south.</p> | |

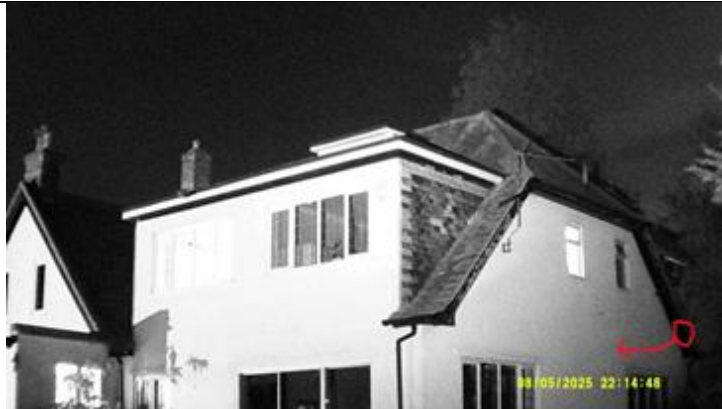
| <p><i>IR position 4</i><br/> <i>One Nightfox Whisker</i><br/> <i>IR camera + one</i><br/> <i>Nightfox XB5 PRO IR</i><br/> <i>torch</i></p> | <p>Camera position: observing the north and west elevations of B1<br/> Emergences observed: Yes</p> <p><b>Emergences observed -</b><br/> <b>Soprano pipistrelle roost 2:</b><br/> <b>Number of emergences:</b> 2<br/> <b>Time(s):</b> 21:06, 21:17<br/> <b>Location of access point(s):</b> gap under lifted tiles on the west end of south facing elevation<br/> <b>Direction(s) of travel on emergence:</b> North</p> | <p>Screenshot of darkest part of survey. Emergence point marked on image.</p> |

| | <p>The surveyor did not observe the emergence, and the emergence was confirmed in IR review. The first emergence lines up with soprano pipistrelle passes observed by surveyor 4, allowing the individual to be identified. No calls were recorded at the time of the second emergence, however the bat was determined to be a soprano pipistrelle based on size, species of previous emergences, and high level of soprano pipistrelle activity on site.</p> <p>All other footage was in line with the observations of surveyor 4 with no additional activity.</p> | | | | |

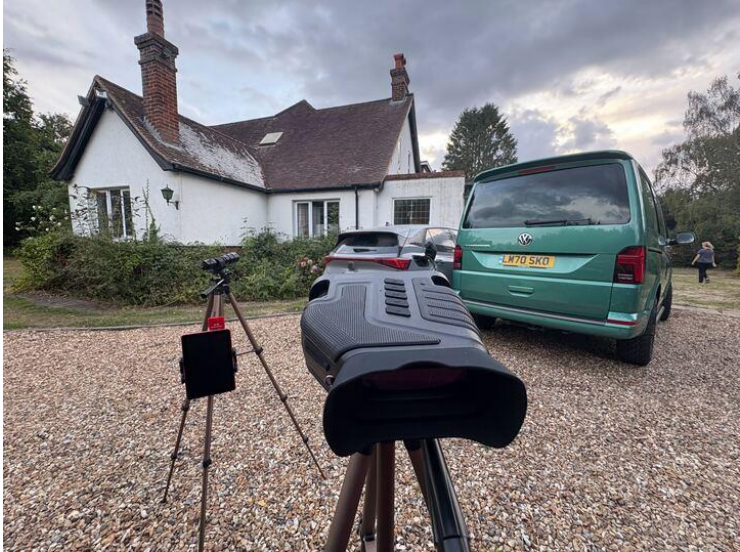
| Results | | |
|---|---|---|
| Surveyor 1 | <p><b>No emergencies or re-entries observed</b></p> <p>Summary of general activity:<br/> Species – Common pipistrelle, soprano pipistrelle, noctule<br/> Flight paths – No key flight lines identified<br/> Foraging areas – No key foraging areas identified</p> <p>The first bat activity recorded was a noctule heard not seen at 20.21. Further noctule activity was heard not seen at 20.22 and 20.31.</p> <p>At 20:43, a common pipistrelle was heard and seen passing to the east of B1, heading north. At 21:01 a common pipistrelle was heard and seen passing from the east, then heading north. Common pipistrelle activity was heard not seen sporadically between 20:34 and 21:26.</p> <p>Soprano pipistrelle activity was heard not seen sporadically between 20:58 and 21:31.</p> | <p>Full elevation photo showing surveyor's view.</p> |

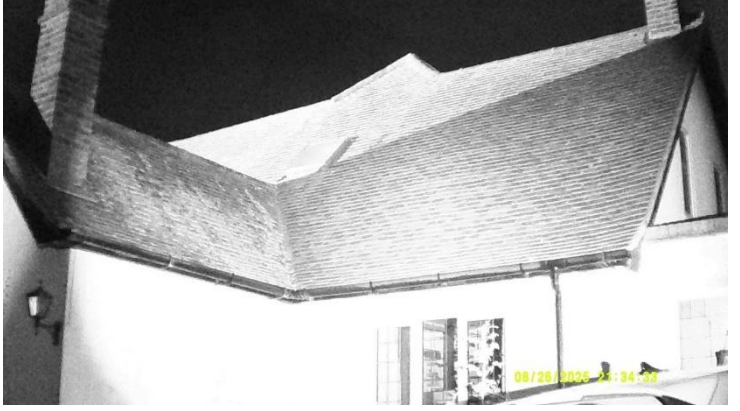
| Results | | |
|---|---|---|
| <i>IR position 1</i><br><i>One Nightfox Whisker</i><br><i>IR camera + one</i> | <p>Camera position: observing the north and east elevations of B1</p> <p>Emergences observed: No</p> | <p>Screenshot of darkest part of survey.</p> |

| <i>Nightfox XB5 PRO IR torch</i> | <p>No emergencies were observed, and the footage was in line with the observations of surveyor 1 with no additional activity.</p> | |

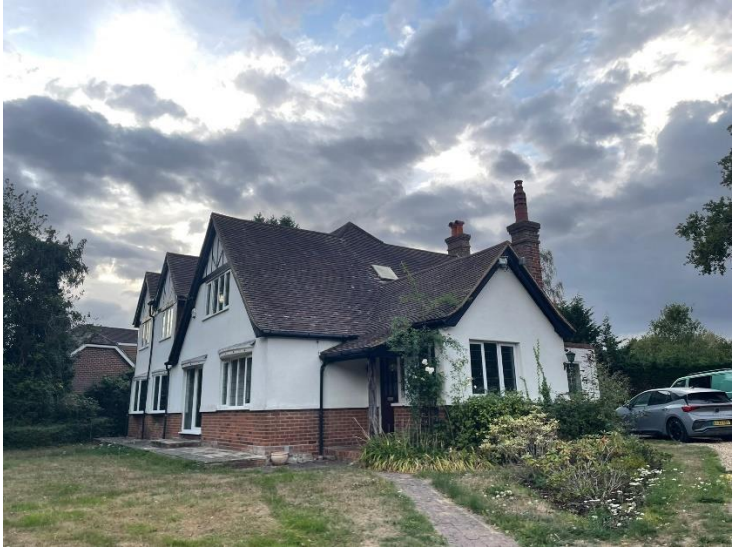
| <i>Surveyor 2</i> | <p><b>No emergencies or re-entries observed</b></p> <p>Summary of general activity:<br/> Species – Common pipistrelle, soprano pipistrelle, noctule<br/> Flight paths – No key flight paths identified<br/> Foraging areas – No key foraging areas identified</p> <p>Activity began with noctule calls heard not seen at 20:20 and 20:21. Further noctule activity was heard not seen at 20:30, 20:35, and 21:04.</p> <p>At 20:44, a bat was seen not heard passing to the south of B1, heading west.</p> <p>Common pipistrelle activity was heard not seen frequently between 20:26 and 21:31.</p> | <p>Full elevation photo showing surveyor's view.</p> |

| | Soprano pipistrelle activity was heard not seen sporadically between 20:57 and 21:33. | |

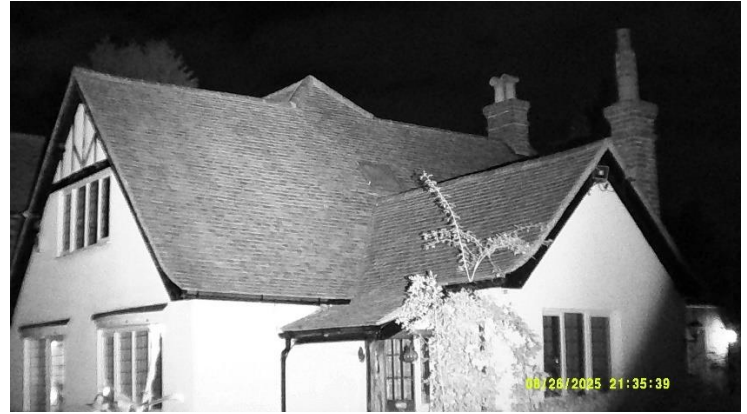
| <i>IR position 2</i><br><i>One Nightfox Whisker</i><br><i>IR camera + one</i><br><i>Nightfox XB5 PRO IR</i><br><i>torch</i> | Camera position: observing south and east elevations of B1<br>Emergences observed: No<br>No emergences were observed, and the footage was in line with the observations of surveyor 2 with no additional activity. | Screenshot of darkest part of survey.<br> |

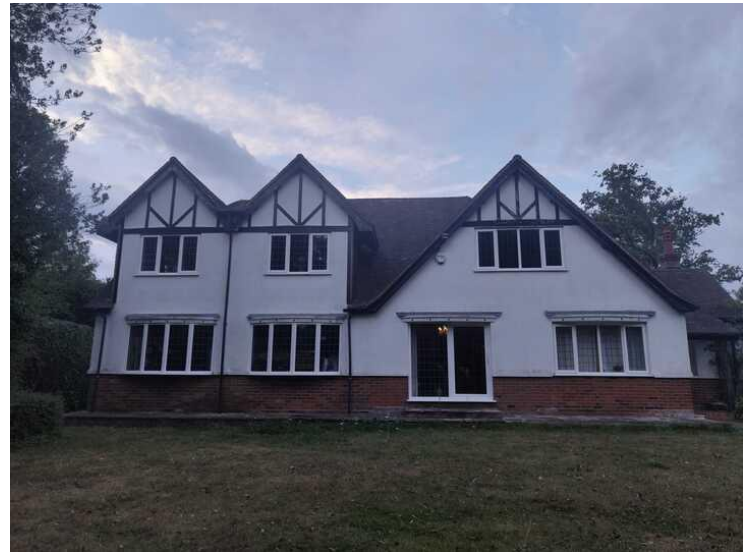
| Surveyor 3 | <b>No emergences or re-entries observed</b><br><br>Summary of general activity:<br>Species – Common pipistrelle, soprano pipistrelle, noctule<br>Flight paths – Along the west elevation of B1<br>Foraging areas – Along the west elevation of B1<br><br>Activity began at 20:21 with a noctule heard not seen. Further noctule activity was heard not seen at 20:31 and 21:05.<br><br>At 20:23 and 20:25, common pipistrelles were heard and seen passing along the west elevation of B1, heading north. At 20:27, a common pipistrelle was heard and | Full elevation photo showing surveyor's view.<br> |

| | <p>seen passing west to south. At 20:31, a common pipistrelle was heard and seen passing west through the garden to the south of B1. Common pipistrelle foraging was heard and seen frequently between 20:28 and 20:59, utilising the hedge to the west of B1. Common pipistrelle activity was heard not seen sporadically between 20:50 and 21:26.</p> <p>Soprano pipistrelle activity was heard not seen sporadically between 20:46 and 21:32.</p> | |

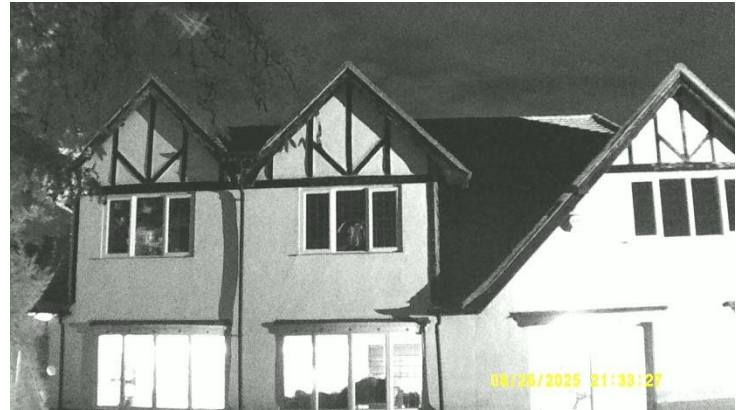
| <p><i>IR position 3</i><br/> <i>One Nightfox Whisker</i><br/> <i>IR camera + one</i><br/> <i>Nightfox XB5 PRO IR</i><br/> <i>torch</i></p> | <p>Camera position: observing the south elevation of B1</p> <p>Emergences observed: No</p> <p>No emergences were observed, and the footage was in line with the observations of surveyor 3 with no additional activity.</p> | <p>Screenshot of darkest part of survey.</p> |

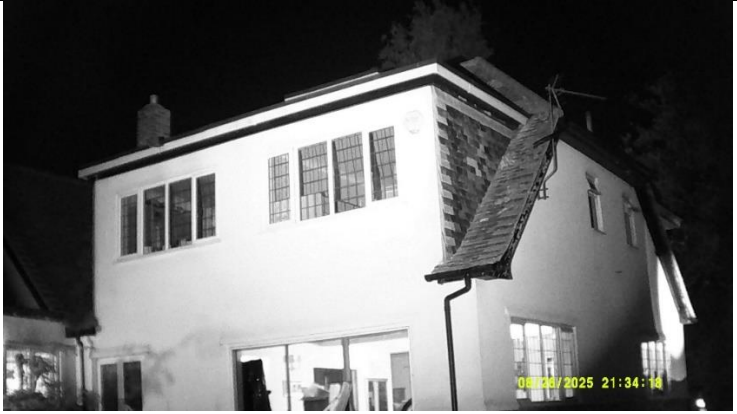
| <i>IR position 4</i><br><i>One Nightfox Whisker</i><br><i>IR camera + one</i><br><i>Nightfox XB5 PRO IR</i><br><i>torch</i> | <p>Camera position: observing the north and west elevations of B1</p> <p>Emergences observed: No</p> | <p>Screenshot of darkest part of survey.</p> |

| | No emergencies were observed, and the footage was in line with the observations of surveyor 4 with no additional activity. | |

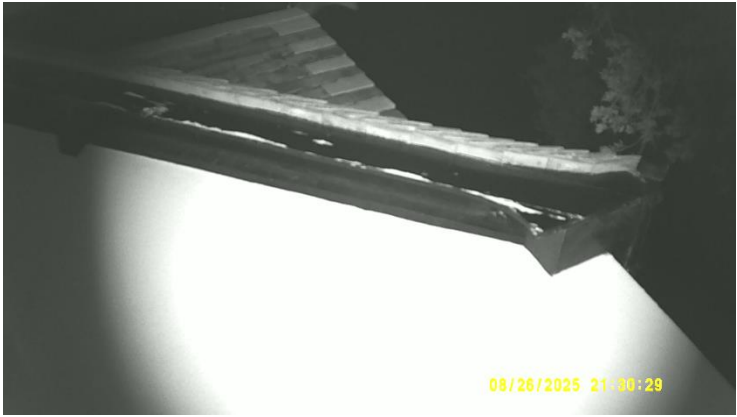
| <i>Position 5 – Unmanned IR<br/>One Nightfox Whisker IR camera + one Nightfox XB5 PRO IR torch</i> | Camera position: observing the south-west corner of B1<br>Emergences observed: No<br>No activity observed. | <p>Screenshot of darkest part of survey.</p> |
