**Glebelands House  
Woolf Drive  
Wokingham  
Berkshire  
RG40 1DU**

## **Preliminary Roost Assessment**

**Report ref.: R2837\_PRA\_a**

**February 2025**

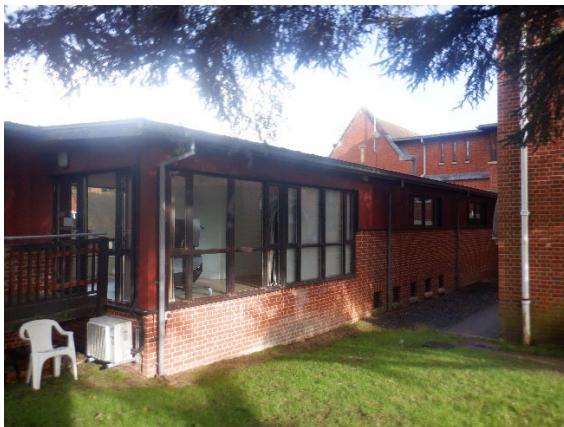
**5.2.2** The building had a flat roof with an additional sloped roof on the north western side, with a part pitched roof and part flat roof attached to the north eastern end and a pitched roof attached to the south western end (**Photographs 1 - 4**).

*Photograph 1. South eastern side of the building.*

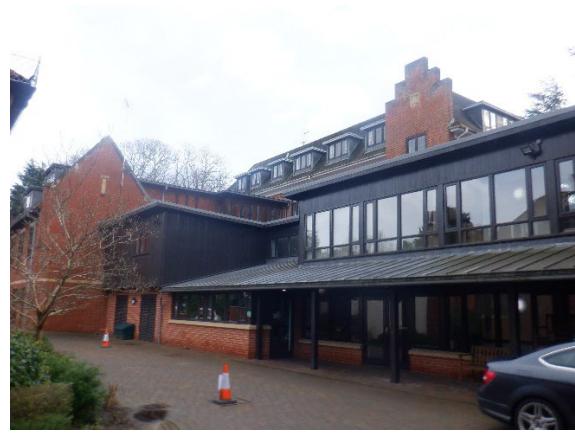
*Photograph 2. North western side of the building with a single storey sloped roof.*

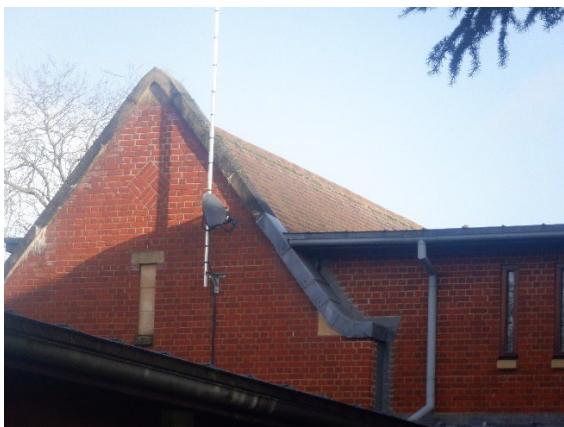
*Photograph 3. Part pitched and flat roof attached to the north eastern end of the building.*

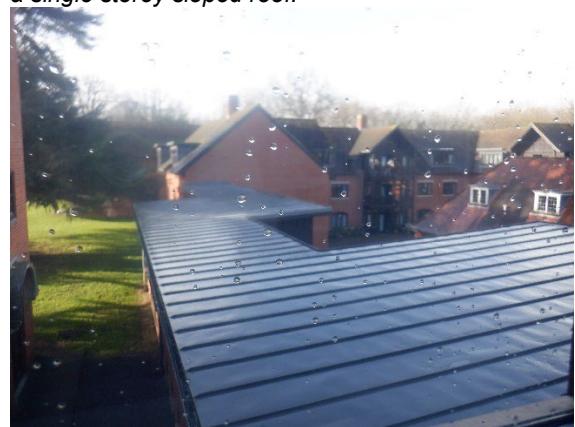
*Photograph 4. Pitched roof attached to the south western end of the building.*

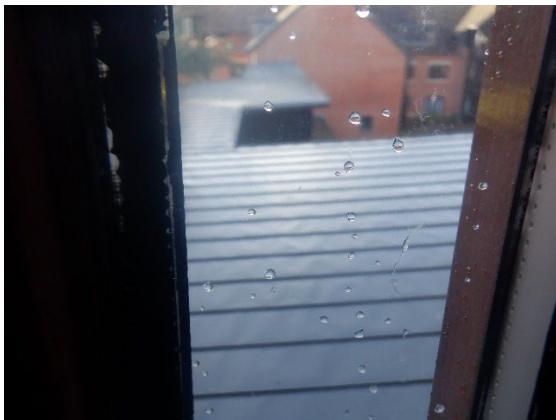
**5.2.3** The main roof flat roof of the building was covered with metal sheets which were tightly fitted (**Photographs 5 & 6**). Overhanging timber soffits were present along the eaves which had narrow gaps where they joined the timber clad walls, which were considered unsuitable for use by roosting bats (**Photograph 7; Target note 1**). A gap was present on the south eastern side of the roof where the building joined the brick wall of the adjoining building to the south (**Photograph 8; Target note 2**). On close inspection with an endoscope the gap was noted to have a sheet of plastic between the timber and

*Photograph 5. Metal sheets tight on the roof.*

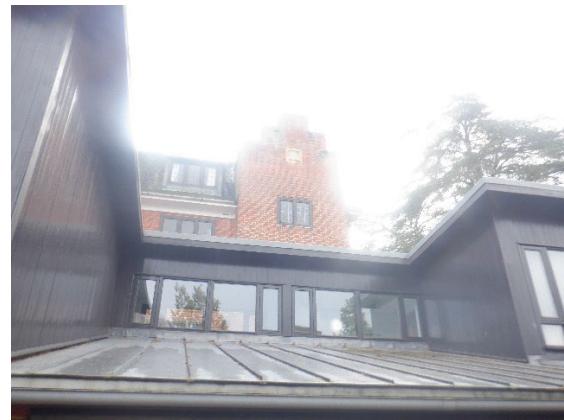
*Photograph 6. Gaps beneath the timber soffits (north western elevation)*

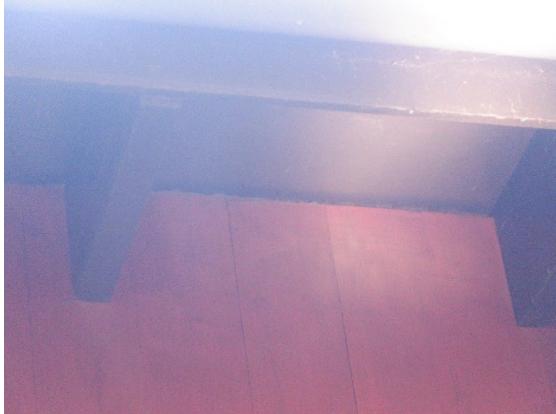
*Photograph 7. Gaps beneath the timber soffits (south eastern elevation).*

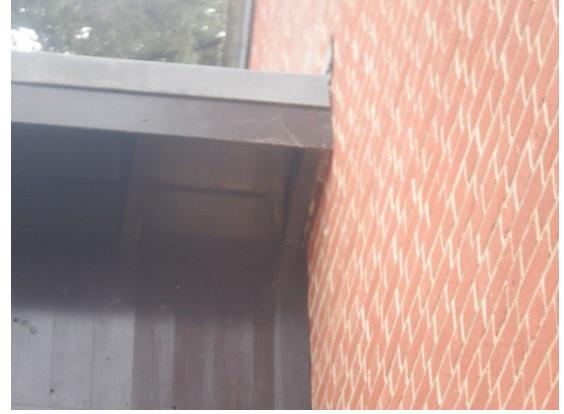
*Photograph 8. Gap at edge of the roof between the roof and adjacent wall (north western elevation).*

- a gap between the timbers of the flat roof and brick wall at the south western end of the roof (**Photograph 8; Target note 2**).

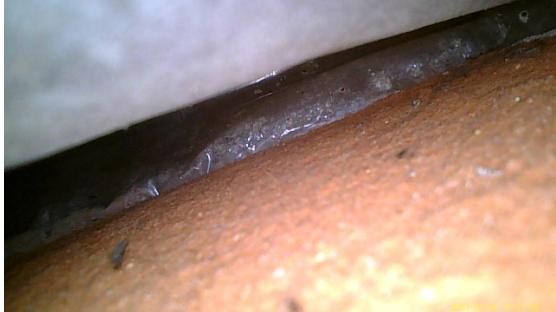
brick wall and it was lightly cobwebbed with no evidence of use by bats (**Photograph 9**).

*Photograph 9. Gap with plastic visible inside and no evidence of bats.*

6.1.5 The endoscopic inspection of the gap between the timber and brick wall showed no evidence of use by bats, therefore the presence of crevice-dwelling bats is considered to be highly unlikely within the flat roof section of the property.

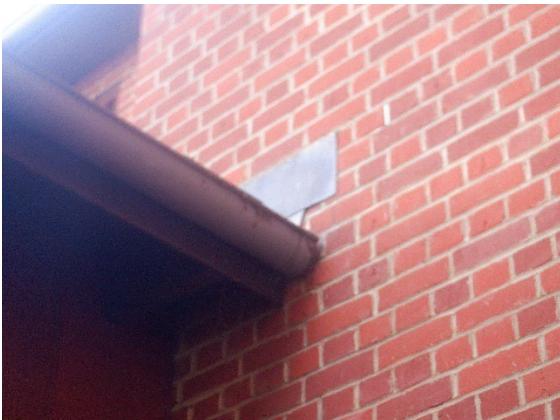
**5.2.4** The lead flashing was tight around the roof junctions (**Photograph 10**). A gap was present at the base of the timber soffit box beneath the timber clad wall on the north western elevation, which was unsuitable for use by roosting bats (**Photograph 11; Target note 3**).

*Photograph 10. Lead flashing tight to the wall at the eastern end of the building (south eastern elevation).*

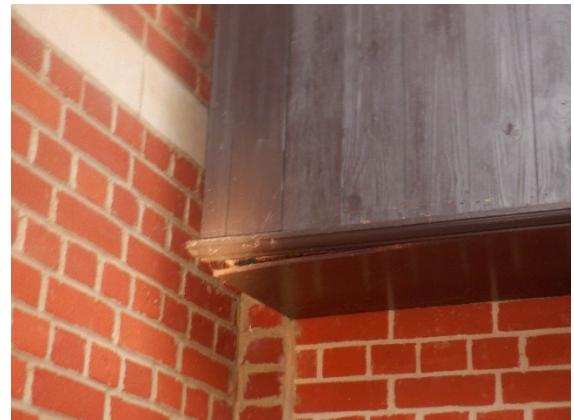
*Photograph 11. Gap at base of timber soffits (north western elevation).*

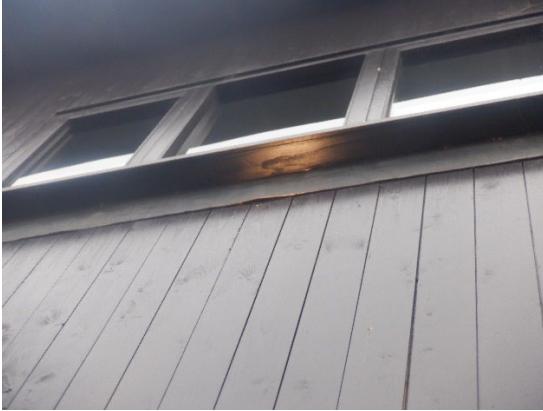
**5.2.5** The lead flashing beneath the windows had some gaps of limited extent which were filled with cobwebs (**Photograph 12; Target note 4**).

*Photograph 12. Small gap behind lead flashing beneath a window (north western elevation).*

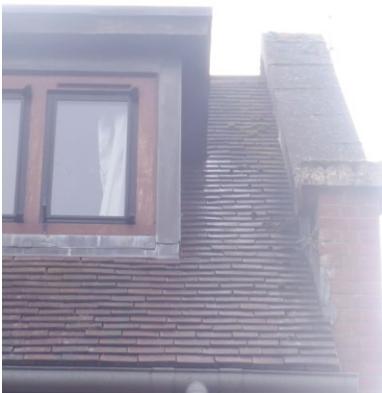
**5.2.6** The pitched roof attached to the north eastern end of the building was tight with flat clay roof tiles and concrete tiles around the top of the gable end wall (**Photograph 13**). Lead flashing was also tight around the edge of the pitched roof below the tightly fitted flat metal-lined roof (**Photograph 14**). The flat roof and adjoining roof of the main house to the east were tightly fitted with painted soffits (**Photograph 15**).

*Photograph 13. Tight roof tiles and concrete around the gable end wall at the northern eastern end of the building (north western elevation).*

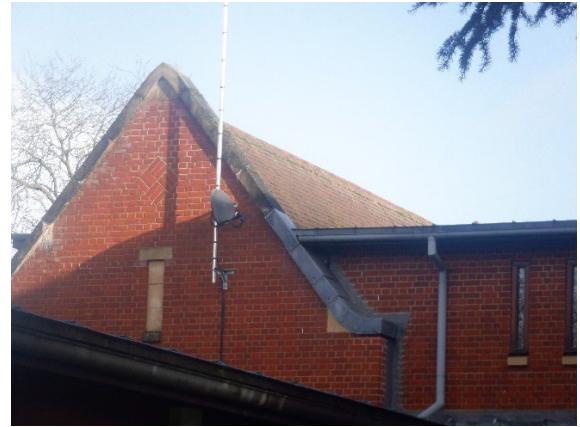
*Photograph 14. Concrete tile ends and lead flashing on the gable end and flat metal roof all tight.*

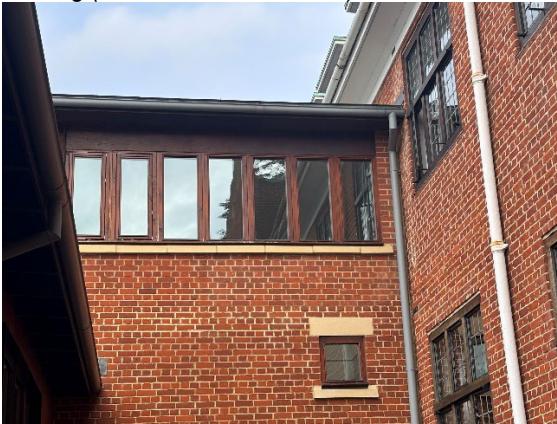
*Photograph 15. Flat roof and adjoining roof of the main house tightly fitted with painted soffits.*

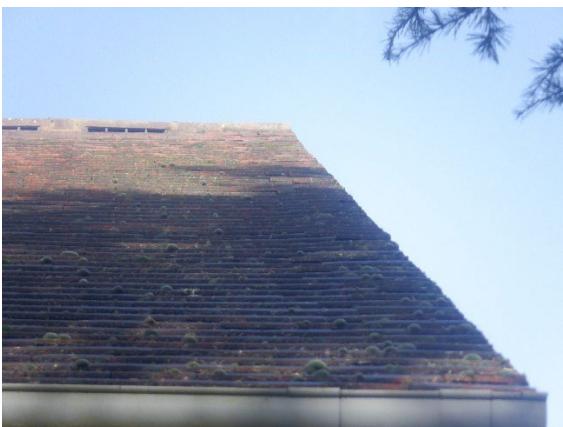
**5.2.7** The pitched roof attached to the south western end of the building had a few lifted roof tiles towards the verge (**Photograph 16; Target note 5**). The tile ends were fully mortared at the north eastern end of the roof and the timber fascias were tight to the wall (**Photograph 17**).

*Photograph 16. Roof tiles lifted towards the verge on the pitched roof attached to the south western end of the flat roof building (south eastern elevation).*

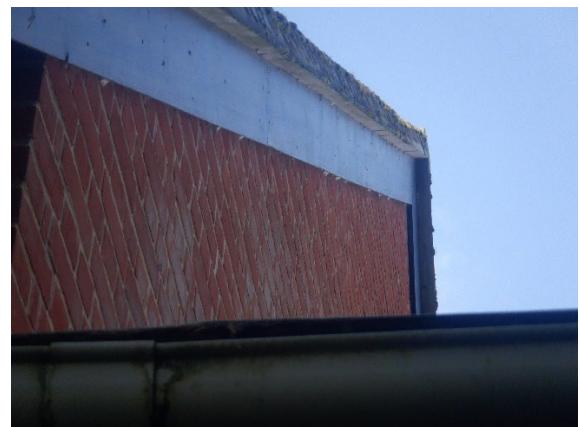
*Photograph 17. Verge mortared and timber fascias tight to the wall attached to the south western end of the flat roof building.*

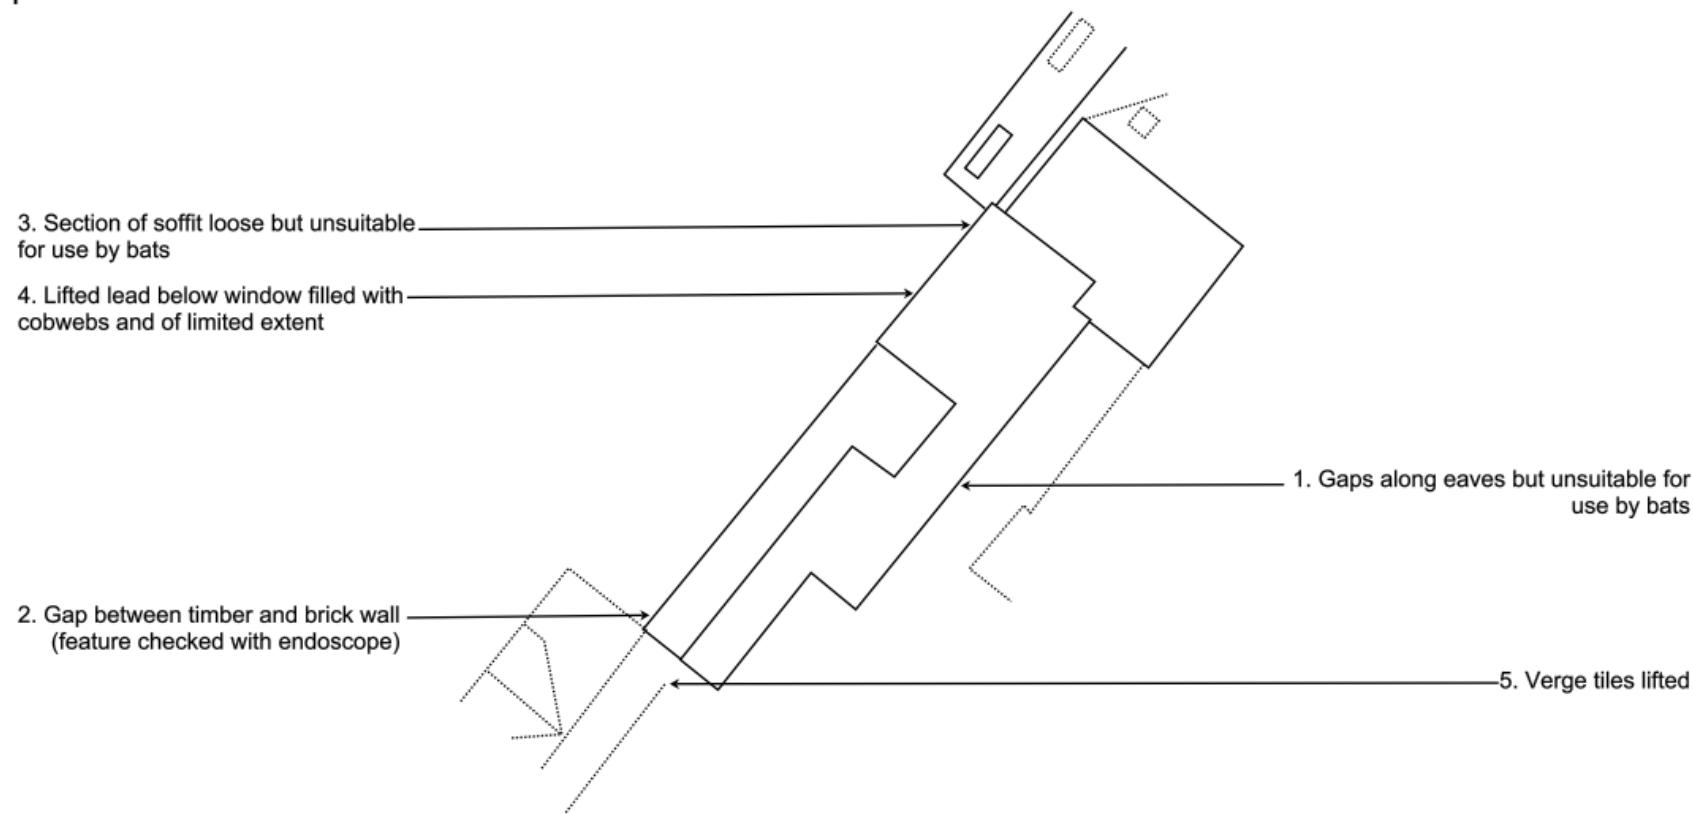
Drawn by:	Date	Scale:	Glebelands House Wokingham Preliminary Bat Roost Assessment Findings	<b>JOHN WENMAN</b> ecological consultancy
VP	Jan 2025	Not to scale

**5.2.1** The findings from the external and internal inspections carried out for the care home are described with photographs and annotated in a plan, as follows:
