## EXTENDED PHASE 1 ECOLOGICAL ASSESSMENT

BIRD PLACE, HENLEY BRIDGE, HENLEY-ON-THAMES, BERKSHIRE, RG9 2LN

FINAL REPORT

June 2025

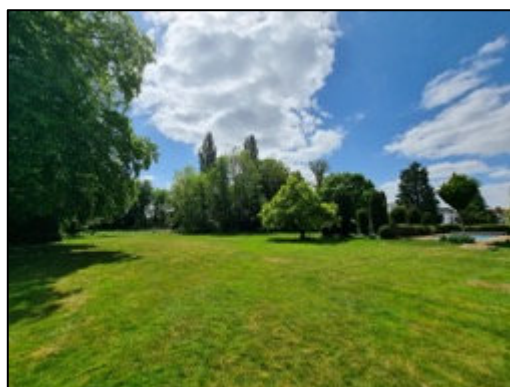
Most of the grassland on site consists of a well-managed lawn located to the south of the buildings, in the centre of the site (Figures 1 and 2). A typical 1x1m quadrat area of the grassland included, perennial rye-grass *Lolium perenne*, Yorkshire fog *Holcus lanatus*, germander speedwell *Veronica chamaedrys* and field wood-rush *Luzula campestris*.

**Figure 1** – Grassland in the centre of the site.

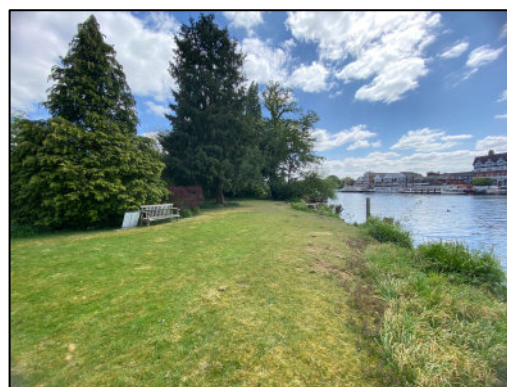
**Figure 2** – Grassland along the western boundary of the site.

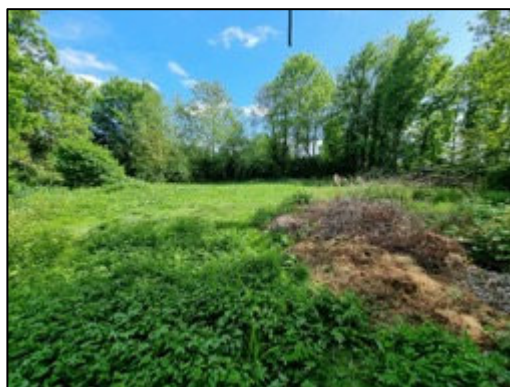
Beyond the stream in the southern tip of the site, the grassland is less frequently managed and contains greater species diversity within the sward (Figures 3 and 4). A typical 1x1m quadrat area of this grassland included, perennial rye-grass, red fescue *Festuca rubra*, Yorkshire fog, creeping buttercup, broad-leaved dock *Rumex obtusifolius*, yarrow, thistle sp. and cinquefoil sp *Potentilla* sp.

**Figure 3** – Southern grassland on site with brash and compost pile present.

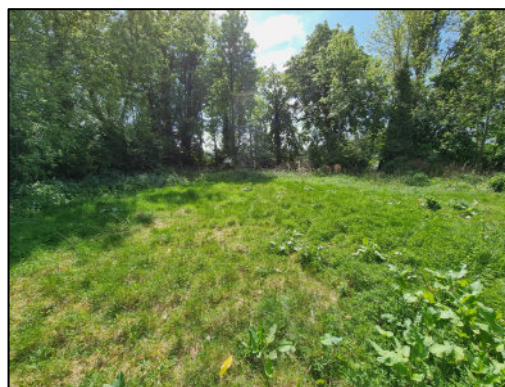
**Figure 4** – Southern grassland on site.

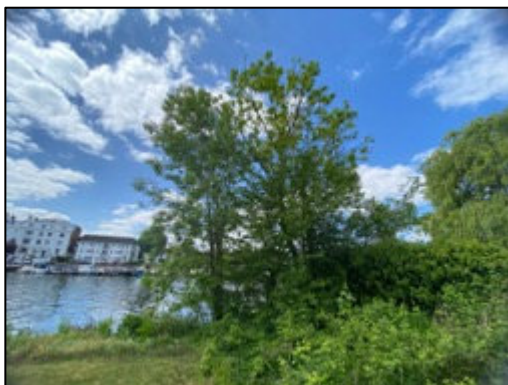
A small cluster of trees, likely self-seeded, have emerged at the end of the boat ramp in the north-western corner of the site where they overhang the river (Figure 7). The trees noted in this group included ash, sycamore, hazel and elm sp. *Ulmus sp.*

**Figure 7** – North-western group of trees on-site.

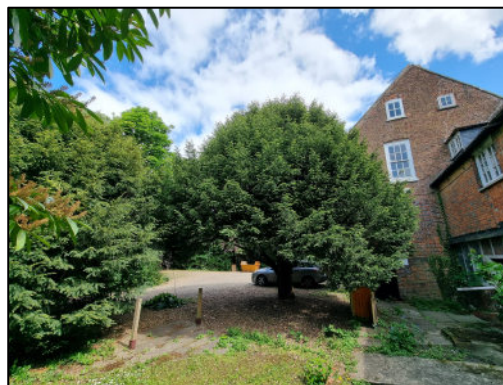
A single yew tree is located to the north of the house and is anticipated to be removed as a part of the proposals (Figure 8).

**Figure 8** – Single yew tree to the north of the cottage.

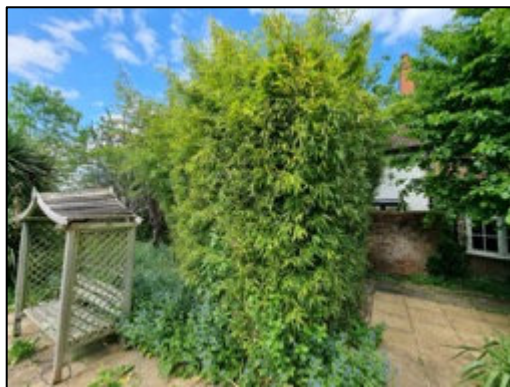
Non-native hedgerows are located in the western lawn area and extend around the outdoor pool. Ornamental shrubs have been planted around the hedgerows in these areas including just south of Rose Cottage where a patch of bamboo *Bambusa* is located (Figures 9 and 10). This plant can be invasive quickly spreading throughout an area and can grow underneath building foundations causing structural damage.

**Figure 9** – Ornamental bamboo located to the south of the cottage.

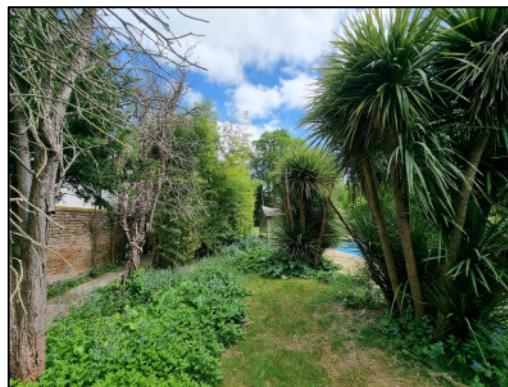
**Figure 10** – Ornamental planting adjacent to outdoor pool.

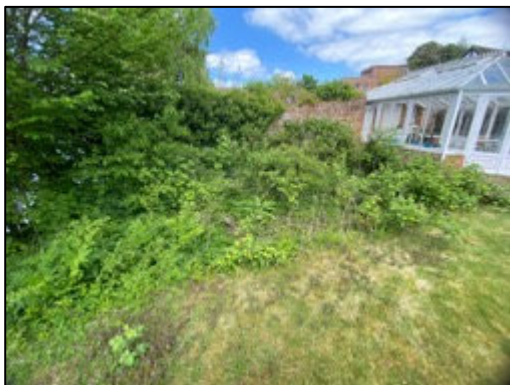
A localized patch of scrub has established where the boat ramp was previously situated (Figure 11). The species recorded within this area included English oak, burdock *Arctium lappa*, dogwood, bramble, ribwort plantain, pendulous sedge, daffodil, cow parsley, common ivy, dogrose *Rosa canina* and a elm sp.

**Figure 11** – Encroaching scrub on boat ramp.

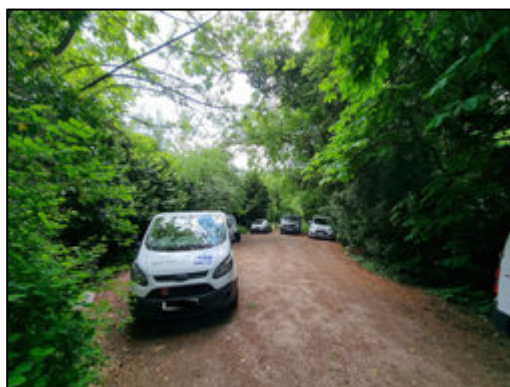
A large driveway extends from both the northwest and northern site boundaries in front of the main house to the north and terminates along the eastern boundary in the woodland understory (Figure 13). A patio area is located to the south of the house and hardstanding surrounds the outdoor pool (Figure 14).

**Figure 13** – Hardstanding in understorey of eastern woodland.

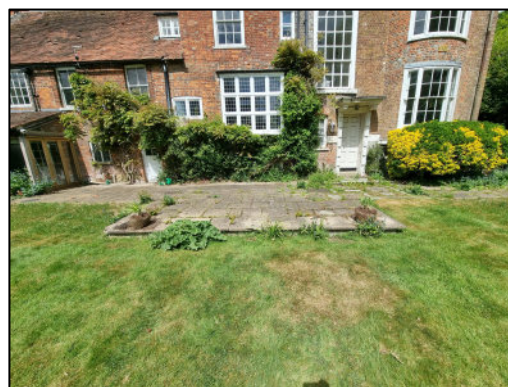
**Figure 14** – Southern patio on the main house and cottage.

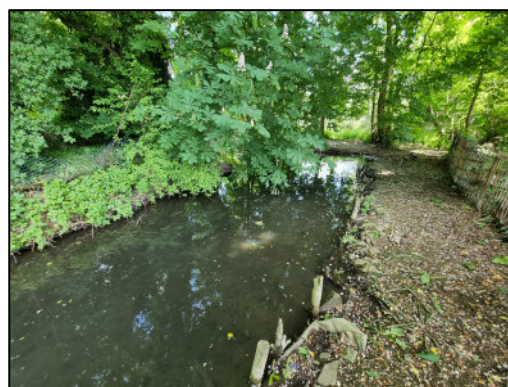
A man-made stream enters the site from a culvert along the eastern site boundary, extending westwards to the south of the lawn, through the woodland and into the River Thames (Figures 15 and 16). At the time of the survey the water level was low inside the waterway with no observable flow.

**Figure 15** – Stream south of the lawn onsite.

**Figure 16** – Stream extending through south-western woodland.

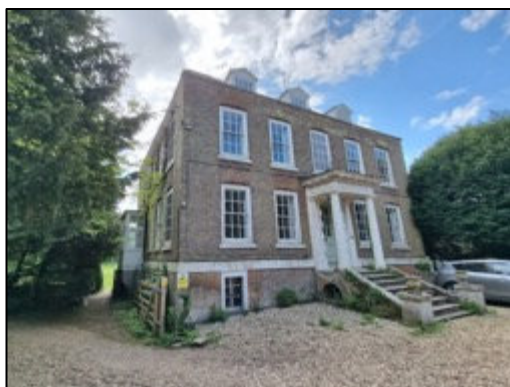
The house comprises a three-storey brick-built structure which rises to a multi-pitched and gable end roof design clad with clay and slate roof and ridge tiles (Figures 17 and 18). The house is oriented north to south. A parapet extends around the eastern and northern edges of the roof. Stone copping is present on the western gable end and along the parapet. An open porch extension protrudes from the northern elevation of the house. The eaves along the gable ends of the building are infilled with mortar. There are multiple flat roof extensions clad with hanging tiles on their elevations located on the roof of the building. Three pitched dormer windows are located on the northern roof face. There are two brick-built chimneys surrounded by lead flashing on the east and west of the roof. The window frames and door frames are set in wooden frames which are loose-fitting to the surrounding brickwork where mortar has fallen away.

**Figure 17** – North-eastern corner of the main house.

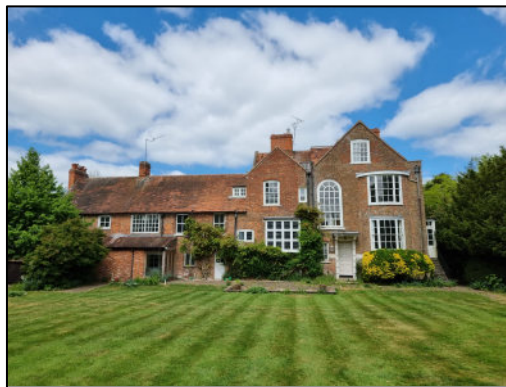
**Figure 18** – Southern elevations of the main house and western Rose Cottage.

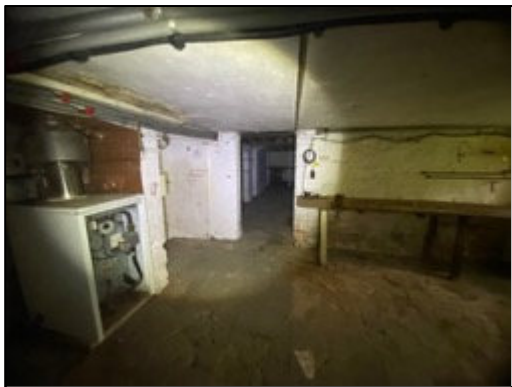
The basement area is  $\frac{3}{4}$  height with multiple rooms and light cobwebbing throughout (Figure 19). At the time of the survey the door from the house to the basement was left open allowing continuous access to the buildings interior.

**Figure 19** – Basement under the main house.

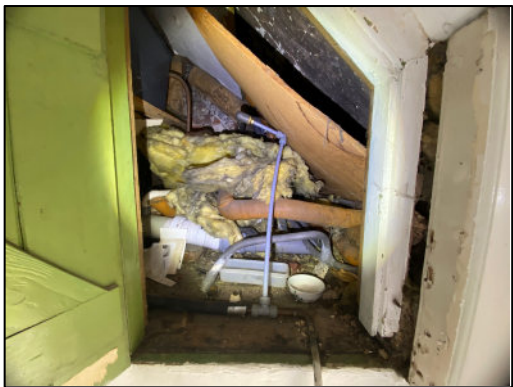
**Figure 20** – Roof void 1 in side eaves of the bathroom.

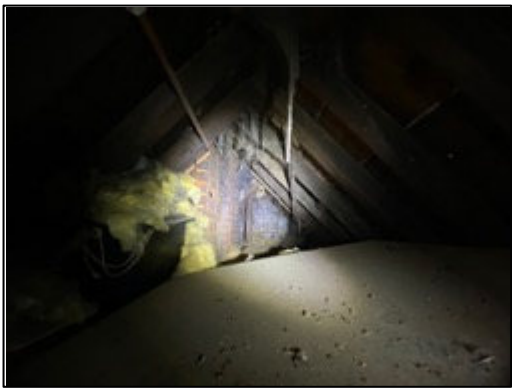
**Figure 21** – Roof void 2 inside northern pitched roof.

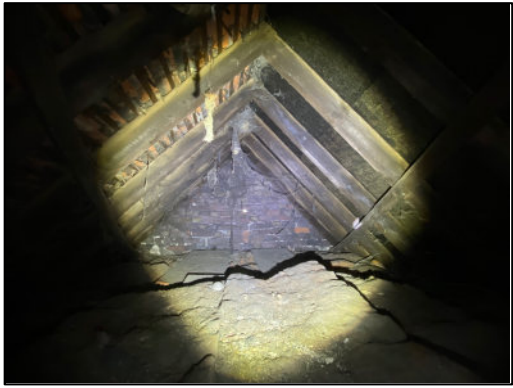
**Figure 22** – Roof void 3 inside south-eastern roof pitch.

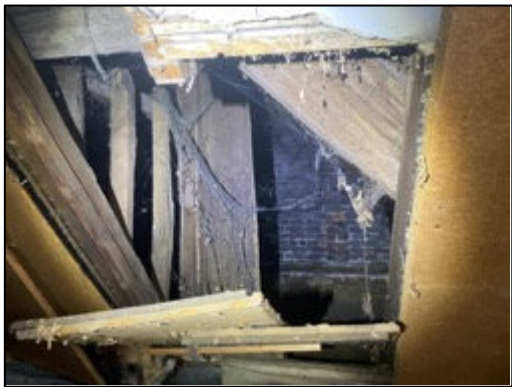
Void 4 extends along the south-western roof pitch. The roof is bitumen felt lined with fibreglass insulation on the floor. The space is heavily cobwebbed throughout (Figure 23).

**Figure 23** – Roof void 4 inside south-western roof pitch.

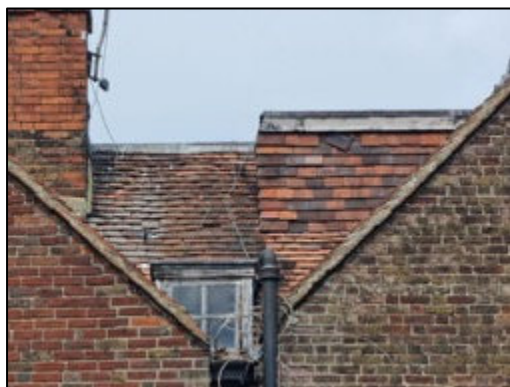
| | <i>Suitability</i> | <i>Evidence</i> |
|---|---|---|
| | <p>are either lifted or have slipped away on rear roof faces (Figure 24).</p> <ul style="list-style-type: none"> <li>- Gaps are located under the hanging tiles on the flat roof extensions on the roof of the house (Figure 24).</li> <li>- Crevices in the brickwork of the building where cracks have formed (Figures 25 and 26).</li> <li>- Crevices around window frames where mortar has fallen away (Figure 27).</li> <li>- Missing mortar under stone copping (Figure 28).</li> </ul> | |

**Figure 24** – lifted roof tiles on the southern roof face and slipped hanging tiles.

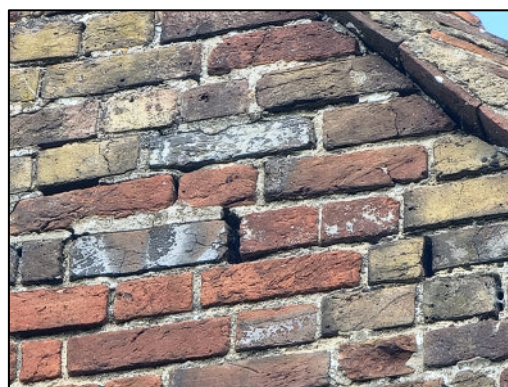
**Figure 25** – Southern elevation of the main house.

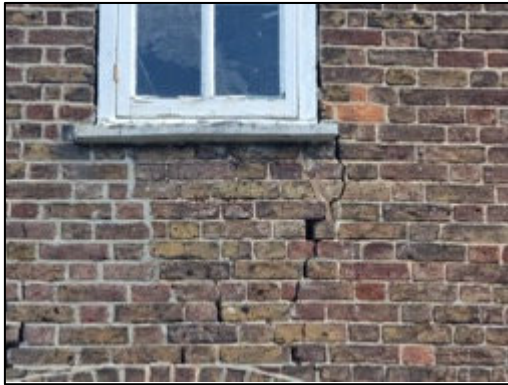
**Figure 26** – Cracks in the western elevation of the house.

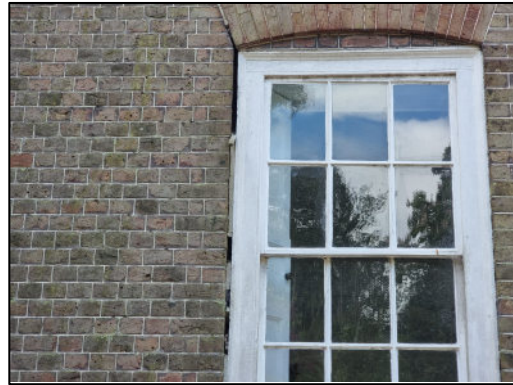
**Figure 27** – Crevices around the window frames where mortar has fallen away.

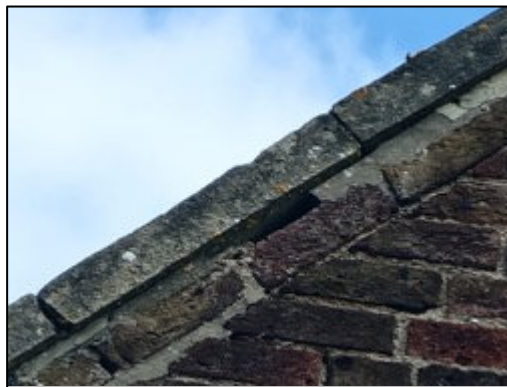
**Figure 28** – Gaps under stone coping where mortar is missing.

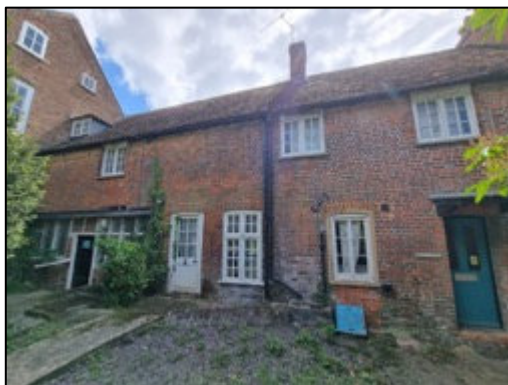
The cottage consists of a two-storey extension which protrudes westwards from the eastern elevation of the main house (Figures 29 and 30). The extension rises to a pitched roof clad with clay roof and ridge tiles. The cottage is oriented north to south. A single-storey lean-to extension protrudes from the southern elevation of the cottage clad with clay roof tiles and lead flashing at the joins. A single dormer window is located on both the northern and southern roof faces. A brick-built chimney is located along the central ridge of the roof with lead flashing at the base. The eaves remain open but are infilled with brick between them. All windows and doors are set in wooden frames.

**Figure 29** – Northern elevation of Rose Cottage.

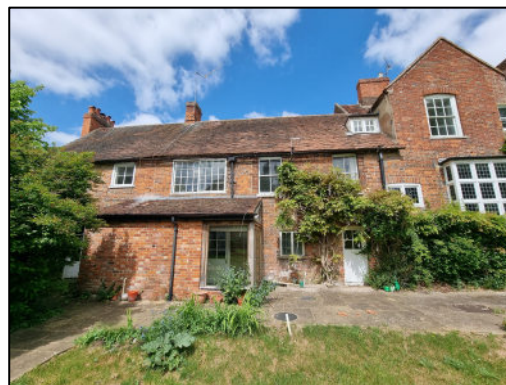
**Figure 30** – Northern elevation of Rose Cottage.

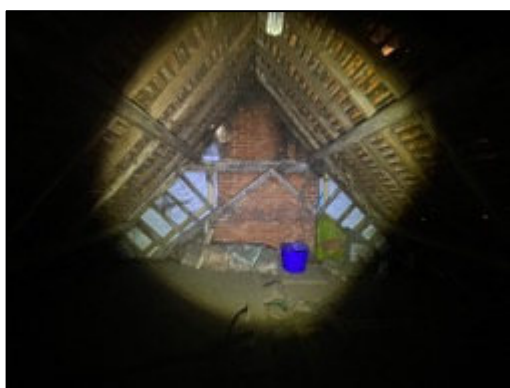
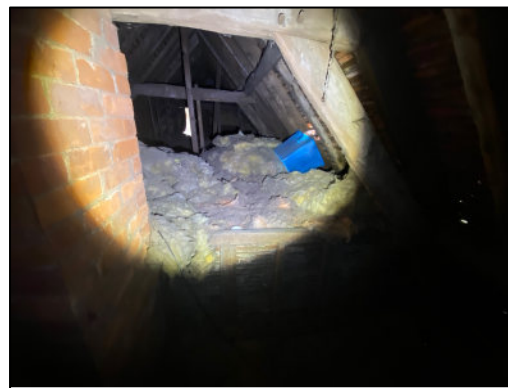
A single roof void extends along the entire roof pitch of the building (Figures 31 and 32). The roof remains unlined with the underside of the clay tiles exposed. The floor is insulated with fibreglass and partially boarded. Cobwebbing is present around the joists and under the tiles.

**Figure 31** – Interior roof void of the cottage looking west.

**Figure 32** – Interior roof void of the cottage looking east.

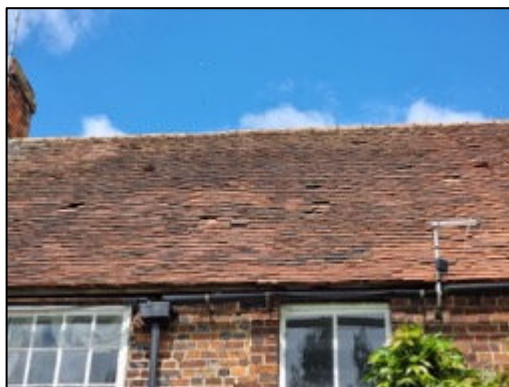
**Figure 33** – Southern roof face of Rose Cottage with slipped roof tiles.

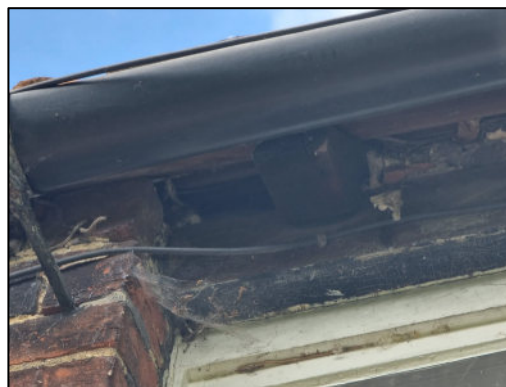
**Figure 34** – Gap in the eaves above the northern elevation.

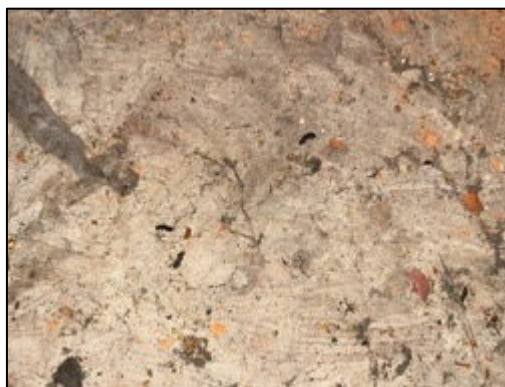
| | <i>Suitability</i> | <i>Evidence</i> |
|---|---|---|
| <i>Interior</i> | <p>The following suitable access/egress and roosting features were recorded internally during the survey.</p> <p>N/A</p> | <p>The following evidence of roosting activity was recorded internally during the survey.</p> <ul style="list-style-type: none"> <li>- Approximately 50 long-eared bat type droppings were recorded scattered around the roof void inside Rose Cottage (Figure 35).</li> </ul> |

**Figure 35** – Scattered long-eared bat droppings in the roof void.

The preliminary roost assessment has confirmed that the house and attached cottage support high suitability for roosting bats. Therefore, further survey effort is recommended to confirm the presence/absence of roosts, characterise any bat roost/s, assess the extent bats may be affected by the proposed alteration and construction works and devise an appropriate mitigation strategy to support the proposed works and address any breaches in the legislation. In accordance with Natural England standing advice and BCT Good Practice Guidelines, three presence/absence surveys for the house and cottage should be undertaken between May and September. No further survey work is required for the conservatory outbuilding.

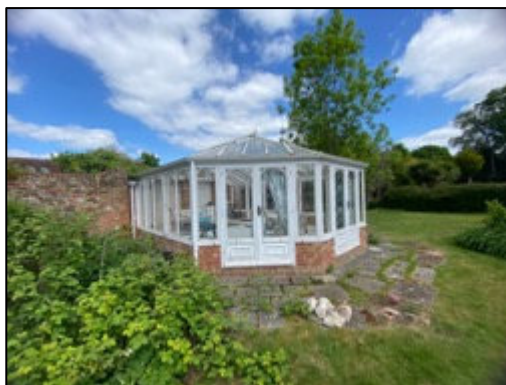
The building is built on a brick plinth with shallow brick walls and a wooden framed structure rising to a hipped and pitched glass roof (Figure 36). The windows and doors are set in wooden frames and uPVC guttering extends around the roof.

**Figure 36** – Conservatory outbuilding.
