**Bat Emergence Re-entry Survey**  
**11A Belmont Road, Crowthorne, Berkshire, RG45 6SA**  
**Date of Issue: 25/08/2026**

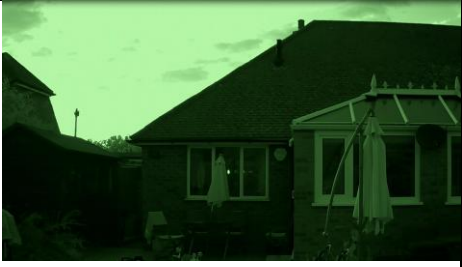
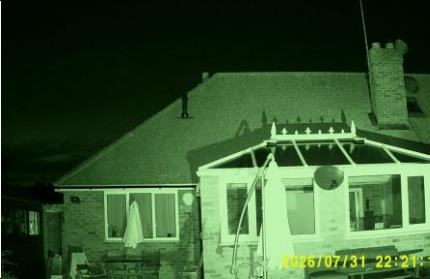
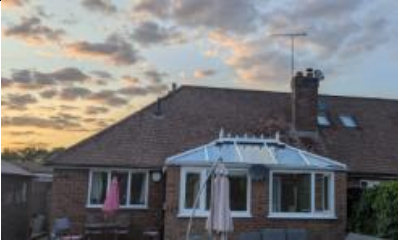
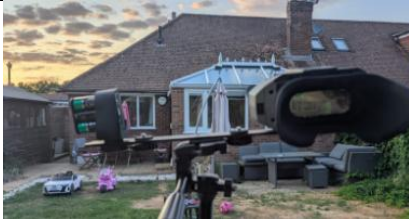
| <b>Table 1.</b> Photographs of surveyor views, surveyor setups and NVA view at start and end of survey on 31 <sup>st</sup> July 2026. | | | | |
|---|---|---|---|---|
| B1<br>SL1<br>NVA1<br>Infrared | | | | |

| <b>Table 1.</b> Photographs of surveyor views, surveyor setups and NVA view at start and end of survey on 31 <sup>st</sup> July 2026. | | | | |

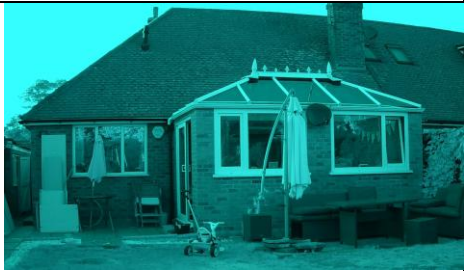
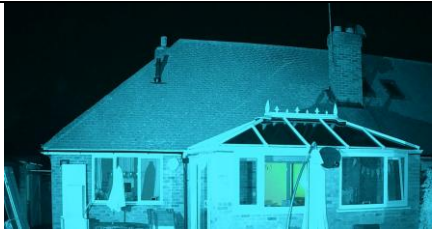
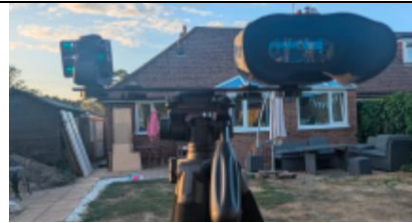
| <b>Table 3.</b> Photographs of surveyor views, surveyor setups and NVA views at start and end of survey on 22 <sup>nd</sup> of August 2026. | | | | |
|---|---|---|---|---|
| B1<br>SL1<br>NVA1<br>Infrared | | | | |

| <b>Table 3.</b> Photographs of surveyor views, surveyor setups and NVA views at start and end of survey on 22 <sup>nd</sup> of August 2026. | | | | |
