**Re: Parcel 7, Finchampstead: Verification of Clean Cover in Plots 133, 141 and 142**

Leap Environmental, a trading name of RSK Environment Ltd (hereafter referred to as **LEAP**) was appointed by BDW Southern Counties (hereafter referred to as 'the client') to undertake the verification of clean cover in Plots 133, 141, 142 at the site referred to as Parcel 7, Finchampstead. A site location plan is presented in Drawing Ref. 3750855-LW-111-XX-D-G-11101-C01, **Appendix B**.

Finchampstead, Verification of Plots 133, 141 and 142

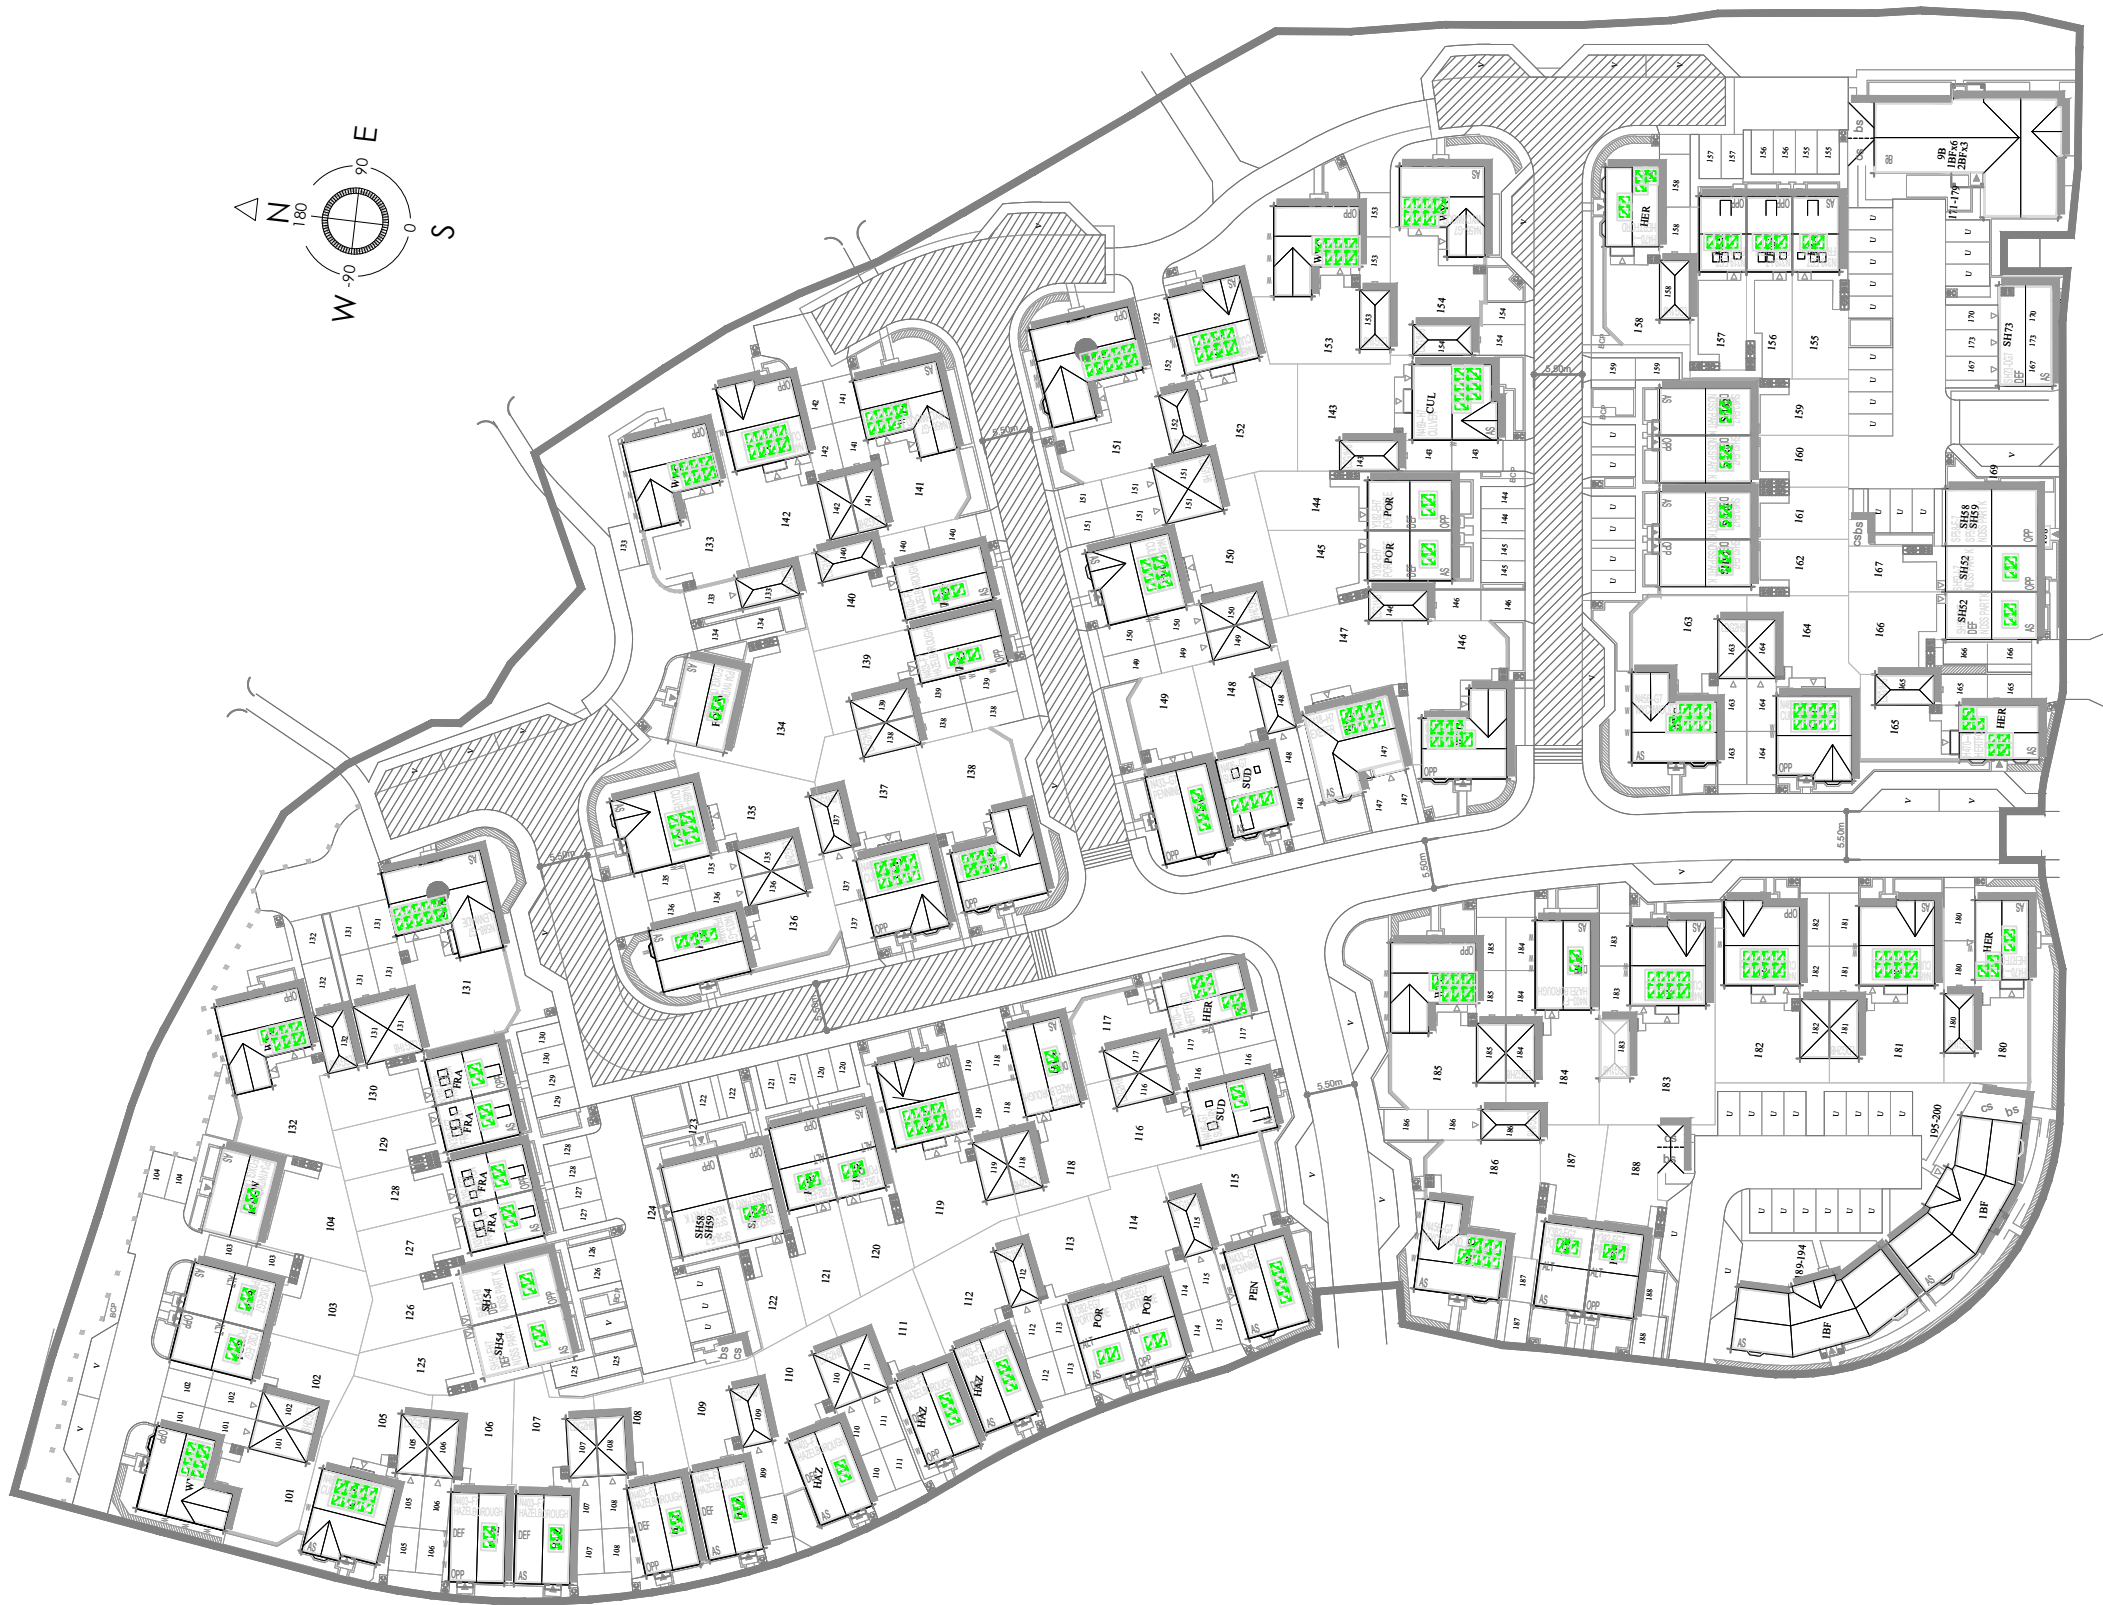
## PV Site Layout - Plots 101 - 200

It is understood that the site is being redeveloped by BDW Southern Counties with 200 residential dwellings with associated private gardens, open landscaping and infrastructure, as shown on Drawing BAR-FIN-500 RevB in **Appendix B**. Prior to development the site was predominantly greenfield aside from some made ground in the east of the site, which was shown to pose a risk to future site users. Remedial measures were required to be undertaken on impacted plots, Plots 133, 141 and 142, with the placement of clean cover in the rear gardens. This report presents verification of the remedial works undertaken in Plots 133, 141 and 142 only.

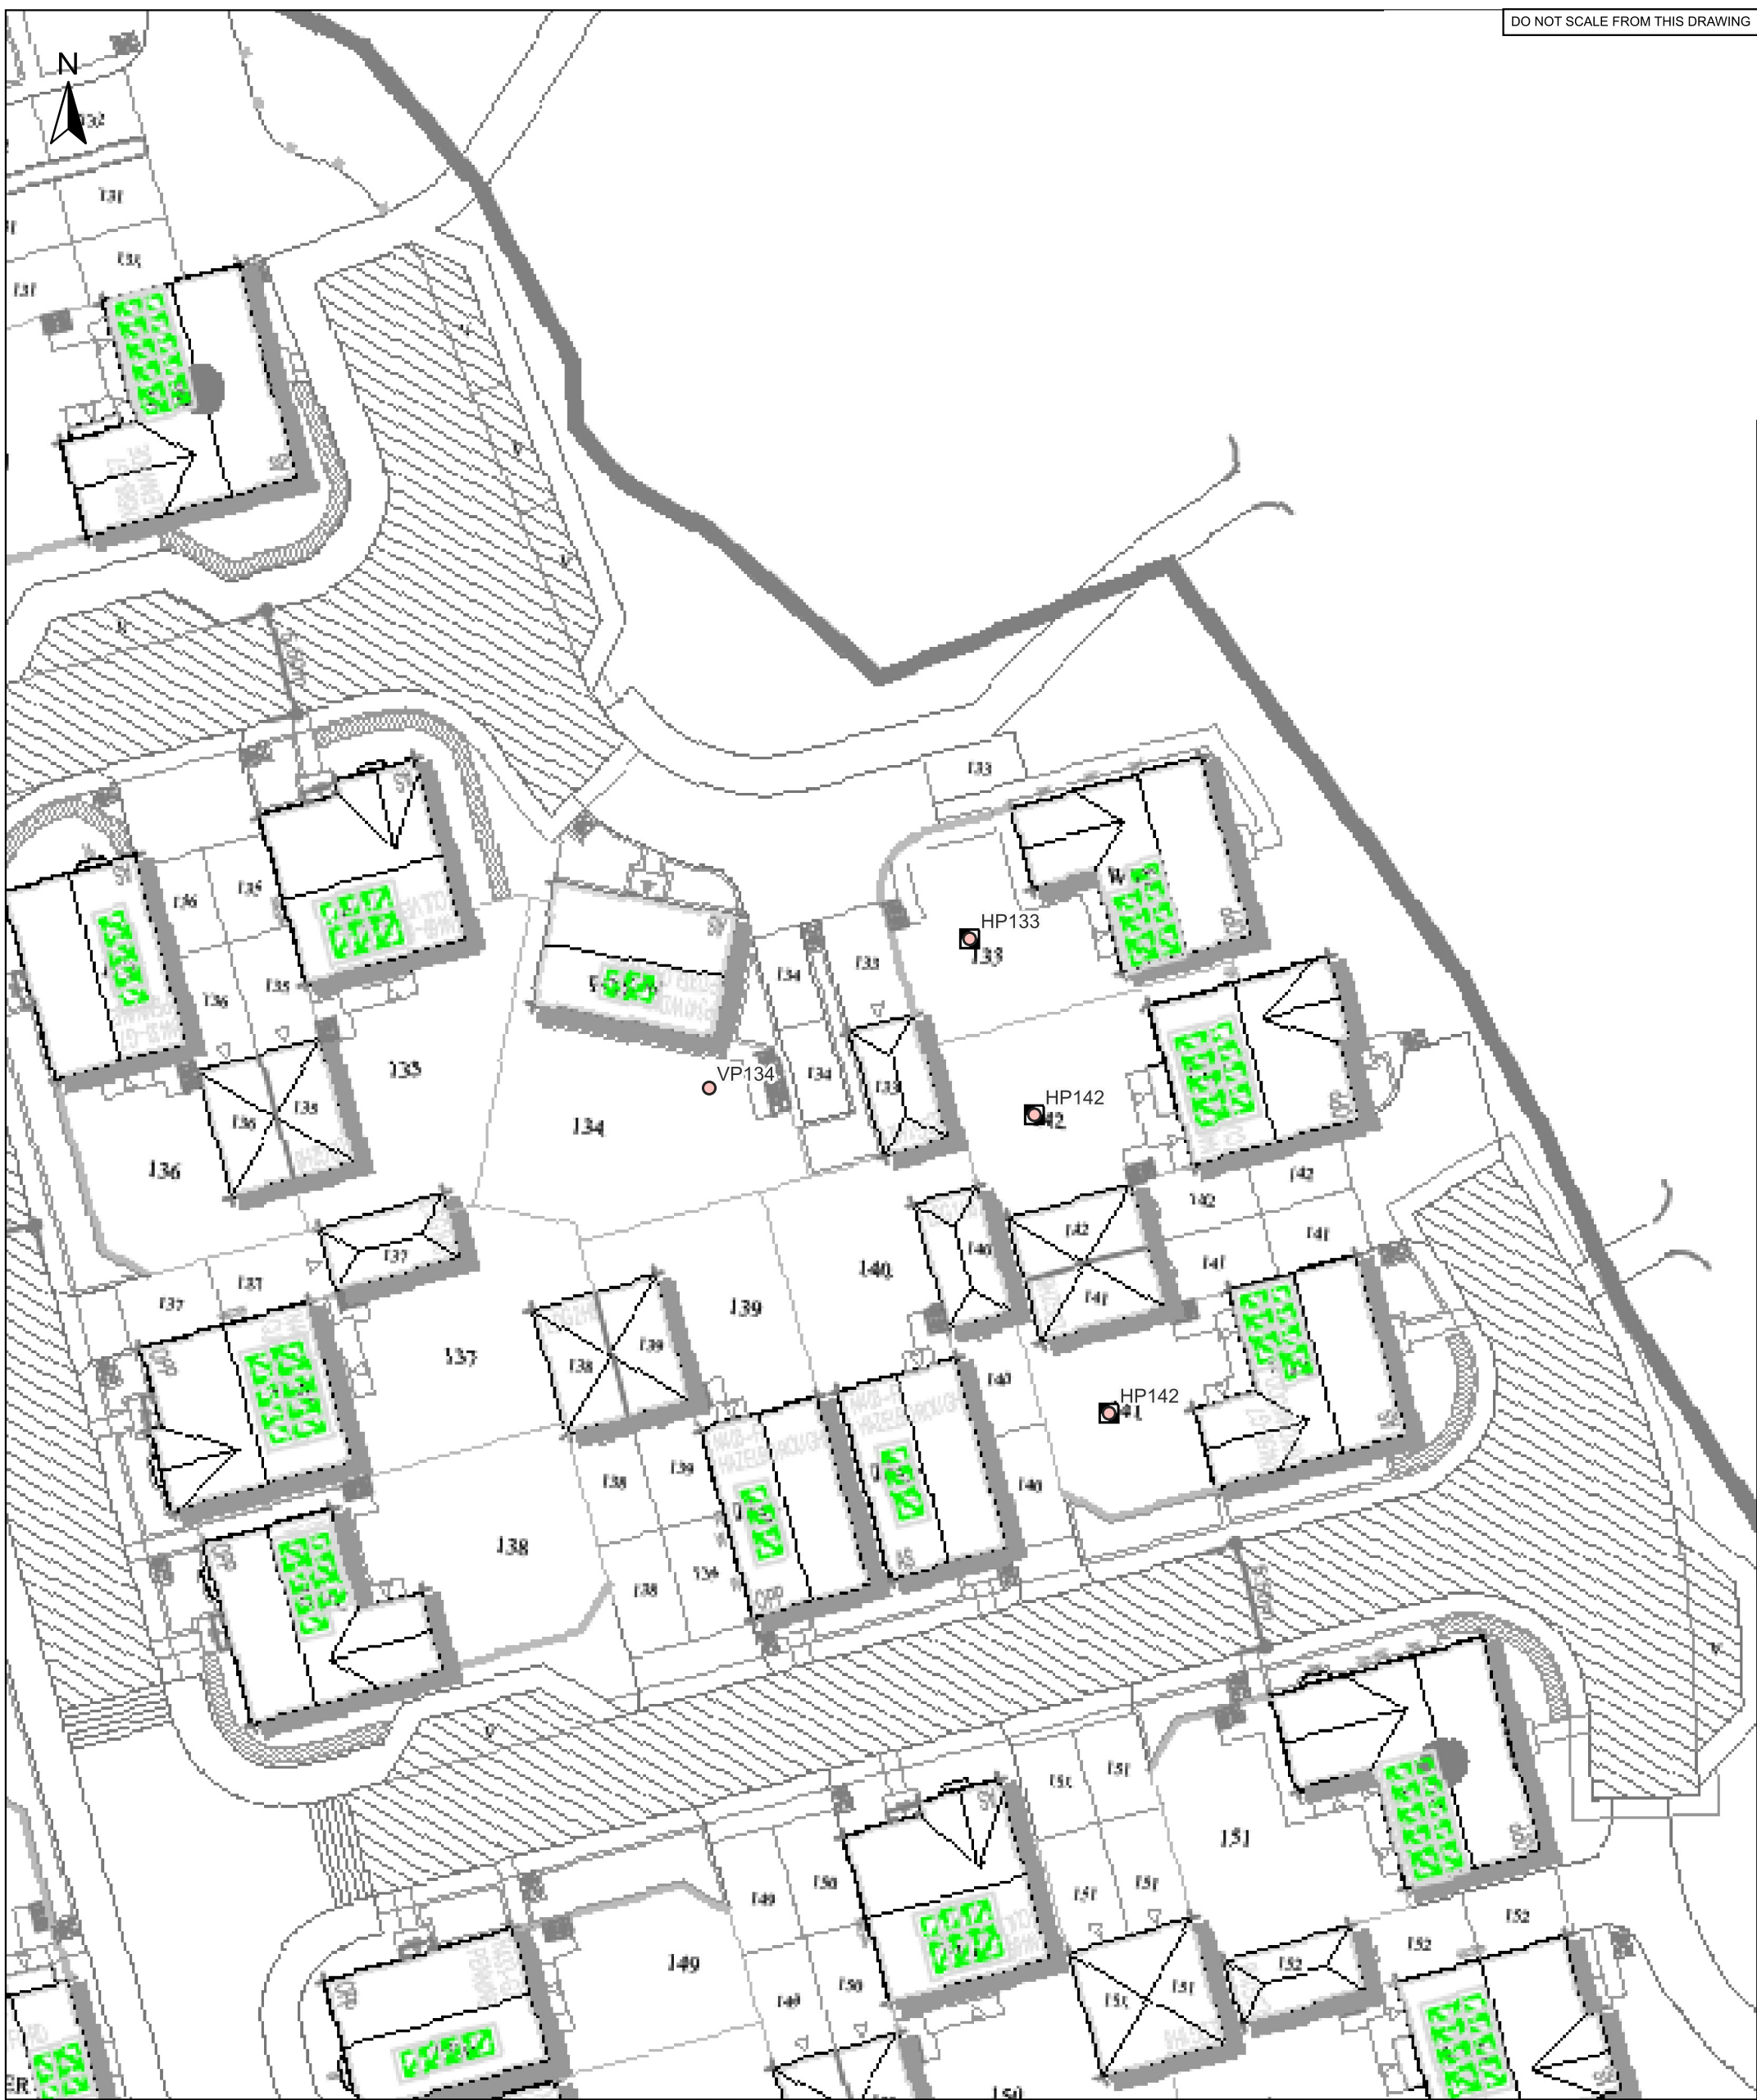
As part of the inspection verification inspection pits were excavated in each of the three plots, through the subsoil to the underlying soils. Drawing 3750855-LW-222-XX-D-G-22201-C01 in **Appendix B** shows the location of the pits. **Table 2** provides a summary of the soils encountered within the verification inspection pits excavated by LEAP, and photographs of the soils encountered are included in **Appendix C**.

Hand Dug Pit Location
-

Sample Location

Notes:  
Base plan provided by the Client  
Drawing Ref: 'BAR-FIN-500' PV Site Layout - Plots 101-200
