Project: 25_PRA_06_69

Site: L'ortolan, Church Lane, Shinfield, Reading, RG2 9BY

Project Number:	25_PRA_06_69
Report Type:	Preliminary Roost Assessment Report [PRA] Daytime Bat Walkover (DBW)
Site Address:	L'ortolan, Church Lane, Shinfield, Reading, RG2 9BY

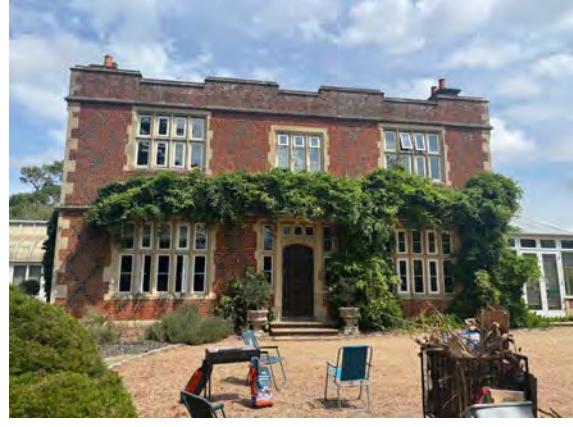
Detail	Photograph
<i>Plate 1 - Front elevation of B1.</i>

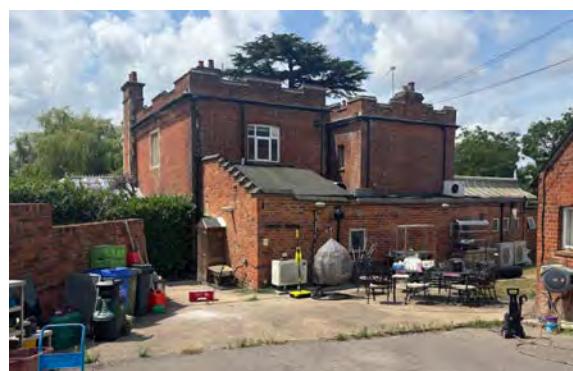
<i>Plate 2 - Rear elevation of B1.</i>

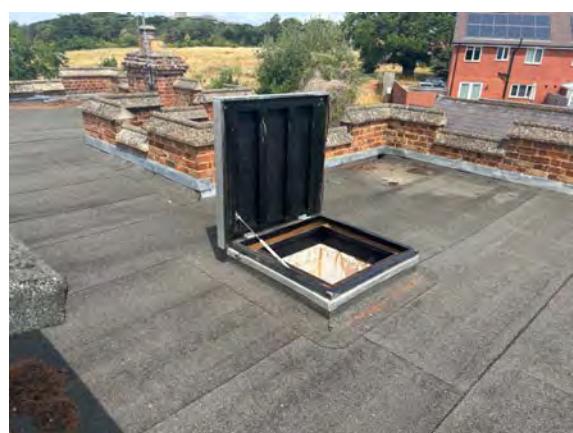
<i>Plate 3 - Entrance onto flat roof of B1.</i>

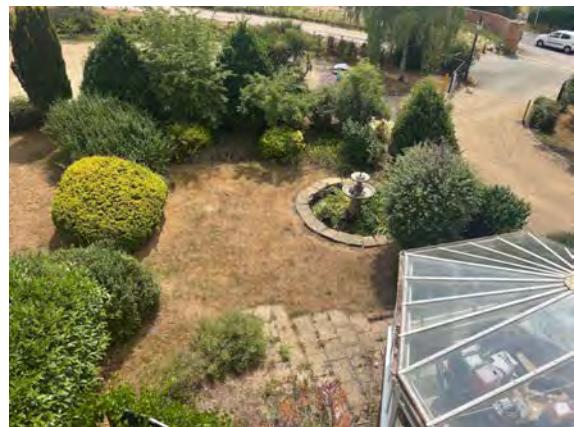
Plate 4 - View from B1 roof showing front garden and small oriental pond (TN1).

TN1: Located to the south of Building B1 within the vegetated garden, this small ornamental pond is heavily shaded and overgrown with marginal vegetation. The waterbody contains minimal open water and appears subject to seasonal drying. The pond has steep, hard edges that limit accessibility for amphibians and lacks surrounding wetland habitat or gradual shelving, both important for breeding suitability. Based on current condition and structural features, the pond is assessed as having negligible suitability for amphibians.

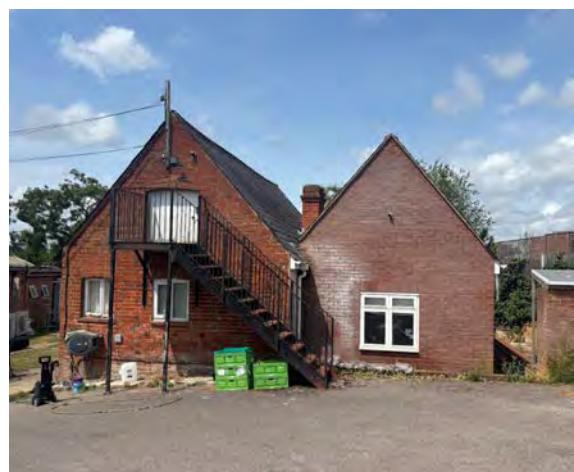
- 5.3 The lifted tiles, missing cladding around the eaves and possible gaps at the ridge line provide roosting potential for crevice dwelling bats species such as common pipistrelle which are known to be present in the local area. Therefore, based on this information and the guidance outlined by the Bat Conservation Trust, building B2 has been assessed as having moderate suitability for roosting bats.

Plate 5 - Building B2. This was assessed as having moderate potential for roosting bats.

- 7.4 It is recommended that two presence/absence surveys be carried out on B2. The surveys should be carried out between May and September (with September considered to be sub-optimal). However, **please refer to paragraph 7.6 for the clients preferred course of mitigation.**

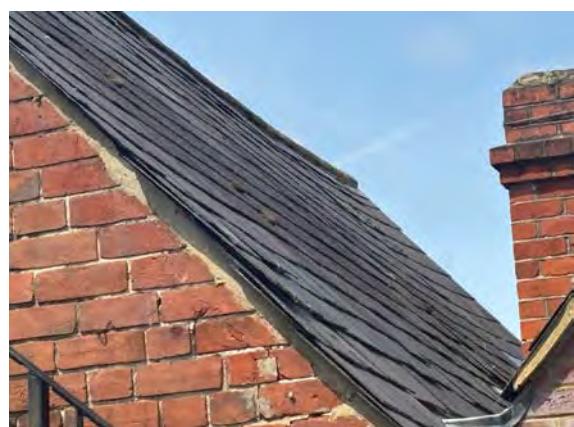
The roof of B2 consists of two traditional pitched roofs clad in slate tiles with a central ridge. The surface shows typical ageing, with slipped and lifted tiles observed, creating several areas with potential for crevice-roosting bats. The presence of missing cladding around the eaves and possible gaps at the ridge line further increases the likelihood of bat access. In combination with its proximity to mature trees, linear vegetative features, and limited disturbance levels, the roof of B2 has moderate suitability for roosting bats.

Plate 6 - PRFs on B2 in the form of lifted and slipped tiles.

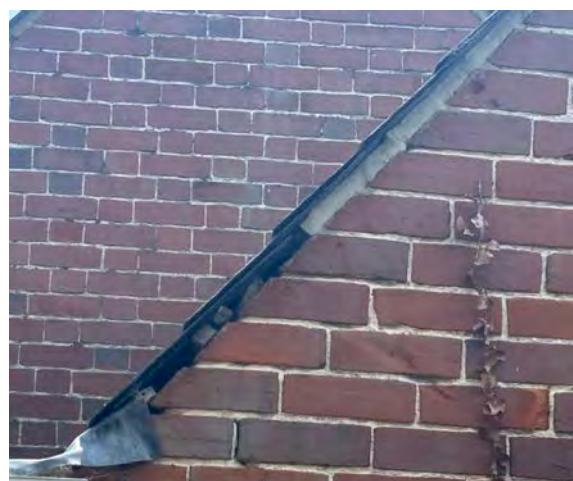
Plate 7 - PRFs on B2 in the form of gaps under tiles due to missing mortar.

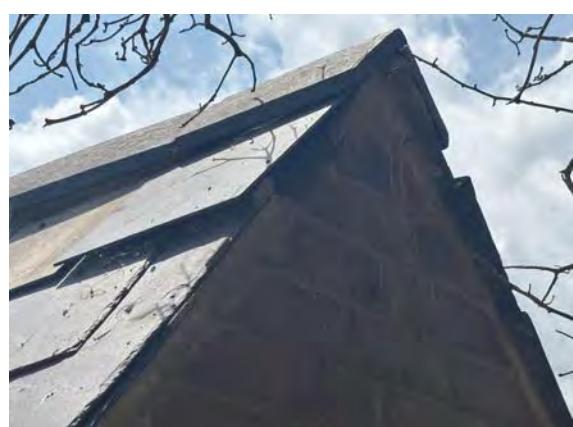
Plate 8 - PRFs on B2 in the form of a significant section of missing mortar at the verge edge.

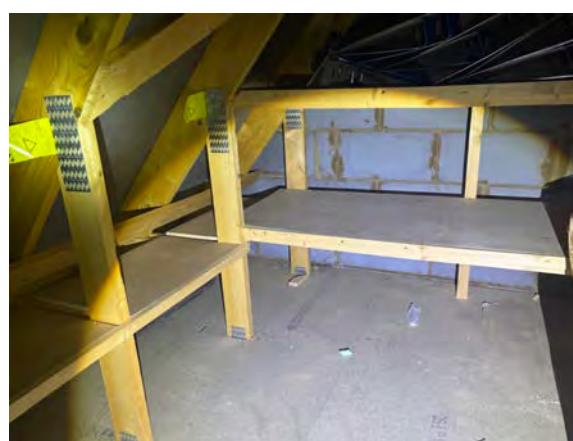
No evidence of bats was identified during the internal inspection. Specifically, no bat droppings, urine staining, feeding remains, or characteristic odours associated with roosting colonies were observed on floors, sills, or beneath potential entry points such as loft hatches, window frames, or rafters. Finishes and furnishings across the interiors do not suggest any history of bat occupation. Given the lack of

Plate 9 - No evidence of bats was found within the void space.

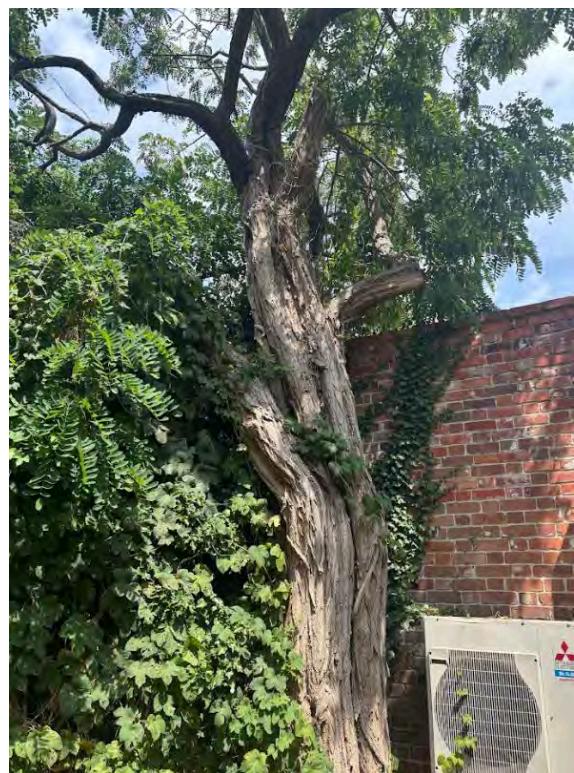
Plate 10 - Five trees were identified as having PRFs on site.

The site supports a number of mature and early veteran trees that hold potential roosting features (PRFs) suitable for bats. Five trees within or adjacent to the vegetated garden area were subject to closer assessment due to their structure, age, or visible features consistent with bat use.

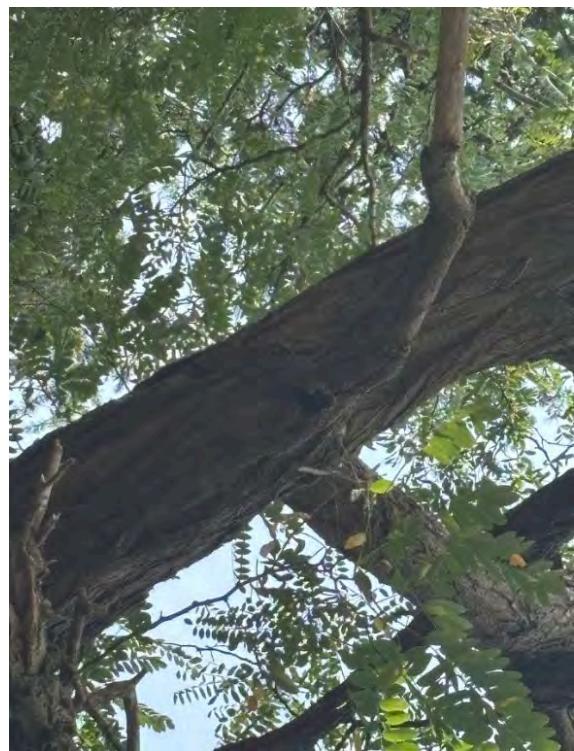
Plate 11 - PRFs were identified on trees in the form of peeled and lifting bark.

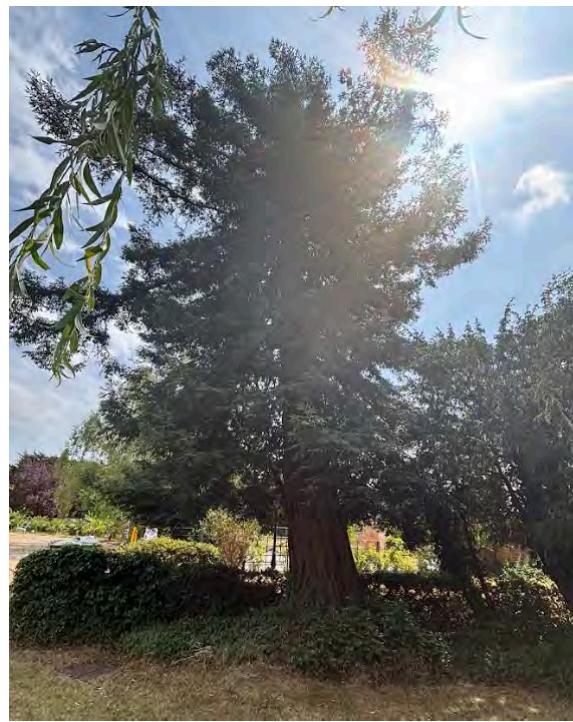
*Plate 12 - A very large coast redwood (*Sequoia sempervirens*), is in good condition and supports PRF type I in the form of peeling bark, providing small sheltered crevices which could be used by crevice-dwelling bats.*

T1, a very large coast redwood (*Sequoia sempervirens*), is in good condition and supports PRF type I in the form of peeling bark, providing small sheltered crevices which could be used by crevice-dwelling bats. T2, a large weeping willow (*Salix babylonica*), also in good health, has a prominent pruning wound identified as PRF type I. This wound may extend into the sapwood, offering a stable and sheltered opportunity for bats to roost. T3, a very large Cyprus cedar (*Cedrus*

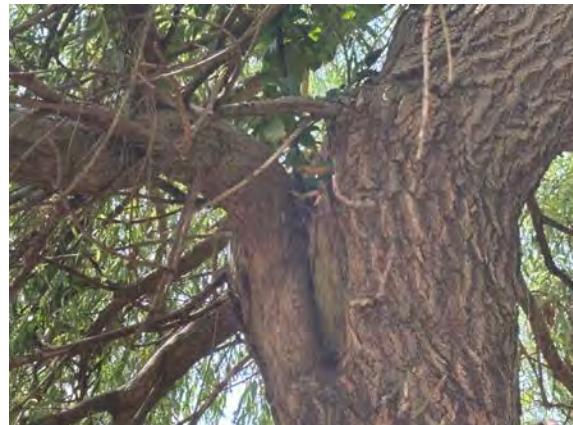
Plate 13 - Mature tree exhibiting a PRF type I in the form of a significant vertical cavity on the main trunk with signs of structural decay. Multiple limbs show narrow unions with potential included bark.
