Report prepared for: EU Plants Ltd

For the Site of: Manor Farm, Longwater Road, Finchampstead, Wokingham, RG40 3TS

# Preliminary Roost Assessment (PRA)

The client commissioned Cherryfield Ecology to undertake a PRA as the proposals include for the conversion of a barn into 3no. residential dwellings. Plans have been provided (Appendix I).

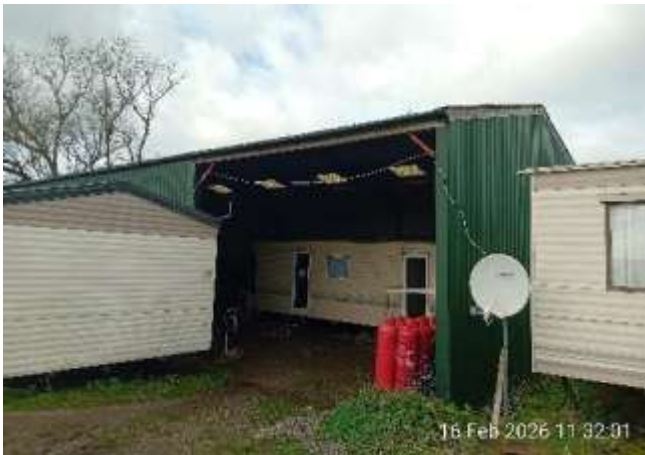
| Building/Tree/Structure Number | Description |
|---|---|
| B1 | <p>B1 is an open access, metal barn with a pitched roof. The roof is constructed from corrugated metal sheets with some corrugated plexiglass roofing panels. The roof and walls are unlined and supported by a metal frame. B1 houses B2, B3, B4 &amp; B5 as detailed below.</p> <p>Figure 2: Exterior of B1.</p> |

| Potential for bat use | <p>Buildings:</p> <p>Level of likelihood of roosting presence - Negligible (All buildings)</p> <p>The buildings on site provide negligible potential for roosting bats due to an absence of suitable roosting features. B1 has open access, however, lacks any crevices or cavities that could be utilised for roosting. B2, B3, and B6 do not have any roof tiles which could be used for roosting or an access point. B4 and B5 lack any suitable crevices for roosting bats.</p> |

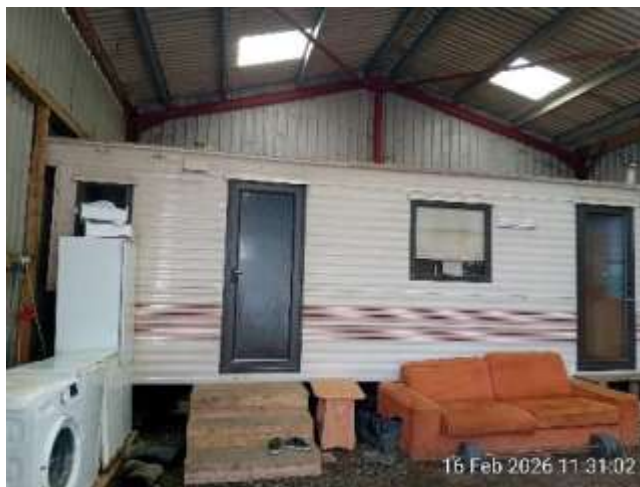
Figure 4: Example of B2.

B2 is a single-storey mobile home with a flat roof. The windows and doors have PVC frames. Internal access was not provided.

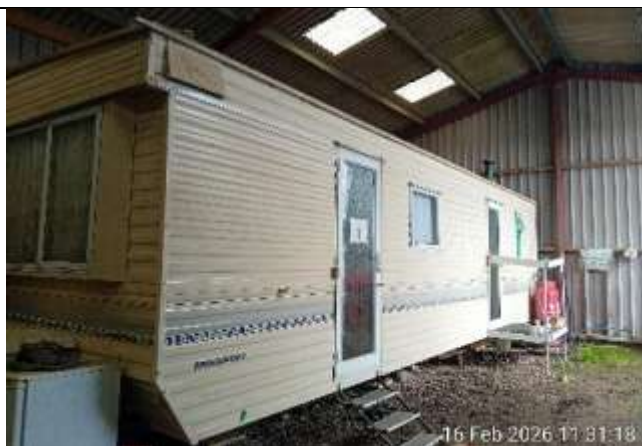
Figure 5: Example of B3.

B3 is a single-storey mobile home with a flat roof. The windows and doors have PVC frames. Internal access was not provided.

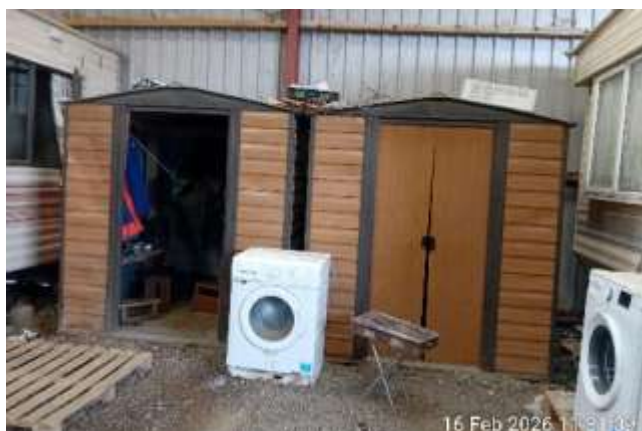
Figure 6: Example of B4 and B5.

B4 and B5 are a pair of plastic sheds with pitched roofs. Internally, the sheds are unlined.

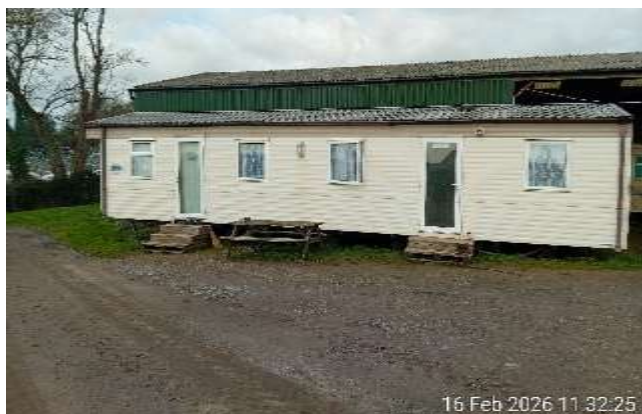
Figure 7: Example of B6.

B6 is a single-storey mobile home with a pitched roof. The roof is covered in interlocking tile sheets. The windows and doors have PVC frames. Internal access was not provided.
