WRENBRIDGE

SHINFIELD PARK  
READING

PROPOSED EARTHWORKS  
OPTION 16

## **Annex B: Site Photographs**

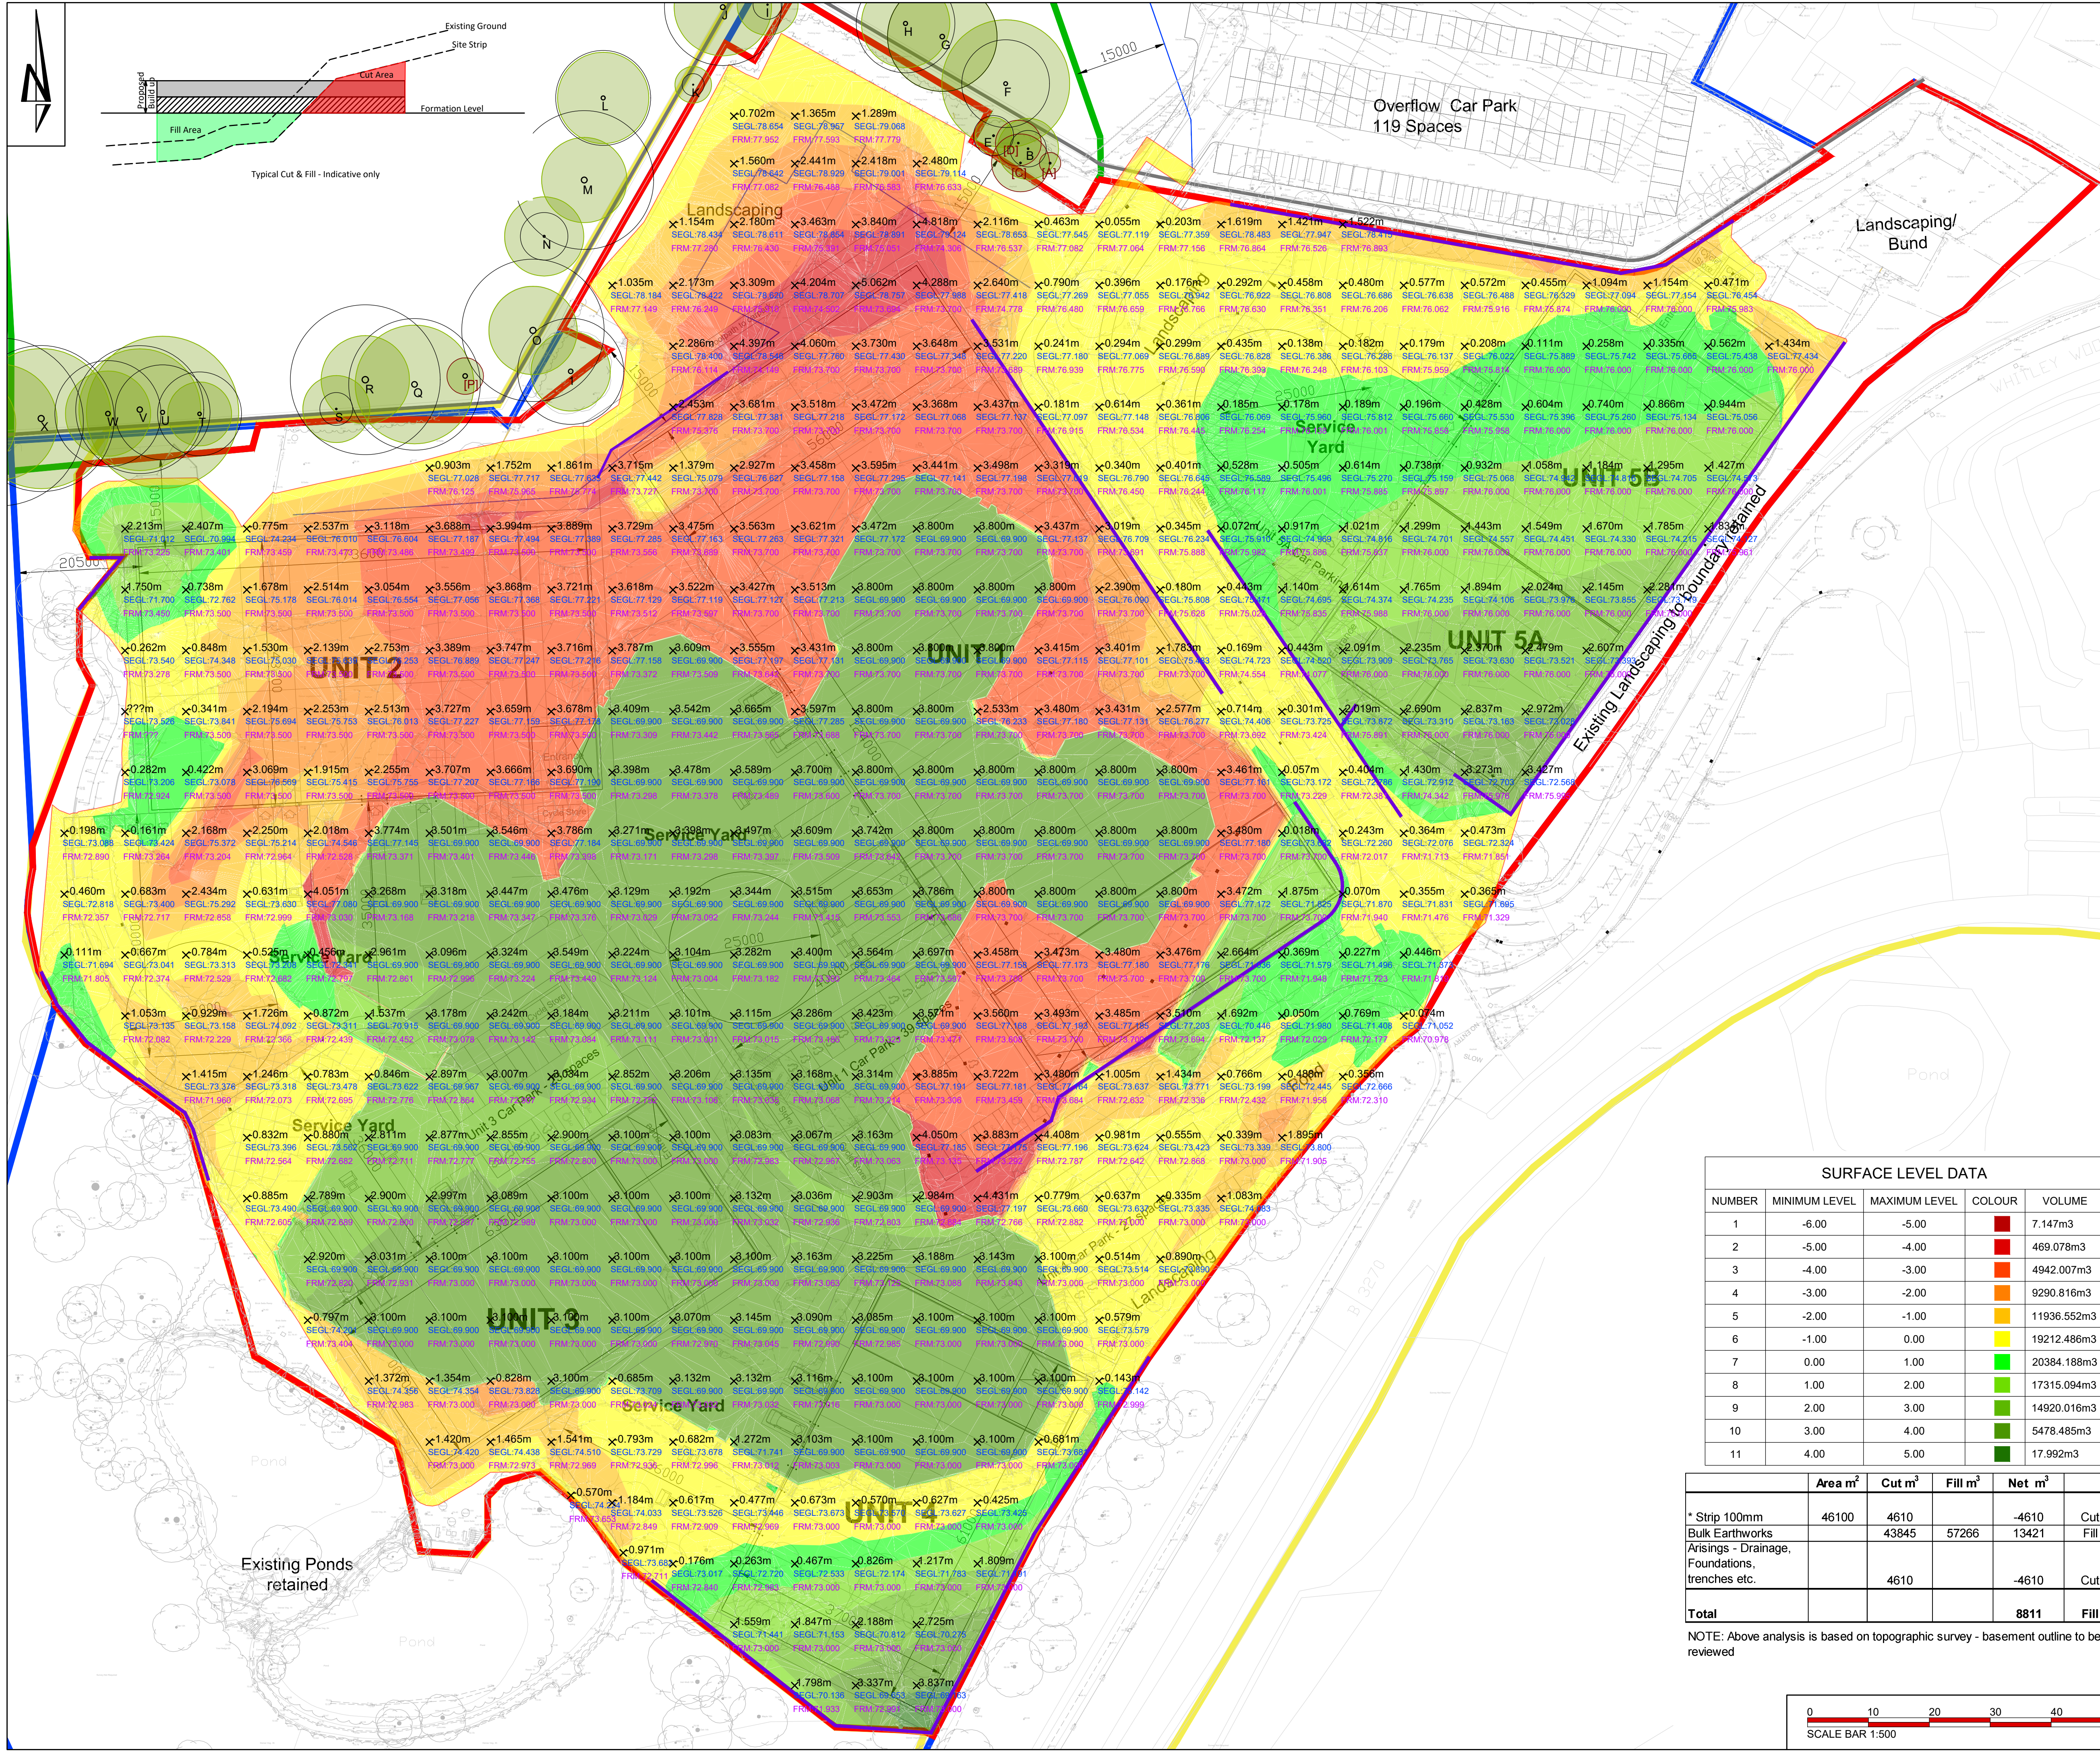
40237-BGL-XX-XX-DR-C-00201

NOTE: Above analysis is based on topographic survey - basement outline to be reviewed

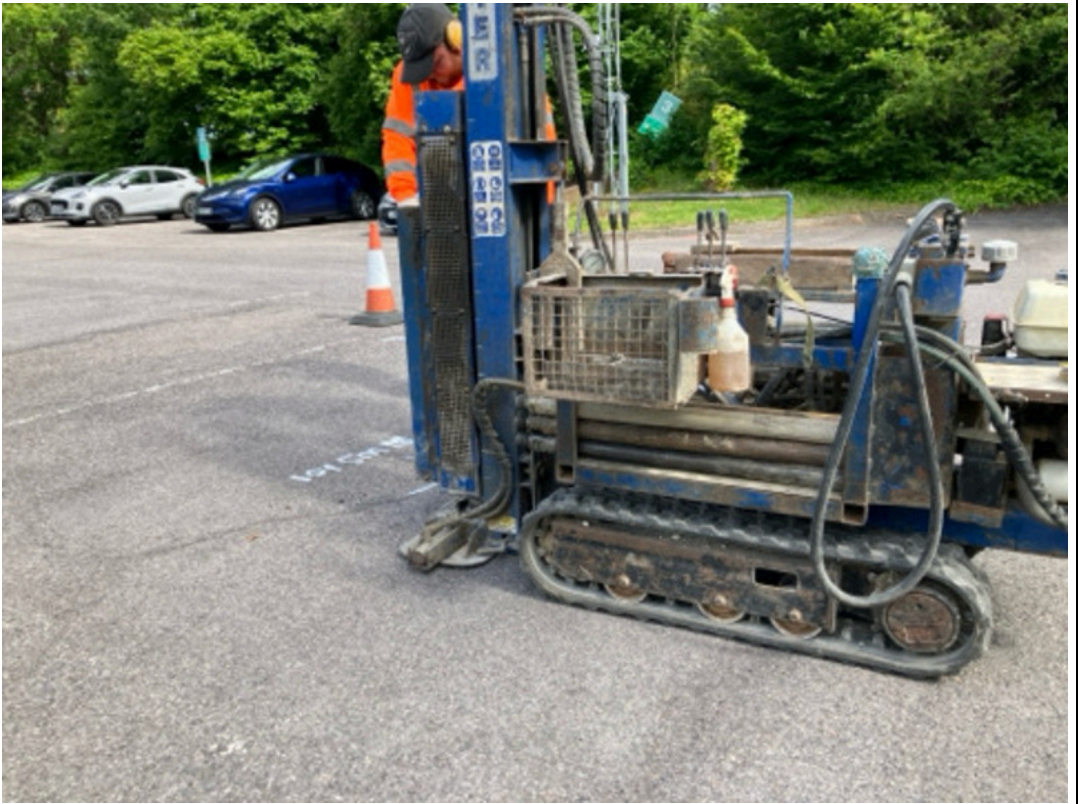
| Client: | | Site Location: | Project No.: |
|---|---|---|---|
| 1 | 19/06/24<br>- 21/06/24 | | |

| Client: | | Site Location: | Project No.: |
|---|---|---|---|
| WS101 - rig in position | | | |

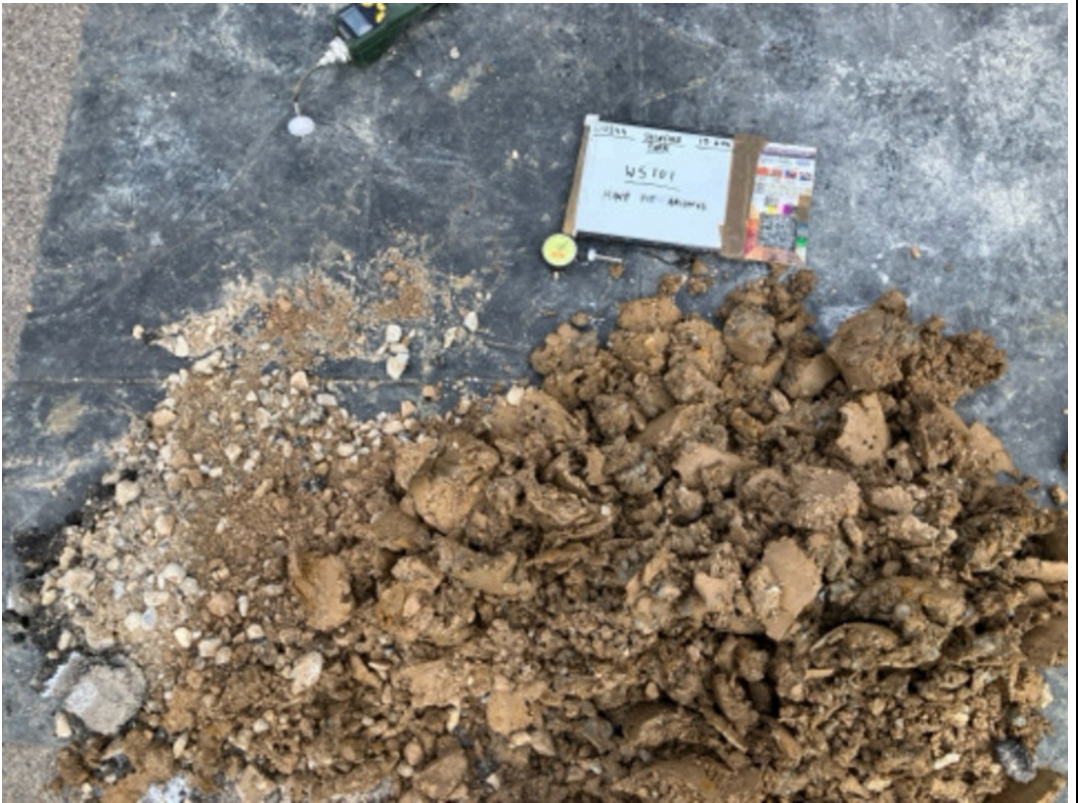
| Photo No. | Date | | |
|---|---|---|--|
| 2 | 19/06/24<br>- 21/06/24 | | |

| Photo No. | Date | | |
|---|---|---|--|
| WS101 - hand pit arisings | | | |

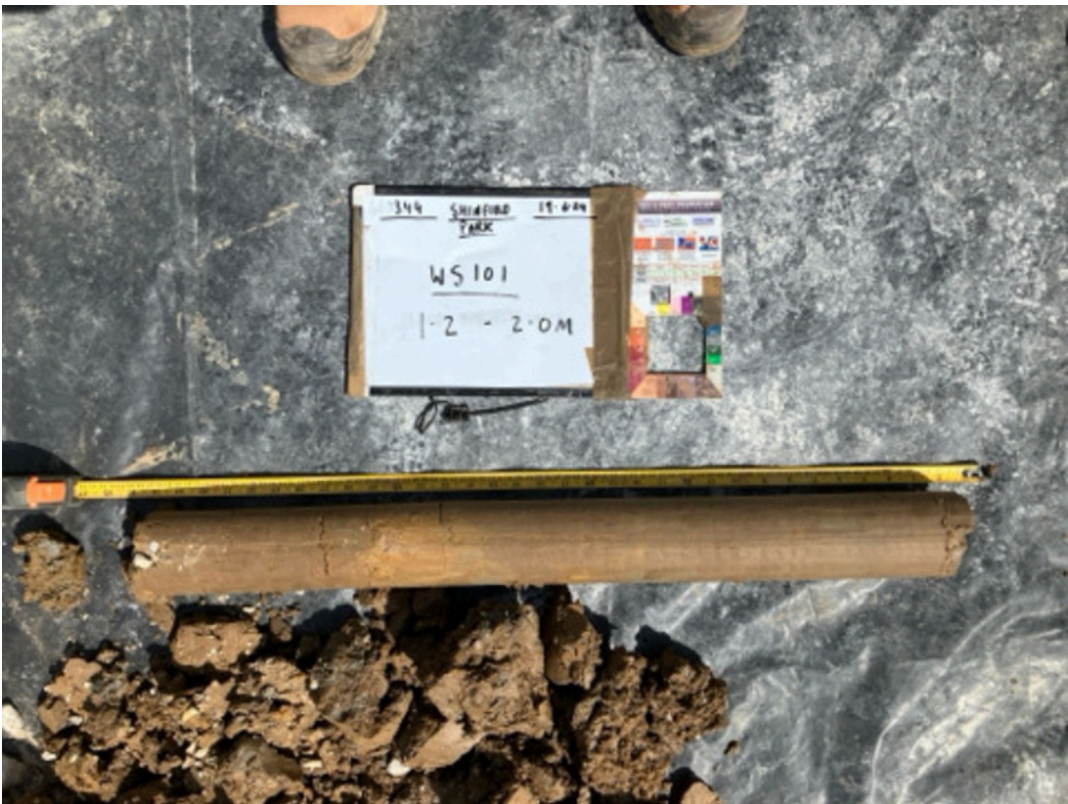
| Client: | | Site Location: | Project No.: |
|---|---|---|---|
| 3 | 19/06/24<br>- 21/06/24 | | |

| Client: | | Site Location: | Project No.: |
|---|---|---|---|
| <b>Description</b><br>WS101 - recovery from 1.2 to 2.0m bgl | | | |

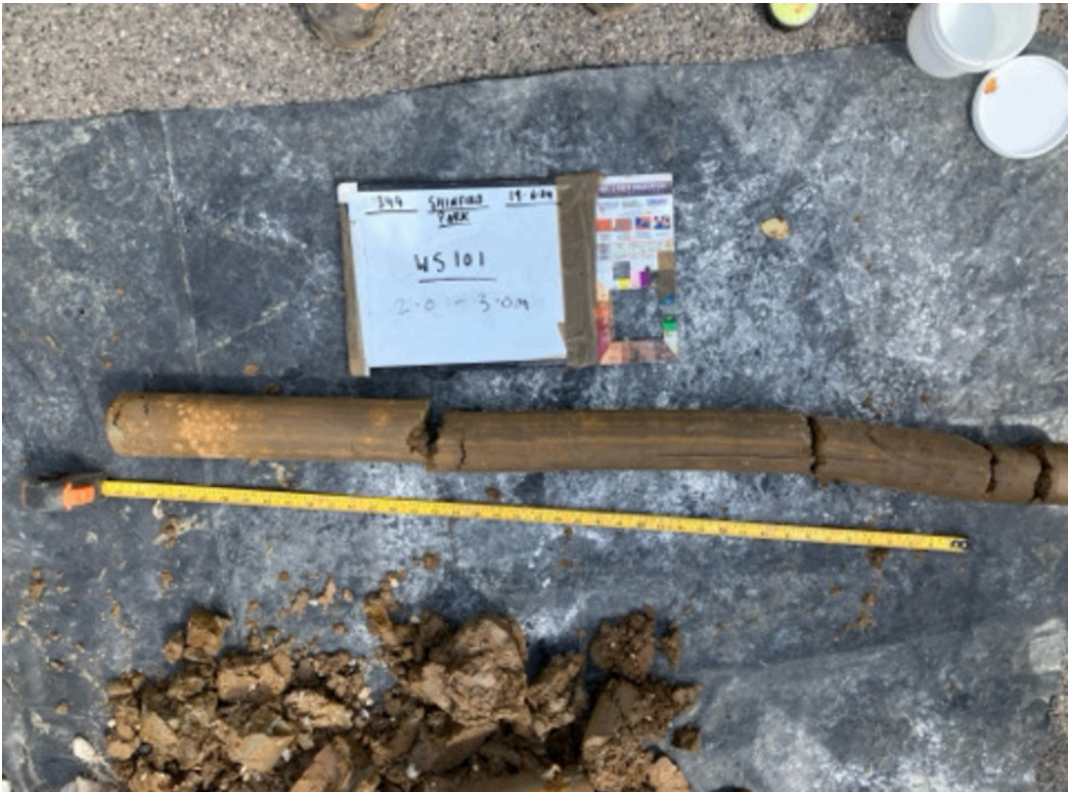
| Photo No. | Date | | |
|---|---|---|--|
| 4 | 19/06/24<br>- 21/06/24 | | |

| Photo No. | Date | | |
|---|---|---|--|
| <b>Description</b><br>WS101 - recovery from 2.0 to 3.0m bgl | | | |

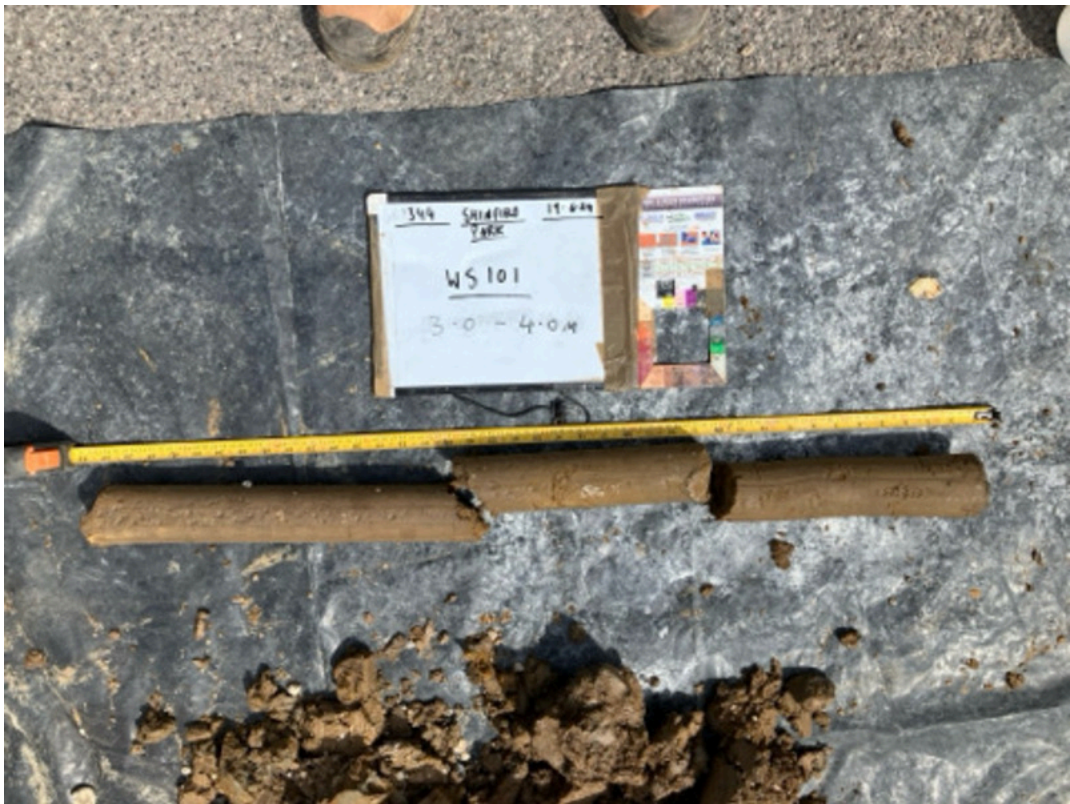
| Client: | | Site Location: | Project No.: |
|---|---|---|---|
| 5 | 19/06/24<br>- 21/06/24 | | |

| Client: | | Site Location: | Project No.: |
|---|---|---|---|
| <b>Description</b><br>WS101 - recovery from 3.0 to 4.0m bgl | | | |

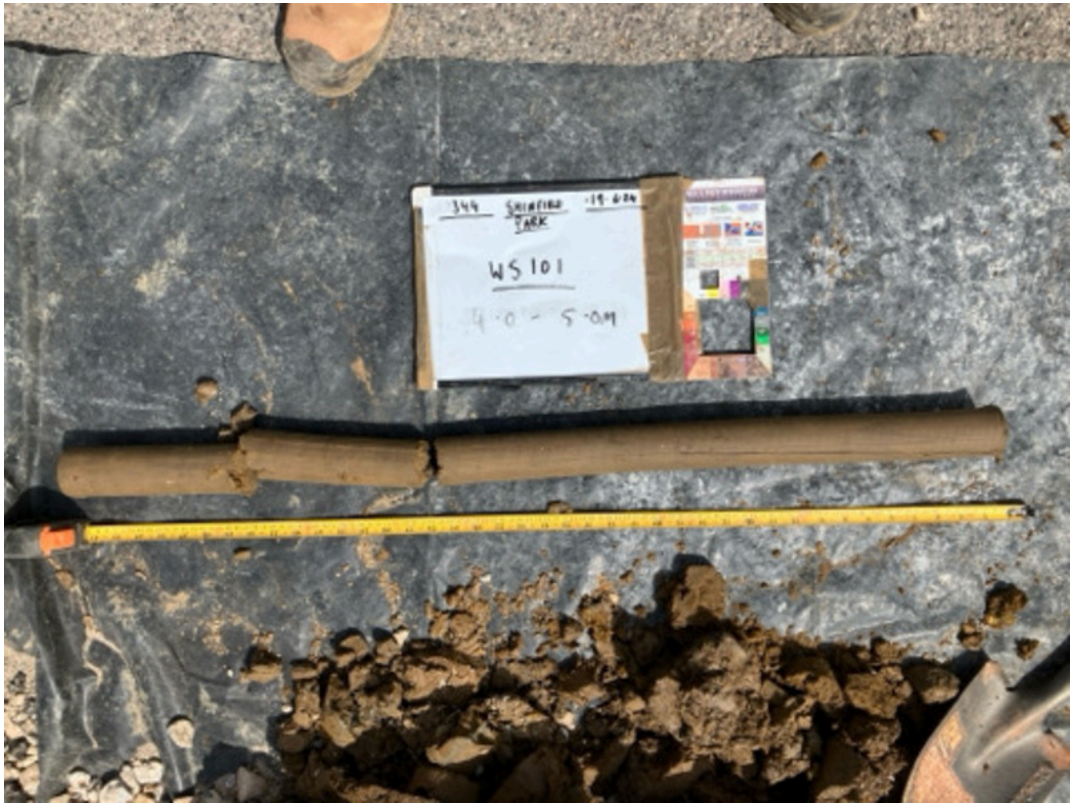
| Photo No. | Date | | |
|---|---|---|--|
| 6 | 19/06/24<br>- 21/06/24 | | |

| Photo No. | Date | | |
|---|---|---|--|
| <b>Description</b><br>WS101 - recovery from 4.0 to 5.0m bgl | | | |

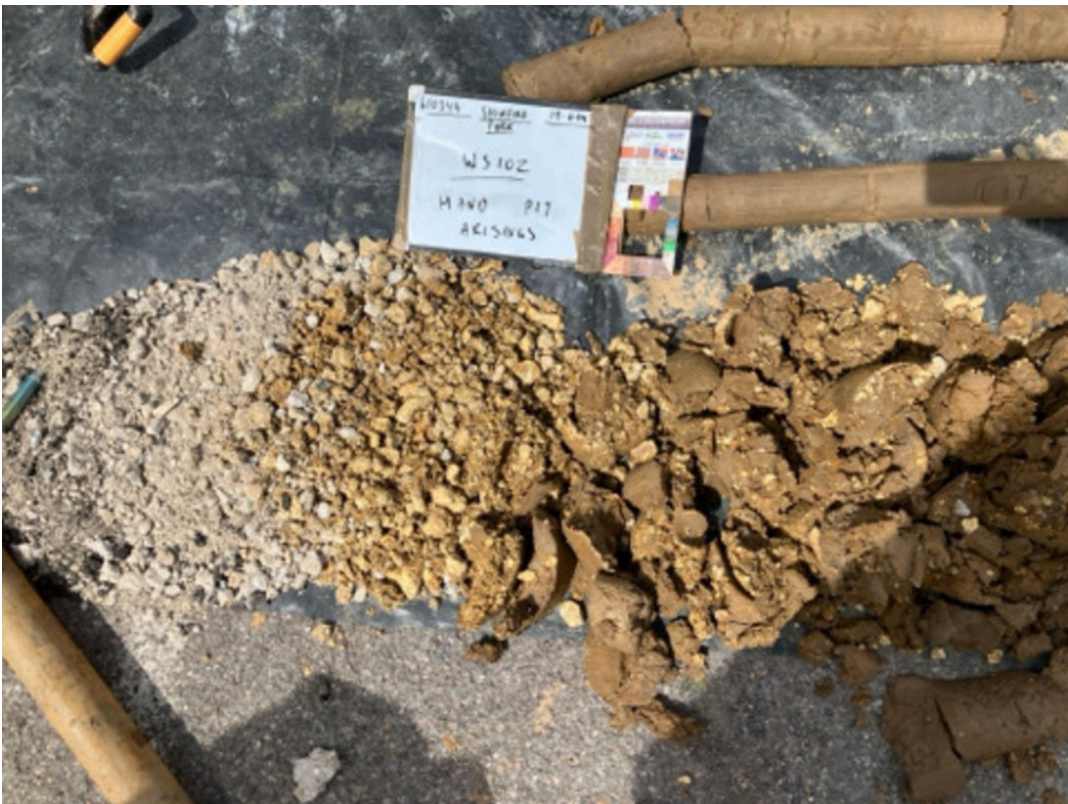
| Client: | | Site Location: | Project No.: |
|---|---|---|---|
| 7 | 19/06/24<br>- 21/06/24 | | |

| Client: | | Site Location: | Project No.: |
|---|---|---|---|
| WS102 - inspection pit arisings | | | |

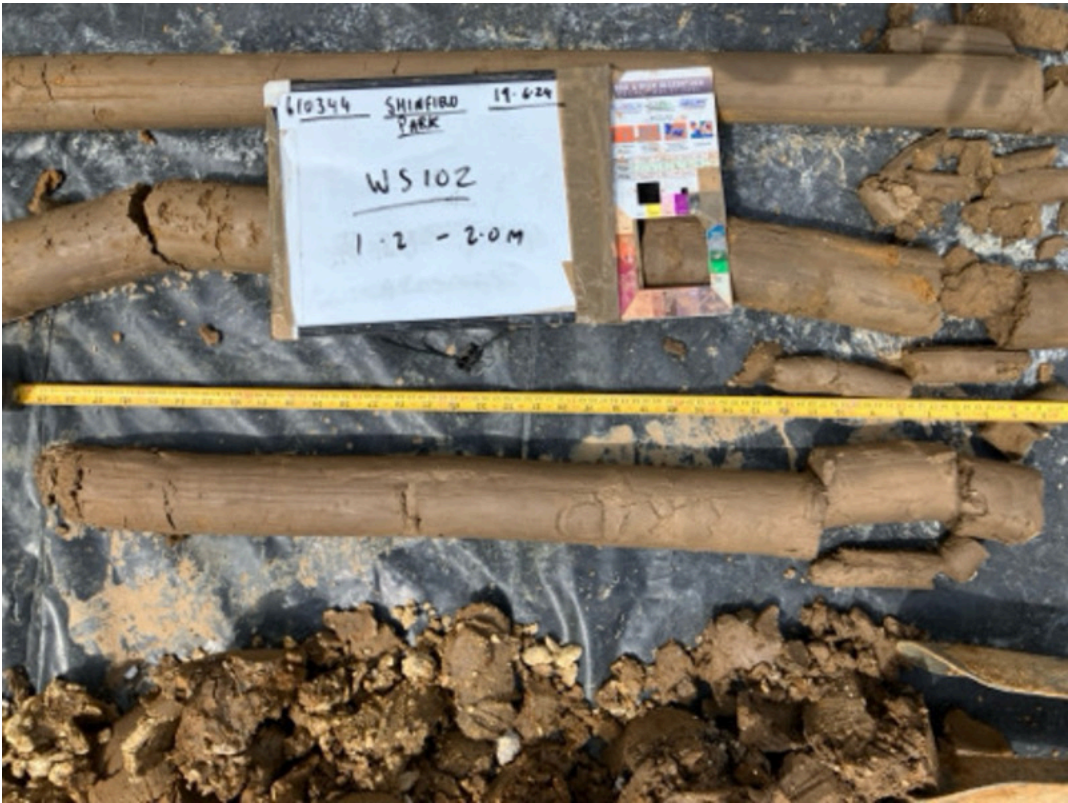
| Photo No. | Date | | |
|---|---|---|--|
| 8 | 19/06/24<br>- 21/06/24 | | |

| Photo No. | Date | | |
|---|---|---|--|
| WS102 - recovery from 1.2 to 2.0m bgl | | | |

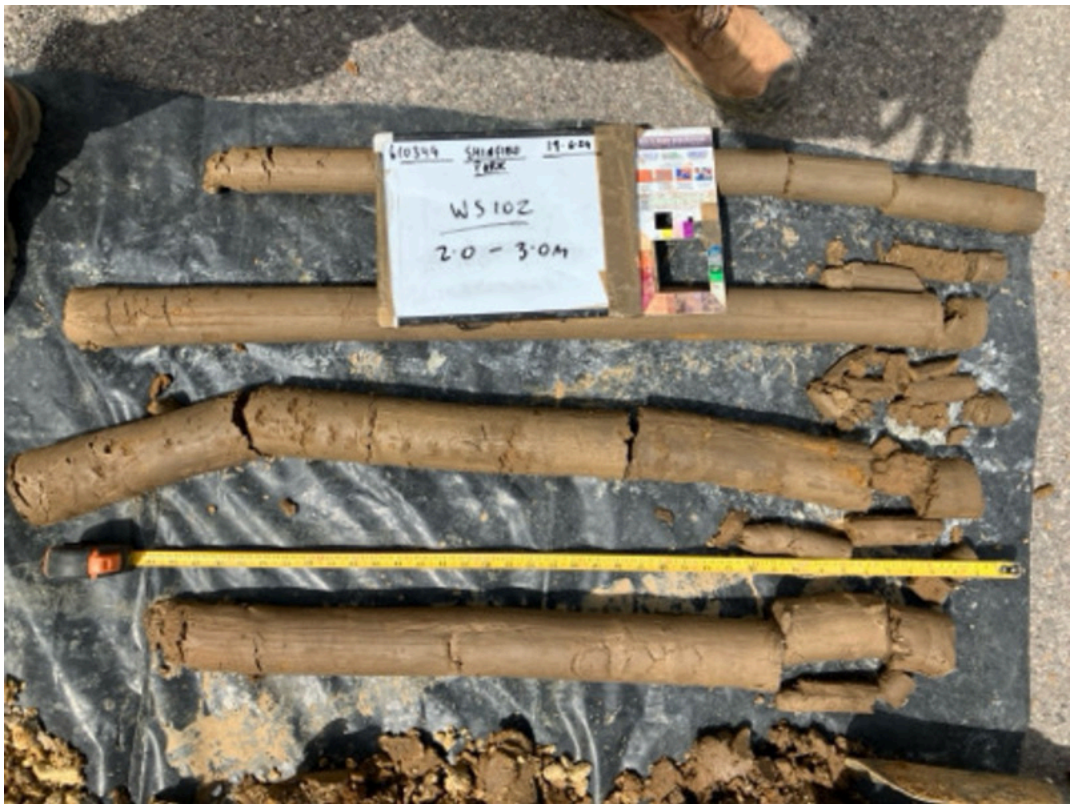
| Client: | | Site Location: | Project No.: |
|---|---|---|---|
| 9 | 19/06/24<br>- 21/06/24 | | |

| Client: | | Site Location: | Project No.: |
|---|---|---|---|
| <b>Description</b><br>WS102 - recovery from 2.0 to 3.0m bgl | | | |

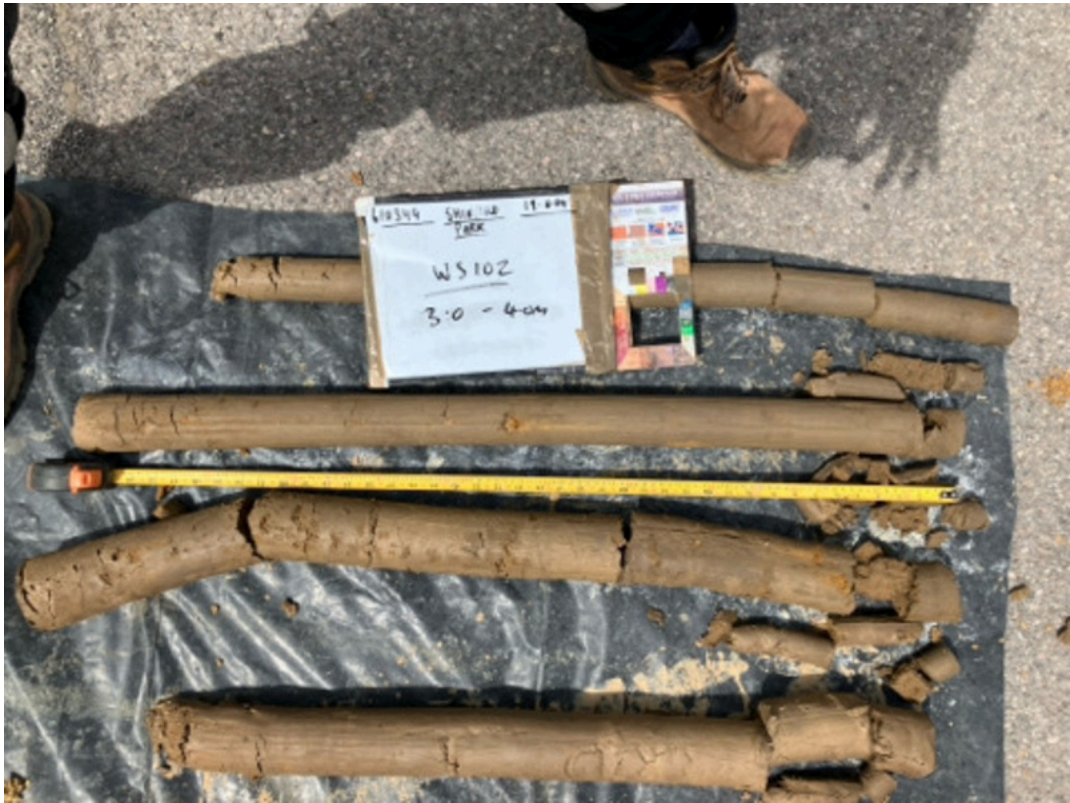
| Photo No. | Date | | |
|---|---|---|--|
| 10 | 19/06/24<br>- 21/06/24 | | |

| Photo No. | Date | | |
|---|---|---|--|
| <b>Description</b><br>WS102 - recovery from 3.0 to 4.0m bgl | | | |

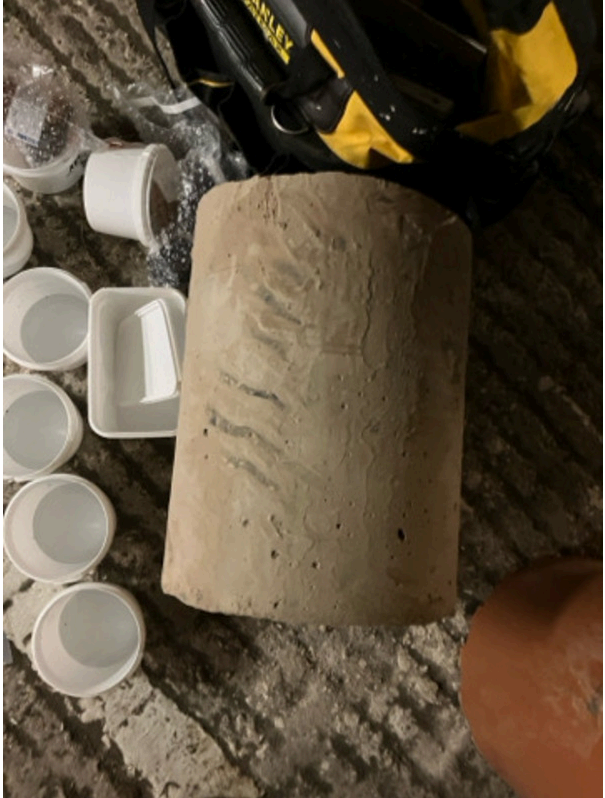
| Client: | | Site Location: | Project No.: |
|---|---|---|---|
| 11 | 19/06/24<br>- 21/06/24 | | |

| Client: | | Site Location: | Project No.: |
|---|---|---|---|
| <b>Description</b><br>WS110 - concrete core | | | |

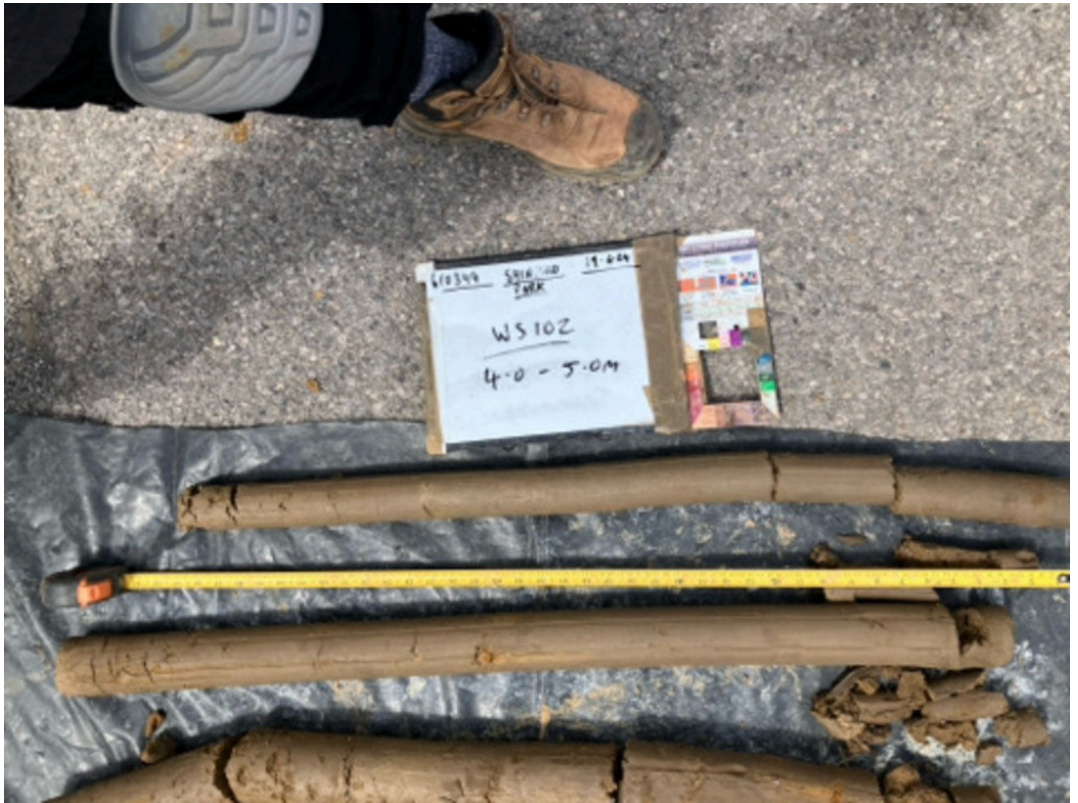
| Photo No. | Date | | |
|---|---|---|--|
| 12 | 19/06/24<br>- 21/06/24 | | |

| Photo No. | Date | | |
|---|---|---|--|
| <b>Description</b><br>WS102 - recovery from 4.0 to 5.0m bgl | | | |

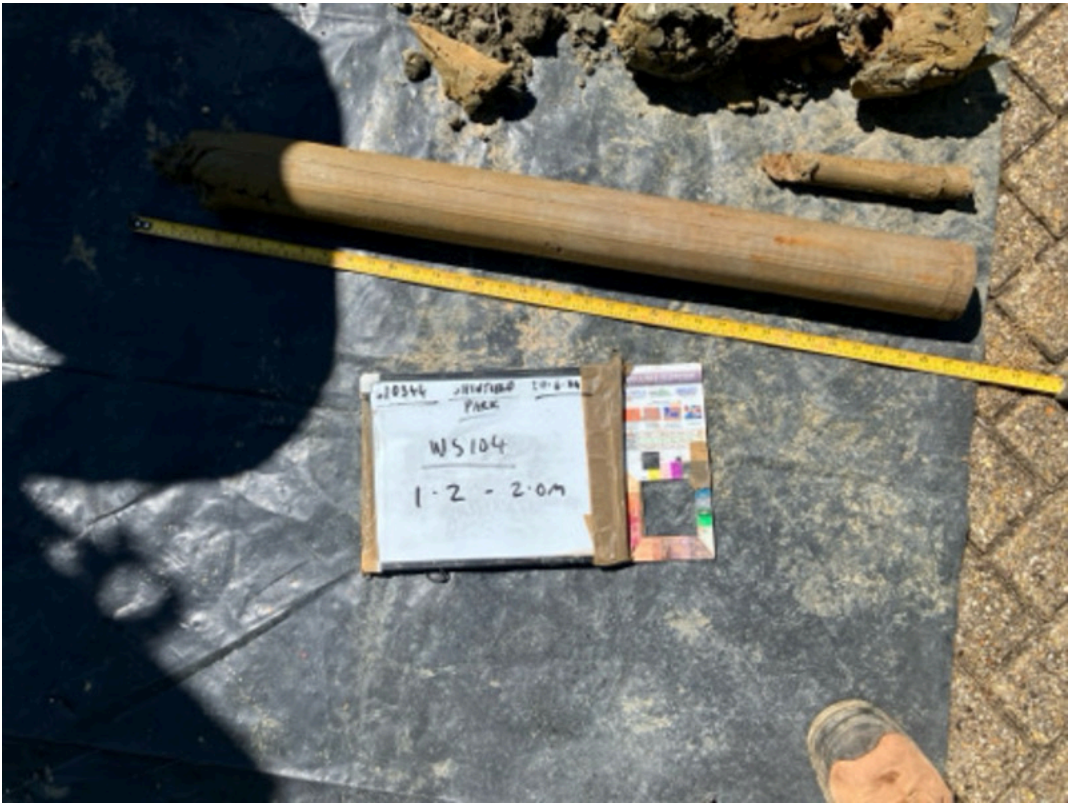
| Photo No. | Date | | |
|---|---|---|--|
| 14 | 19/06/24<br>- 21/06/24 | | |

| Photo No. | Date | | |
|---|---|---|--|
| WS104 - recovery from 1.2 to 2.0m bgl | | | |

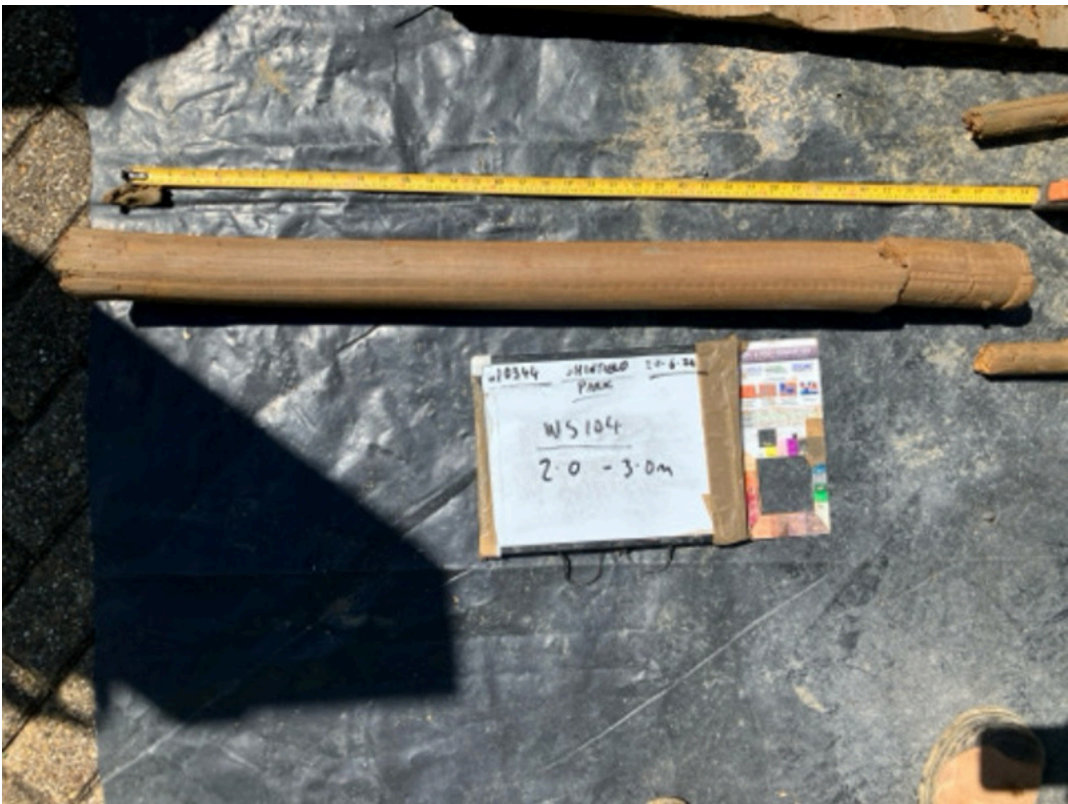
| Client: | | Site Location: | Project No.: |
|---|---|---|---|
| 15 | 19/06/24<br>- 21/06/24 | | |

| Client: | | Site Location: | Project No.: |
|---|---|---|---|
| <b>Description</b><br>WS104 - recovery from 2.0 to 3.0m bgl | | | |

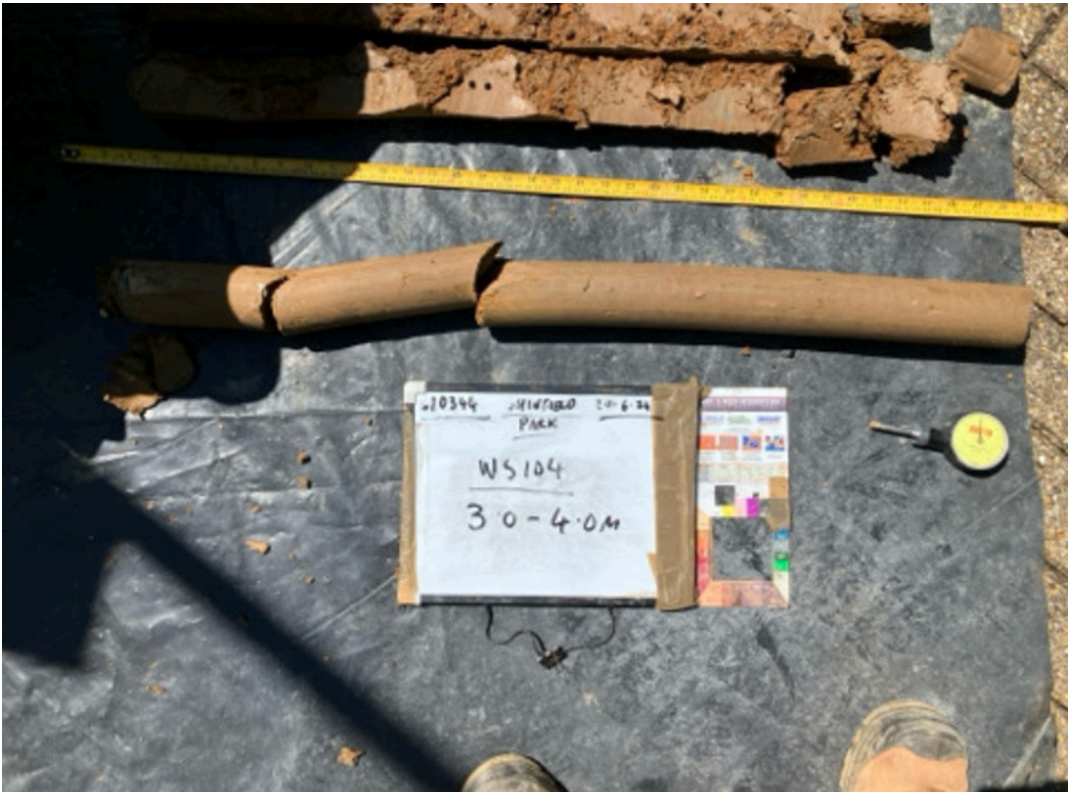
| Photo No. | Date | | |
|---|---|---|--|
| 16 | 19/06/24<br>- 21/06/24 | | |

| Photo No. | Date | | |
|---|---|---|--|
| <b>Description</b><br>WS104 - recovery from 3.0 to 4.0m bgl | | | |

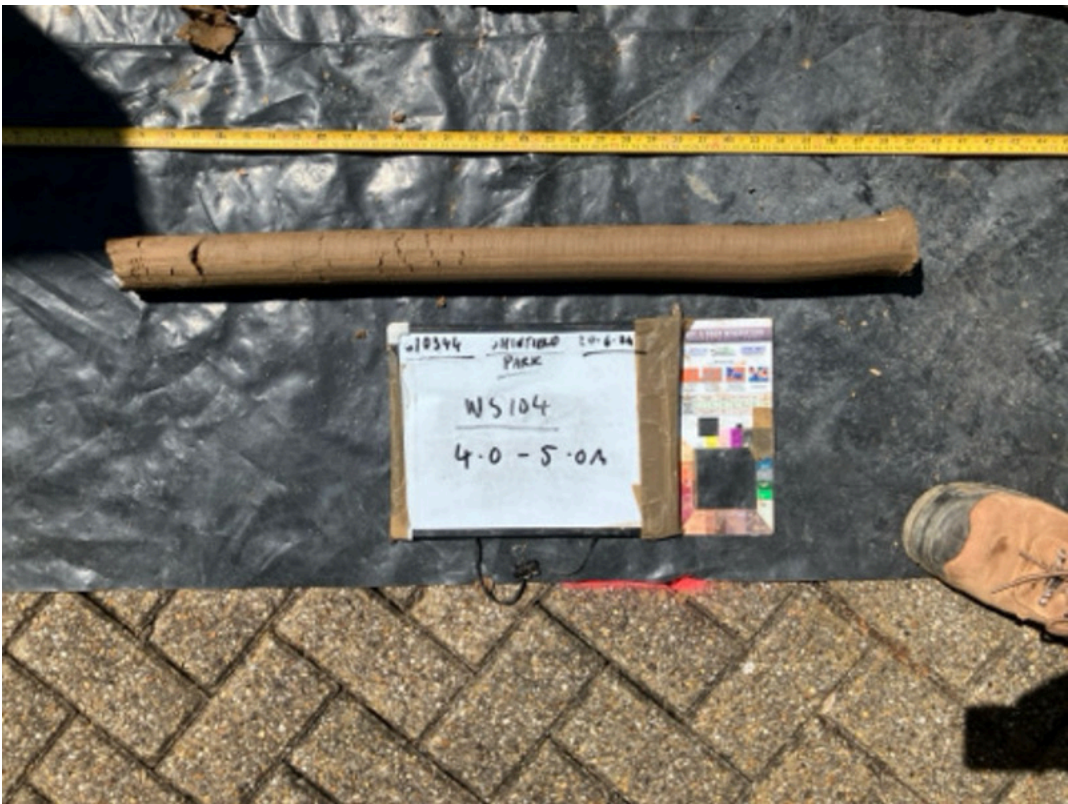
| Client: | | Site Location: | Project No.: |
|---|---|---|---|
| 17 | 19/06/24<br>- 21/06/24 | | |

| Client: | | Site Location: | Project No.: |
|---|---|---|---|
| <b>Description</b><br>WS104 - recovery from 4.0 to 5.0m bgl | | | |

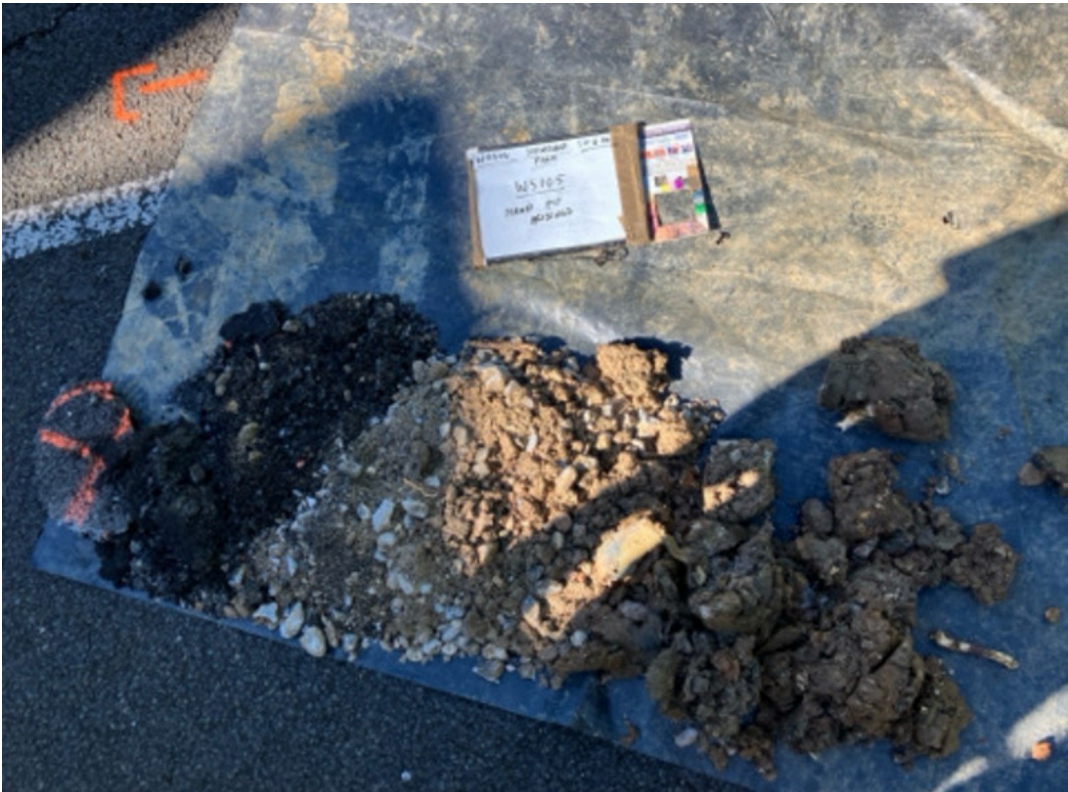
| Photo No. | Date | | |
|---|---|---|--|
| 18 | 19/06/24<br>- 21/06/24 | | |

| Photo No. | Date | | |
|---|---|---|--|
| <b>Description</b><br>WS105 - inspection pit arisings | | | |

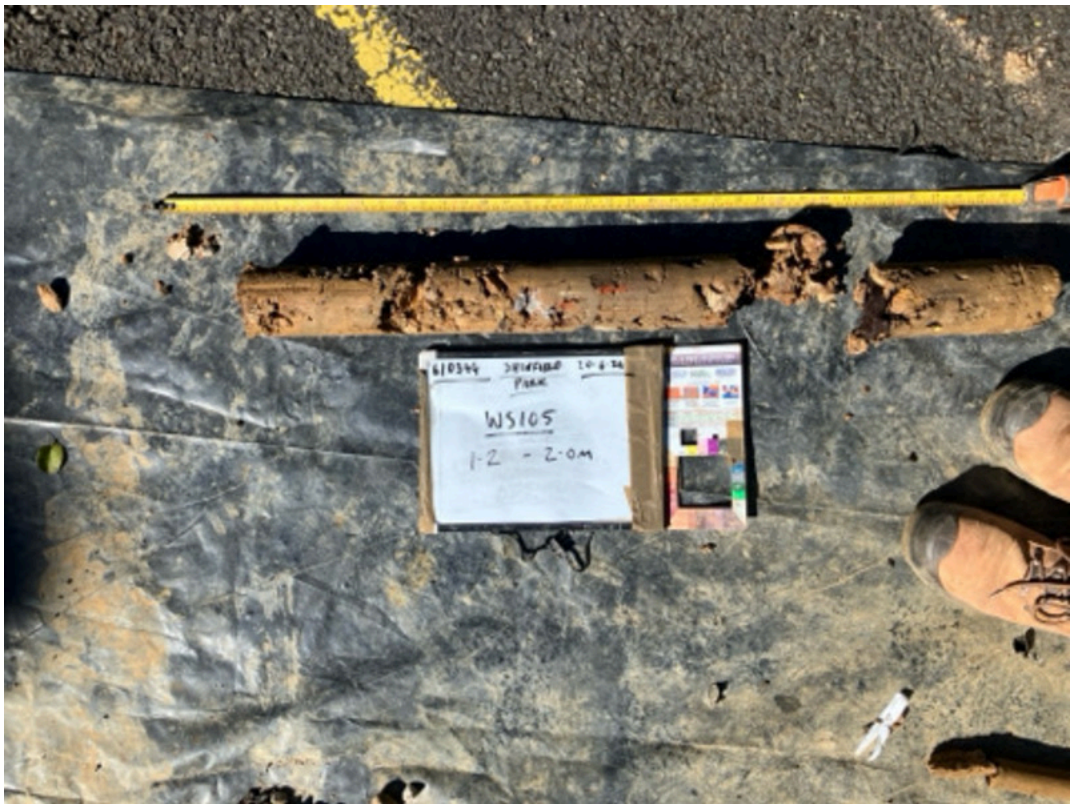
| Client: | | Site Location: | Project No.: |
|---|---|---|---|
| 19 | 19/06/24<br>- 21/06/24 | | |

| Client: | | Site Location: | Project No.: |
|---|---|---|---|
| <b>Description</b><br>WS105 - recovery from 1.2 to 2.0m bgl | | | |

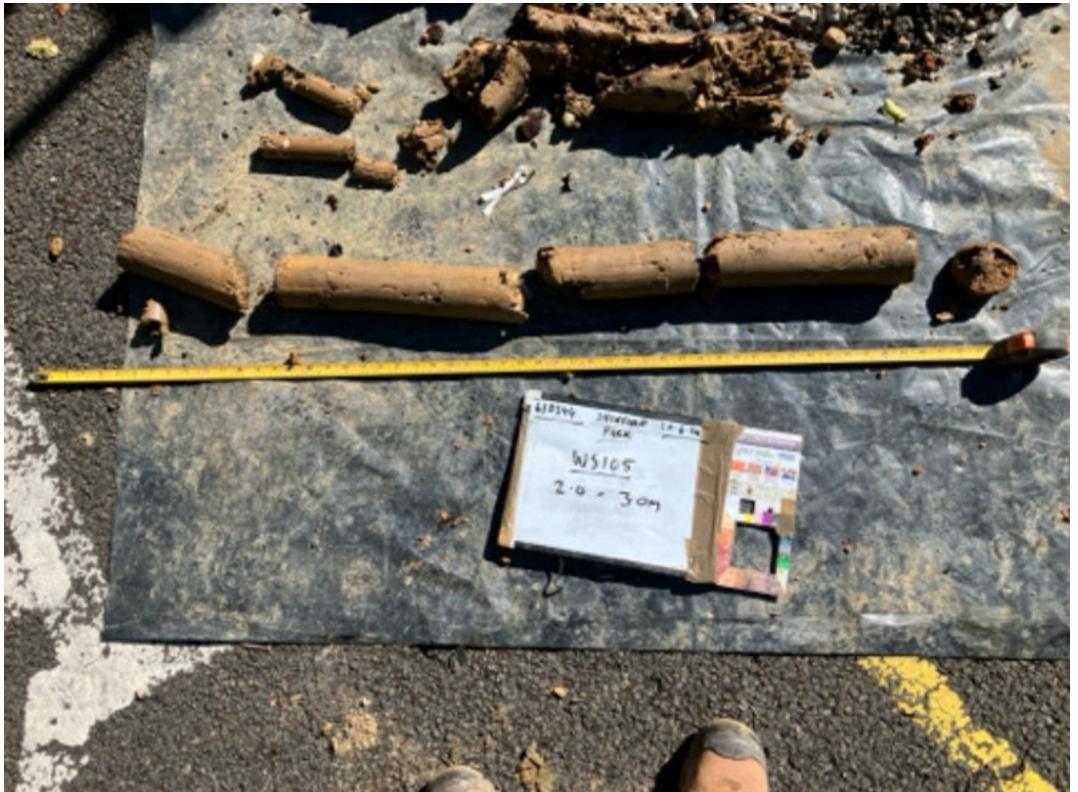
| Photo No. | Date | | |
|---|---|---|--|
| 20 | 19/06/24<br>- 21/06/24 | | |

| Photo No. | Date | | |
|---|---|---|--|
| <b>Description</b><br>WS105 - recovery from 2.0 to 3.0m bgl | | | |

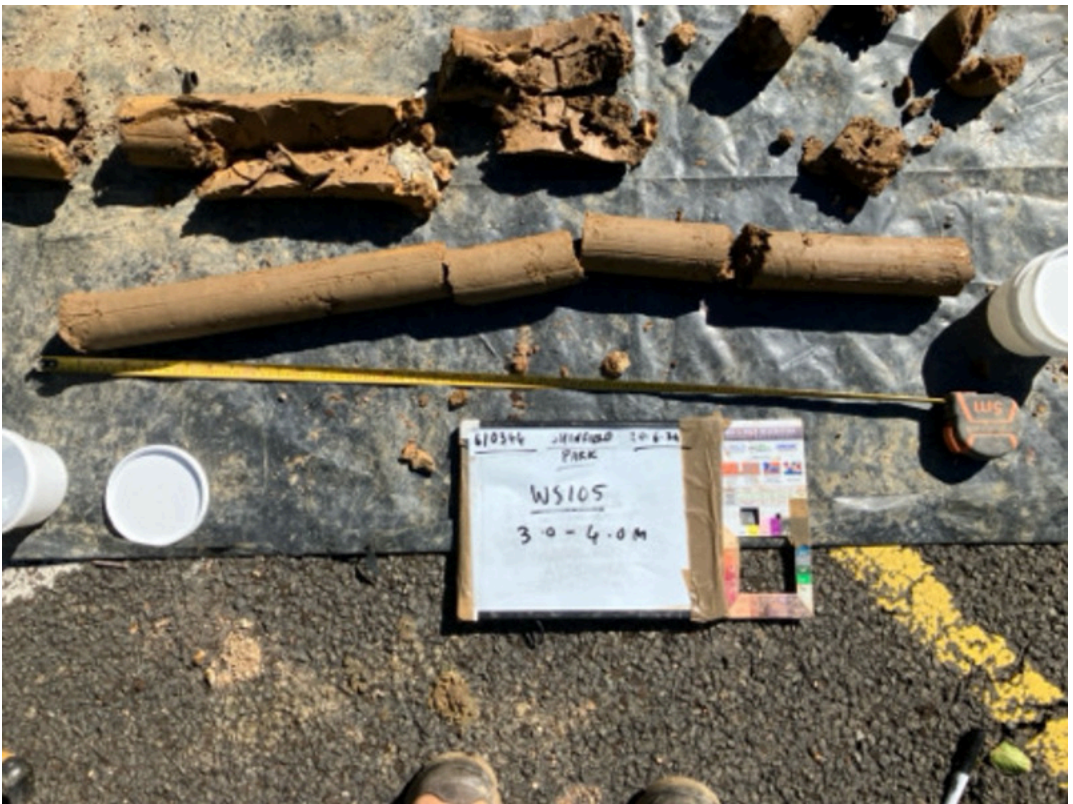
| Client: | | Site Location: | Project No.: |
|---|---|---|---|
| 21 | 19/06/24<br>- 21/06/24 | | |

| Client: | | Site Location: | Project No.: |
|---|---|---|---|
| <b>Description</b><br>WS105 - recovery from 3.0 to 4.0m bgl | | | |

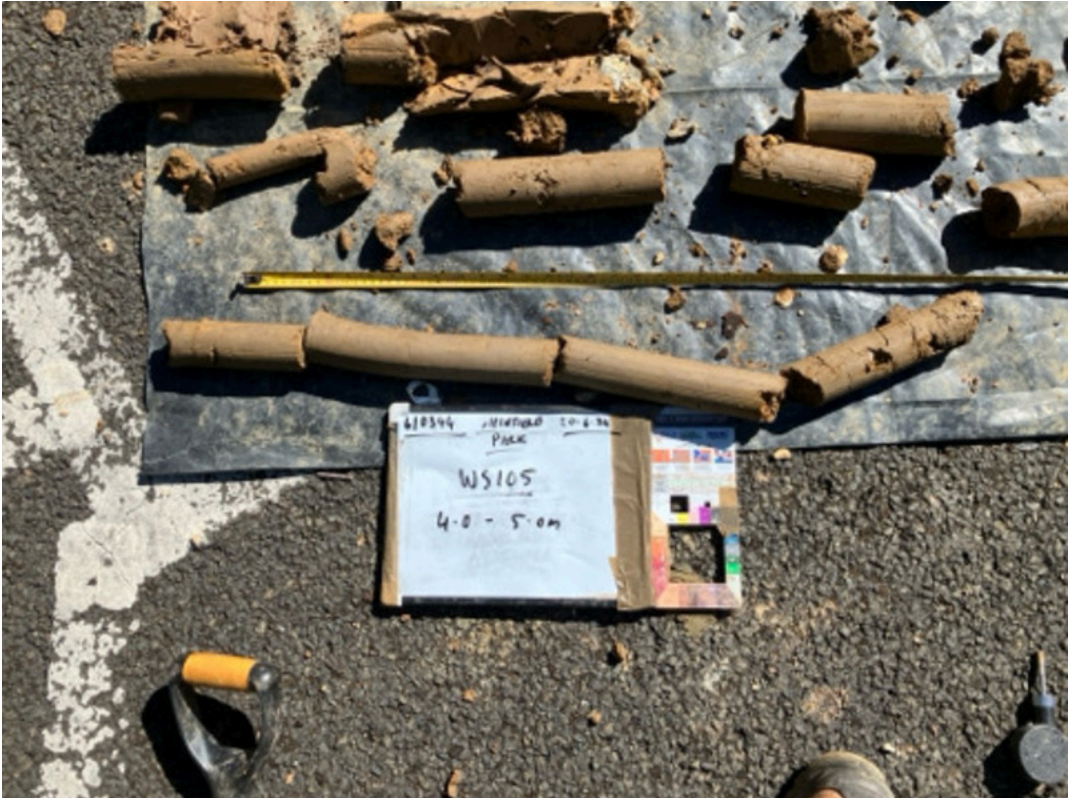
| Photo No. | Date | | |
|---|---|---|--|
| 22 | 19/06/24<br>- 21/06/24 | | |

| Photo No. | Date | | |
|---|---|---|--|
| <b>Description</b><br>WS105 - recovery from 4.0 to 5.0m bgl | | | |
