WRENBRIDGE

SHINFIELD PARK  
READING

PROPOSED EARTHWORKS  
OPTION 16

## **Annex B: Site Photographs**

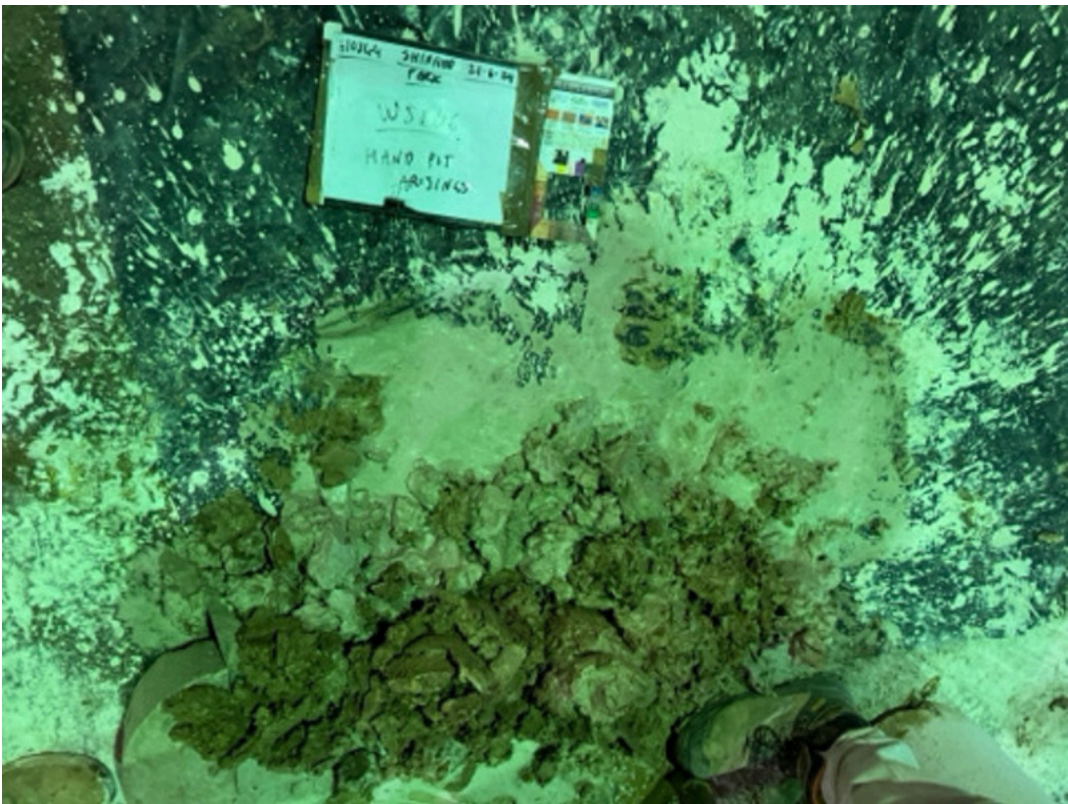
| Client: | | Site Location: | Project No.: |
|---|---|---|---|
| 23 | 19/06/24<br>- 21/06/24 | | |

| Client: | | Site Location: | Project No.: |
|---|---|---|---|
| <b>Description</b><br>WS106 - inspection pit arisings | | | |

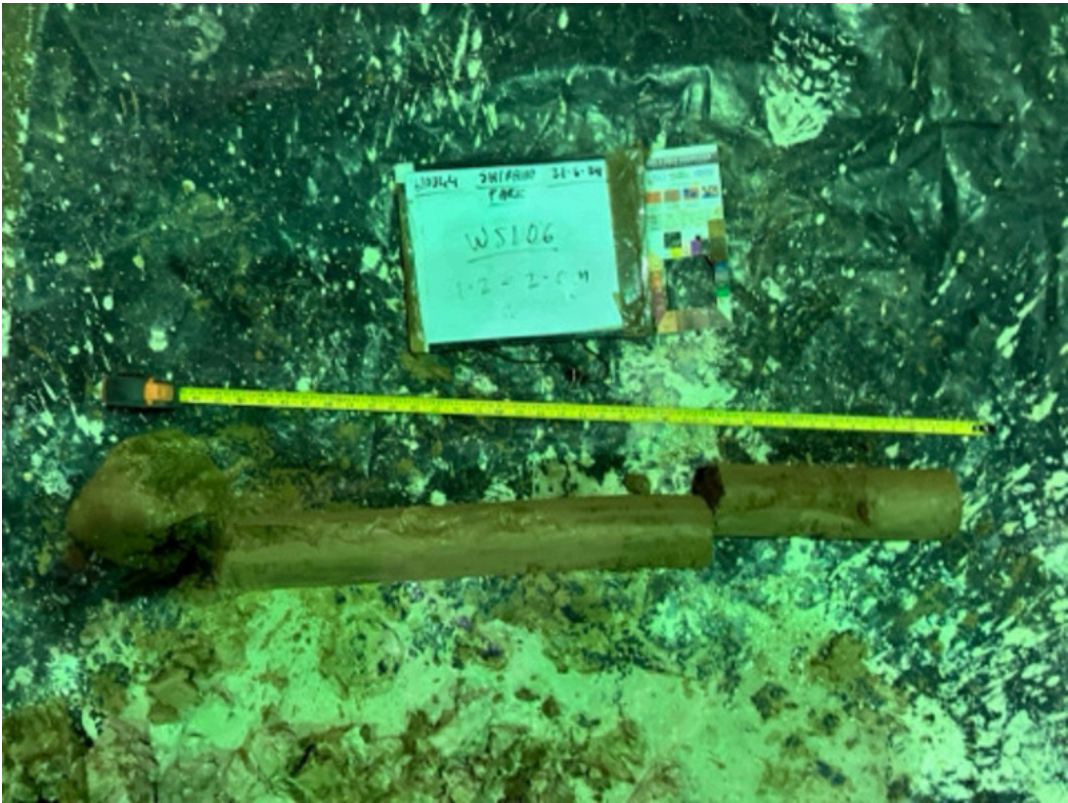
| Photo No. | Date | | |
|---|---|---|--|
| 24 | 19/06/24<br>- 21/06/24 | | |

| Photo No. | Date | | |
|---|---|---|--|
| <b>Description</b><br>WS106 - recovery from 1.2 to 2.0m bgl | | | |

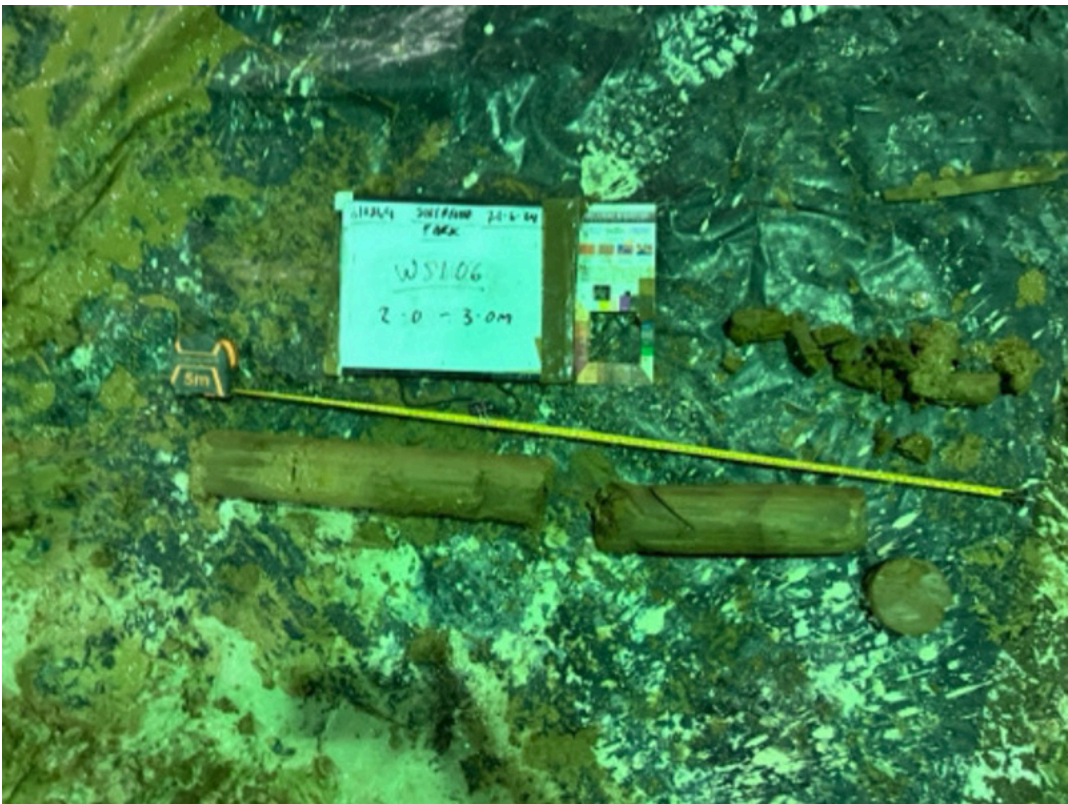
| Client: | | Site Location: | Project No.: |
|---|---|---|---|
| 25 | 19/06/24<br>- 21/06/24 | | |

| Client: | | Site Location: | Project No.: |
|---|---|---|---|
| <b>Description</b><br>WS106 - recovery from 2.0 to 3.0m bgl | | | |

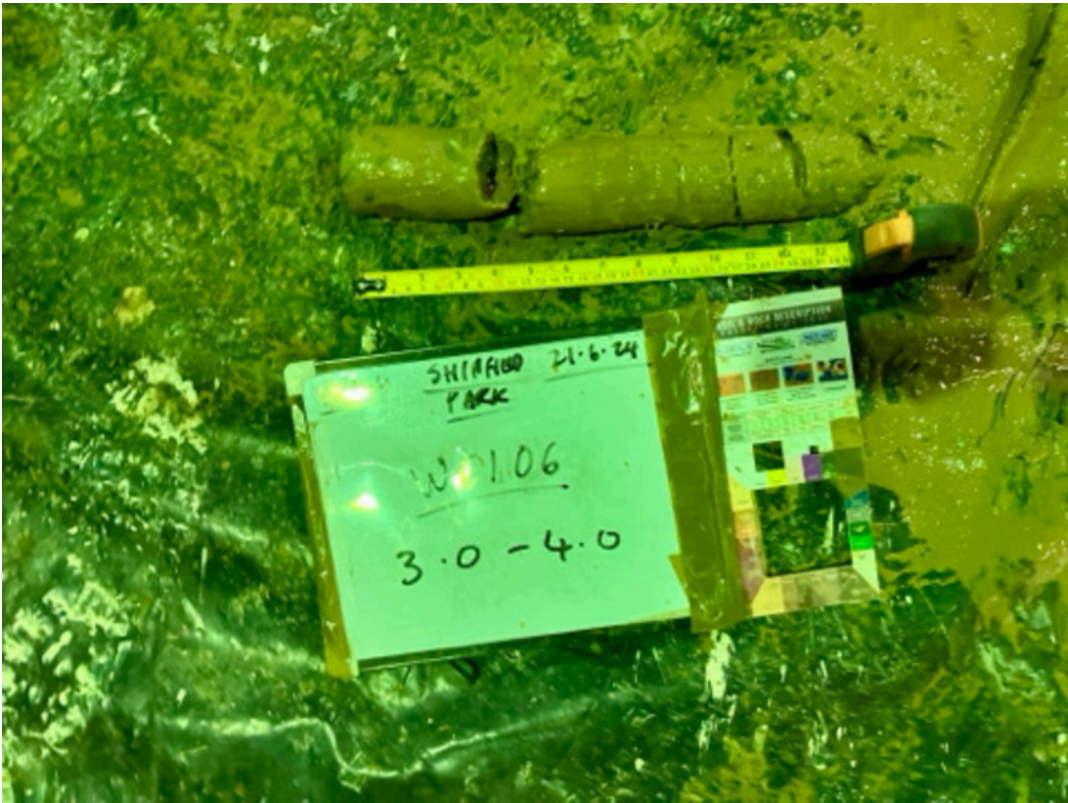
| Photo No. | Date | | |
|---|---|---|--|
| 26 | 19/06/24<br>- 21/06/24 | | |

| Photo No. | Date | | |
|---|---|---|--|
| <b>Description</b><br>WS106 - recovery from 3.0 to 4.0m bgl | | | |

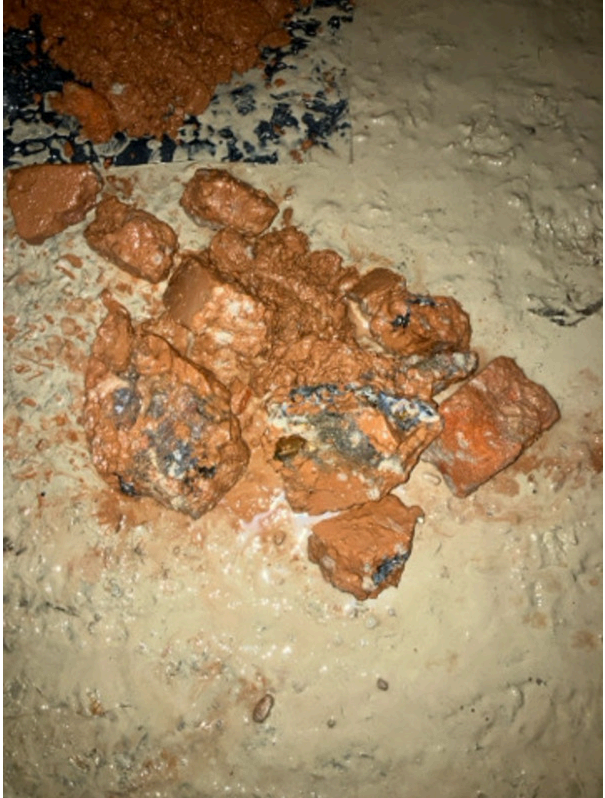
| Client: | | Site Location: | Project No.: |
|---|---|---|---|
| 27 | 19/06/24<br>- 21/06/24 | | |

| Client: | | Site Location: | Project No.: |
|---|---|---|---|
| <b>Description</b><br>WS110 - bricks from pit | | | |

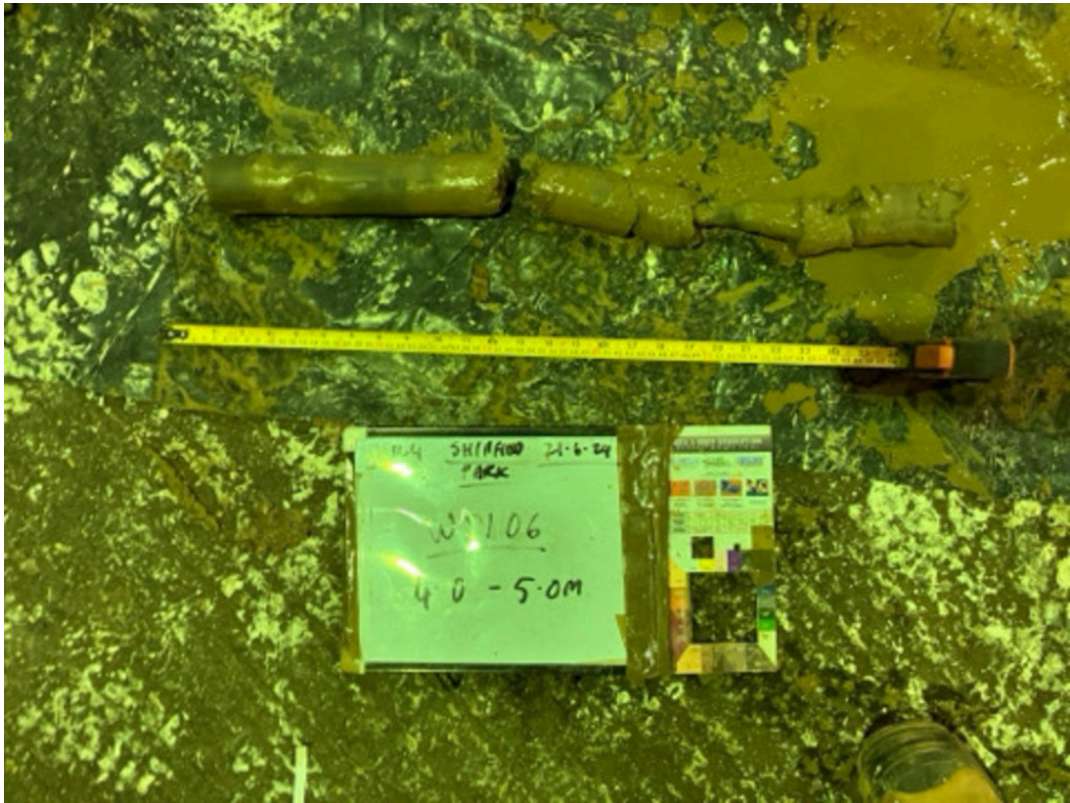
| Photo No. | Date | | |
|---|---|---|--|
| 28 | 19/06/24<br>- 21/06/24 | | |

| Photo No. | Date | | |
|---|---|---|--|
| <b>Description</b><br>WS106 - recovery from 4.0 to 5.0m bgl | | | |

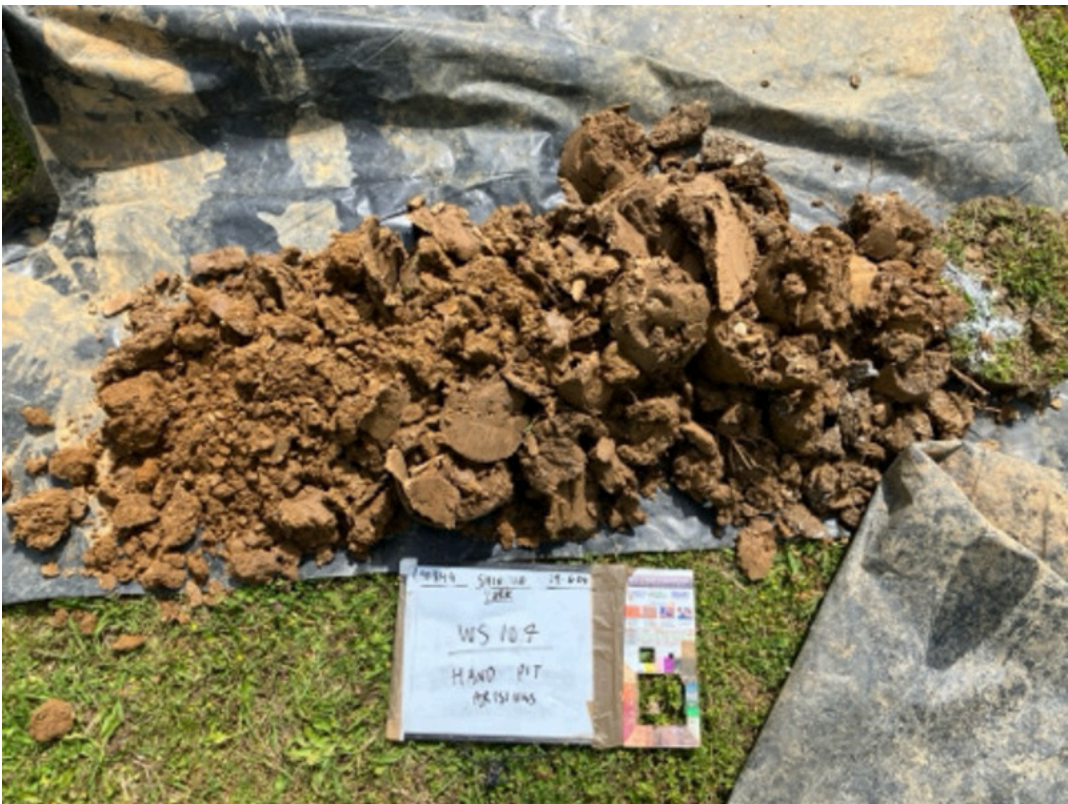
| Client: | | Site Location: | Project No.: |
|---|---|---|---|
| 29 | 19/06/24<br>- 21/06/24 | | |

| Client: | | Site Location: | Project No.: |
|---|---|---|---|
| <b>Description</b><br>WS107 - inspection pit arisings | | | |

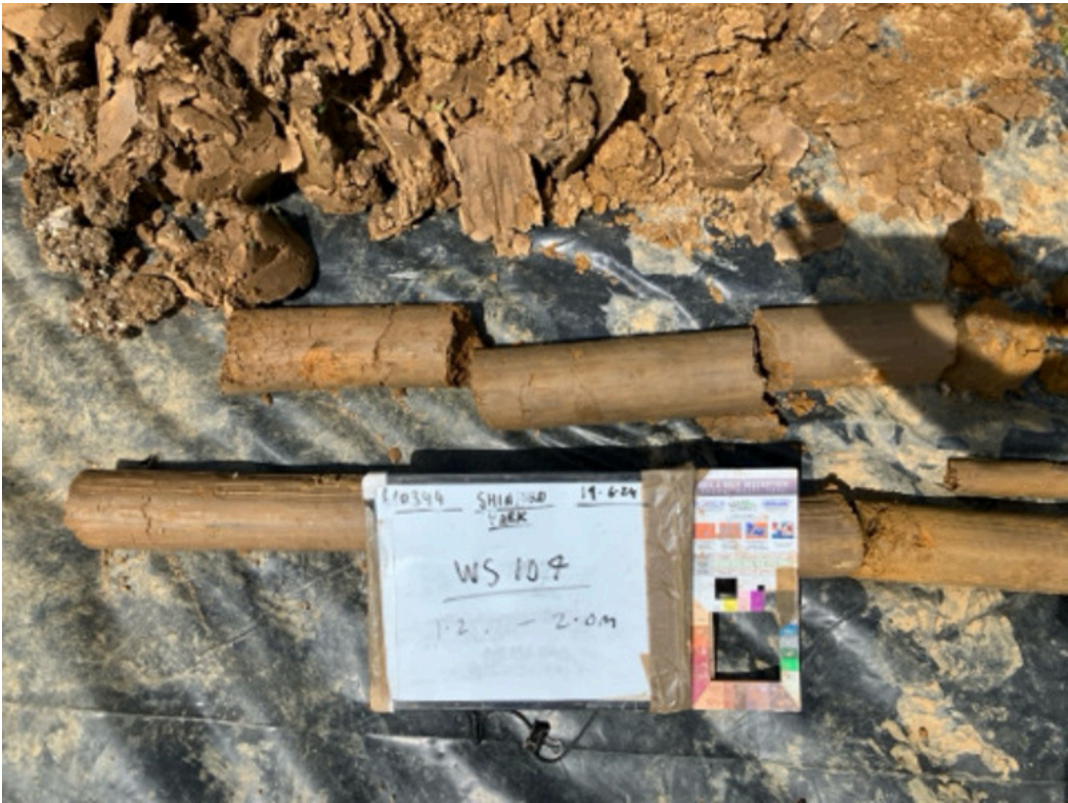
| Photo No. | Date | | |
|---|---|---|--|
| 30 | 19/06/24<br>- 21/06/24 | | |

| Photo No. | Date | | |
|---|---|---|--|
| <b>Description</b><br>WS107 - recovery from 1.2 to 2.0m bgl | | | |
