**6 Barber Close  
Hurst  
Reading  
Berkshire  
RG10 0RZ**

## **Preliminary Roost Assessment**

Report ref.: R2851\_PRA\_a

**February 2025**

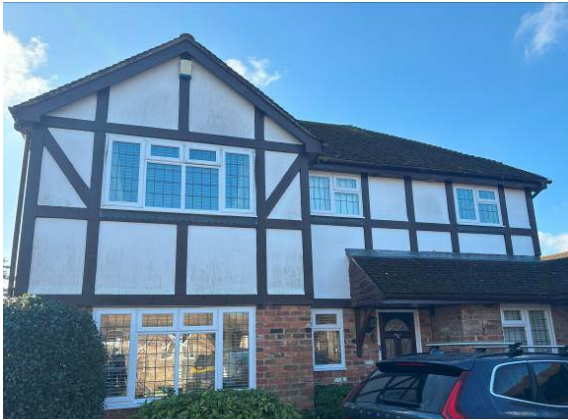
- 5.2.2** The property was a detached brick built residential dwelling with a connecting garage (Photographs 1 - 3).

Photograph 1. Front of the house viewed from the north.

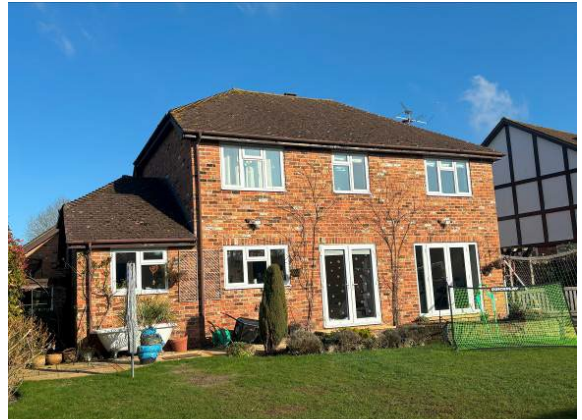
Photograph 2. Rear of the house viewed from the south.

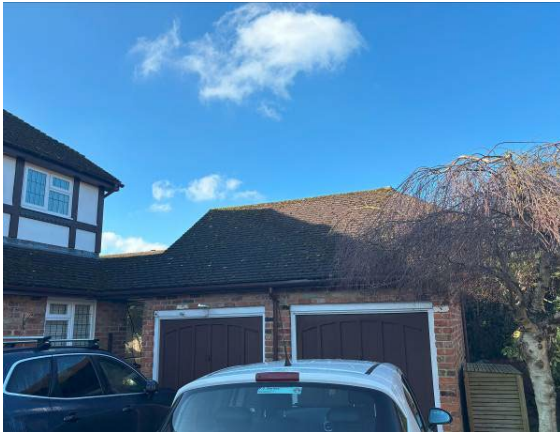
Photograph 3. Garage towards the front western side of the house.

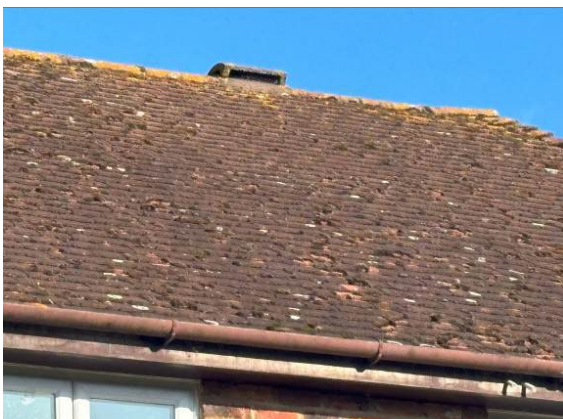
- 5.2.3** The plain roof tiles were flat and intact throughout on the main roof, half hipped single storey side extension and porch which connected to the garage (**Photograph 4**). The tiles were heavily moss covered in particular on the northern elevations of the main roof and side extension roof (**Photograph 5**).

Photograph 4. Roof tiles all in place, flat and tightly fitted on the main roof.

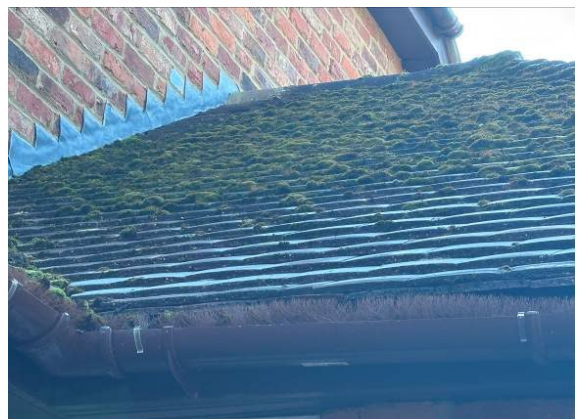
Photograph 5. Roof tiles moss covered on the single storey side extension.

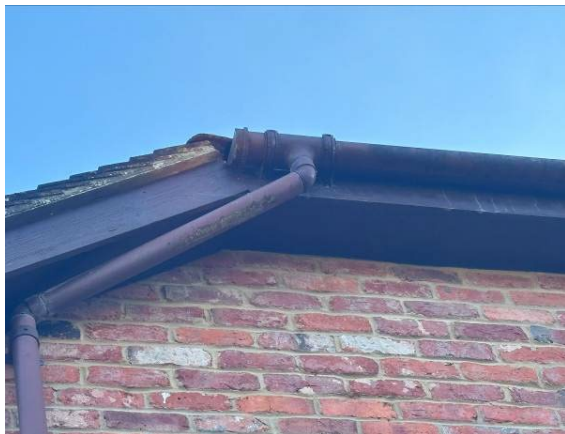
- 5.2.4** The mortar beneath the ridge and hip tiles was mostly intact throughout apart from one gap at the north western corner, which was partially observed by guttering (**Photograph 6; Target note 1**).

*Photograph 6. Gap in mortar at the north western corner of the side.*

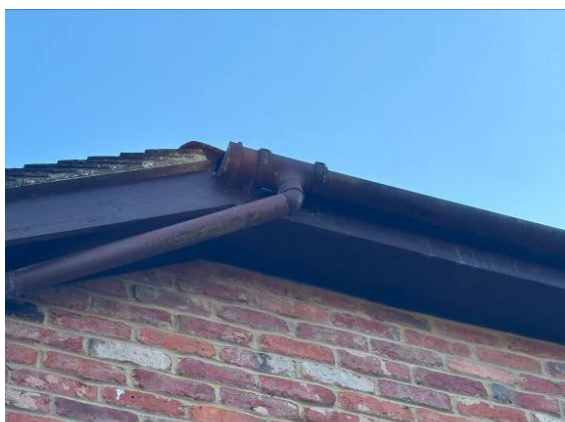
- 5.2.5** The timber soffits were tight to the brickwork throughout and lead flashing was tight where the extension and porch joined the main house (**Photographs 7 & 8**). The chimney was also tight at the eastern end of the house (**Photograph 9**).

*Photograph 7. Soffits tight along the eaves at the western side of the house.*

**6.1.1** The property had potential bat access points beneath a hip tile at the western end of the property, where mortar was missing and daylight was visible internally, and slight gaps behind the hanging tiles on the porch (**Photographs 7, 12 & 10; Target notes 1, 4 & 2**).

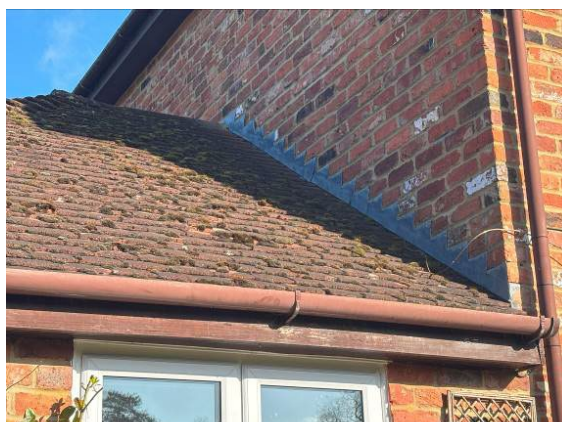
*Photograph 8. Lead flashing tight at the junction of the single storey extension with the main house.*

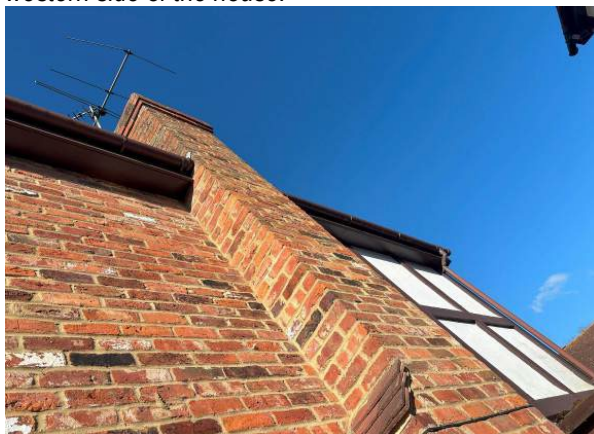
*Photograph 9. Chimney tight at the eastern end of the house.*

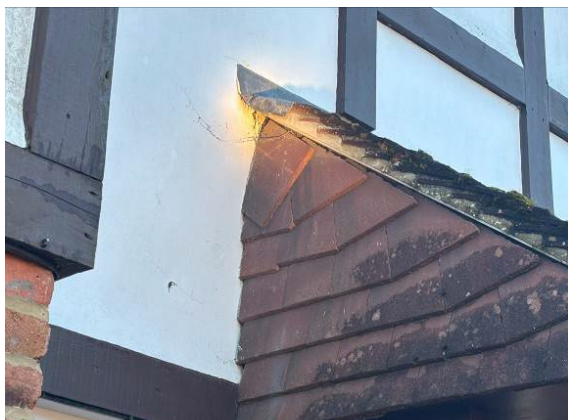
- 5.2.6** A small section of the porch was clad with hanging tiles, which had gaps at the apex and along the edges, offering a feature considered to be of low potential for use by bats (**Photographs 10; Target note 2**).

*Photograph 10. Gaps around edges of hanging tiles on the porch.*

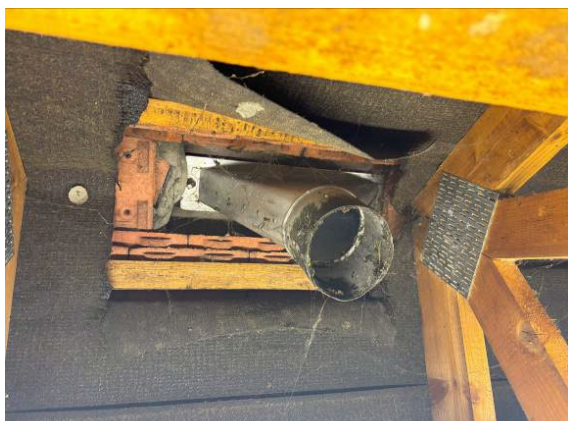
- 5.2.7** The building had two roof voids. The main roof void covered the two storey footprint of the house and was accessed via a central hatch. The space had a maximum height of approximately 2.5m and was lined with bitumen felt, which was intact throughout, apart from a gap around a ventilation pipe along the ridge, which was not suitable for use by bats (**Photograph 11; Target note 3**). The floor was covered in fibreglass insulation, which filled most of the eaves. The half hipped end was tight with blockwork with no daylight visible at the eastern end, Daylight was visible towards the north western corner, where a timber ledge was visible, which showed no evidence of use by bats and had no crevices present (**Photograph 12; Target note 4**). The front northern facing gable end was of blockwork construction which was tight with no daylight visible (**Photograph 13**). The ridge beam was lightly cobwebbed. Overall the void was clear of items and clean. No evidence of bats was found (**Photograph 14**).

*Photograph 11. Gap in felt around a ventilation pipe.*

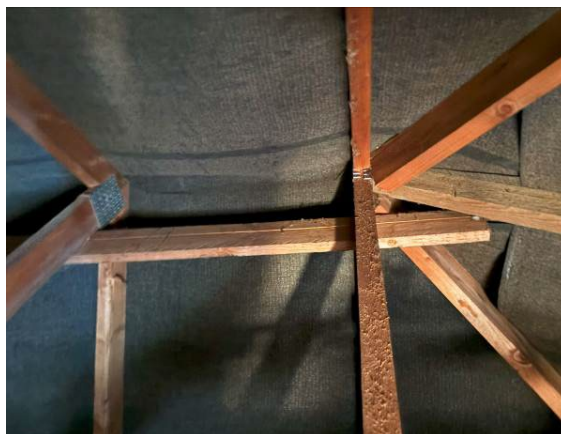
**5.2.8** The second void was accessed via a small hatch on the single storey extension at the western end of the property. The space had a maximum height of approximately 1.5m and was lined with bitumen felt, which was intact throughout. The floor was covered in fibreglass insulation into the eaves. The blockwork and brickwork gables were intact with no daylight visible. The ridge beam was lightly cobwebbed. Overall the void was clear of items and clean. No evidence of bats was found (**Photographs 15 & 16**).

*Photograph 16. Bitumen felt intact throughout the void and the ridge was lightly cobwebbed.*
