**22a and 22b Barkham Ride  
Finchampstead**

**Report for:**  
A1 Roberts Properties Limited  
31 Barkham Ride  
Finchampstead  
Berkshire  
RG40 4EX

### **Follow-up Site Survey (Photographs 1 - 4)**

## **Photograph Record Sheet**

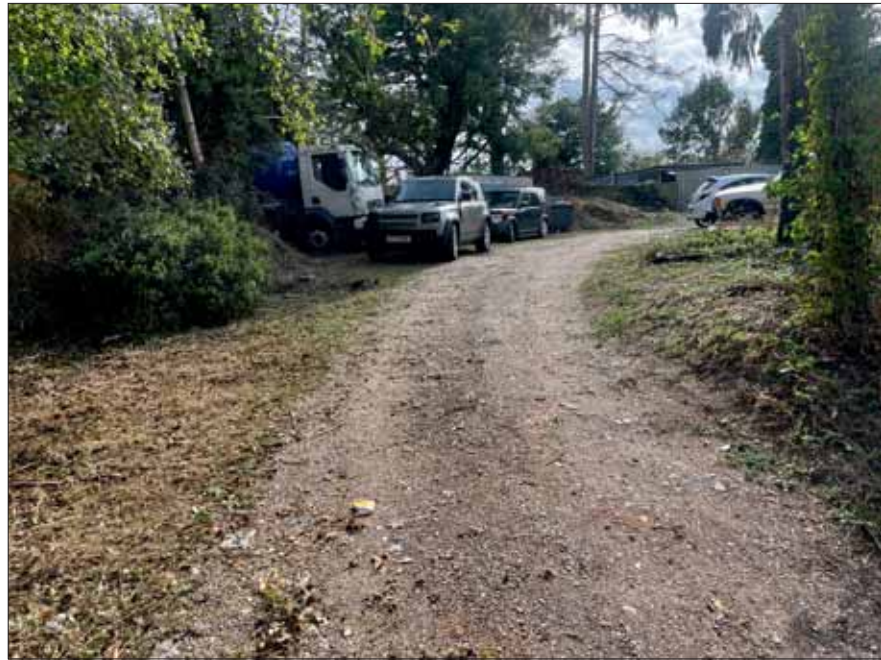
Photograph 1: Showing the existing access.

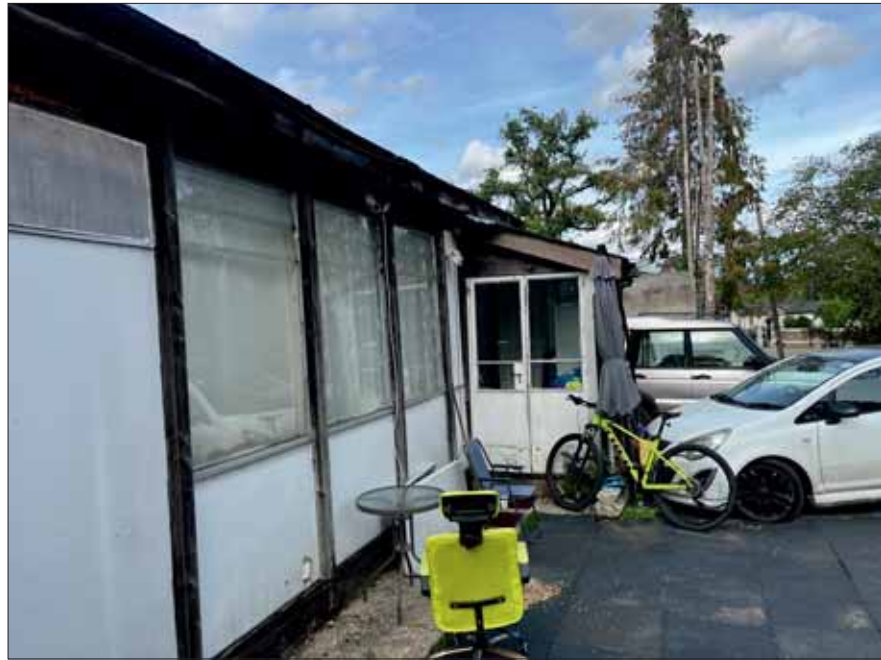
Conditions on the site remained similar to those previously recorded, with the site comprising the existing buildings with associated hardstanding and vegetation. The buildings remained in a similar condition as previously recorded.

Photograph 2: Showing the front of the existing buildings.

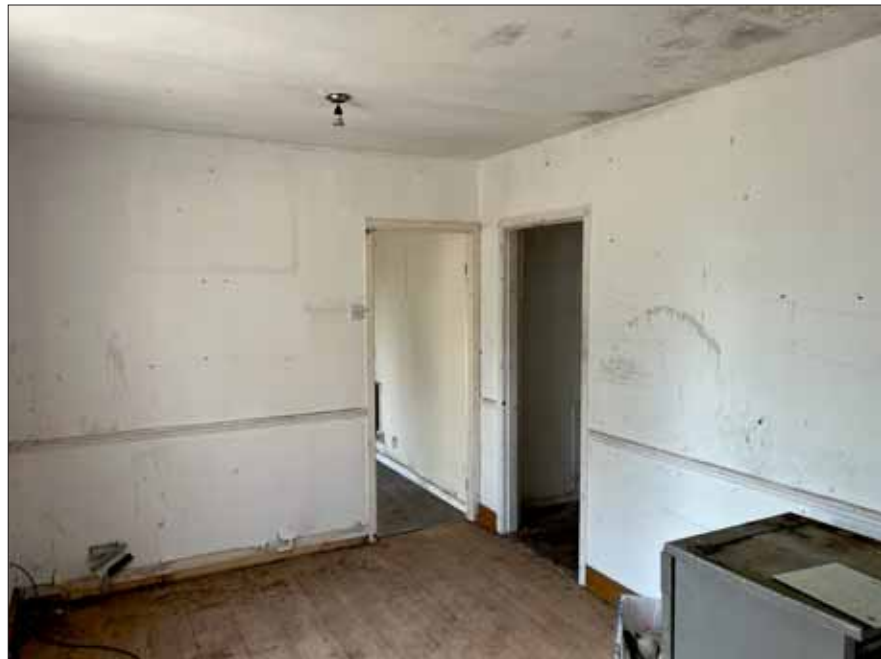
No evidence of bats was recorded during a careful re-inspection of the buildings, which due to their construction type and/or condition were assessed to provide **negligible** roosting opportunities for bats. The site, being dominated by the buildings and bare/disturbed ground, provides only limited foraging opportunities for bats. A number of trees require felling, but all have been assessed under the category **NONE**, due to their age, size and/or lack of any obvious PRF's. The off-site apple tree was assessed under the category **FAR** due to the presence of a rot hole on one branch. On further investigation, the rot hole was fully investigated with no evidence of bats recorded and consequently the tree was assessed under the category **PRF-I**. **N.B. The apple tree is located off-site and consequently scheduled to be retained.**

Photograph 3: Showing the internal structure of one of the buildings.

A thorough examination of the existing buildings has been completed over a number of years (originally in 2023, repeated in 2024 and again this year, 2026), with all potential access points and/or roosting opportunities fully inspected for evidence of bats. Although no evidence of bats was recorded, with the buildings assessed to provide **negligible** roosting opportunities and no further surveys are considered necessary, in accordance with best practice all site operatives should be given a toolbox talk so that they are fully aware of current legislation protecting bats and their roosts (copy has been attached at Appendix A). In the unlikely event of any bats being encountered on the site, then works should stop immediately and Natural England or AAe contacted so that appropriate advice can be provided (**N.B. a European Protected Species Licence may then be required to permit the works to continue**).

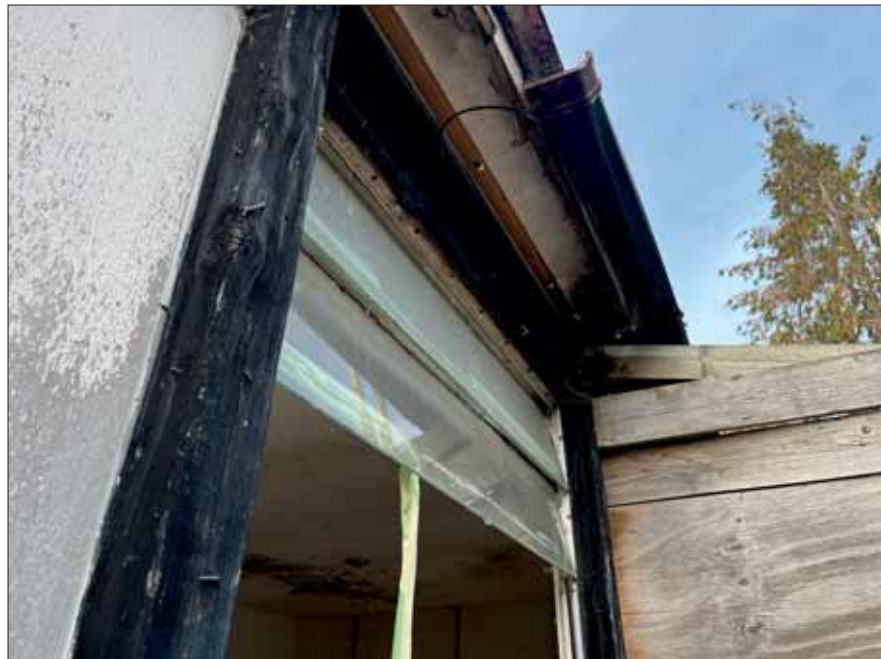
Photograph 4: Showing a close-up inspection of the front exterior on one of the buildings.
