**25 Hatch Ride  
Crowthorne  
Berkshire  
RG45 6LB**

# **Preliminary Roost Assessment**

Report ref.: R2832\_PRA\_a

**January 2025**

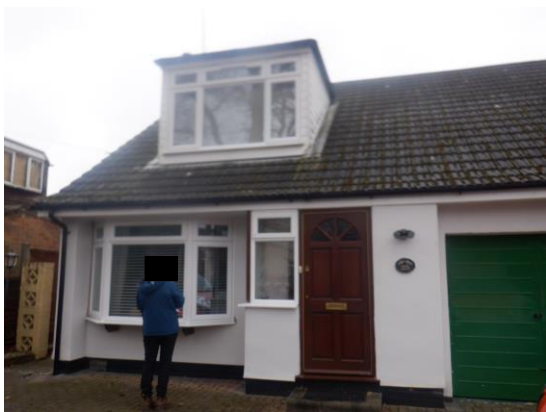
- 5.2.2** The semi-detached property of cavity wall construction had a pitched roof with flat roof dormers present on the front and rear elevation (**Photographs 1 & 2**).

Photograph 1. Front of house viewed from south.

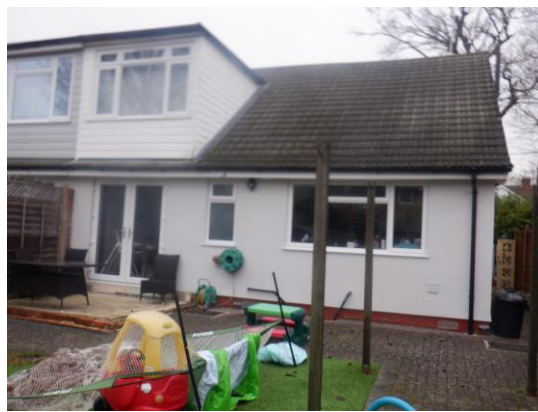
Photograph 2. Rear of house viewed from north.

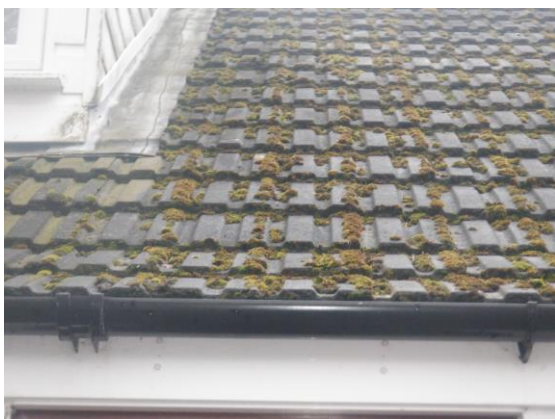
**5.2.3** The roof was covered by concrete interlocking tiles that were all tight on the front elevation of the roof and mossy in places, with one lifted tile on the rear elevation adjacent to the dormer (**Photographs 3 & 4; Target note 1**). The ridge tiles were dry-fixed and were tight across the roof of the property (**Photograph 4**).

Photograph 3. Tight interlocking roof tiles (northern elevation).

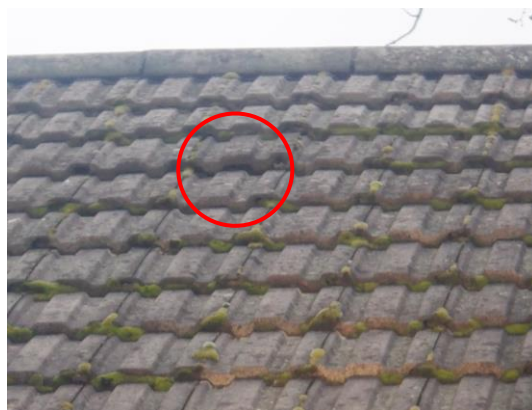
Photograph 4. Lifted interlocking tile; intact dry-fixed ridge tiles (southern elevation).

- 6.1.3** Externally, the property had one lifted interlocking roof tile on the rear elevation which resembled a potential roost feature that could be used on occasion, opportunistically by an individual crevice-dwelling bat, such as the locally recorded common pipistrelle (*P. pipistrellus*) and soprano pipistrelle (*P. pygmaeus*). Therefore, the house has been assigned low potential suitability for bats (see **Appendix 2** for potential suitability categories).

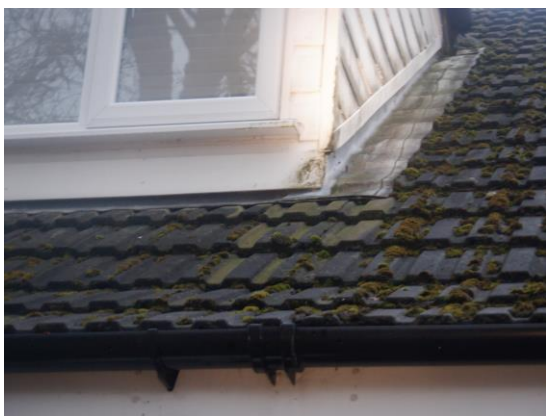
**5.2.4** The front dormer had flat lead flashing along the sides, and slightly lifted lead flashing present below, but lead to no significant crevice (**Photograph 5; Target note 2**). Both dormers were clad with tight uPVC cladding, with guttering blocking the soffit of the flat roofs (**Photograph 6**).

Photograph 5. Slightly lifted lead flashing (northern elevation).

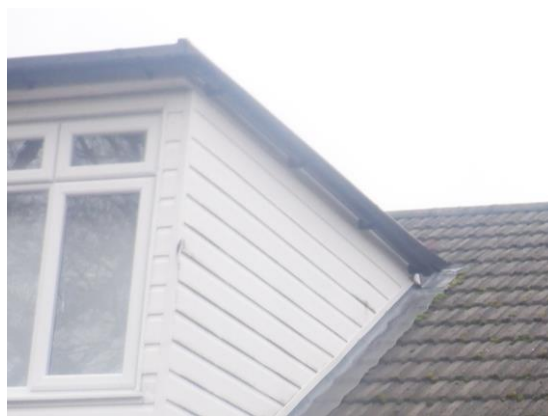
Photograph 6. Tight cladding on dormer (southern elevation).

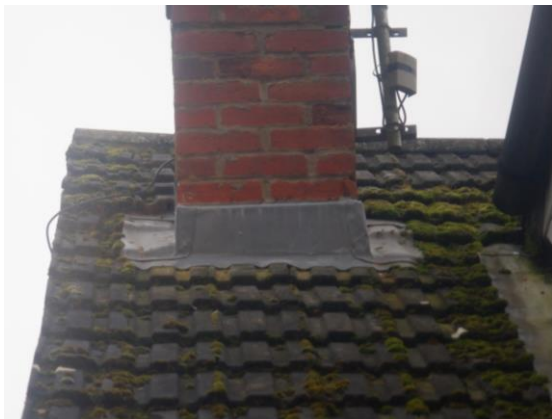
- 5.2.5** The lead flashing was flat around the chimney on the north-eastern end of the roof (**Photograph 7**). The verge mortar was crumbling in places along the eastern gable, but the cracks were superficial only and no ingress opportunities for roosting bats was observed (**Photograph 8; Target note 3**).

*Photograph 7. Slightly lifted lead flashing (northern elevation).*

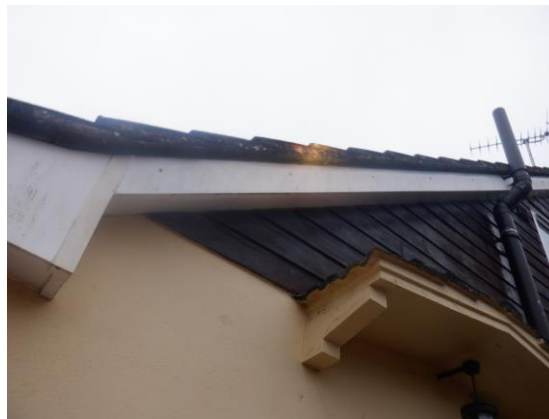
*Photograph 8. Superficially crumbling verge mortar (eastern elevation).*

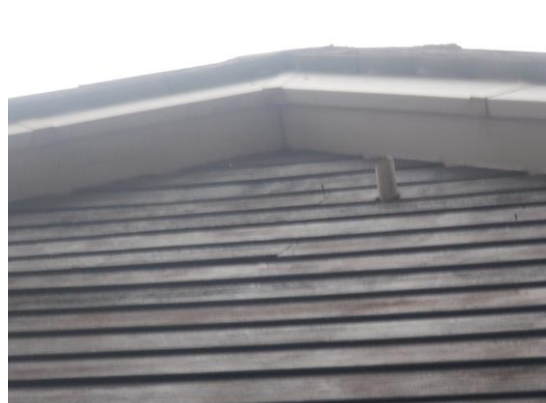
- 5.2.6** The eastern gable was clad with tight tongue-in-groove timber cladding, which featured intact sealant between the cladding and the soffit (**Photograph 9**). The soffit was tight to the painted render wall on the front elevation (**Photograph 10**).

*Photograph 9. Tight timber cladding and intact sealant along soffit (eastern elevation).*

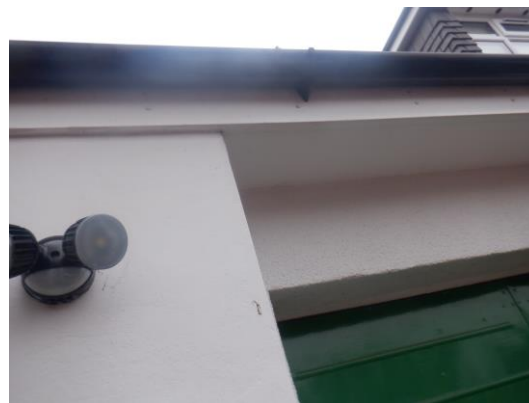
*Photograph 10. Tight soffit to painted render wall (northern elevation).*

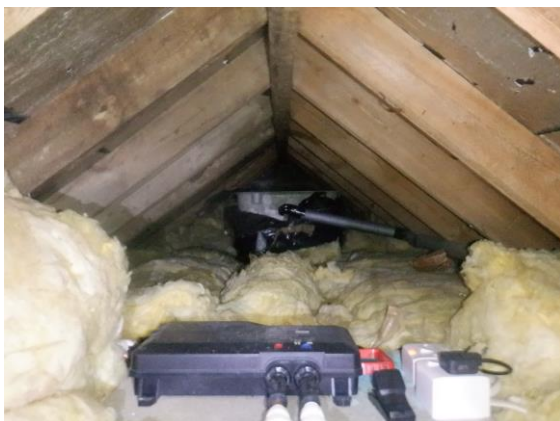
- 5.2.7** The property had one roof void and one eaves space on the front elevation. The roof void covered the ridge of the pitched roof, and was accessible via a loft hatch on the first floor. It was of cut and pitch construction and had an approximate floor-to-ridge height of 0.5 metres. The floor was covered with a thick layer of fibreglass insulation throughout the void (**Photograph 11**). The eaves were open in places, with the boarding of the dormer windows visible in the north-eastern and south-western sides of the void (**Photograph 12**).

Photograph 11. Fibreglass insulation present throughout (roof void).

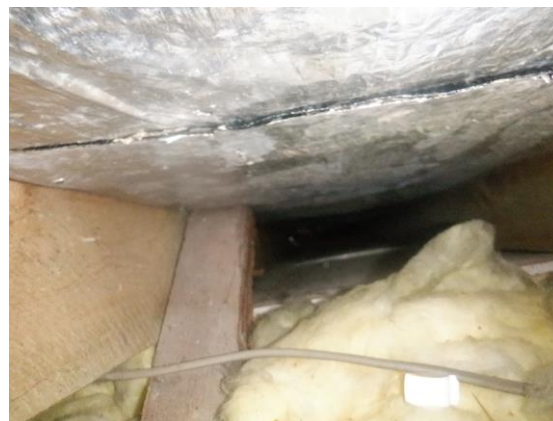
Photograph 12. Open eaves (roof void).

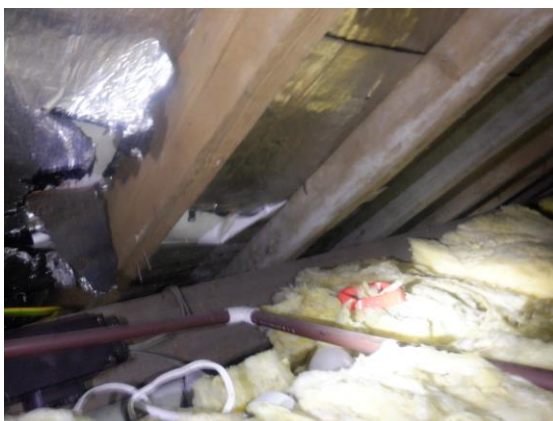
**5.2.8** The roof was lined with a foil-backed bitumen felt that was mostly intact, with occasional tears present, but there was breathable membrane visible underneath (**Photograph 13; Target note 4**). The ridge was cobwebbed throughout, with the blockwork party wall also cobwebbed (**Photograph 14**).

Photograph 13. Tears in foil-backed bituminous roofing felt (roof void).

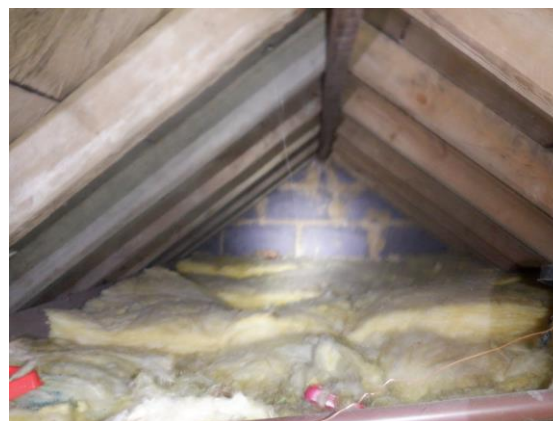
Photograph 14. Cobwebbed along ridge and up to blockwork party wall (roof void).

- 6.1.2** The roof void inside the property lacked sufficient space for the internal flight exhibited by void-dwelling bats, such as the locally recorded brown long-eared (*P. auritus*). The void was heavily cobwebbed which also can indicate a lack of disturbance from internal flight. The eaves space was also small and was fully boarded internally, with no external access. The absence of any evidence, combined with no ingress opportunities observed externally and internally, it is considered highly unlikely that void-dwelling bats are present in the house.

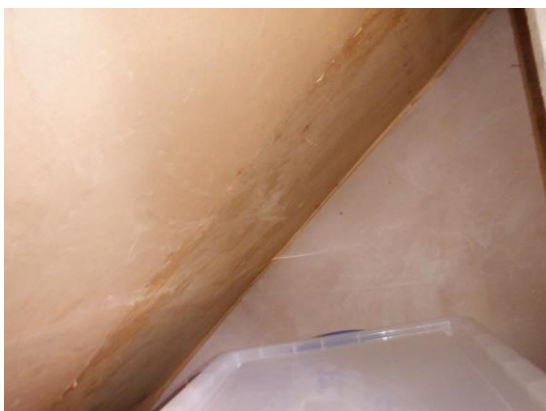
**5.2.9** The eaves space was accessible via a small door on the first floor. The space had been covered with plaster board on the sides and roof, with boarding and carpet present on the floor of the space, and skirting board blocking the eaves (**Photograph 15**).

Photograph 15. Intact plasterboard on ceiling and side (eaves space).

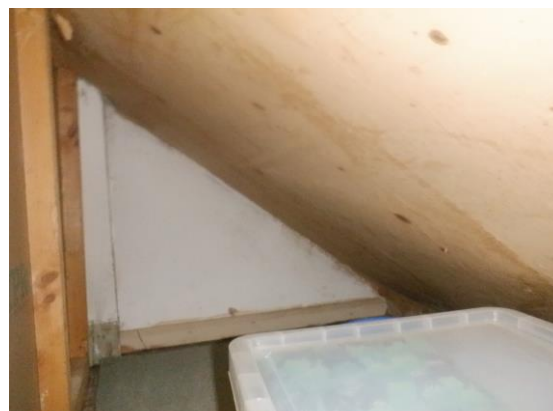
Photograph 16. Intact plasterboard on ceiling and boarding with carpet on floor (eaves space).

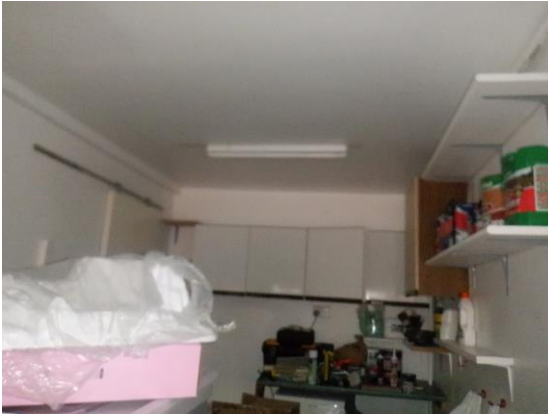
**5.2.10** Internally, the garage was sealed with plasterboard and painted (**Photograph 17**). The door was tight to the frame, offering no ingress opportunities for bats.

*Photograph 17. Painted plasterboard internally (garage).*
