# Preliminary Roost Assessment

12 Lancaster Gardens, Earley, Reading RG6 7PA

This report is prepared to inform a planning application with Wokingham Borough Council. The proposal can be described as “TWO STOREY SIDE/ FRONT EXTENSION AND SINGLE STOREY REAR EXTENSION”.

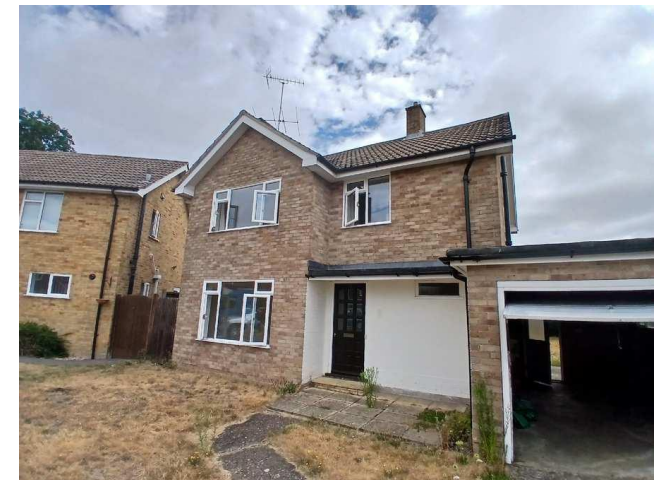
The building is a residential dwelling with brick walls in good condition and a clay tiled roof in good condition, incorporating overhanging eaves with uPVC barge boards and fascia boards. The internal roof void comprises timber rafters lined with bitumen felt. Several tears were identified within the bitumen felt lining, creating potential access points between the roof covering and the internal roof void. Externally, lifted lead flashing was identified at the base of the chimney on the northern elevation, together with two lifted roof tiles, one on the northern elevation and one on the southern elevation. Collectively, these features could provide bats with access into the internal roof void and offer suitable roosting opportunities for a small number of crevice-dwelling bats. No evidence of bats, including droppings, feeding remains, staining or live bats, was identified during the inspection.

In line with Good Practice Guidelines (Collins, J (Ed) 2023), B1 is assessed to have **low** habitat value for roosting bats.

*Southern elevation of B1.*

One bat emergence/re-entry survey will be required on B1, requiring 2 survey positions to provide full coverage of the building's elevations. If bat roosts are confirmed in the building two additional surveys may be required to characterise the roost and to inform an EPSL application to Natural England.

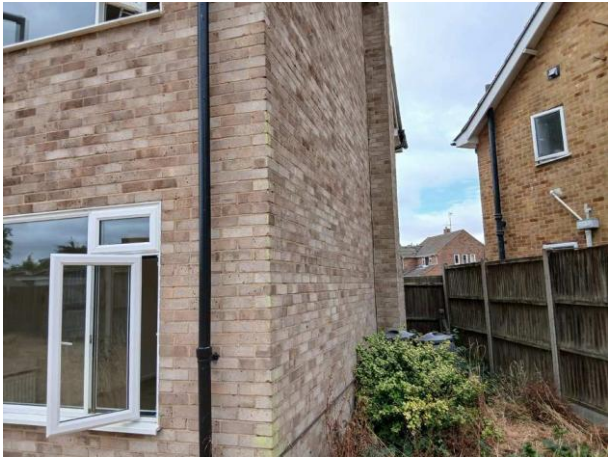
| Feature | Materials/Details | Condition / description / suitability | Photograph |
|---|---|---|---|
| Walls | Brick | <p><b>Condition/description</b><br/>The walls of B1 are in good condition with no gaps or cracks.</p> <p><b>Suitability/access/evidence of bats</b><br/>No bat roosting features or access points were identified.</p> | <p>Northwestern walls of B1.</p> |

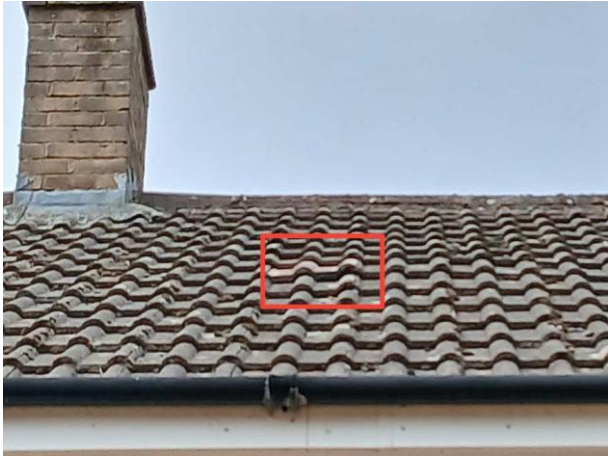
| Feature | Materials/Details | Condition / description / suitability | Photograph |
|---|---|---|---|
| Roof | Clay tiles | <p><b>Condition/description</b><br/>The roof of B1 is generally in good condition. However, lifted lead flashing at the base of the chimney on the northern elevation and two total lifted tiles on the northern and southern elevation were identified.</p> <p><b>Suitability/access/evidence of bats</b><br/>The numerous tears within the internal roof lining provide potential access into the main roof void from beneath the roof covering. Consequently, gaps beneath the roof tiles may allow bats to access both</p> | <p>A lifted tile on the northern elevation roof.</p> |

A two-storey side/front and a single-storey rear extension is proposed on the northern, southern and eastern elevations of B1. B2 will be destroyed as part of the proposed works. These works will result in the removal of/impact to bat roosting features, such as lifted lead flashing at the base of the chimney and lifted roof tiles on the northern elevation of B1. These features have been assessed as providing low suitability for roosting bats within B1.

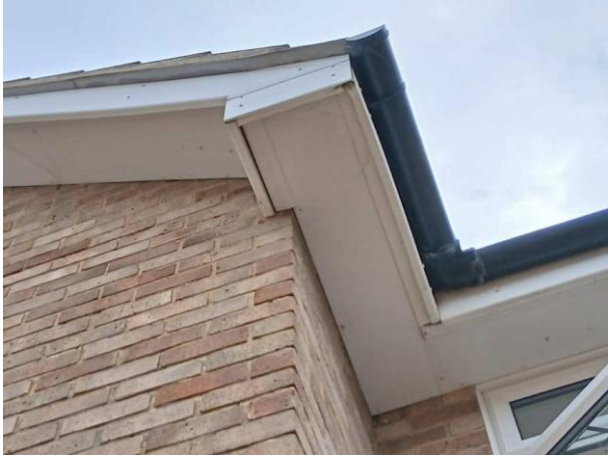
| Eaves | Overhanging | <p><b>Condition/description</b><br/>The uPVC soffit boxes of B1 are in good condition with no gaps.</p> <p><b>Suitability/access/evidence of bats</b><br/>No bat roosting features or access points were identified.</p> | <p><i>Soffit boxes on the southern elevation in good condition.</i></p> |

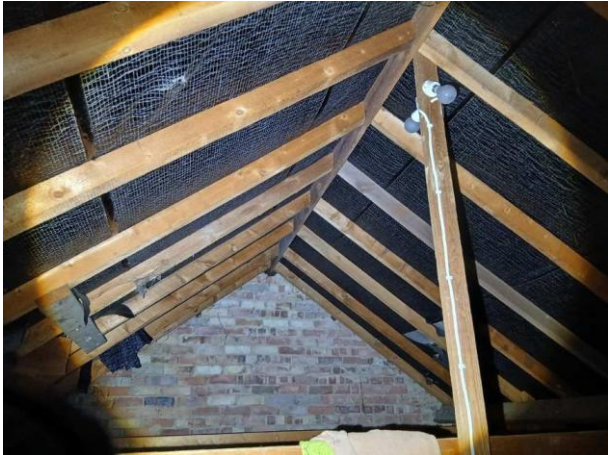
| Internal void | Bitumen felt lining.<br>Timber rafters | <p>The internal void 1 of B1 is accessible and measures ~7.5m in length, ~6m in width, and ~2m in height.</p> <p>The internal lining is generally in good condition. A few tears in the lining were identified that lead to the brick tiles on the northern elevation.</p> <p>The flooring of the loft void is partially covered in timber beams and plywood allowing access to all areas.</p> <p>The timber ridge beam in the internal void presents a roosting feature.</p> <p>No rodent droppings were identified within the loft void.</p> | <p><i>B1 internal void, facing west.</i></p> |

No evidence of roosting bats was identified within this void.

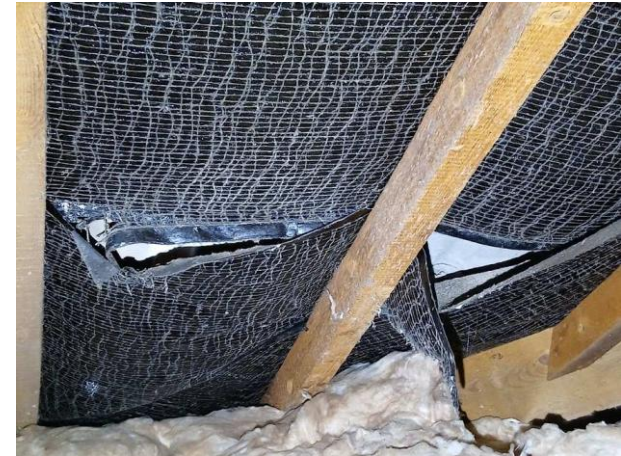
*Tears in the internal lining.*

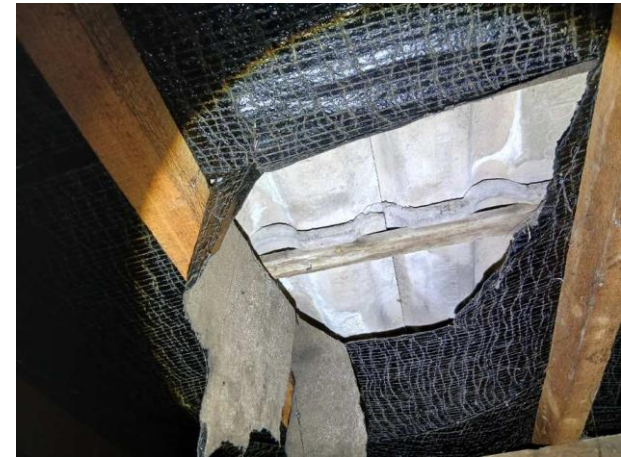
*Tears in the internal lining.*

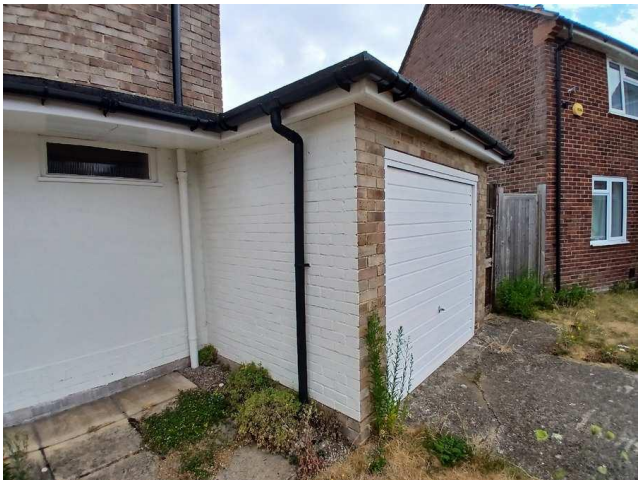
B2 is a garage with a flat bitumen felt roof, uPVC fascia boards and window frames, all in good condition. While timber rafters are present within the internal void, the overall structure is well-sealed and presents negligible suitability for bat roosting, with no identified features or access points. No evidence of bats was found during the survey.

In line with Good Practice Guidelines (Collins, J (Ed) 2023), B2 is assessed to have **negligible** habitat value for roosting bats.

Southwestern elevation of B2.

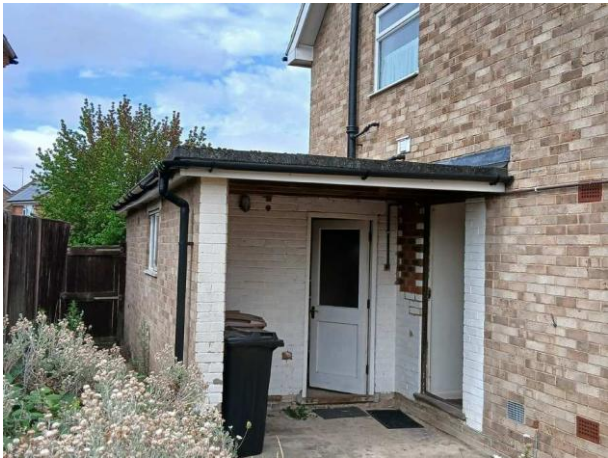
| Feature | Materials/Details | Condition / description / suitability | Photograph |
|---|---|---|---|
| Roof | Bitumen felt | <p><b>Condition/description</b></p> <p>The roof structure comprises timber boards overlaid with bitumen roofing felt. The felt covering appears continuous and in good condition with no gaps identified at the roof edges.</p> <p><b>Suitability/access/evidence of bats</b></p> <p>No gaps, features or access points suitable for roosting bats were identified.</p> | <p>Photograph of the northern elevation of building B2, showing a white door, a small window, and a black downspout. The building is adjacent to a brick wall.</p> |

Northern elevation of B2.

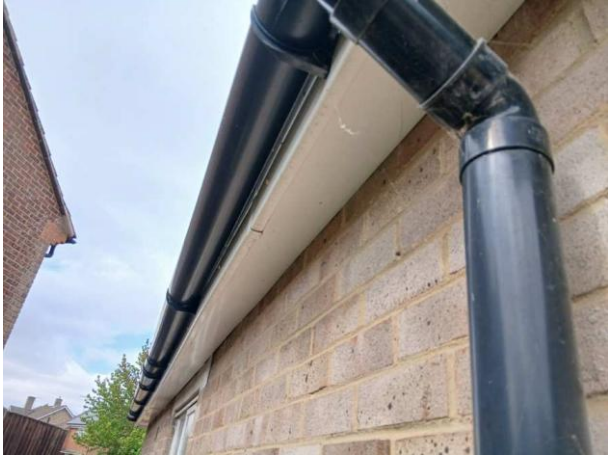
| Eaves | uPVC | <p><b>Condition/description</b><br/>The soffit boxes are in good condition and well-sealed.</p> <p><b>Suitability/access/evidence of bats</b><br/>No gaps, features or access points suitable for roosting bats were identified.</p> | <p><i>Soffit box on the eastern elevation.</i></p> |

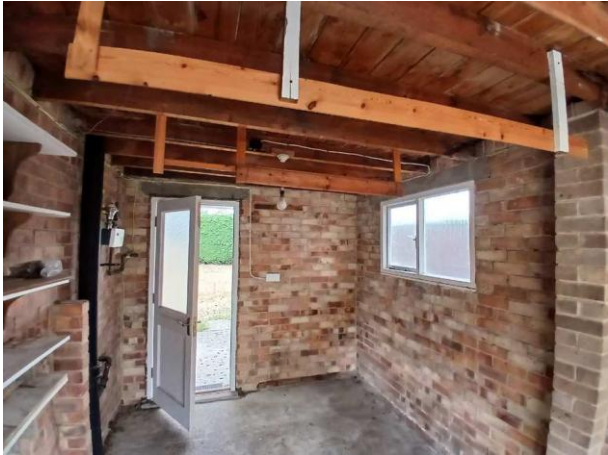
| Internal void 1 | Timber rafters | <p><b>Condition/description</b><br/>The timber roof is in good condition and well-sealed. The timber rafters could present a feature.</p> <p>The window and door on the eastern and northern elevation allow high levels of natural light into the internal space. The conditions created by the windows result in a bright, exposed and thermally unstable environment, which is unsuitable for roosting bats, as bats typically favour dark, sheltered spaces with relatively stable microclimatic conditions.</p> <p>The internal space is well-sealed, with no gaps, cracks or access points identified that would allow bats to enter the building.</p> | <p><i>B2 internal space, facing north.</i></p> |

| | | No evidence of roosting bats was identified within this void. | |

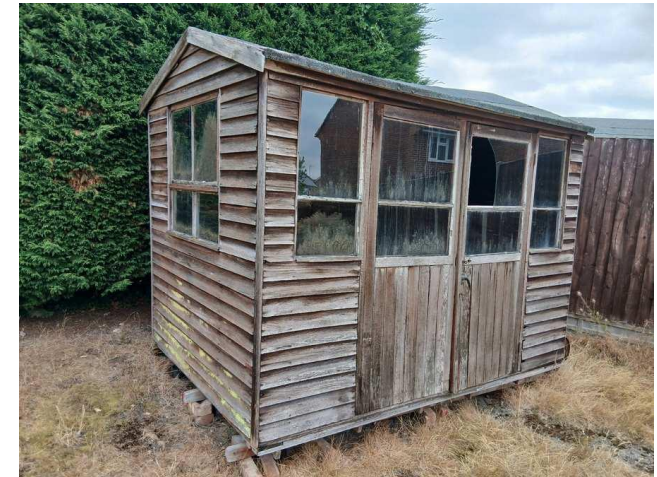
B3 is a detached, single-storey timber-built shed with a gabled roof clad in bitumen felt. The structure is single-skinned, and the internal space is generally well sealed, with no gaps, cracks or access points identified that would allow bats to enter the building or access any internal voids. No evidence of bats (e.g. droppings, staining or feeding remains) was recorded during the inspection.

B3 also contains windows one of which is broken, which allow high levels of natural light into the internal space. In addition, the single-skinned timber construction provides little thermal insulation, resulting in significant temperature fluctuations throughout the day and night. These conditions create a bright, exposed and thermally unstable environment, which is unsuitable for roosting bats, as bats typically favour dark, sheltered spaces with relatively stable microclimatic conditions.

In line with Bat Conservation Trust Good Practice Guidelines (Collins, J (Ed) 2023), B3 is assessed to have **negligible** habitat value for roosting bats, as no features likely to be used by bats at any time of the year were identified.

*Southwestern elevation of B3.*
