**Castlemans Cottage  
Bath Road  
Knowl Hill  
Reading  
Berkshire  
RG10 9UT**

## **Preliminary Roost Assessment**

Report ref.: R2980\_PRA\_a

**November 2025**

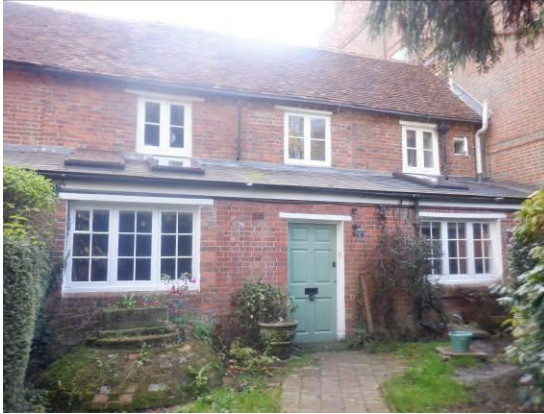
- 5.2.2** The property was a two storey mid-terrace cottage with a pitched roof to the front and a hipped roof to the rear (**Photograph 1**). There was a valley running down to a small flat roofed area in the centre of the roof. There was a ground floor slate sloped roof to the front with skylights (**Photograph 2**).

*Photograph 1. Front of property viewed from the northwest.*

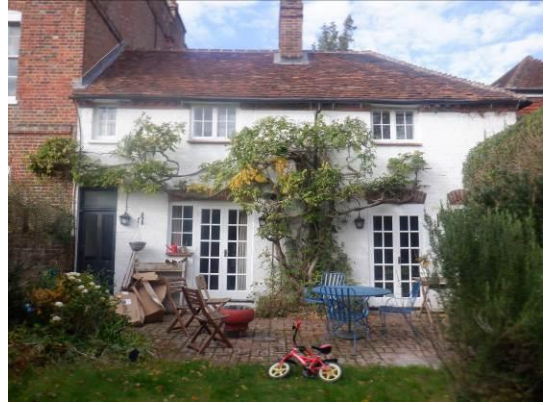
*Photograph 2. Rear of property viewed from the southeast.*

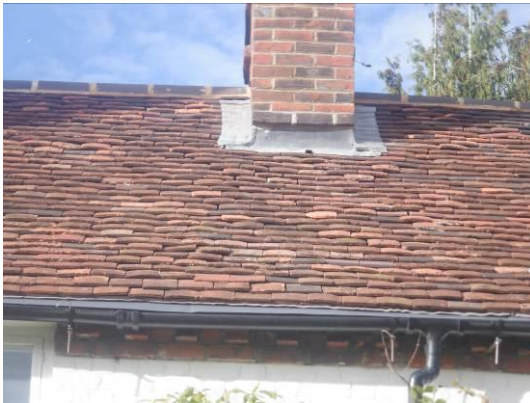
- 5.2.3** The handmade clay roof tiles were uneven and lifted in numerous places creating multiple crevices suitable for use by bats (**Photograph 3 & 4; Target Note 1**). Across the rear roof there were 5 access tiles installed, 2 with access via the felt and 3 without. On the rear elevation, the lead flashing against the chimney had an additional bat access point (**Photograph 5 & 6; Target Note 2**).

*Photograph 3. Raised roof tiles at the rear (southeastern rear view)*

- 6.1.4** The handmade clay tiles provided multiple roosting opportunities for crevice dwelling bats such as pipistrelles (*Pipistrellus sp.*). While no evidence of bats was found after the initial roof stripping and during this updated internal inspection, there is ample opportunity and extensive mitigation in place for crevice-dwelling bats such as the bat access tiles, ridge access tiles and bat boxes.

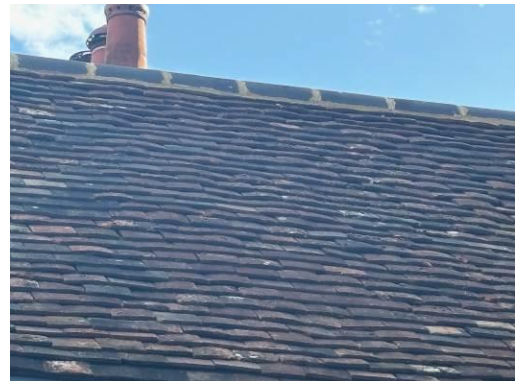
*Photograph 4. Raised roof tiles along the front elevation (northwestern view).*

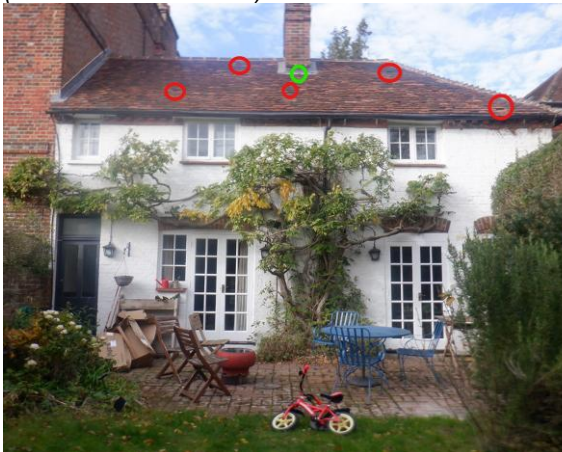
*Photograph 5. Bat access tiles at the rear (southeastern rear view)*

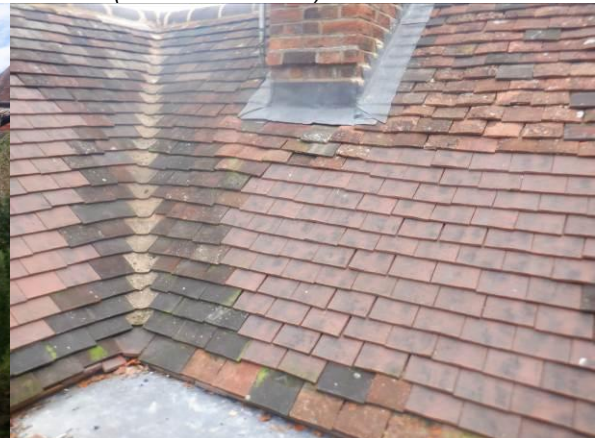
*Photograph 6. Uneven roof tiles along the valley (centre of the roof)*

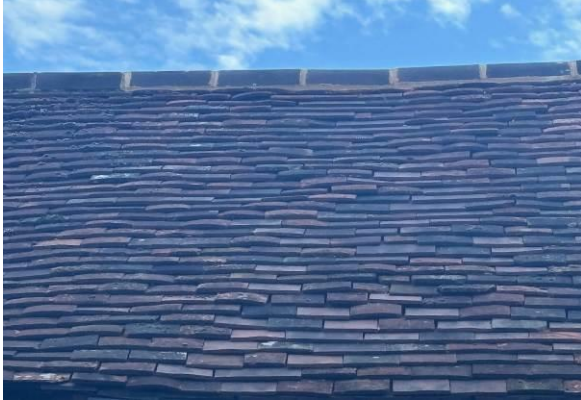
- 5.2.4** The ridge and hip tiles were fully intact with new mortar (**Photograph 7 & 8**). On the north eastern elevation there was a sixth bat access tile with access into the roof and

*Photograph 7. Ridge mortar intact (northwest front elevation)*

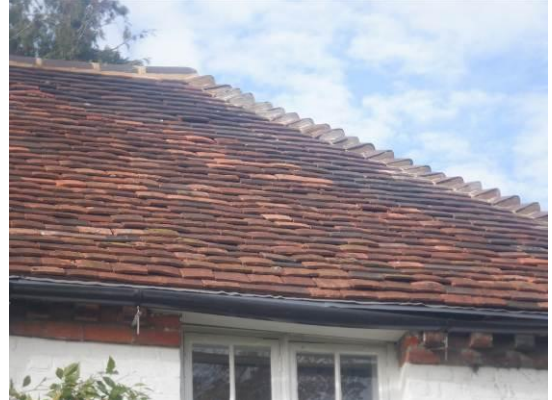
*Photograph 8. Full mortared hip tiles (southeastern rear view)*

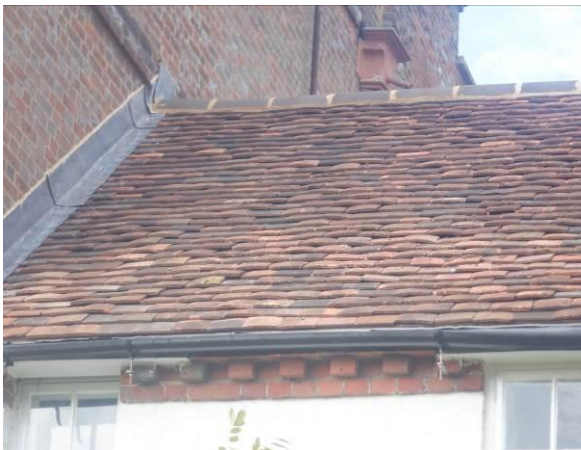
- 5.2.5** The lead flashing between the cottage and the neighbouring Castlemans House was flat with some small crevices along the joining tiles (**Photograph 9; Target note 3**). Along the front elevation there were hanging tiles joining the same adjacent property which provided additional crevice roosting opportunities (**Photograph 10; Target note 4**).

*Photograph 9. Flat lead flashing (southeastern rear elevation).*

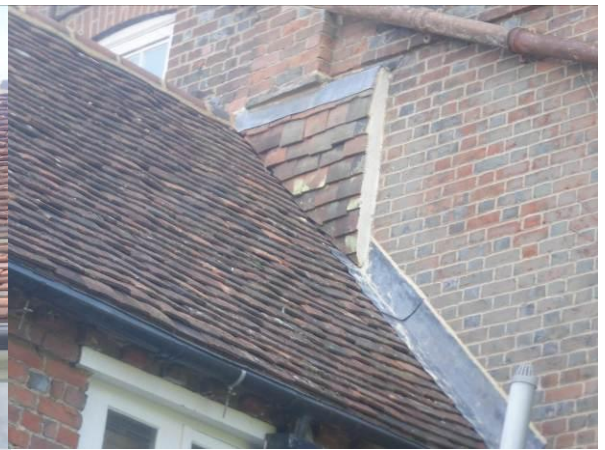
*Photograph 10. Hanging tiles on adjacent property (front elevation).*

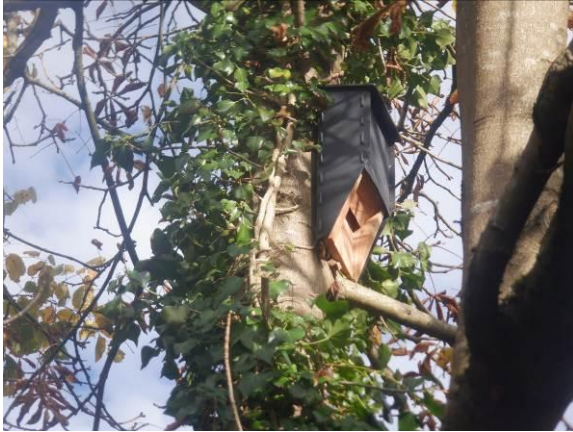
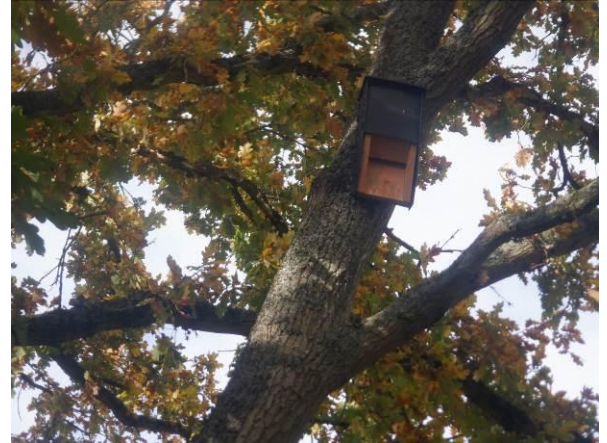
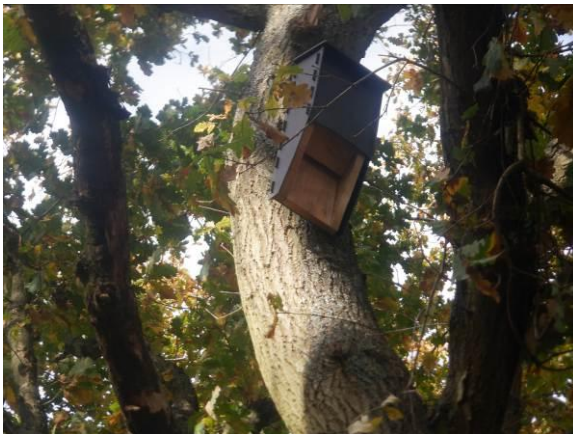
- 5.2.6** Throughout the garden there were 3 bat boxes attached to mature trees (**Photographs 11, 12 & 13**).

*Photograph 11. Bat box in mature garden tree*

*Photograph 12. Bat box in mature garden tree*

*Photograph 13. Bat box in mature garden tree*

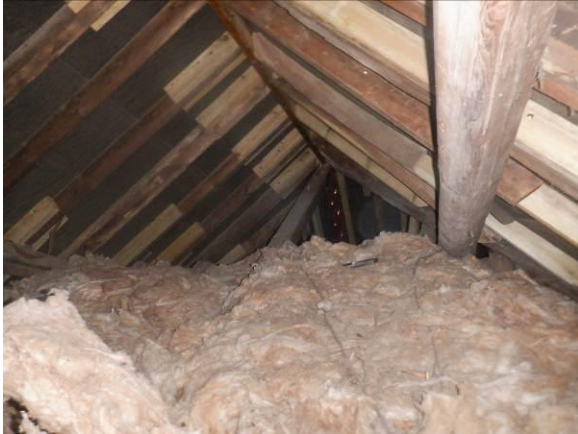
- 5.2.7** The property had one roof void that covered its second-storey footprint. The roof void was accessible via a first-floor loft hatch and had a ridge-to-floor height of approximately 2m.
- 5.2.8** The roof was of 'cut and pitch' construction with a ridge beam. There were new batons attached to the upper beams to provide extra support for the ridge. The roof was tightly lined with bitumen felt roofing membrane (**Photograph 14 & 15**).

Photograph 14. 'Cut and Pitch' roof construction with supporting batons against the ridge

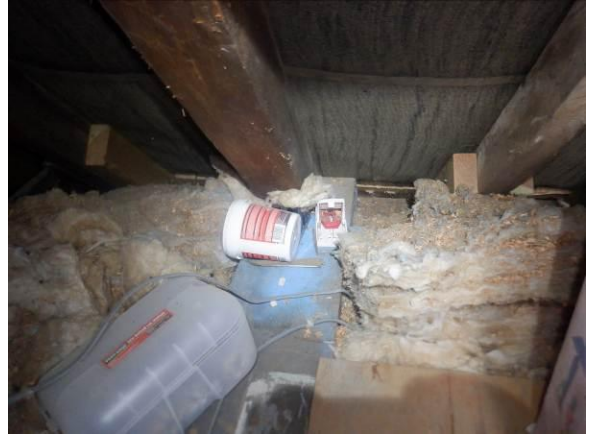
Photograph 15. Tightly fitted roofing bitumen

- 6.1.3** The roof void was lined with bitumen felt and cluttered with thick layers of fibreglass insulation. The Velux window allowed a significant amount of light into the void on the west and north elevations. This provides sub-optimal conditions for void-dwelling species such as brown long-eared (*P. auritus*) bats and therefore their presence is considered unlikely and also historically unlikely as these conditions are unchanged from pre-works.

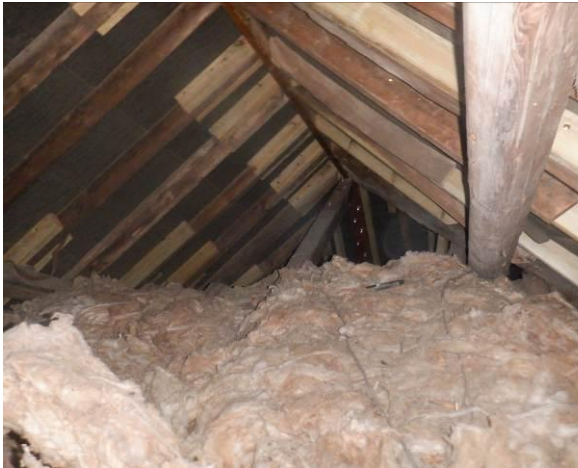
- 5.2.9** The floor was centrally boarded with thickly packed fibreglass insulation throughout (**Photograph 16**). The eaves were open with daylight visible (**Photograph 17**).

Photograph 16. Thickly packed fibreglass insulation

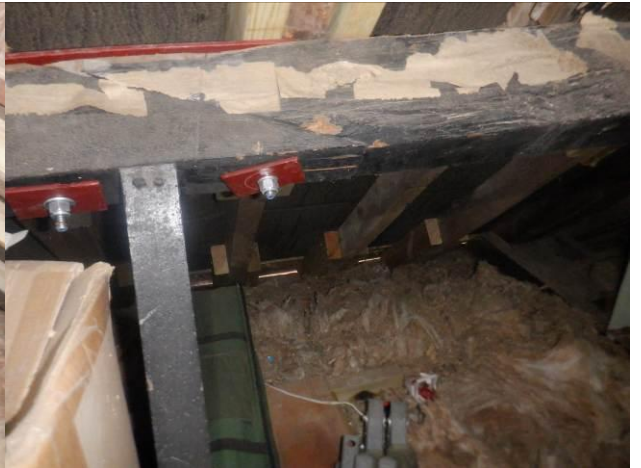
Photograph 17. Daylight visible at eaves

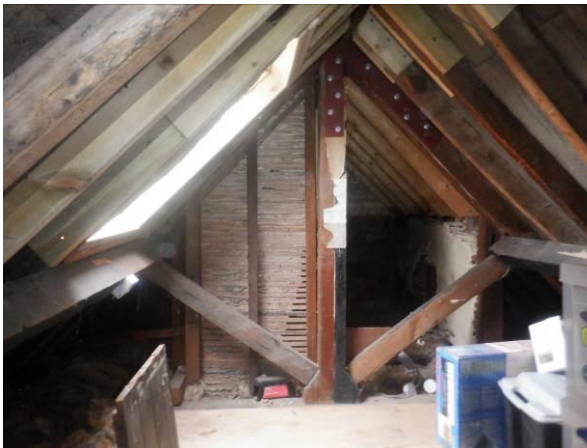
- 5.2.10** Towards the western elevation there was a lathe, plaster and timber board cladding (**Photograph 18**). There was a Velux window overlooking the valley on the roof (**Photograph 19**).

Photograph 18. Lathe, plaster and timber board cladding towards western elevation with Velux window

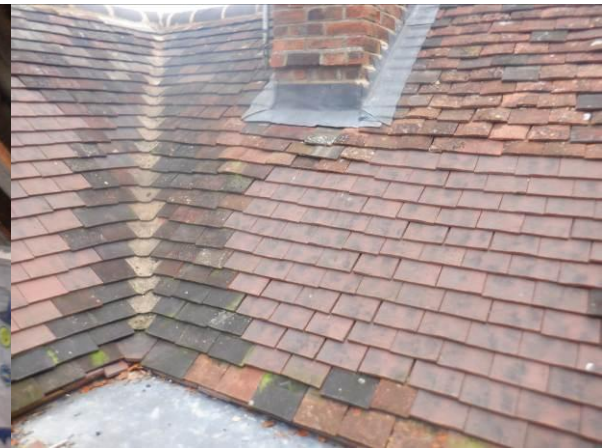
Photograph 19. View from the Velux window

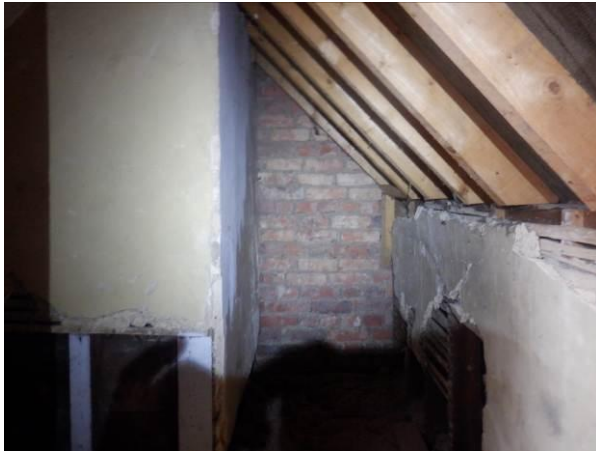
- 5.2.11** The gables were constructed of lathe and plaster at the base, with plaster board to the top with some brickwork visible at the southwestern end (**Photograph 20**).

*Photograph 20. Southwestern gable with brickwork, lathe and plaster.*

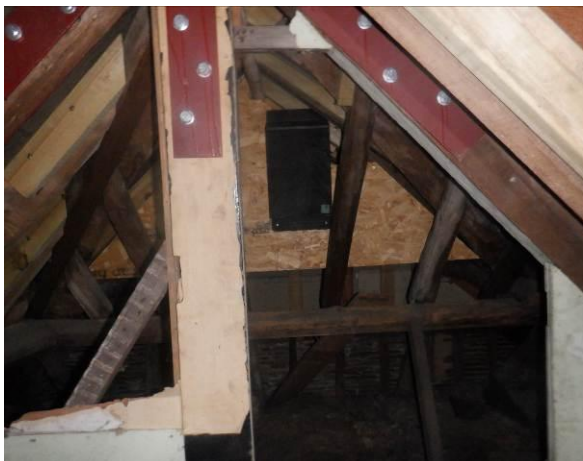
- 5.2.12** A crevice-dwelling maternity bat box was installed at the north end of the void against a sheet of plywood (**Photograph 21; Target note 5**). It was placed below the ridge access tile and to the left of a roof access tile. There was access through a gap made in the felt (**Photograph 22**).

*Photograph 21. Maternity bat box.*
