## **PRELIMINARY ECOLOGICAL APPRAISAL (DBW) AT 21 LANGHAMS WAY WARGRAVE**

**Prepared for:  
Ms E Theron  
21 Langhams Way  
Wargrave  
Wokingham  
RG10 8AX**

**31 August 2024**

**Ref: SPH/NP/PEA-24/20.08**

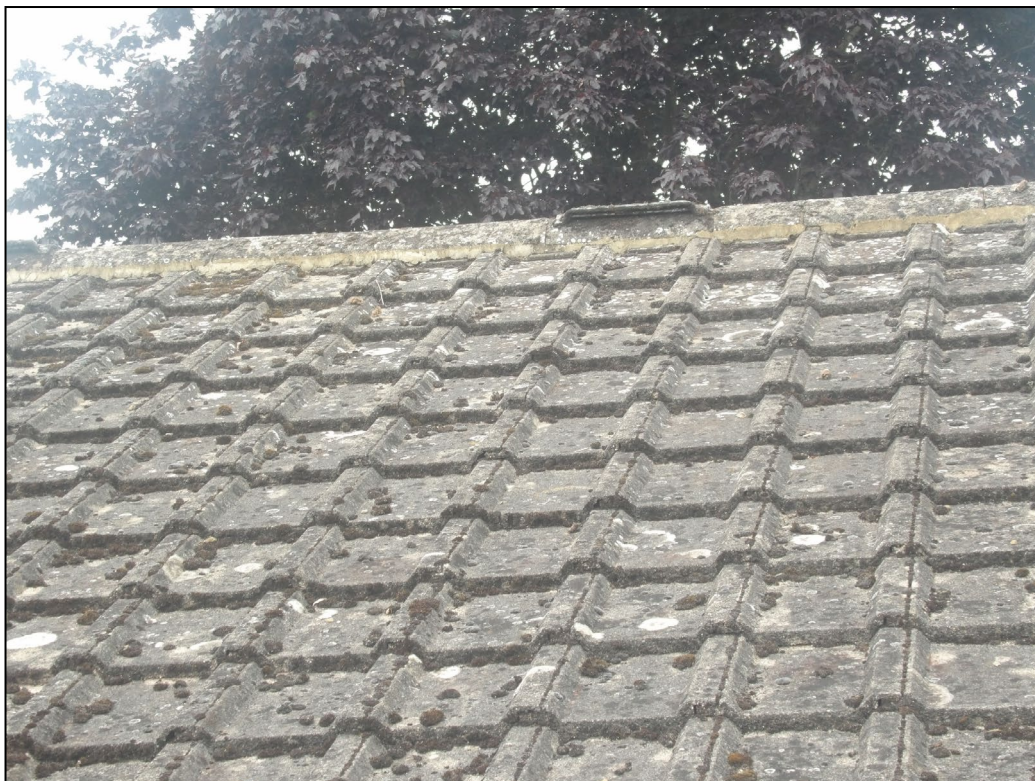
The property is a detached, brick-built building with an attached garage. The pitched roof is covered in interlocking tiles, all of which are well fitted with none missing or broken, see Figure 4 below. The ridge tiles and verges are all in a good condition with no gaps which roosting bats could exploit, see Figure 5 on page 9. To the rear is a single storey brick build extension, the flat roof of which is covered in bitumen felt with no rips or tears, see Figure 6 on page 9. The tiles covering the front porch, mono pitched roof and false pitched roof to the front of the garage are all tight with no gaps, as are the verges and lead flashing, see Figure 7 on page 10. There are hanging tiles on both the front and rear elevations, the majority of which are well fitted however, on the rear elevation, a few of the tiles have moved leaving gaps that could be exploited by crevice dwelling bat species, see Figure 8 on page 10. The flat roof section of the garage is covered in well fitted bitumen felt with no rips or tears, see Figure 9 on page 11 and the uPVC soffits and fascias are tight to the walls with no gaps that could be exploited by crevice dwelling bat species, see Figure 10 on page 11.

Figure 4. Example roof tiles. 21 Langhams Way, Wargrave. 20.08.24

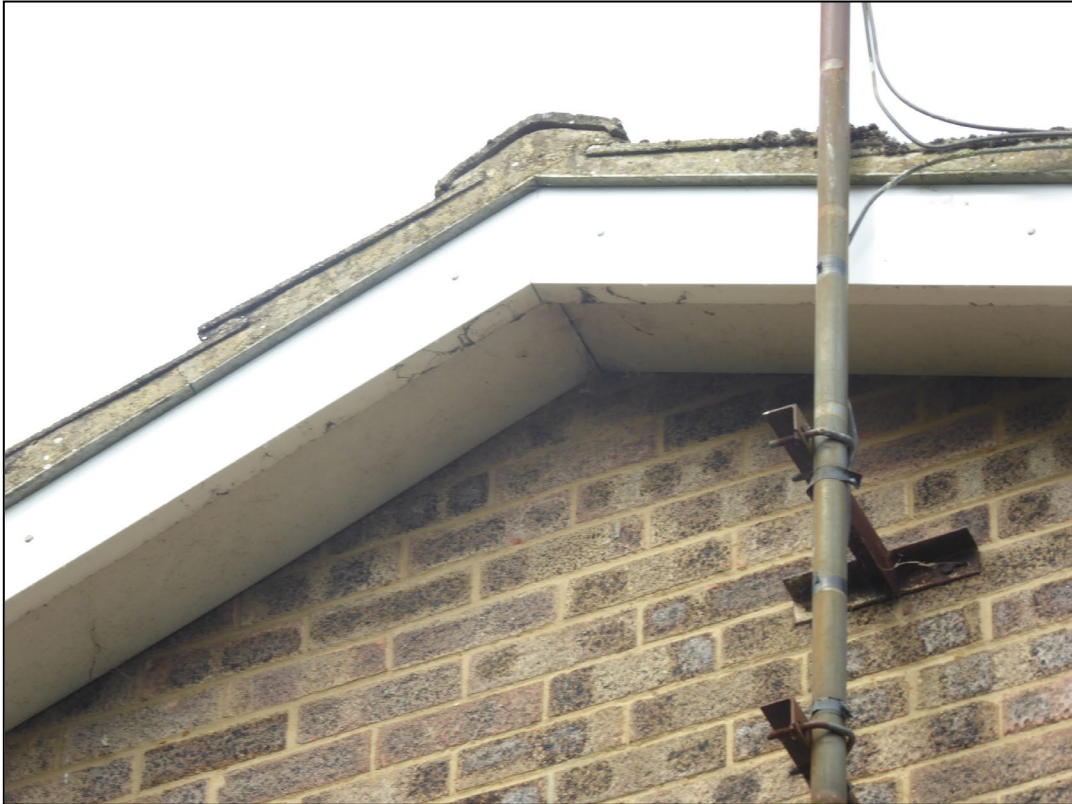
Figure 5. Example of sealed verges. 21 Langhams Way, Wargrave. 20.08.24

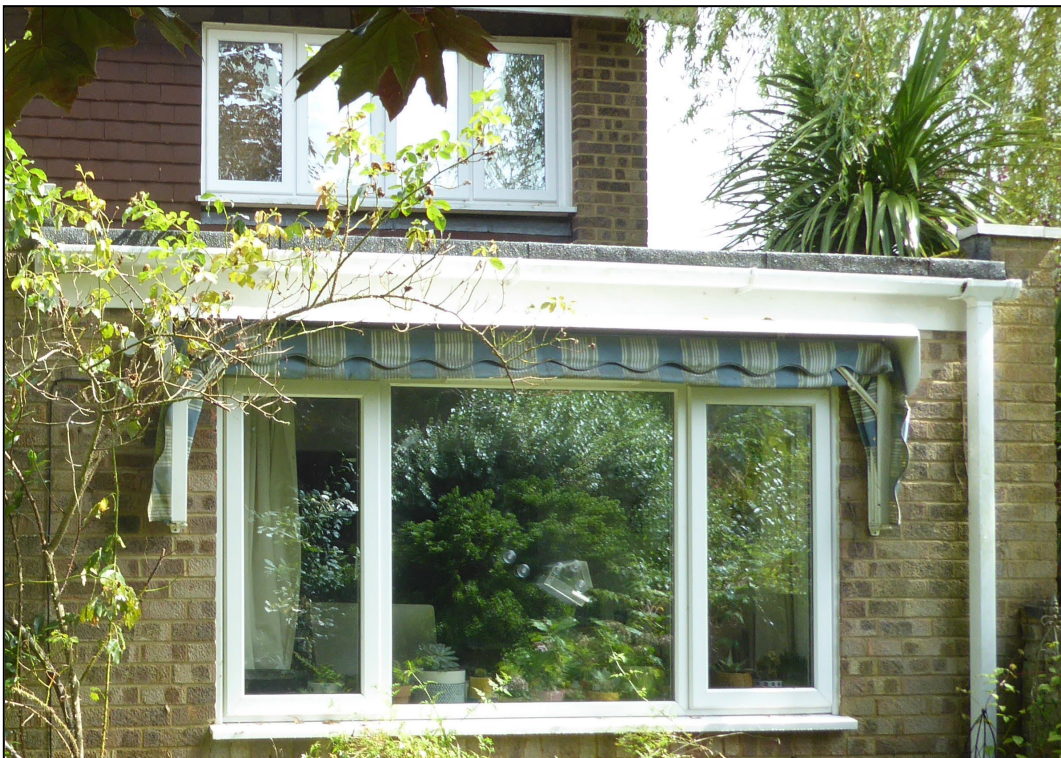
Figure 6. Single storey rear extension and bitumen covered flat roof. 21 Langhams Way, Wargrave. 20.08.24

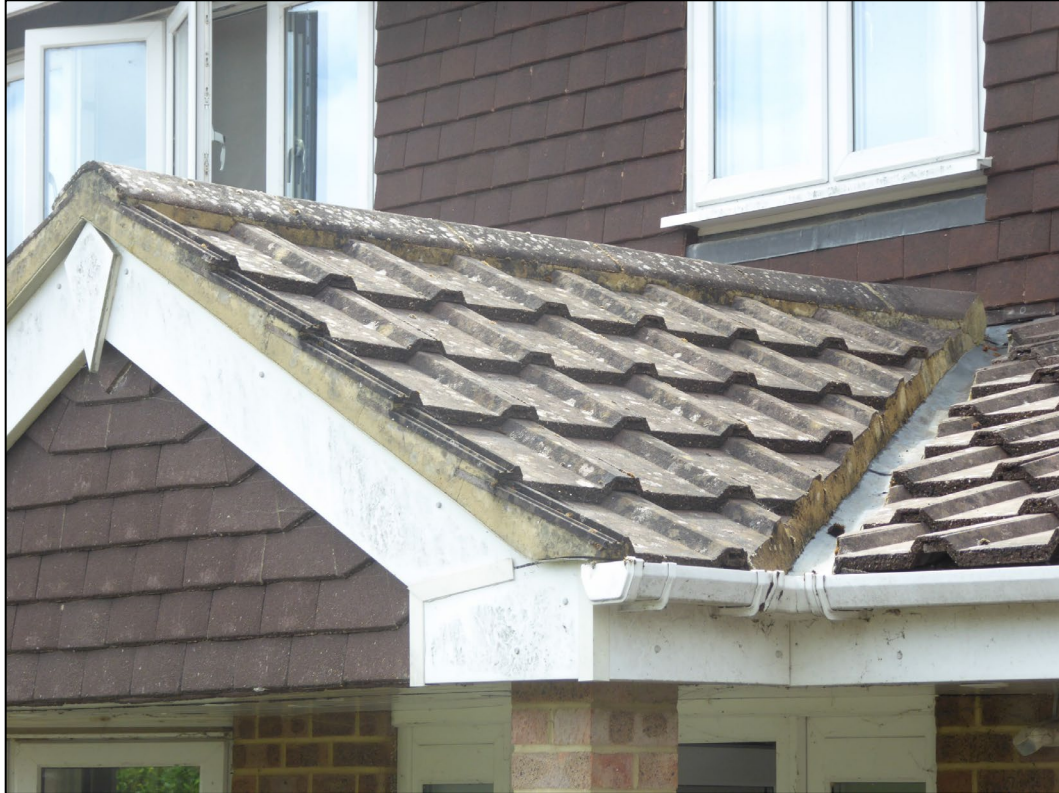
Figure 7. Example of sealed tiles/valleys/lead flashing on front porch/mono pitched roof. 21 Langhams Way, Wargrave. 20.08.24

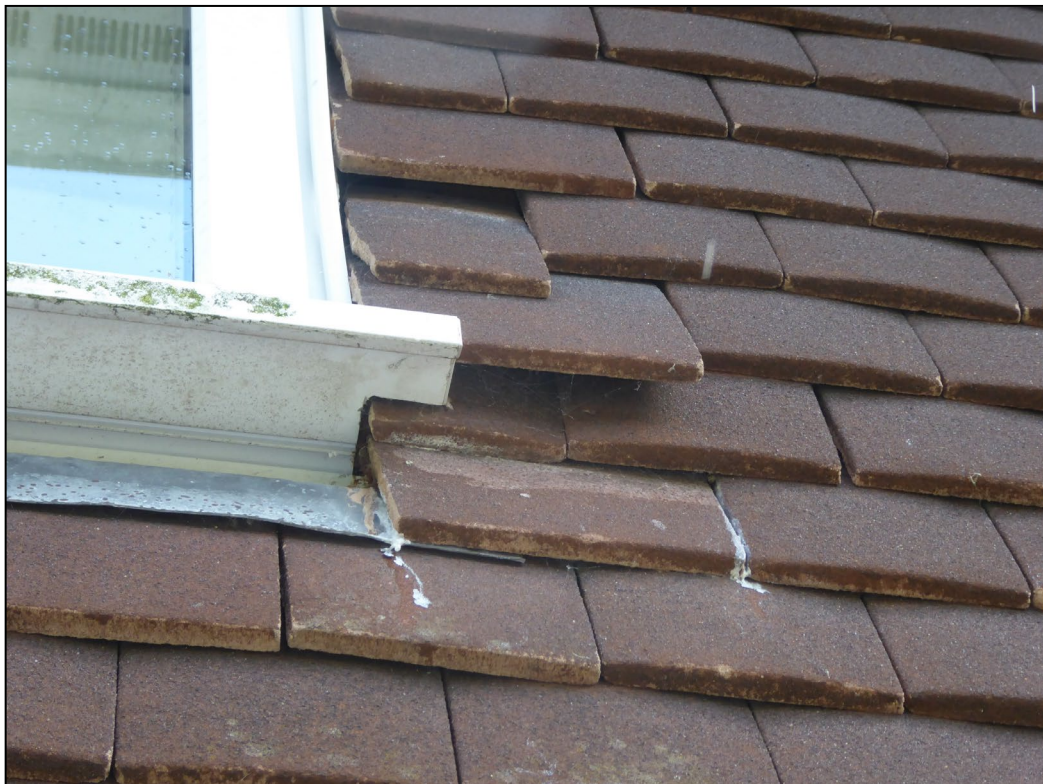
No bats or evidence of bats was recorded during the external inspection of the property but the raised hanging tiles on the rear elevation offer potential roosting opportunities for bats and the presence or absence of bats cannot be determined without further survey effort.

Figure 8. Gaps in hanging tiles on rear elevation. 21 Langhams Way, Wargrave. 20.08.24

The property and attached garage are in a good condition internally and externally and there were no bats, live or dead, and no droppings or other evidence to indicate that bats have used the dwelling to roost. However, on the rear elevation, there are raised hanging tiles which may provide potential roosting opportunities for bats and the presence or absence of bats could not be determined.

When the evidence is combined, the raised hanging tiles, surrounding habitat being suitable for foraging, commuting and roosting bats, and records of bats roosting nearby it is concluded that the property has a low potential to support roosting bats. Based on the Bat Workers Manual and the Bat Surveys Good Practice Guidelines, it is recommended that one dusk emergence survey is undertaken on the property, between May and August, in order to establish the presence/ absence of bats. One surveyor will be required in order to cover the potential roosting features (hanging tiles).

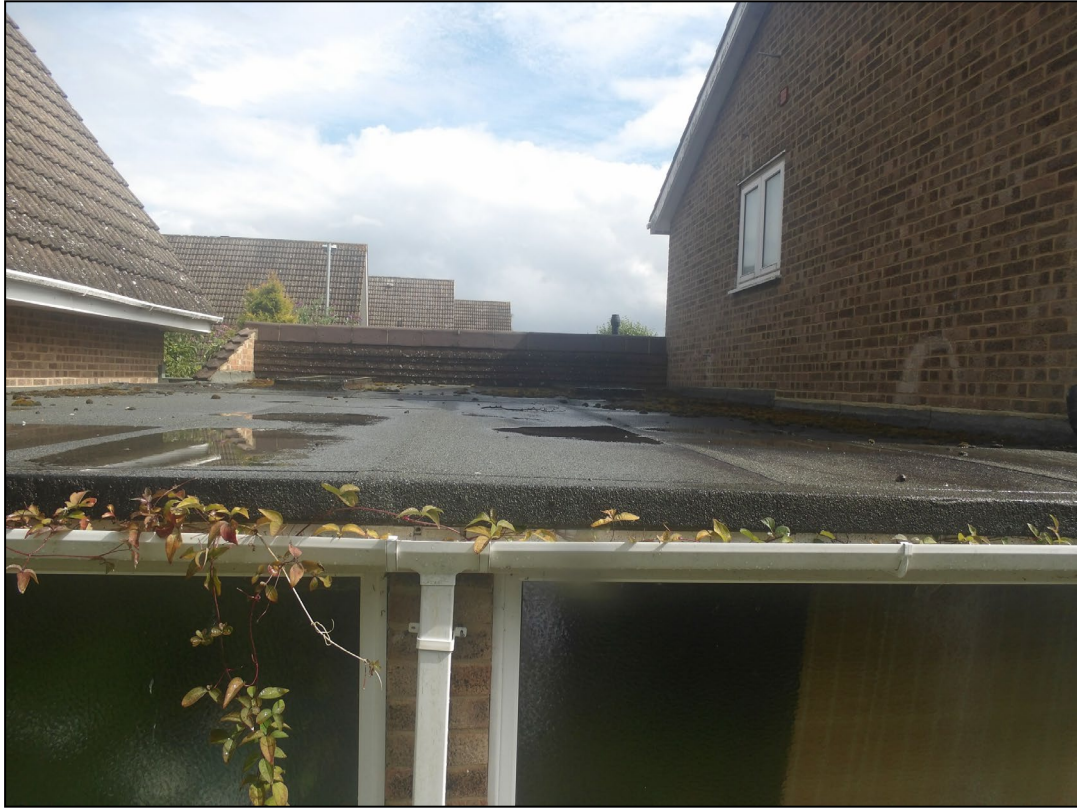
Figure 9. Example of sealed bitumen felt on garage roof. 21 Langhams Way, Wargrave. 20.08.24

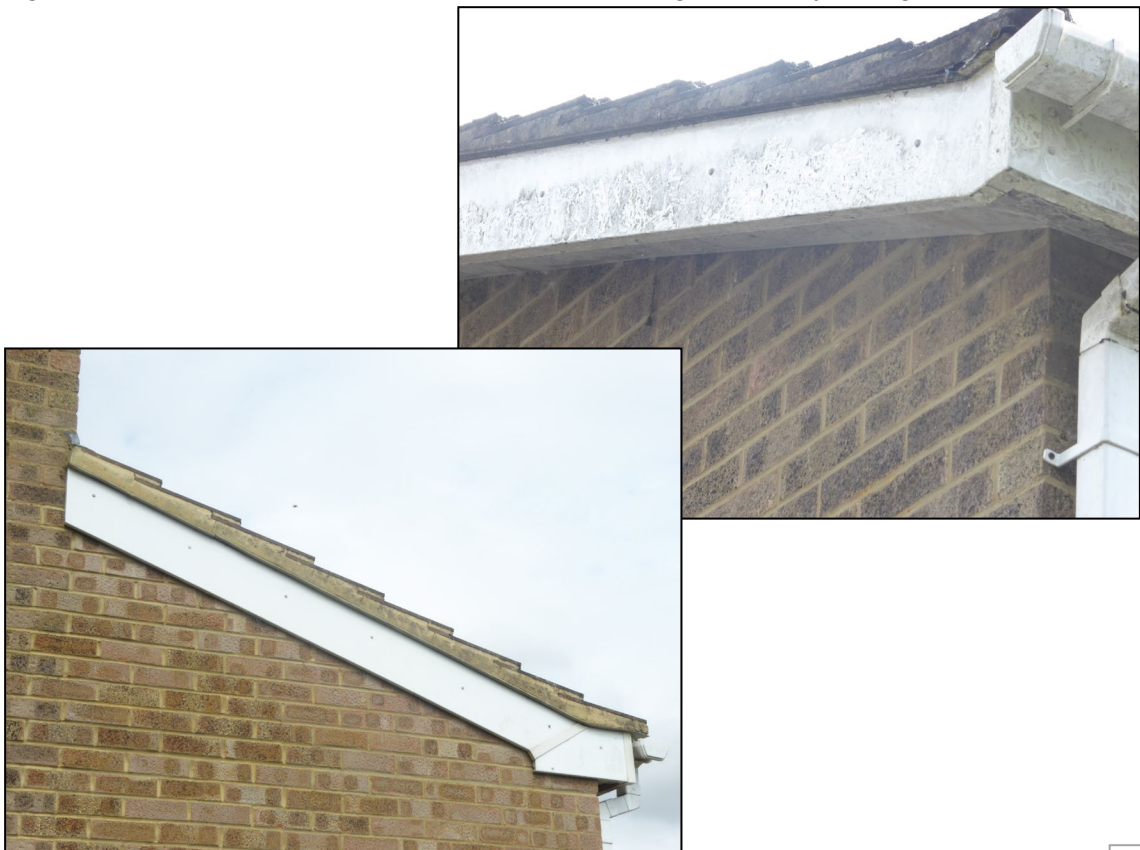
Figure 10. Example of sealed soffits/fascias. 21 Langhams Way, Wargrave. 20.08.24

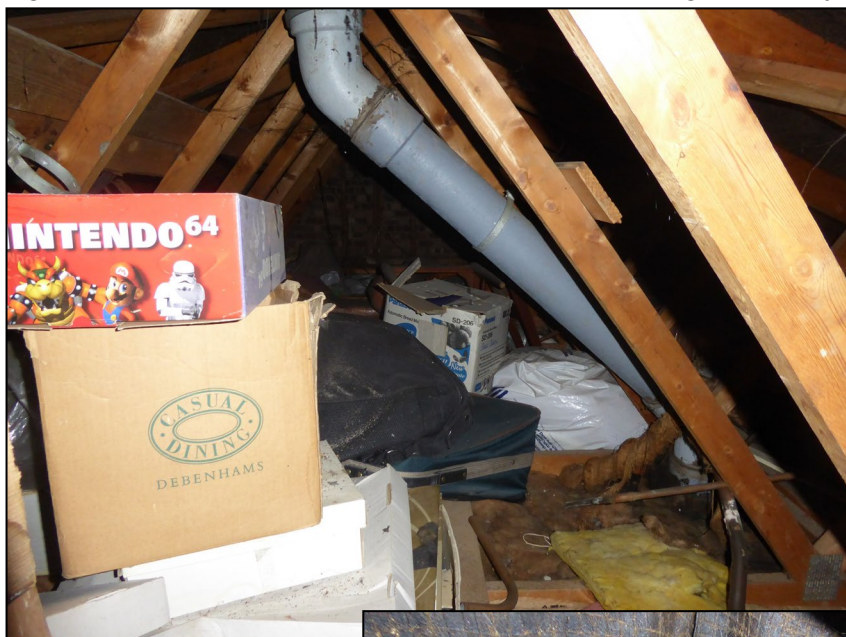
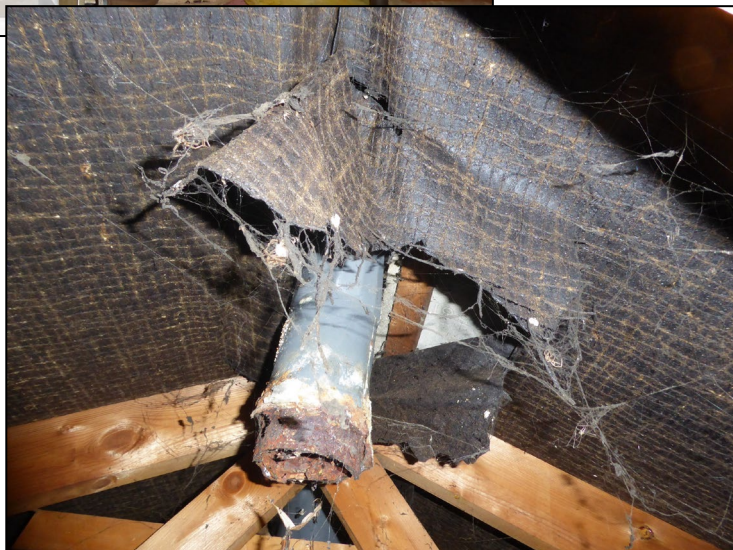
The loft of the property was accessed via a ladder and was in a good condition internally. The loft is being used for personal storage and is cluttered. It was not lit, is partially boarded and deeply insulated, see Figure 11 below. The roof tiles are lined with bitumen felt, some of which was torn but given the good state of the roof tiles externally this was not considered a significant constraint, see Figure 11 below.

Figure 11. Example loft space & bitumen felt. 21 Langhams Way, Wargrave. 20.08.24

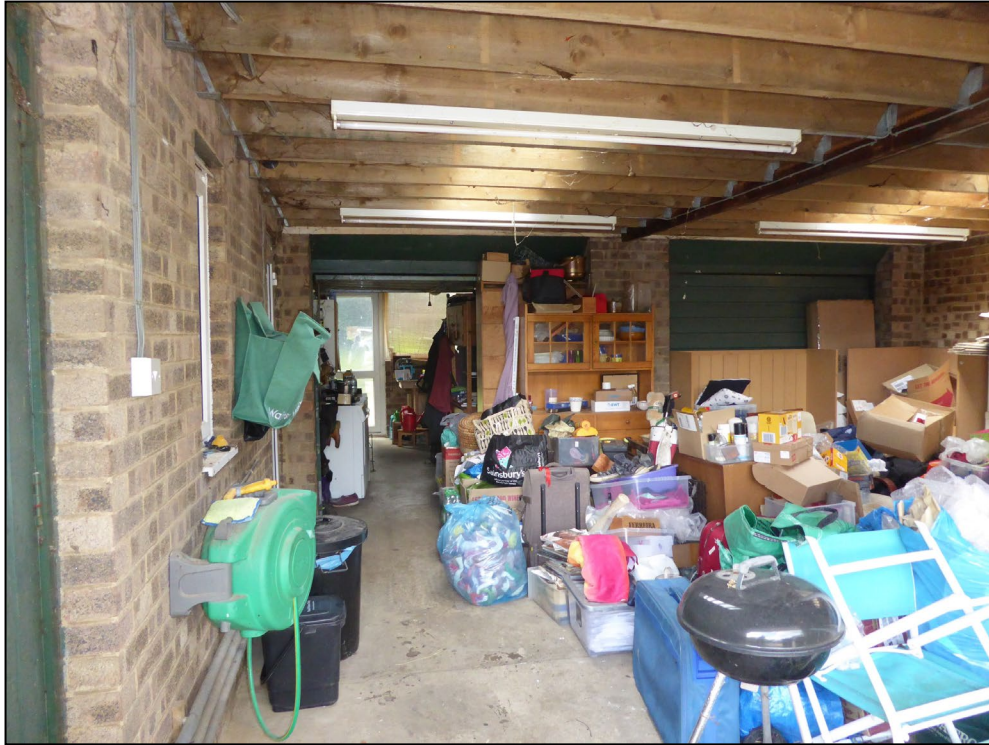
Figure 12. Internal view of garage. 21 Langhams Way, Wargrave. 20.08.24

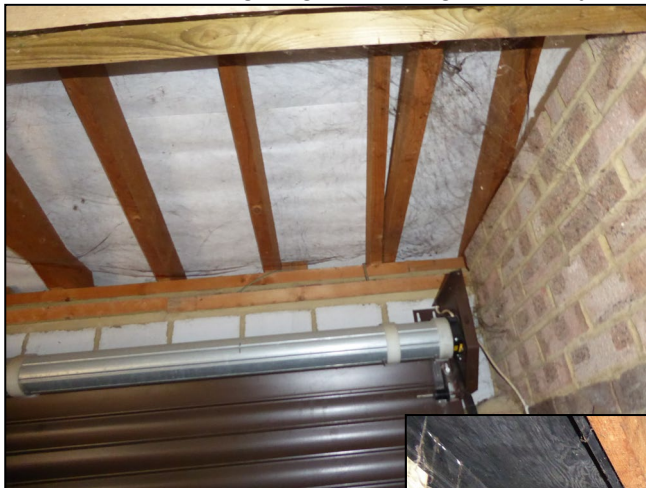
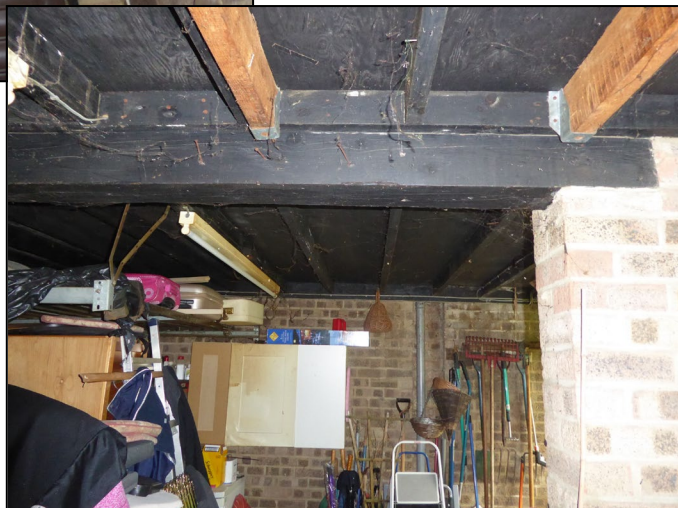
The attached garage was also inspected internally. The garage is used for storage and is in a good condition, see Figure 12 on page 13. A membrane covers the tiles on the false pitched section with the flat section being boarded and had no cracks or splits which roosting bats could exploit, see Figure 13 on page 13.

Figure 12. Example membrane on false pitched section of garage roof and example flat roof section of garage. 21 Langhams Way, Wargrave. 20.08.24
