# ARBORICULTURAL IMPACT ASSESSMENT

Bridge Farm,  
Twyford

March 2025

**Barton Hyett Associates**  
Arboricultural Consultants

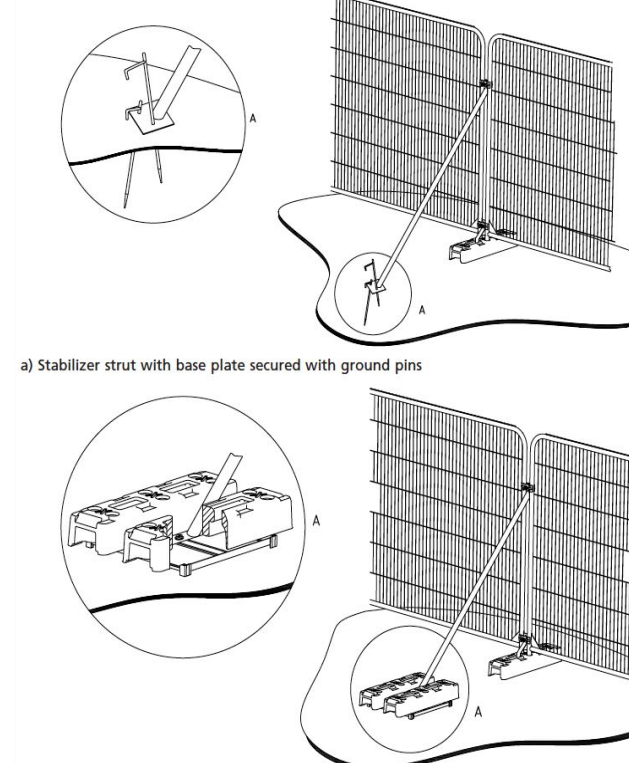
BS5837:2012 Figure 3 Examples of above-ground stabilizing systems

For more details refer to BS5837:2012. Trees in relation to design, demolition and construction - Recommendations p.71
