## BS:5837 ARBORICULTURAL REPORT

ARBORICULTURAL SURVEY & ARBORICULTURAL IMPACT ASSESSMENT &  
METHOD STATEMENT

SILVER BIRCHES (POOL & POOLHOUSE)  
HEATH RIDE  
FINCHAMPSTEAD  
BERKSHIRE  
RG40 3QJ

**Project:** Proposed construction of a new swimming pool & pool house

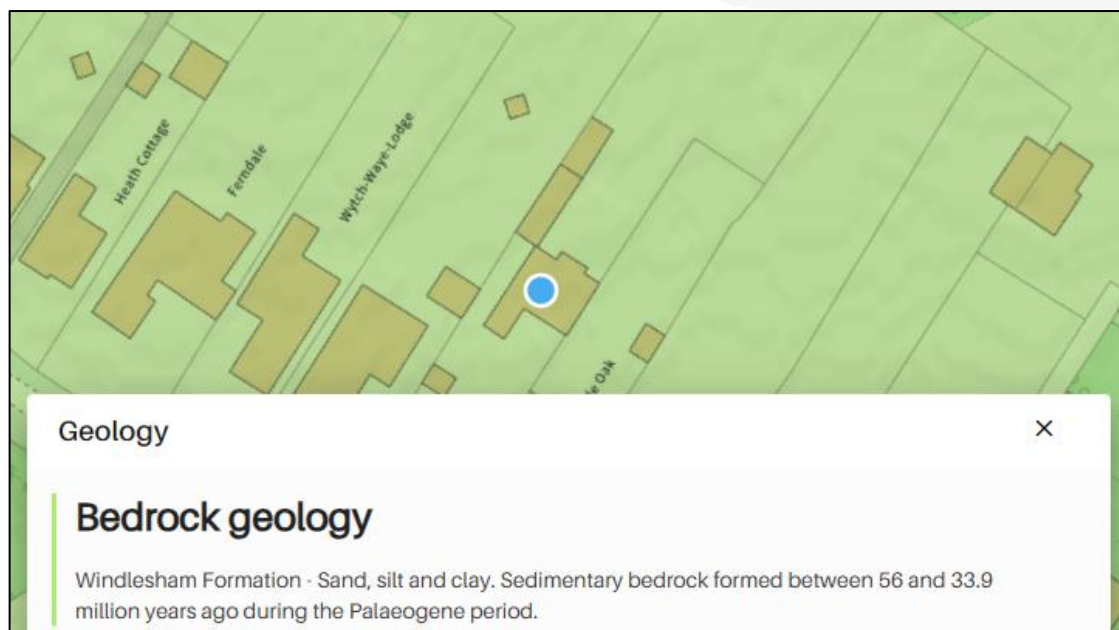
Figure 1 - Detail from the British Geological Survey

The surveyors visual observations indicate the ground is very sandy. However, if clay is present the nutrient levels may be higher and the water holding capacity greater. Clay can also give the soil capacity to shrink and swell with changing moisture levels which can lead to property subsidence damage.

Foundation depths should be calculated in accordance with NHBC Chapter 4.2 following a detailed on-site soil analysis, taking into account the presence of any clay and future growth of the adjacent trees.

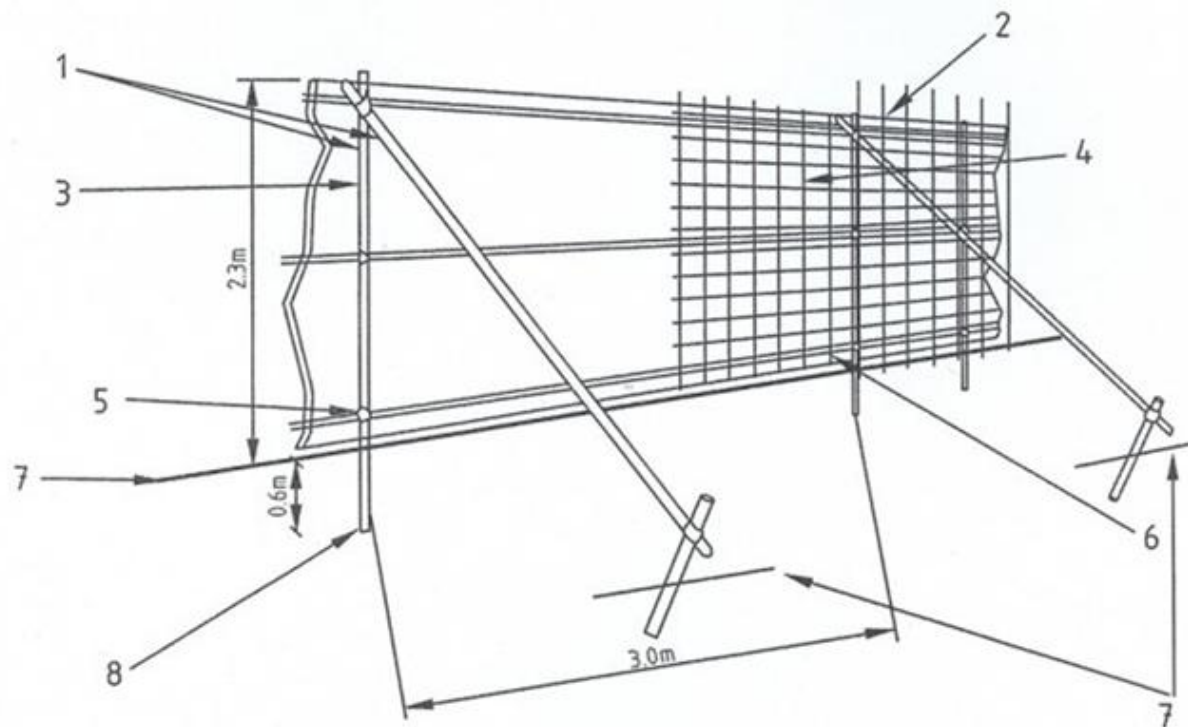
## APPENDIX H - TREE PROTECTION FENCING

- 1 Standard scaffold poles
- 2 Uprights to be driven into the ground
- 3 Panels secured to uprights with wire ties and, where necessary, standard scaffold clamps
- 4 Weldmesh wired to the uprights and horizontals

- 5 Standard clamps
- 6 Wire twisted and secured on inside face of fencing to avoid easy dismantling
- 7 Ground level
- 8 Approx. 0.6m driven into the ground

The fencing will be located to protect trees and their rooting areas and will remain vertical, rigid and complete during development. At no time will Tree Protection Fencing be removed or relocated contrary to the recommendations in this report, without professional arboricultural advice and without the prior consent of the Local Authority Tree Officer.
