## **PRELIMINARY ECOLOGICAL APPRAISAL (DBW) AT BLACKMOOR BASINGSTOKE ROAD, THREE MILE CROSS**

**Prepared for:  
Mr S Chandrasekaran  
Blackmoor  
Basingstoke Road  
Three Mile Cross  
RG7 1AS**

**22 September 2025**

**Ref: SPH/NP/PEA-25/02.09**

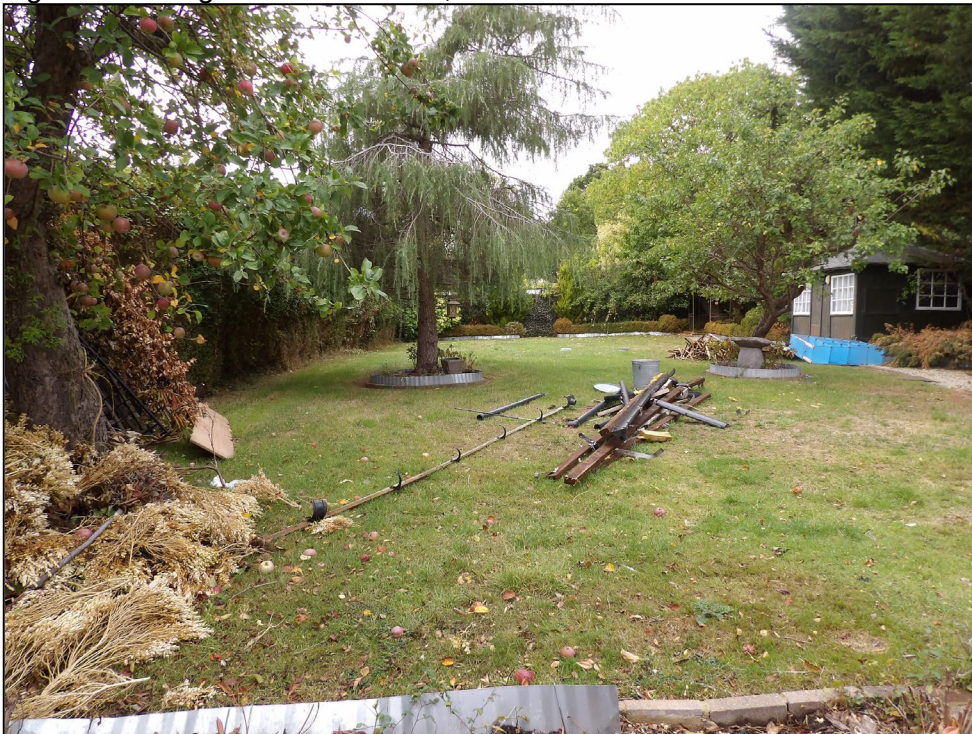
Figure 3. Rear garden. Blackmoor, Three Mile Cross. 02.09.25

The application site comprises detached brick-built two storey property. The remainder of the site comprises a front garden and parking/driveway and shrubs, and a large rear garden that is mainly laid to lawn with patio area and mature trees and hedgerows, see Figure 3 below. The site itself offers good foraging and commuting habitat for bats and there is direct ecological connectivity to bat foraging and commuting habitat in the wider landscape.

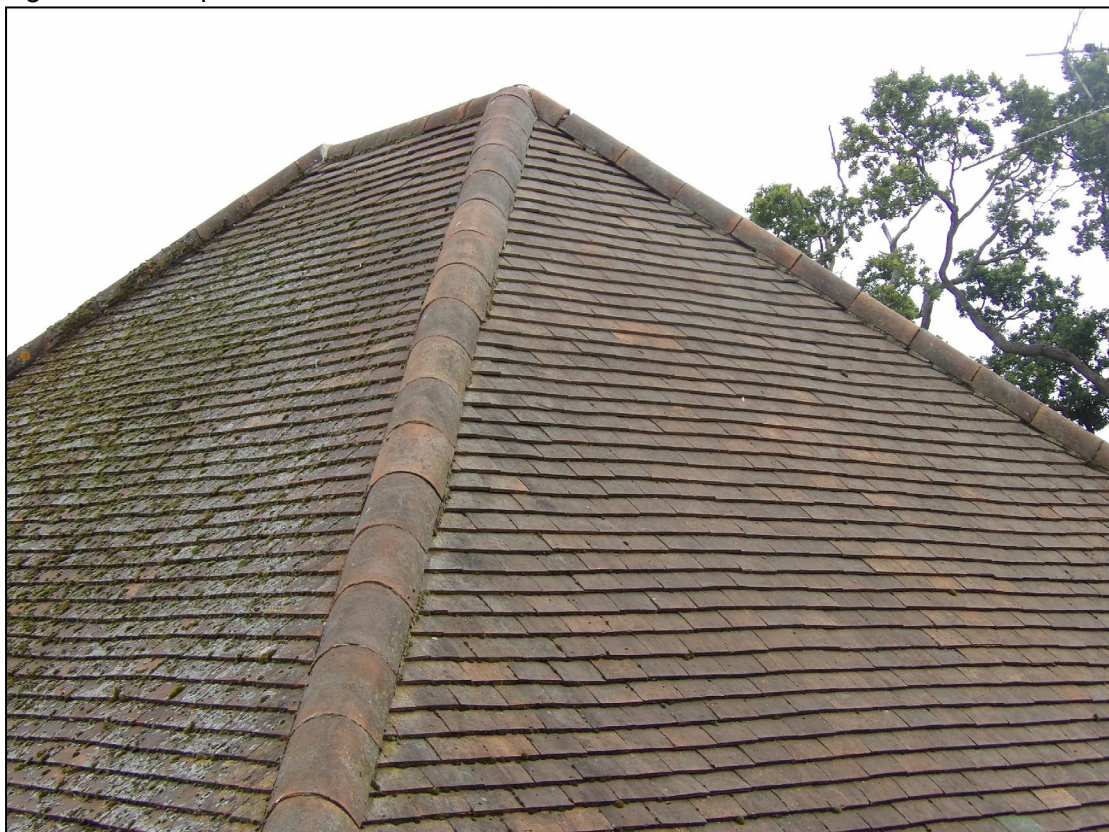
Figure 4. Example of roof tiles. Blackmoor, Three Mile Cross. 02.09.25

The property is a detached, two-storey brick-built building, which is in a good to fair condition externally. The hipped roof of the property and front bay window are covered in tiles (see Figure 4 below), the majority of which are well fitted however, on the southern elevation a tile is missing, see Figure 5 on page 9. There is missing mortar from the majority of the ridge and hip tiles (see Figure 6 on page 9), and there is missing mortar from the verge over the bay window, see Figure 7 on page 10. The lead flashing around the chimney stacks is flush and offers no roosting potential (see Figure 8 on page 10), and the soffits and fascias are tightly fitted to the walls and have no visible gaps in which bats could use for roosting, see Figure 9 on page 11.

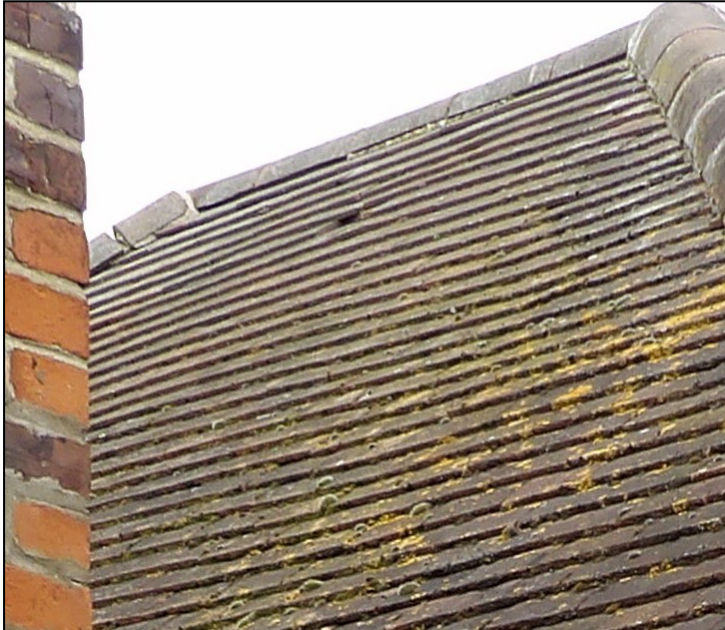
Figure 5. Missing roof tile and missing mortar. Blackmoor, Three Mile Cross. 02.09.25

The combined evidence from the desktop study and the internal and external inspection of the property provides a high level of confidence in support of the opinions set out in this report. There is missing mortar from the majority of the ridge and hip tiles and front verge and a missing roof tile on the southern elevation which provide features suitable for bats to roost and may provide access into the building for roosting bats.

The presence or absence of bat cannot be determined without further survey effort and if the roof were to be directly affected by the proposal or the potential roost features (missing mortar be repaired) a minimum of one bat activity survey would be required. As the current plan (Rev 2) does not affect the potential bat roosting features there will be no requirement for further survey effort. However, should the client or their agents seek a retrospective application to alter the design or repair the gaps that may provide potential roosting opportunities this may potentially disturb, damage or destroy the potential roosting features and at least one bat activity survey would be required.

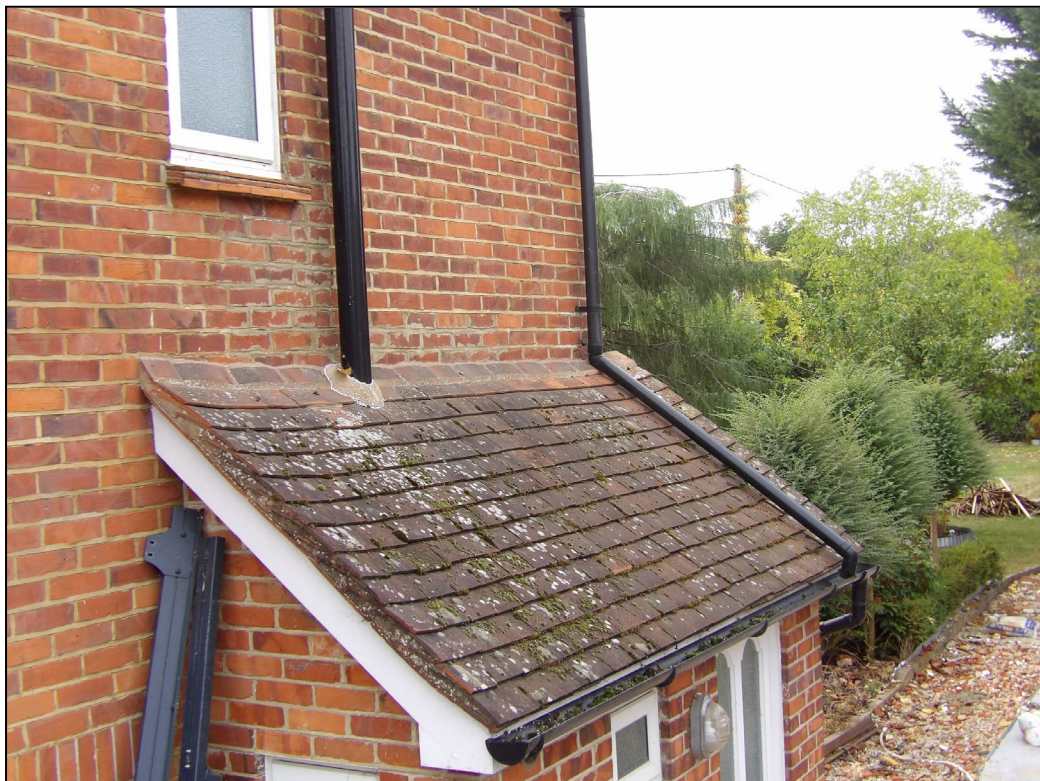
Figure 10. Lean-to building on northern elevation. Blackmoor, Three Mile Cross. 02.09.25

On the northern elevation is a 'lean-to' style building, the roof of which is also covered in tiles, all of which are well fitted with no gaps and are firmly attached to the main dwelling. The verges are sealed and the fascias firmly attached with no gaps with no gaps that could be exploited by crevice dwelling bat species, see Figure 10 on page 11.

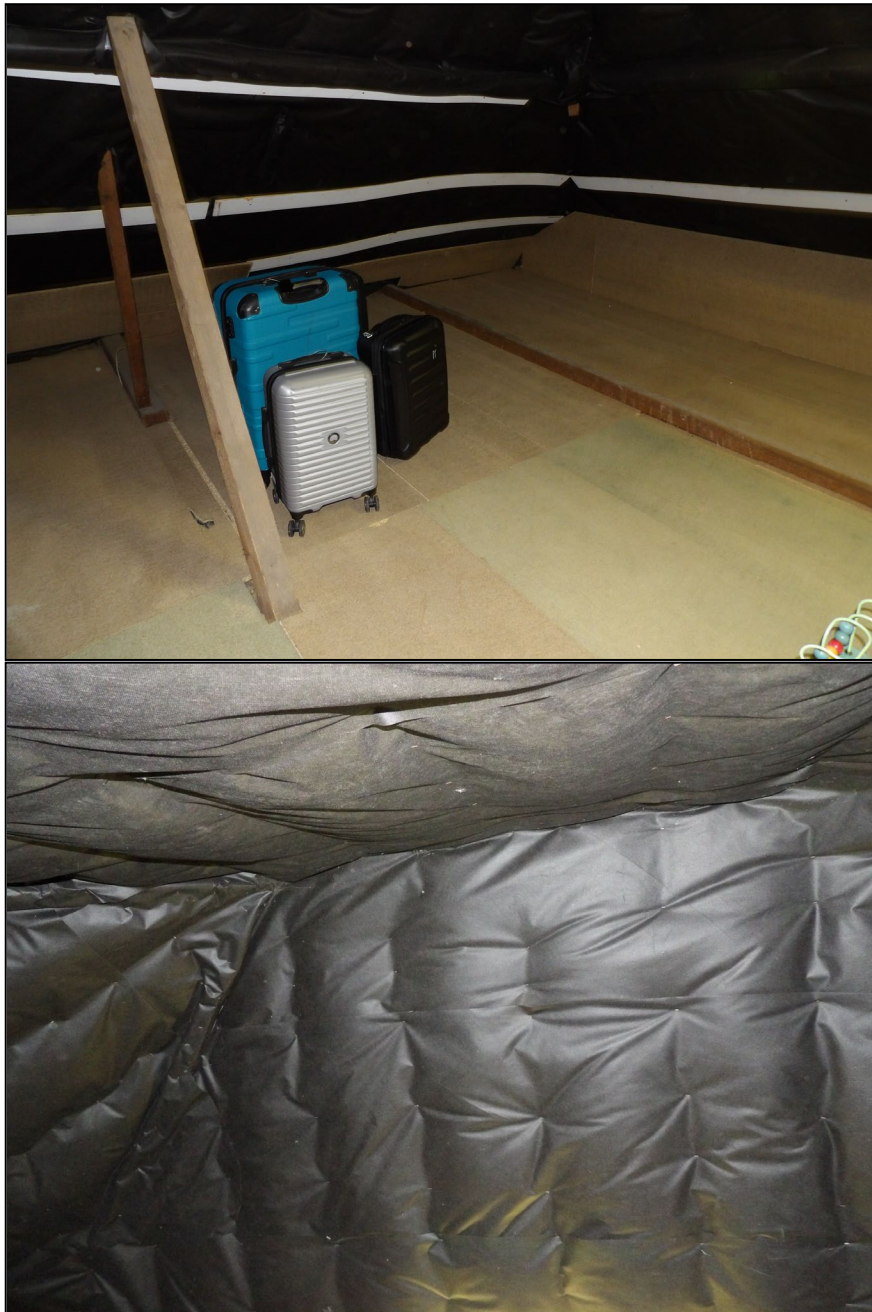
Figure 11. Example of loft space and unlined roof tiles. Blackmoor, Three Mile Cross. 02.09.25

The loft space in the property was accessed through a hatch via a loft ladder and is in a good condition internally. The loft is uncluttered, lit, boarded and the roof tiles lined with insulation, see Figure 11 below. There was no access to the void space in the lean-to building however given the good condition of the roof of this building externally this was not considered a constrain to the survey.

No bats or evidence of bats was recorded during the internal inspection of the property.
