TEMPORARY SHOWROOM ACCESS,  
PARCEL A, SHEERLANDS ROAD,  
ARBORFIELD GREEN  
Stage 1 Road Safety Audit  
J190609

Temporary Showroom Access, Parcel A, Sheerlands Road,  
Arborfield Green

Stage 1 Road Safety Audit

J190609

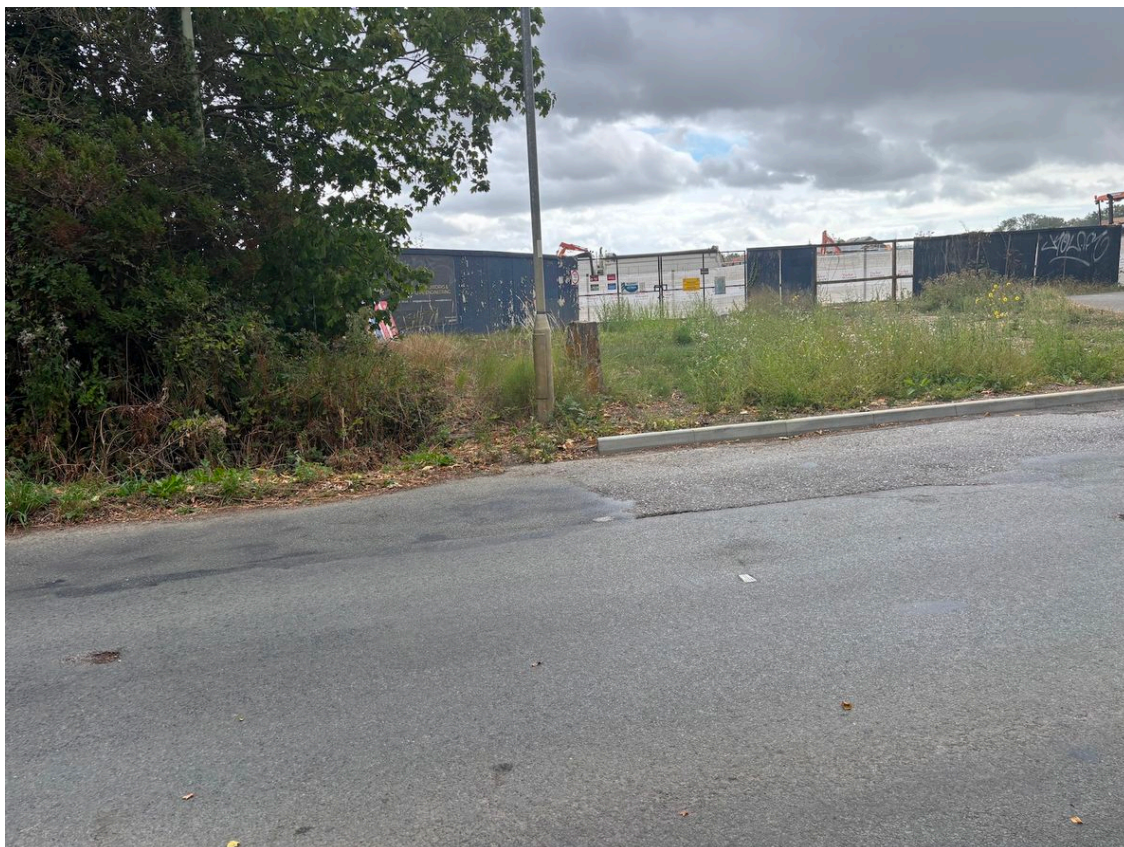
Problem 4

| Location | Pedestrian crossing over access road |
| Summary | Risk of obstructed visibility |

A pedestrian crossing is proposed over the access road. It is not clear to the Audit Team whether hoarding will be installed along the access road. This may cause an obstruction to the pedestrian intervisibility of the crossing. This may result in entering vehicles colliding with pedestrians when they step into the carriageway.

| Recommendation | Ensure pedestrian intervisibility is achieved at the crossing facility. |

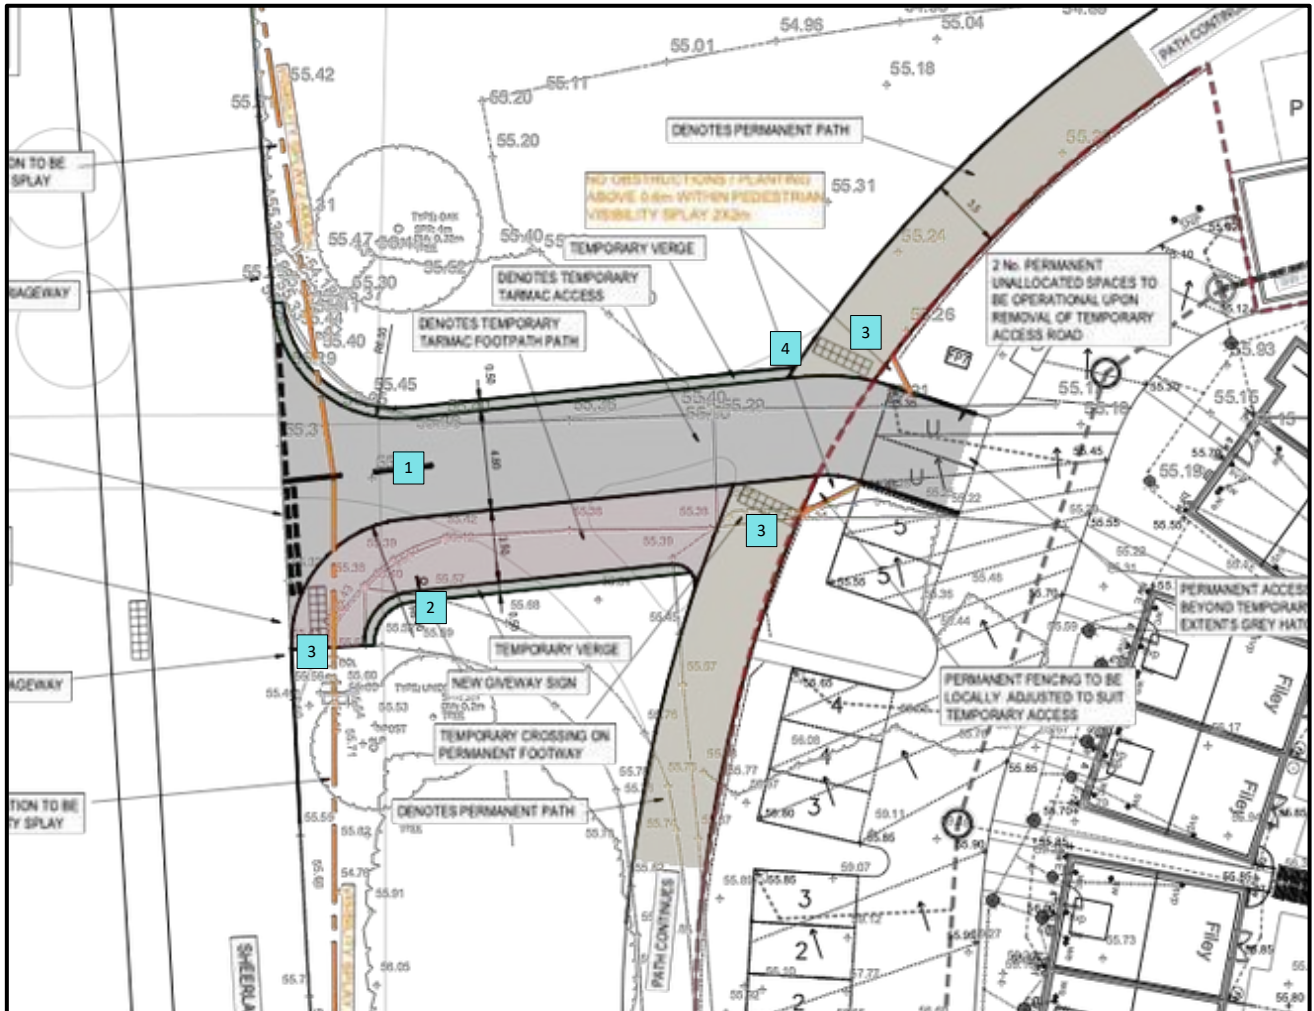
## Appendix C Problem Location Plan

| Problem 1 | |
| Location | Site access |
| Summary | Risk of side-swipe collisions |
| <p>Centre line road markings are proposed on the access road. The use of centre lines is suggested where the road width exceeds 5.5 metres. The access road is 4.8 metres, which may cause entering and exiting vehicles to believe there is sufficient width for all simultaneous movements at the junction. This may result in side-swipe type collisions.</p> | |

| Problem 2 | |
| Location | Site access |
| Summary | Risk of vehicle collisions |
| <p>The proposed give-way sign is facing the wrong way. This will cause the intended instruction not to be provided. This may result in side-swipe type collisions between exiting and passing vehicles.</p> | |

| Problem 3 | |
| Location | Pedestrian crossings |
| Summary | Risk of pedestrian falls |
| <p>The pedestrian crossing shows two rows of tactile paving. This may cause visually impaired pedestrians (VIPs) approaching from the site, not to detect the crossing. This may result in VIPs falling in the carriageway.</p> | |

| Problem 1 | |
|---|---|
| Recommendation | Reduce the number of centre line modules and install where sufficient width allows. |

| Problem 2 | |
|---|---|
| Recommendation | Ensure signage is installed facing the correct direction. |

| Problem 3 | |
|---|---|
| Recommendation | Provide three full rows of tactiles at 'ahead' type crossings. |
