Planning Application 250531

~~Garage~~ at Land adjoining Woodlands  
Wick Hill Lane  
Finchampstead  
Wokingham  
RG40 3PZ

## Preliminary Roost Assessment

Report ref.: R2964\_PRA\_a

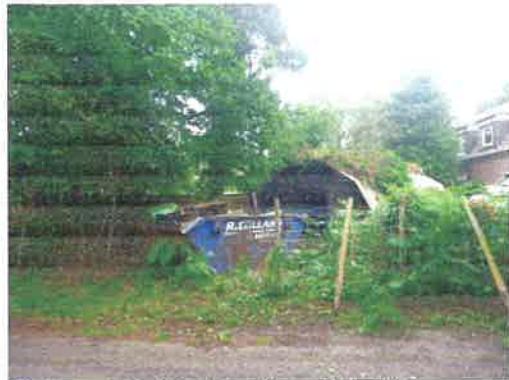
Photograph 1. Site viewed from Wick Hill Lane.

**5.2.2** The garage was a dilapidated Nissen hut with a prefabricated concrete asbestos roof, timber double doors and single-skin cladding (**Photographs 1-4**).

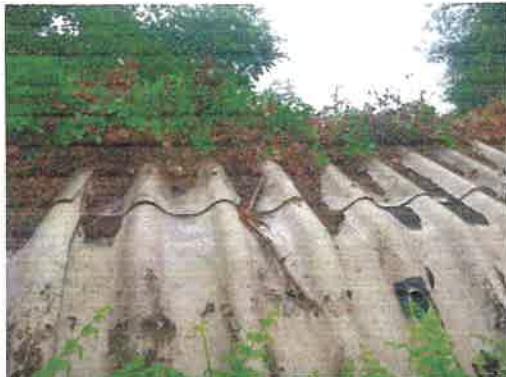
**5.2.3** The concrete asbestos roof provided no potential roosting sites for bats, but there were holes that led directly inside the garage (**Photograph 5**). There was dense ivy (*Hedera helix*) growing over the roof which did not provide any suitable crevices for any opportunistic use by roosting bats.

*Photograph 5. Concrete asbestos roof (side elevation).*

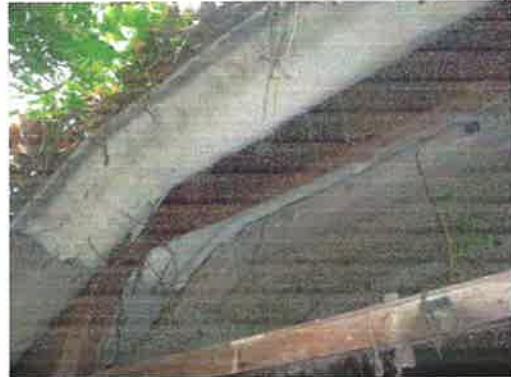
**5.2.4** The single-skin cladding at the front and rear ends of the garage offered no potential roosting opportunities to bats. The double doors were open at the time of survey and

there was a large hole above the door frame that led directly inside the garage (**Photograph 6**).

*Photograph 6. Large hole above door frame (front elevation).*

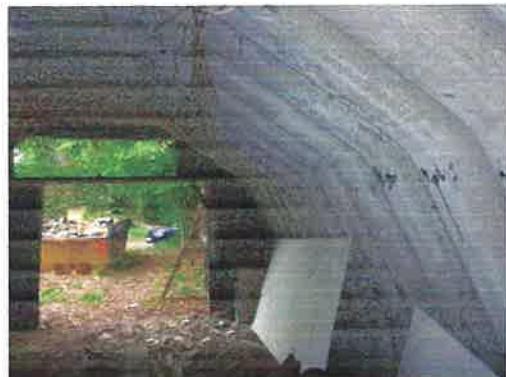
**5.2.6** The inside of the garage was one open space that had previously been used for storage (**Photograph 7**). The floor was bare ground and the ceiling was the underside of the concrete asbestos roof (**Photograph 8**). The garage interior featured no suitable roosting sites for bats.

*Photograph 7. Garage interior.*
