### **37 KERRIS WAY, LOWER EARLEY**

In accordance with your instructions, AA Environmental Limited (AAe) carried out a Preliminary Roost Assessment (PRA) of the above property on Thursday 17 August 2023. The purpose of the survey was to assess the presence or likely absence of bats utilising the buildings and provide appropriate mitigation measures, as necessary. A series of photographs has been attached for reference.

| Rev. | Details | Drawn<br>Chkd. | Date |
|---|---|---|---|
| <b>TITLE</b><br>Photograph Record Sheet | | | |

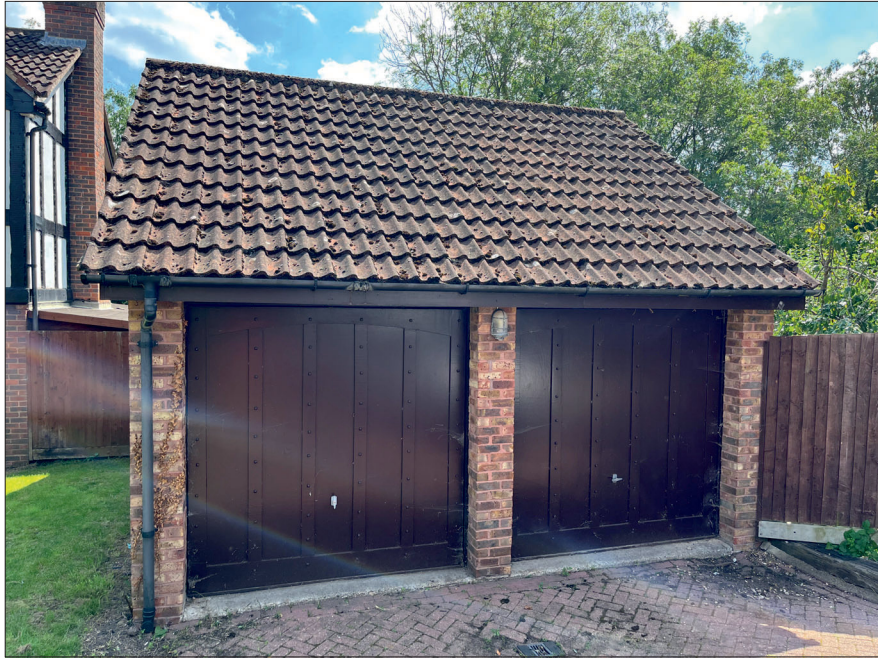
The detached garage was of masonry construction, with a pitched interlocking pantiled roof which was well sealed. The garage had two metal up-and-over doors, with an access door on the side. There were timber soffits/fascias present. Internally, there was an enclosed roof space within the garage, which was used for storage and found to be cluttered with trusses and lined with a bitumen-based felt. The garden shed was of timber construction with a pitched bitumen-based felt roof, with no separate roof space recorded.

Photograph 1: Showing the front of the detached garage.

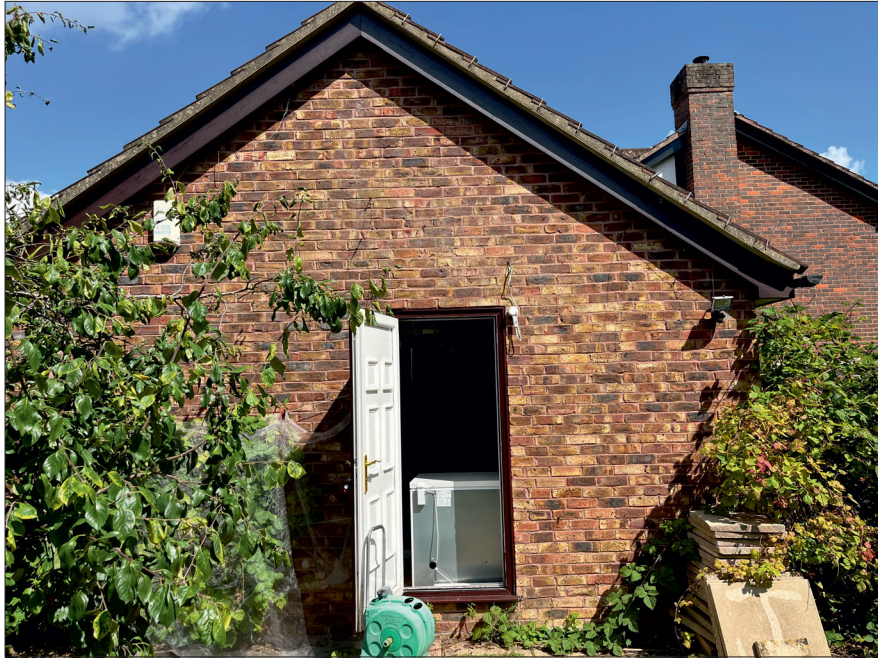
Photograph 2: Showing the side of the detached garage.

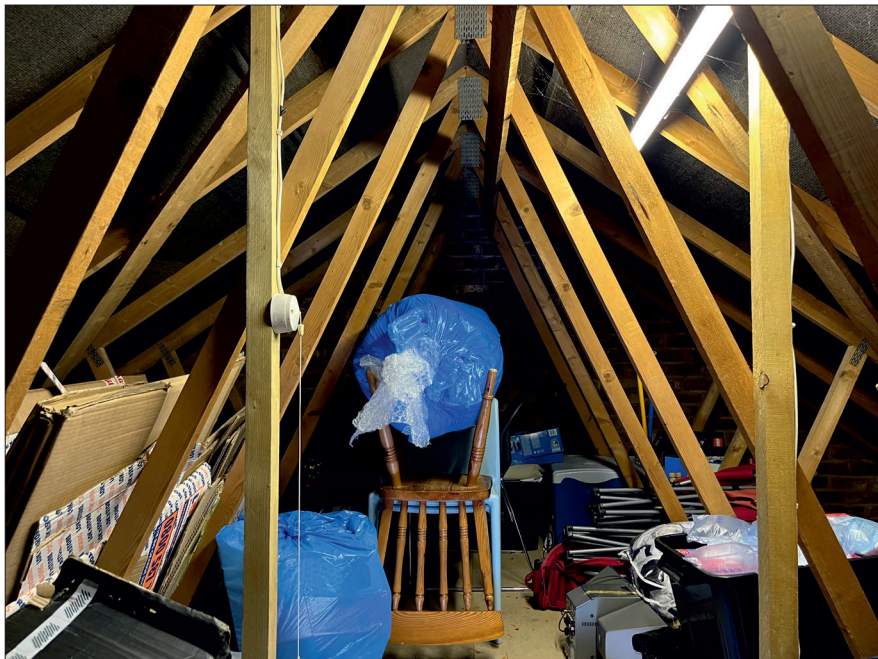
No evidence of bats was recorded during a careful internal and external inspection of the garage and shed. The roof tiles were well aligned and tightly sealed, as were the soffits/fascias, with no obvious access points recorded. Internally, the attic space was fully accessed and not complex allowing a thorough inspection, which appeared to be well-sealed and dusty and heavily cobwebbed throughout. The garage and shed were assessed to provide **negligible** roosting opportunities for bats due to their construction type and condition.

Photograph 3: Showing the roof space above the detached garage, which was cluttered with trusses.

A thorough examination of the buildings was completed, with all potential access points and/or roosting opportunities fully inspected for evidence of bats. The roof space above the garage was fully accessed and not complex allowing a thorough inspection and, therefore, there are considered to be no constraints to the survey findings. Although no evidence of bats was recorded, with the buildings assessed to provide **negligible** roosting opportunities, and no further surveys are considered necessary, all site operatives should be made aware of current legislation protecting bats and their roosts. In the unlikely event of any bats being encountered on the site, then works should stop immediately and Natural England or AAe contacted so that appropriate advice can be provided.

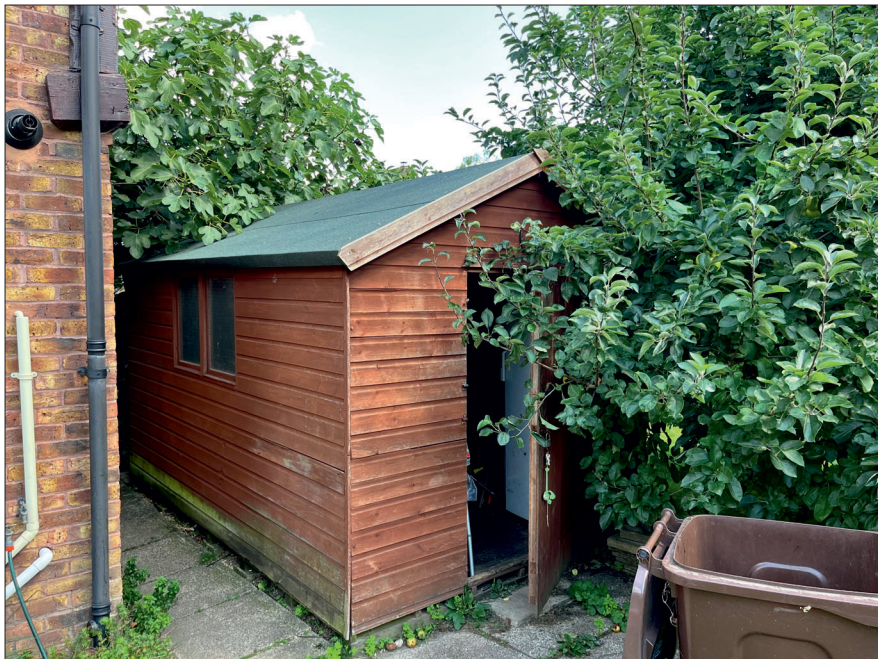
Photograph 4: Showing the timber shed within the garden area.
