## PHASE 1 DAYTIME BAT ASSESSMENT FOR 10 MARATHON CLOSE

This report is required to support a planning application seeking to extend the existing dwelling at 10 Marathon Close.

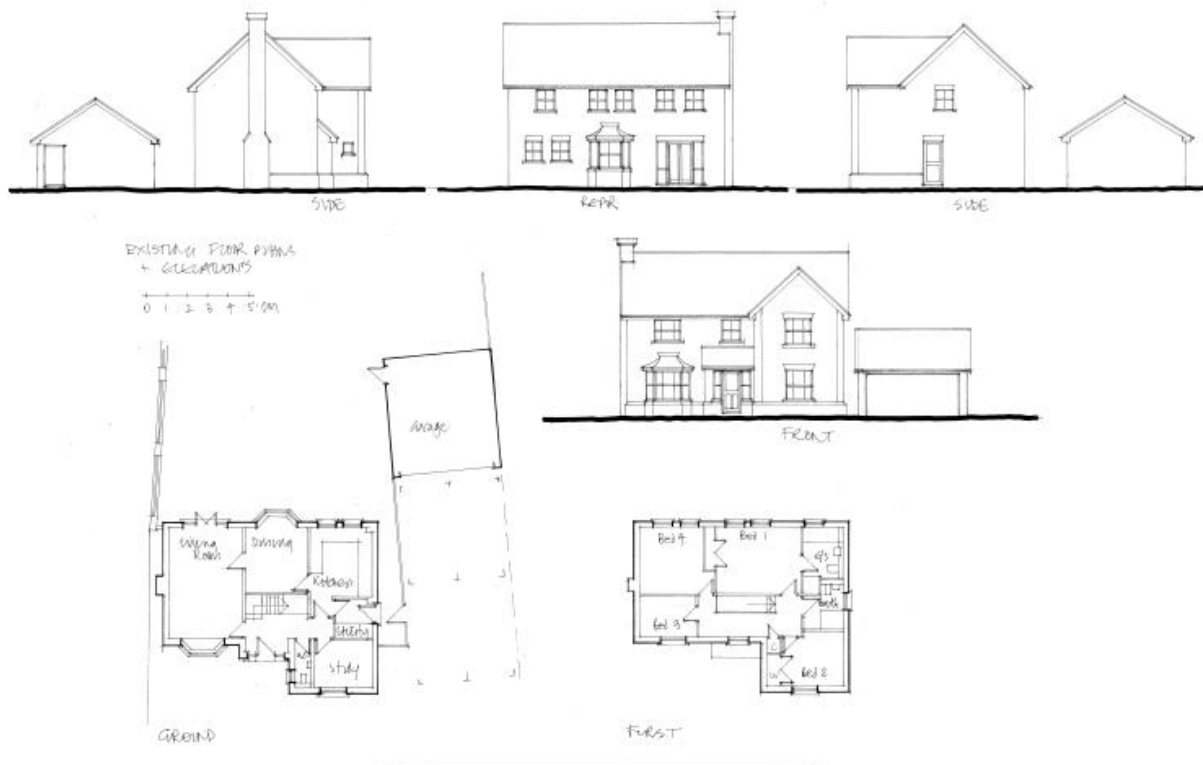
The existing house is a modern structure, built using brick/block construction with a interlocking concrete tiled roof over trusses.

The loft void is accessed via a hatch and is actively used for ancillary household storage.

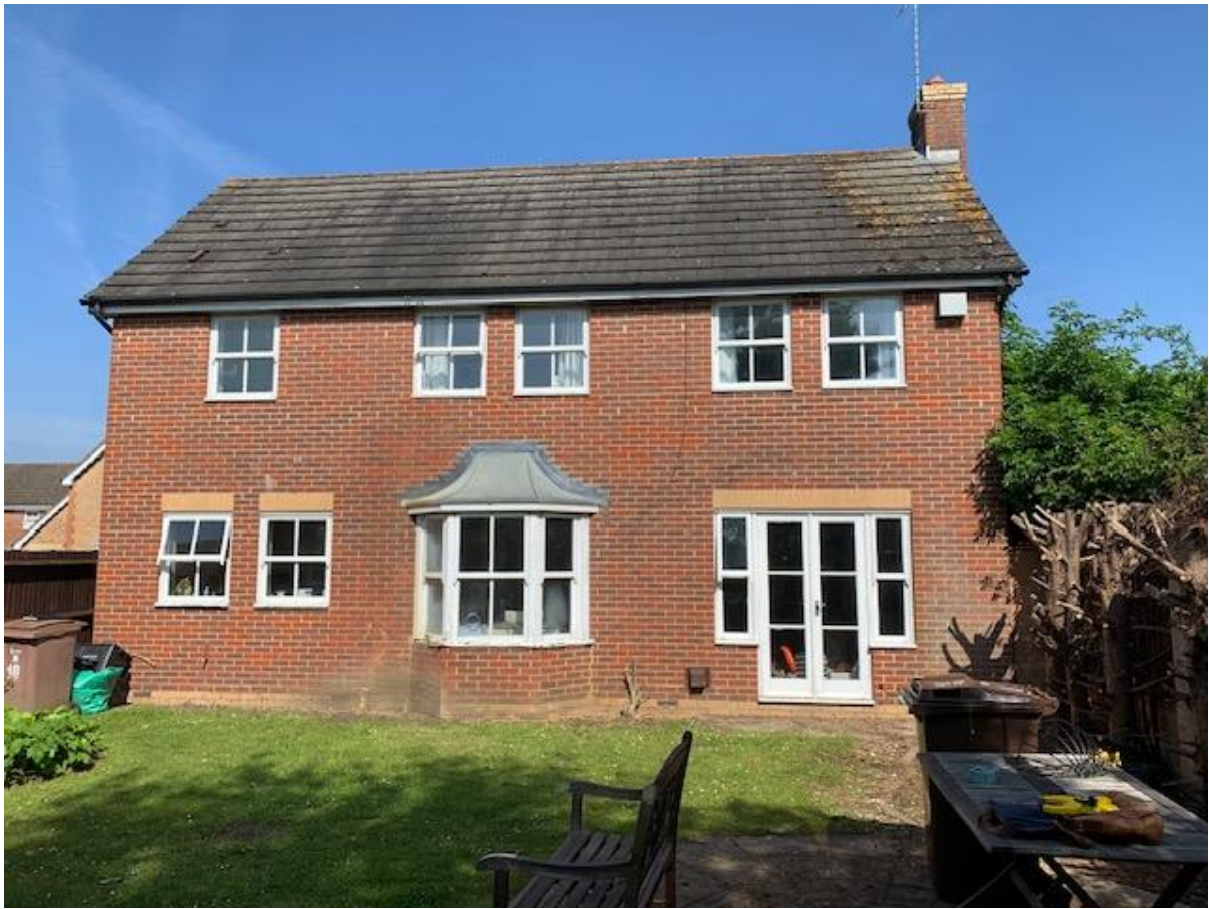
External views

The building is a two storey structure with large concrete interlocking tiled roof. The loft void is used for household storage.

There was no sign of any bat activity. Therefore, the house has negligible potential for bats and a phase 2 emergence survey is *not* recommended.
