## **PRELIMINARY ECOLOGICAL APPRAISAL (DBW) AT 8 HUNTERS WAY SPENCERS WOOD**

**Prepared for:  
Mr M Duffin  
8 Hunters Way  
Spencers Wood  
Wokingham  
RG7 1HW**

**16 September 2024**

**Ref: SPH/NP/PEA-24/28.08**

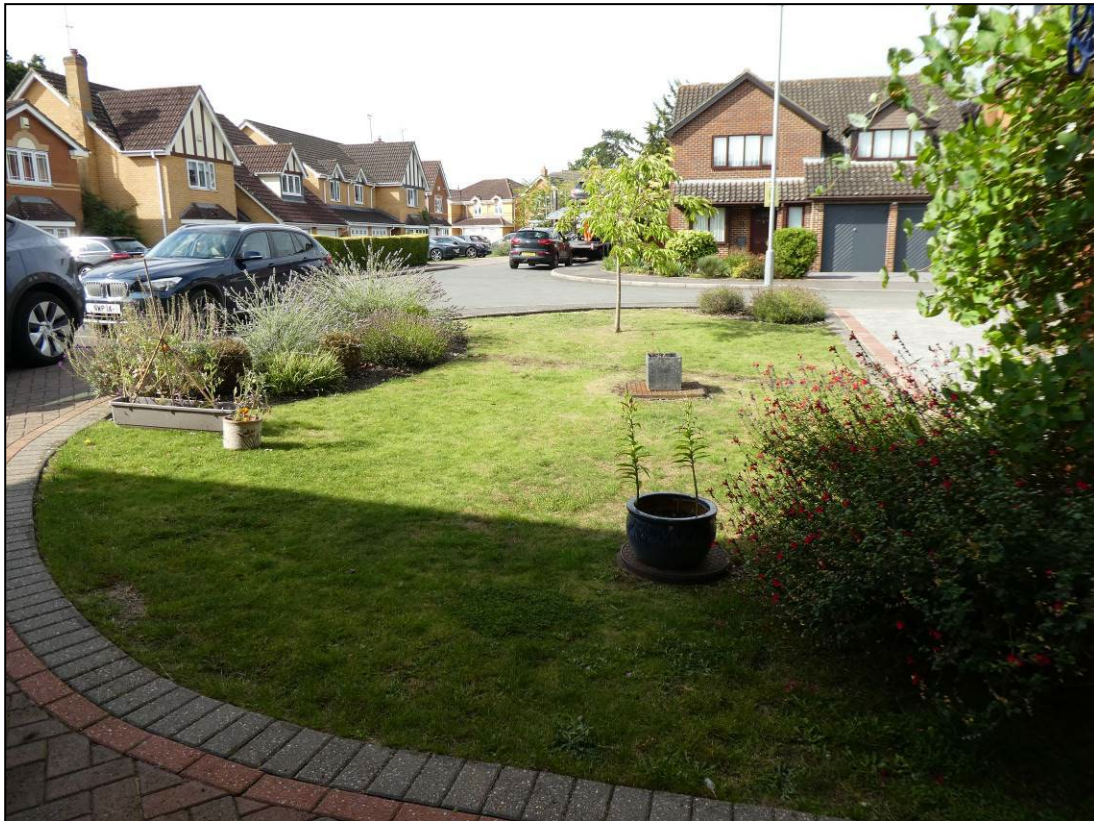
Figure 3. Front garden. 8 Hunters Way, Spencers Wood. 28.08.24

The application site comprises a detached, brick-built property with an attached garage. The remainder of the site comprises a front garden (see Figure 3 below) and a rear garden with patio area and lawn. The site itself offers limited foraging and commuting habitat for bats although there is some ecological connectivity to bat foraging and commuting habitat in the wider landscape.

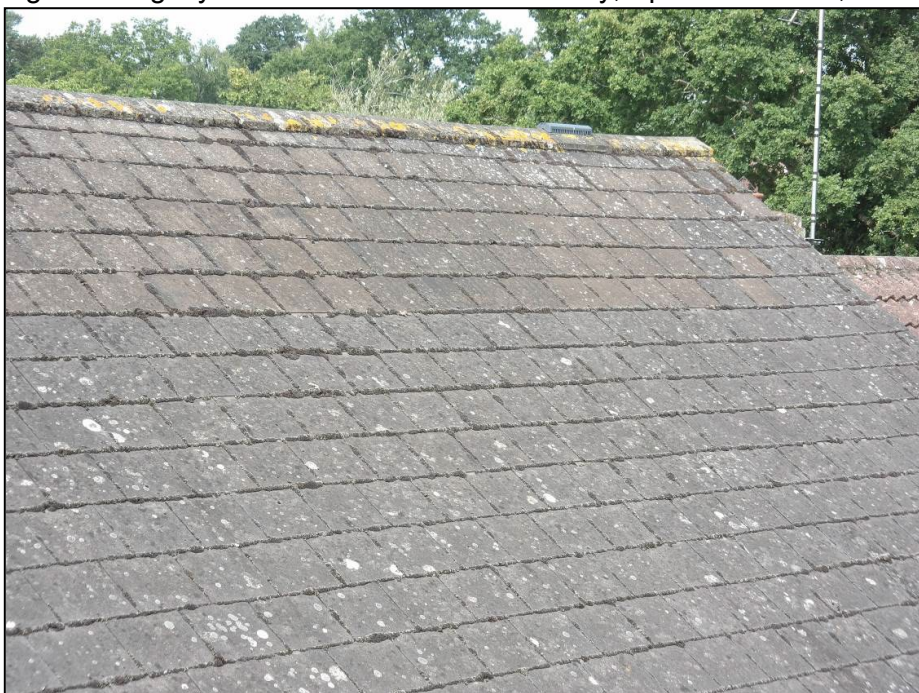
Figure 4. Tightly fitted roof tiles. 8 Hunters Way, Spencers Wood, 28.08.24

The property is a detached, brick-built property with rear, single storey extension and an attached garage, all of which are in a good condition externally. The roof of the property is pitched and covered in closely fitted tiles, none of which are missing or broken, see Figure 4 below. The ridge tiles are all tightly fitted and had no gaps in which roosting bats could exploit (see Figure 5 on page 9) and the verges are all well cemented with no cracks or splits in which crevice dwelling bats could use for roosting. The hip tiles on the roof section above the garage are all closely fitted with no gaps in which roosting bats could utilise (see Figure 6 on page 9), and the lead flashing affixing it to the main property and around the chimney is all tightly fitted with no gaps, see Figure 7 on page 10. The soffits and fascias are tightly fitted to the walls and have no visible gaps in which bats could use for roosting, see Figure 8 on page 10. The pitched roof of the rear, single storey extension is covered in close fitted slate tiles, there is no missing mortar from the verges and the ridge tiles and sealed with ridge clips, see Figure 9 on page 11. The lead flashing around the Velux window and affixing the building to the main property is flush with no gaps and the soffits and fascias are sealed with no splits, see Figure 10 on page 11.

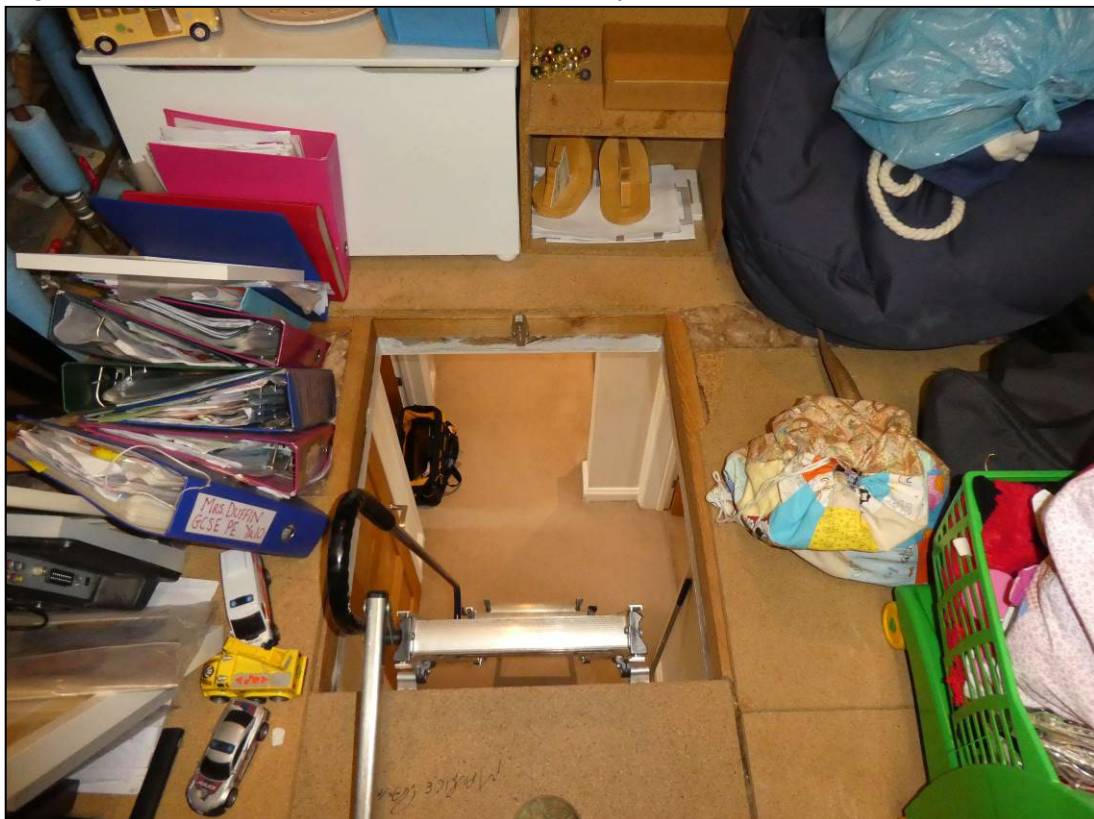
Figure 11. Example of loft hatch. 8 Hunters Way, Spencers Wood, 28.08.24

The loft space in the main property was accessed through a hatch via a loft ladder and is in a good condition internally, see Figure 11 below. The loft is used for storage, lit, boarded and insulated, see Figure 12 on page 13. The roof tiles are lined with bitumen felt, all of which is in a good condition with no rips or tears in which roosting bats could exploit, see Figure 13 on page 13.

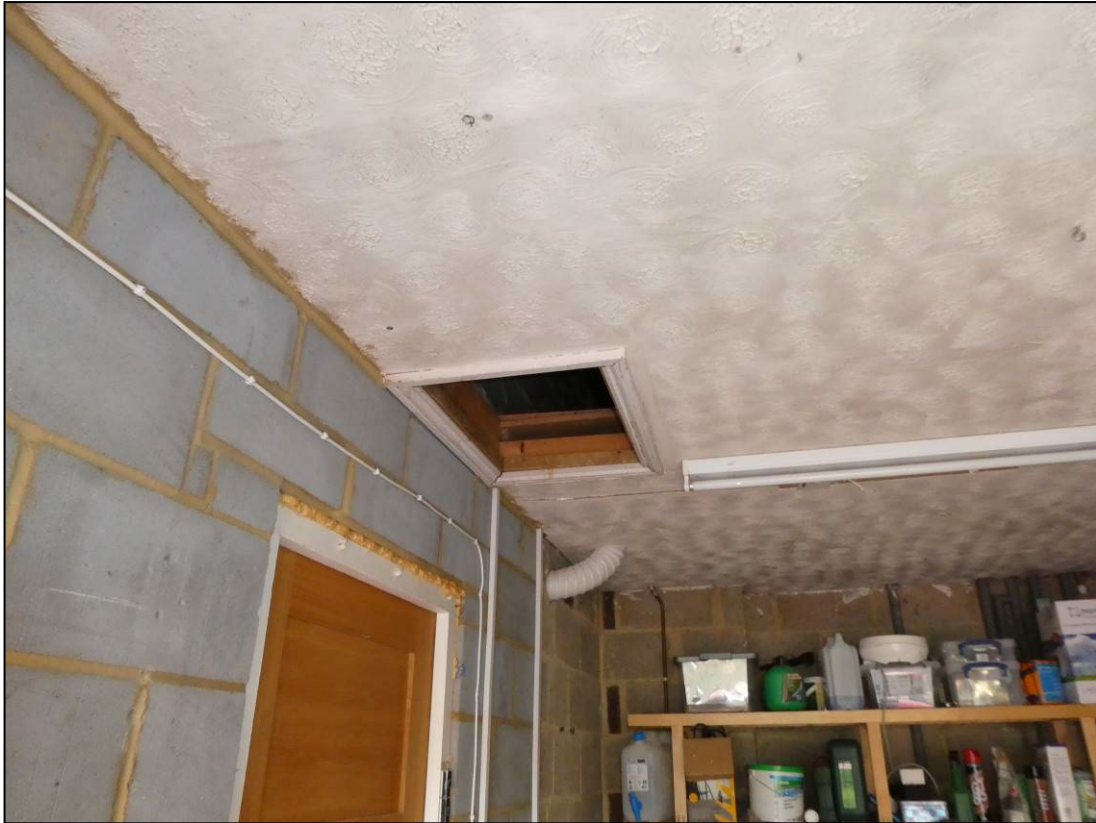
Figure 14. Example of loft hatch to garage loft. 8 Hunters Way, Spencers Wood, 28.08.24

The loft of the garage was also accessed through a hatch via a ladder (see Figure 14 on page 14), is small, uncluttered and also in a good condition, see Figure 15 on page 14. The roof tiles are lined with bitumen felt, all of which is in a good condition with no rips or tears in which roosting bats could exploit, see Figure 16 on page 15.
