## **459 WOKINGHAM ROAD, EARLEY**

### **Introduction**

In accordance with your instructions, AA Environmental Limited (AAe) carried out a Preliminary Roost Assessment (PRA) of the above property on Thursday 16 April 2026. The purpose of the survey was to assess the presence or likely absence of bats utilising the buildings and provide appropriate mitigation measures as necessary. A series of photographs has been attached for reference.

| Rev. | Details | Drawn<br>Chkd. | Date |
|---|---|---|---|
| Photograph Record Sheet | | | |

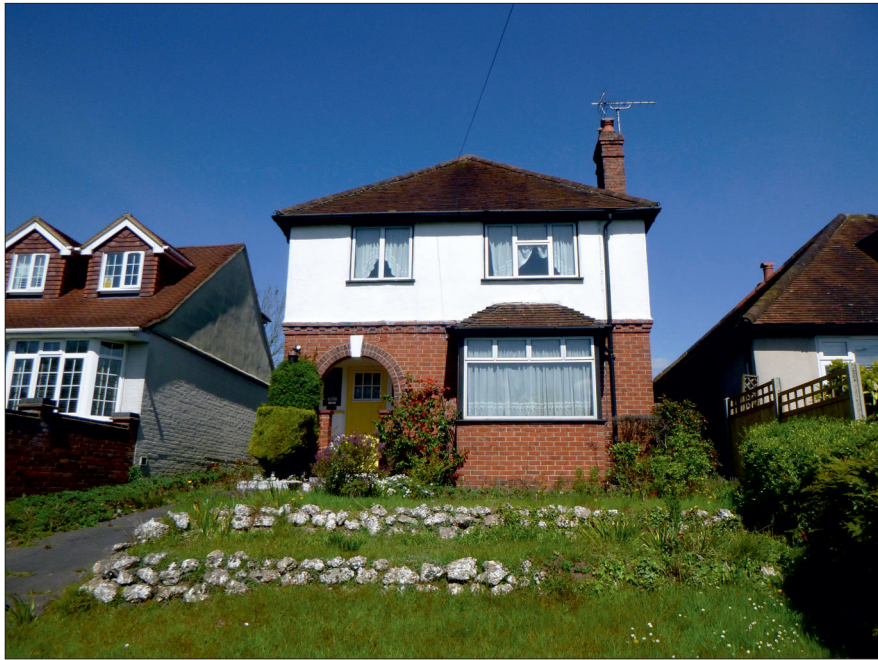
Photograph 1: Showing the front of the building.

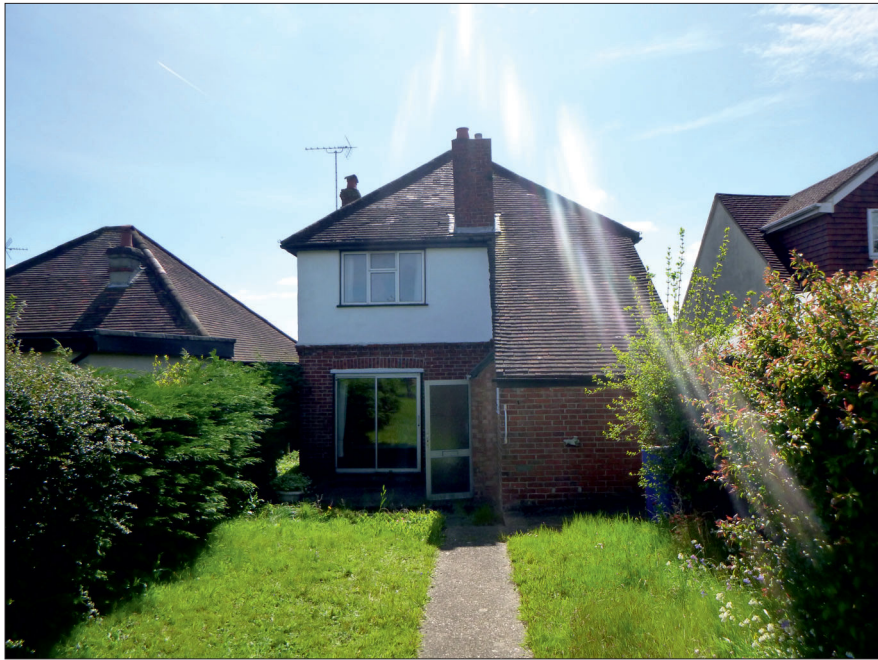
Photograph 2: Showing the rear of the building.

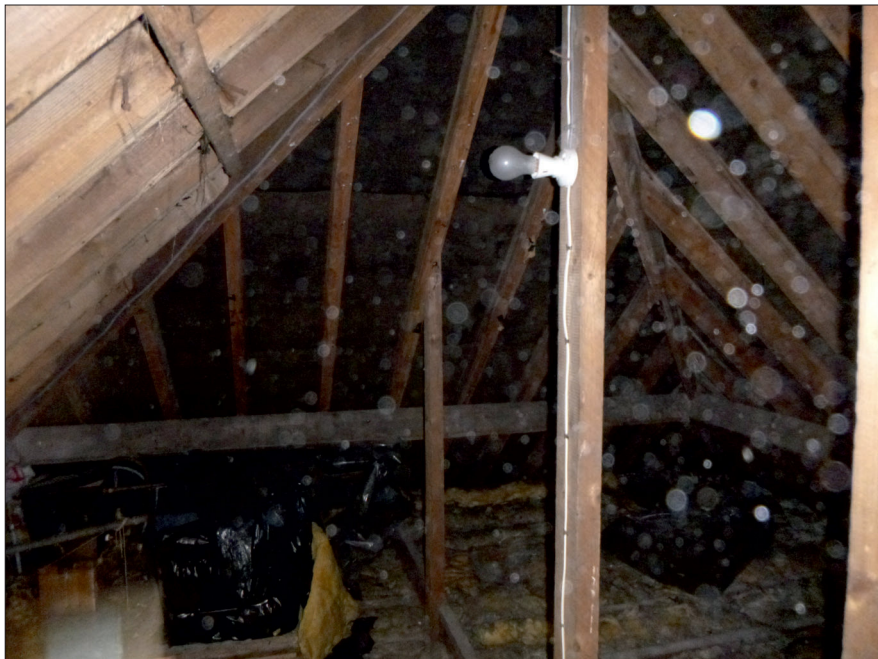
No evidence of bats was found during a thorough internal and external inspection of the property. The roof tiles were in good condition, with no obvious access points recorded. The restricted areas of timber cladding was well-aligned and sealed. Internally, the roof space was fully accessed and found to be dusty and cobwebbed throughout.

Photograph 3: Showing the single roof space, which was dusty and cobwebbed throughout.

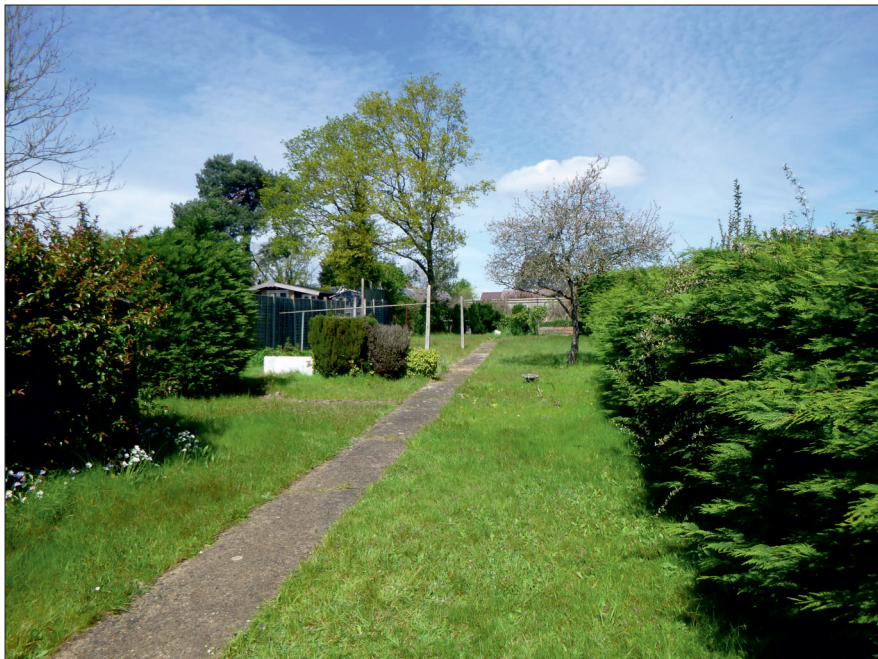
Lawns dominated the garden, with a few individual trees and areas of ornamental planting also recorded. Species recorded in the lawns were typical of amenity grassland and included perennial ryegrass (*Lolium perenne*), Yorkshire-fog (*Holcus lanatus*), ribwort plantain (*Plantago lanceolata*), dandelion (*Taraxacum* agg.), wood-rush (*Luzula* sp.) and daisy (*Bellis perennis*). Ornamental species recorded on site and at the boundaries included grape hyacinth (*Muscari* sp.), daffodil (*Narcissus* sp.), snowdrop (*Galanthus* sp.), bluebell (*Hyacinthoides* sp.), viburnum (*Viburnum* sp.), rose (*Rosa* sp.), stinking iris (*Iris foetidissima*), box (*Buxus sempervirens*), winter jasmine (*Jasminum nudiflorum*), cypress (*Cupressaceae* sp.), quince (*Chaenomeles* sp.), aster (*Aster* sp.) and peony (*Paeonia* sp.). The trees recorded included an immature apple (*Malus* sp.) and semi-mature oak (*Quercus* sp.).

Photograph 4: Showing the well-maintained rear garden.
