**16 Kingsbridge Cottages  
Nine Miles Ride  
Wokingham  
Berkshire  
RG40 3LY**

# **Preliminary Roost Assessment**

**Report ref.: R2899\_PRA\_a**

**March 2025**

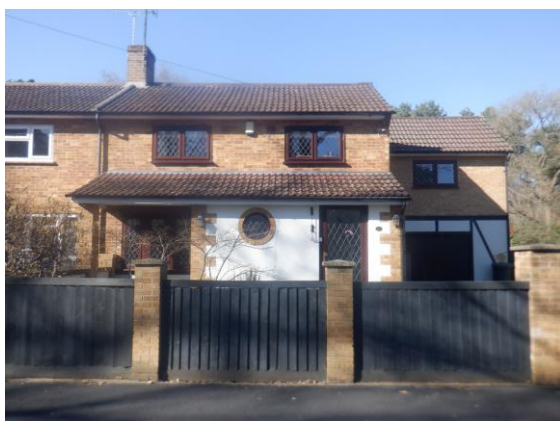
5.2.2 The property was an end-terraced residential house with an existing front porch, a glass-roofed conservatory on the rear elevation and single-storey extensions at the northeast and northwest corners (**Photographs 1 - 2**).

Photograph 1. Front elevation of the property, viewed from the south.

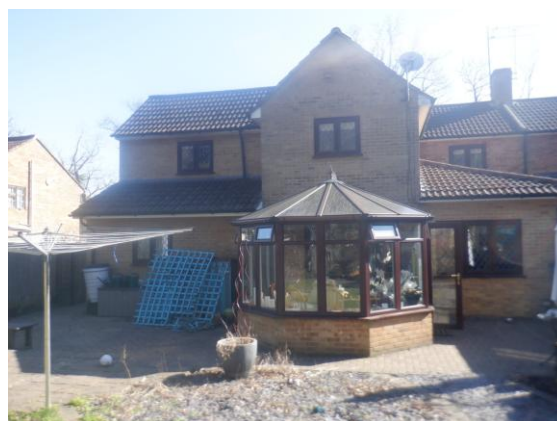
Photograph 2. Rear elevation of the property, viewed from the north.

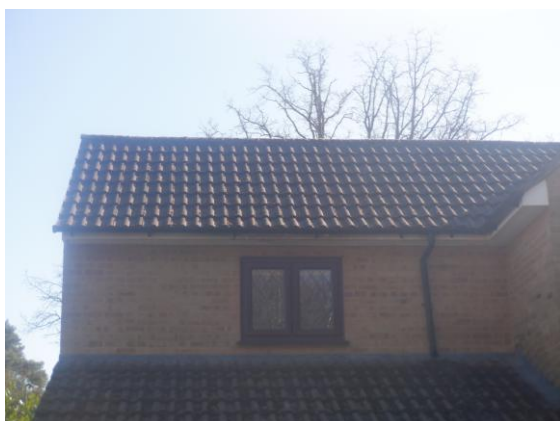
5.2.3 The second-storey pitched roofs were covered by interlocking concrete tiles that were fully sealed on all elevations (**Photograph 3**). Whilst the verge mortar was sealed along both gables, the mortar was partially crumbling along the eastern side of the single-storey rear extension roof, however a close inspection with a high-powered torch confirmed this feature to be of limited extent (**Photographs 4 & 5; Target note 1**). The ridge mortar was mostly intact other than a small section crumbling by the chimney on the rear elevation (**Photograph 6; Target note 2**).

Photograph 3. Fully sealed interlocking roof tiles (rear elevation).

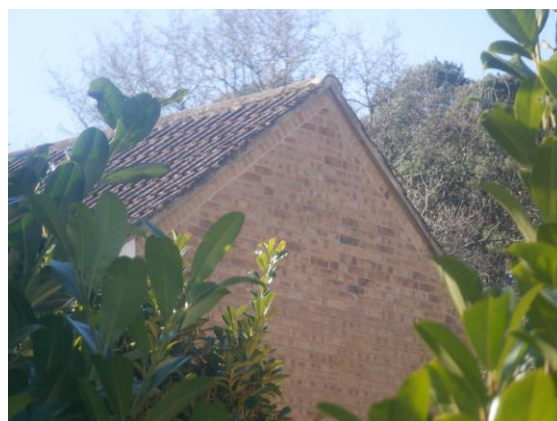
Photograph 4. Intact verge mortar along the gable (east elevation).

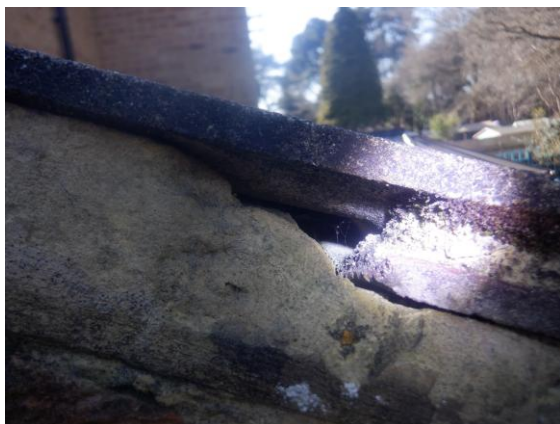
Photograph 5. Gap of limited extent behind crumbling verge mortar (east elevation).

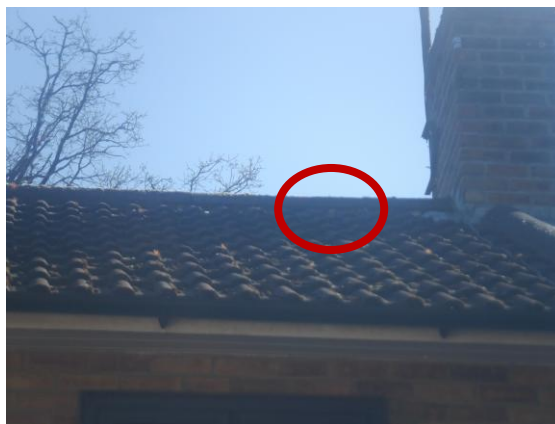
Photograph 6. Crumbling verge mortar (rear elevation).

- Crumbling ridge mortar (**Photograph 6; Target note 2**); and
- Crumbling verge mortar along the western elevation of the front porch (**Photograph 7; Target note 3**).

**6.1.3** The crumbling mortar behind the ridge tile may directly lead inside the roof void, which was of a suitable size and condition for void-dwelling bats, such as the locally recorded brown long-eared (*Plecotus auritus*), however, no bat droppings were observed and so the presence of void-dwelling bats is considered highly unlikely.

**6.1.4** The crumbling mortar at the ridge may also offer potential access and crevice roosting sites for crevice-dwelling bats such as the locally recorded common pipistrelle (*Pipistrellus pipistrellus*) and soprano pipistrelle (*Pipistrellus pygmaeus*). Evidence of

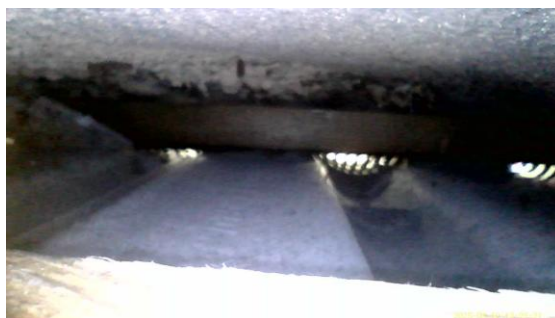
- 5.2.4** The verge mortar was partially crumbling along the western side of the front porch which was closely inspected during a follow-up endoscopic check which showed no evidence of use by roosting bats (**Photographs 7 & 8; Target note 3**).

Photograph 8. Endoscopic check of the crumbling verge mortar with no signs of use by roosting bats.

**6.1.2** Whilst a section of mortar was crumbling along the eastern elevation of the single storey roof, a close inspection with a high-powered torch confirmed the feature to be of limited extent with no signs of use by roosting bats (**Photograph 5; Target note 1**). The crumbling verge mortar along the western elevation of the porch roof was inspected with an endoscope, which showed the gap to be open to the underneath of the tiles and was able to be fully inspected and showed no signs of recent or historic use by roosting bats (**Photographs 7 & 8; Target note 3**).

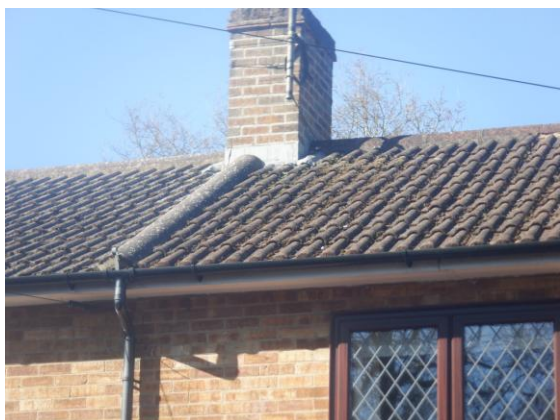
- 5.2.5** The lead flashing was flat around the base of the chimney and the base of the flue pipe, and was fully sealed along the brickwork walls of the property on all elevations (**Photographs 9 – 11**).

Photograph 9. Lead flashing sealed at the base of the chimney (front elevation).

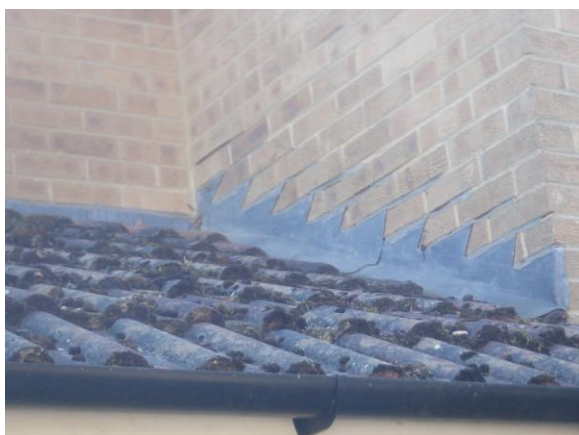
*Photograph 11. Lead flashing sealed to the brickwork wall and roof tiles (rear elevation).*

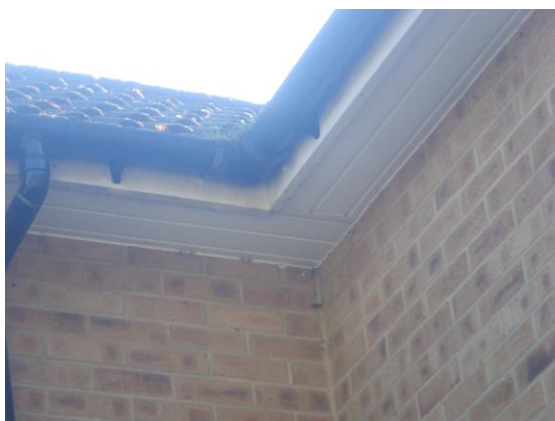
- 5.2.6** The uPVC soffit was fully sealed to the brickwork walls of the building across all elevations (**Photograph 12**).

*Photograph 12. uPVC soffit sealed to the brickwork walls of the building.*

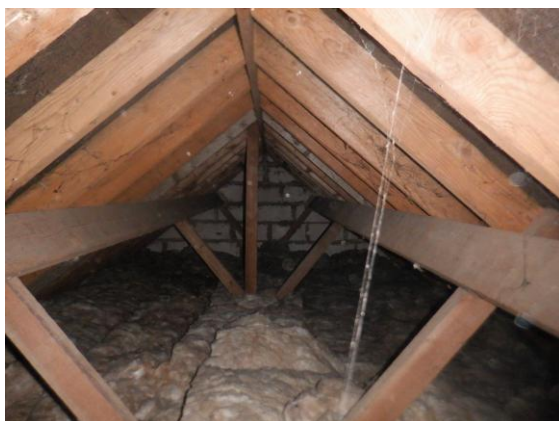
- 5.2.7** The building had one roof void that covered the two-storey footprint, and was accessible via two separate first-floor loft hatches. The void was of cut and pitch construction with an approximate floor-to-ridge height of 1 metre (**Photograph 13**).

*Photograph 13. Void of cut & pitch construction*

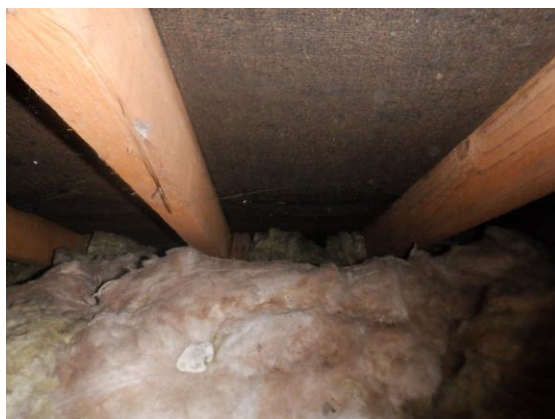
- 5.2.8** The roof was lined by hessian reinforced bitumen felt that was fully intact and cobwebbed throughout the void (**Photograph 14**). The floor was covered by a thick layer of fibreglass insulation that filled the eaves, preventing access to the soffit (**Photograph 15**).

*Photograph 15. Eaves filled with fibreglass insulation.*

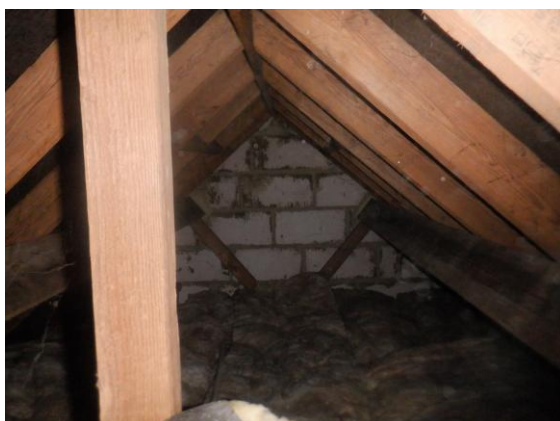
- 5.2.9** The eastern and northern blockwork gables, were fully sealed to the timbers and heavily cobwebbed along their edges (**Photographs 16 – 18**). The western brickwork party wall was visibly cobwebbed, but inaccessible due to a cluttered void (**Photographs 19**).

*Photograph 16. northeastern blockwork gable fully sealed to the timbers.*

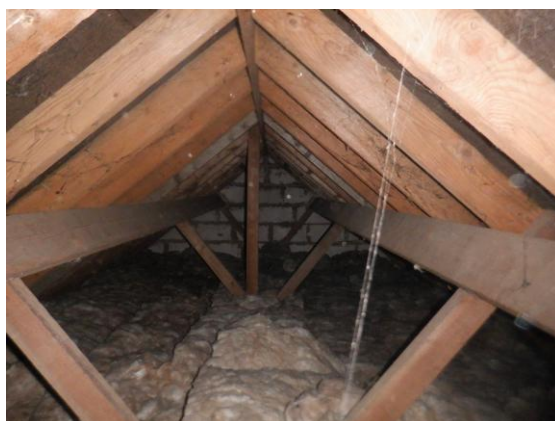
*Photograph 17. Northern blockwork gable fully sealed to the timbers.*

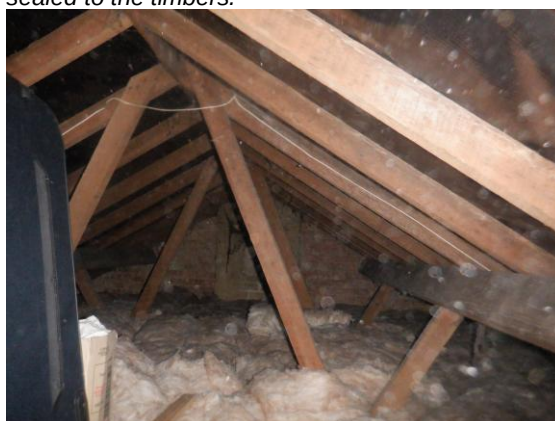
*Photograph 19. Cobwebbed brickwork party wall.*
