# ARBORICULTURAL IMPACT ASSESSMENT

Bridge Farm,  
Twyford

December 2024

**Barton Hyett Associates**  
Arboricultural Consultants

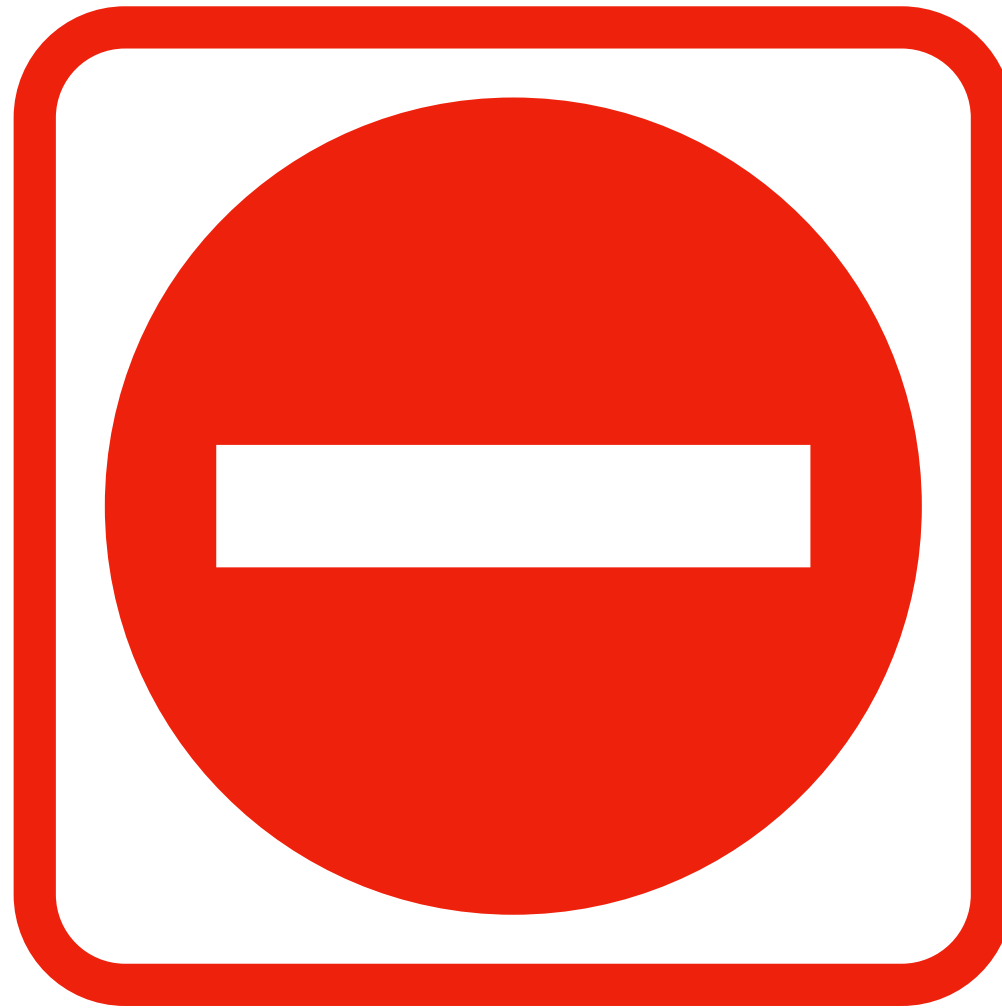
# CONSTRUCTION EXCLUSION ZONE - NO ENTRY

### Within the CEZ:

- No mixing of cement
- No soil/turf stripping, raising/lowering of ground levels (unless advised), deposit or excavation of soil or rubble
- No excavations for services or installation of services
- No storage of materials, machinery fuel, chemicals or other materials of any other description
- No parking/use of tracked or wheeled machinery
- No siting of temporary structures including hard standing areas, portaloos, site huts
- No lighting of fires or disposal of liquids
- Fires on site should be avoided if possible. Where they are unavoidable, they must not be lit in a position where heat could damage foliage or branches. Fires must be a minimum of 20m from the trunk of any retained tree or the centre line of any hedgerow to be retained
- No signs, cables, fixtures or fittings of any other description shall be attached to any part of a retained tree

## TREE PROTECTION FENCING
